FLUVIAL GEOMORPHIC AND EROSION HAZARD ASSESSMENT
STINSON LANDS
OTTAWA, ONTARIO

Prepared for:
NOVATECH ENGINEERING AND CONSULTANTS LTD.

Prepared by:
MATRIX SOLUTIONS INC., A MONTROSE ENVIRONMENTAL COMPANY

Version 1.0
April 2024
Guelph, Ontario

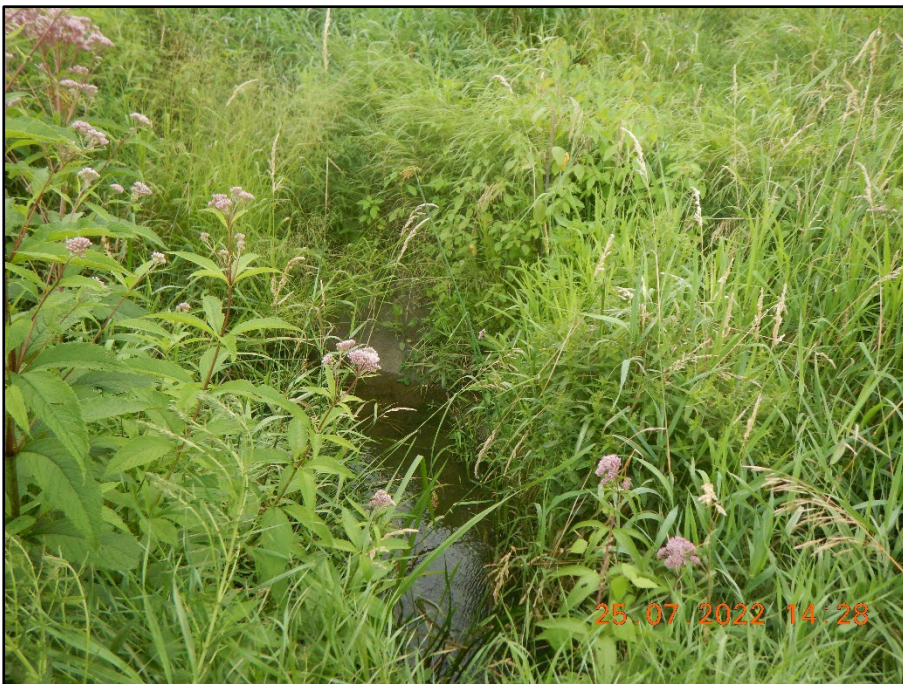
6. Wilson Cowan Drain - Facing downstream, the reach showed consistent signs of erosion in the form of steep outside meander banks, slumped banks, and failed banks

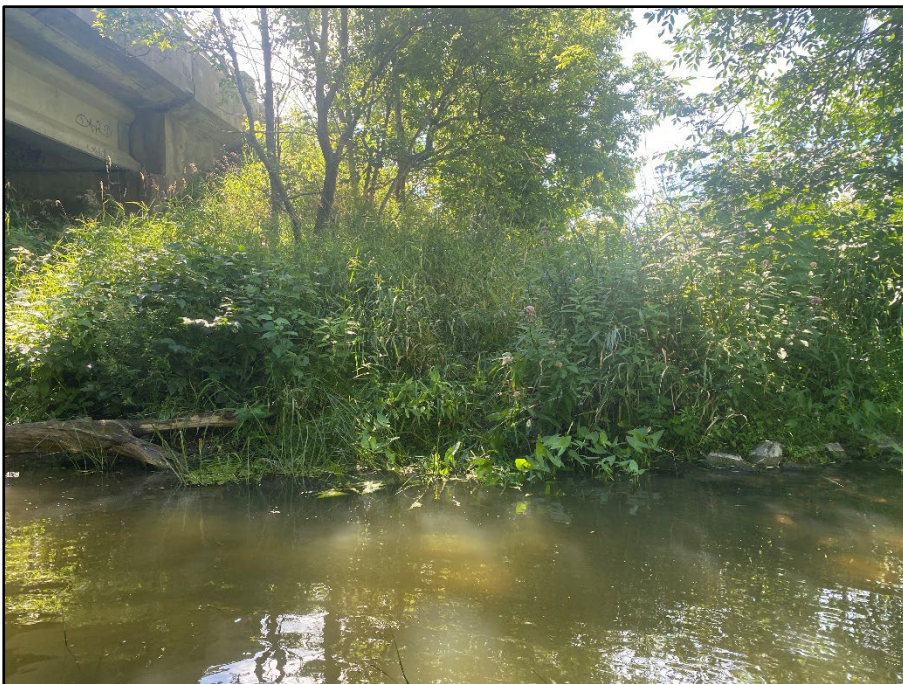
10. Mud Creek – Facing parallel to Rideau Valley Drive N, inlet location from the Oxbow feature into Mud Creek with an approximate 1 – 1.5 m elevation change
