April 25, 2024  
File: PE2830-LET.07

Subject: **Phase I Environmental Site Assessment Update  
Vacant Land  
1034 McGarry Terrace  
Ottawa, Ontario**

## **Phase I - ESA Update, Historical and Records Review**

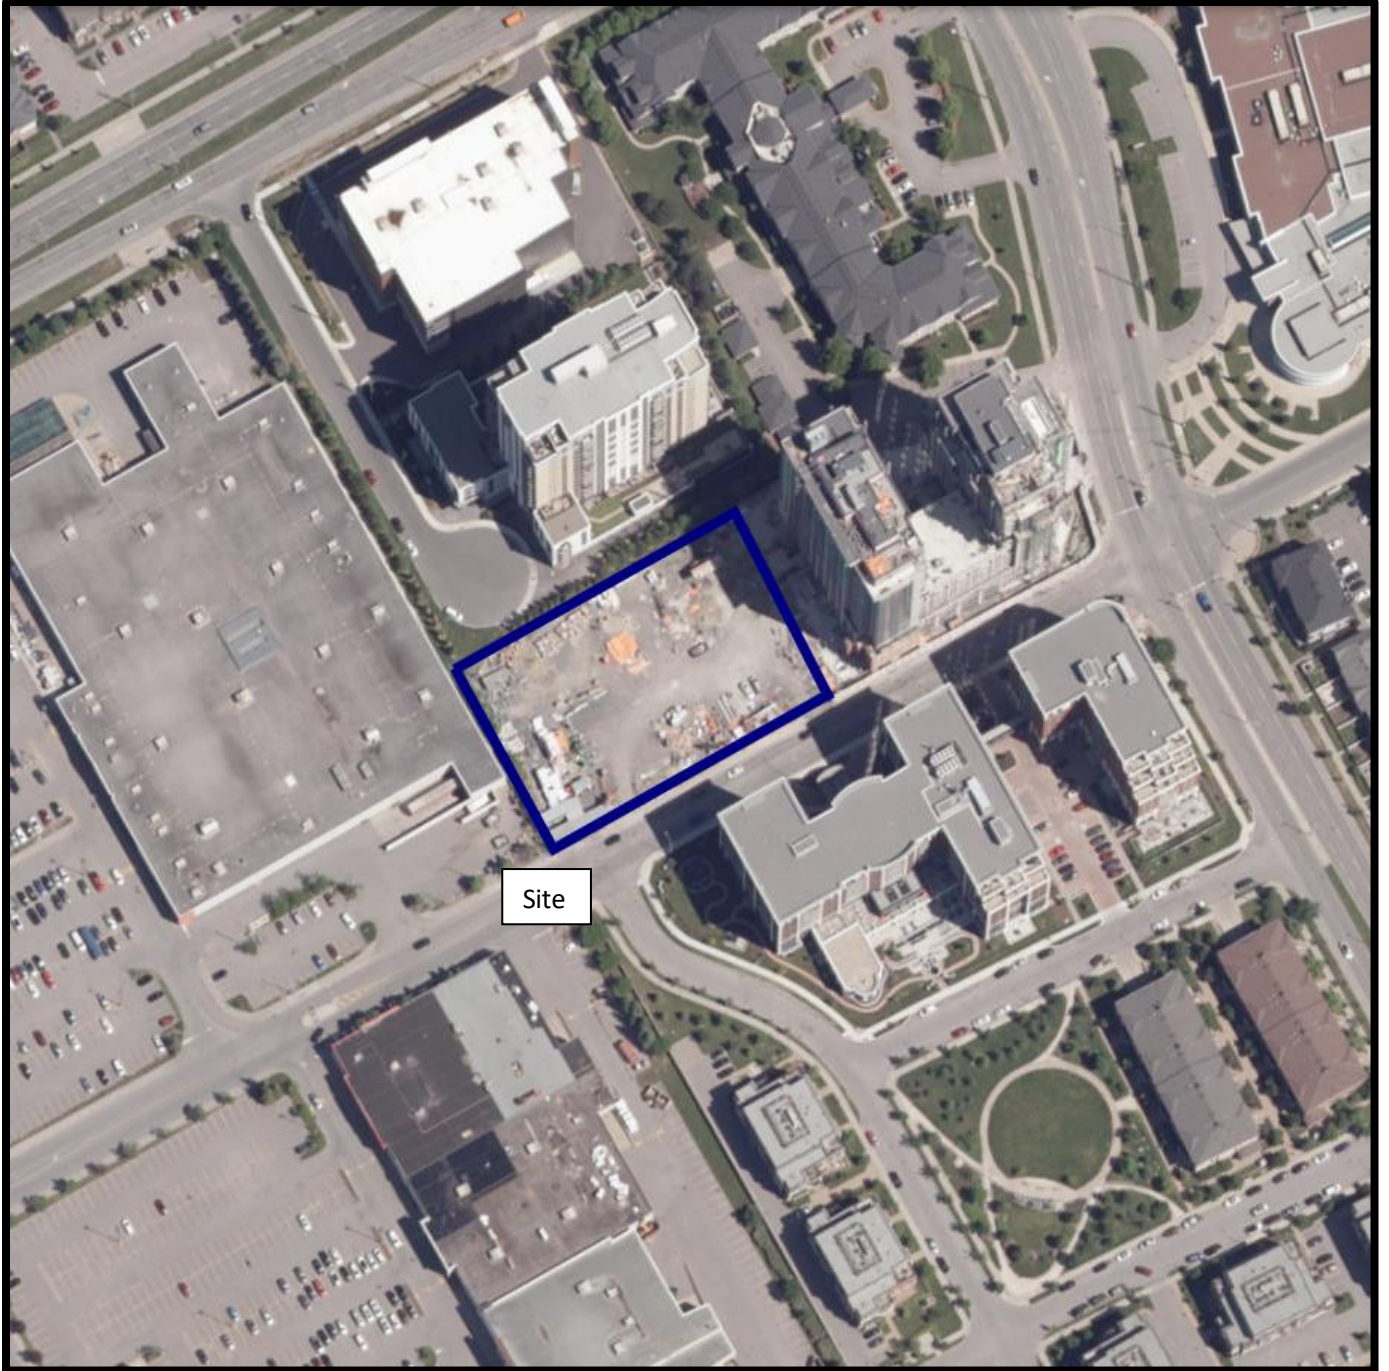
AERIAL PHOTOGRAPH  
2022

The most recent aerial photograph reviewed as part of the 2022 Phase I-ESA Update was taken in 2019. An aerial photograph from 2022, accessed via the City of Ottawa's online mapping tool, was reviewed as part of the current Phase I ESA Update. No

significant changes were observed in the 2022 photograph to the subject site. Two residential buildings and a self-storage building have been constructed east and north of the subject site.
