# Phase One Environmental Site Assessment

47 Beechwood Avenue, 5 Springfield Road, and 12 Douglas  
Avenue  
Ottawa, Ontario

March 15, 2023

Pinchin File: 321299

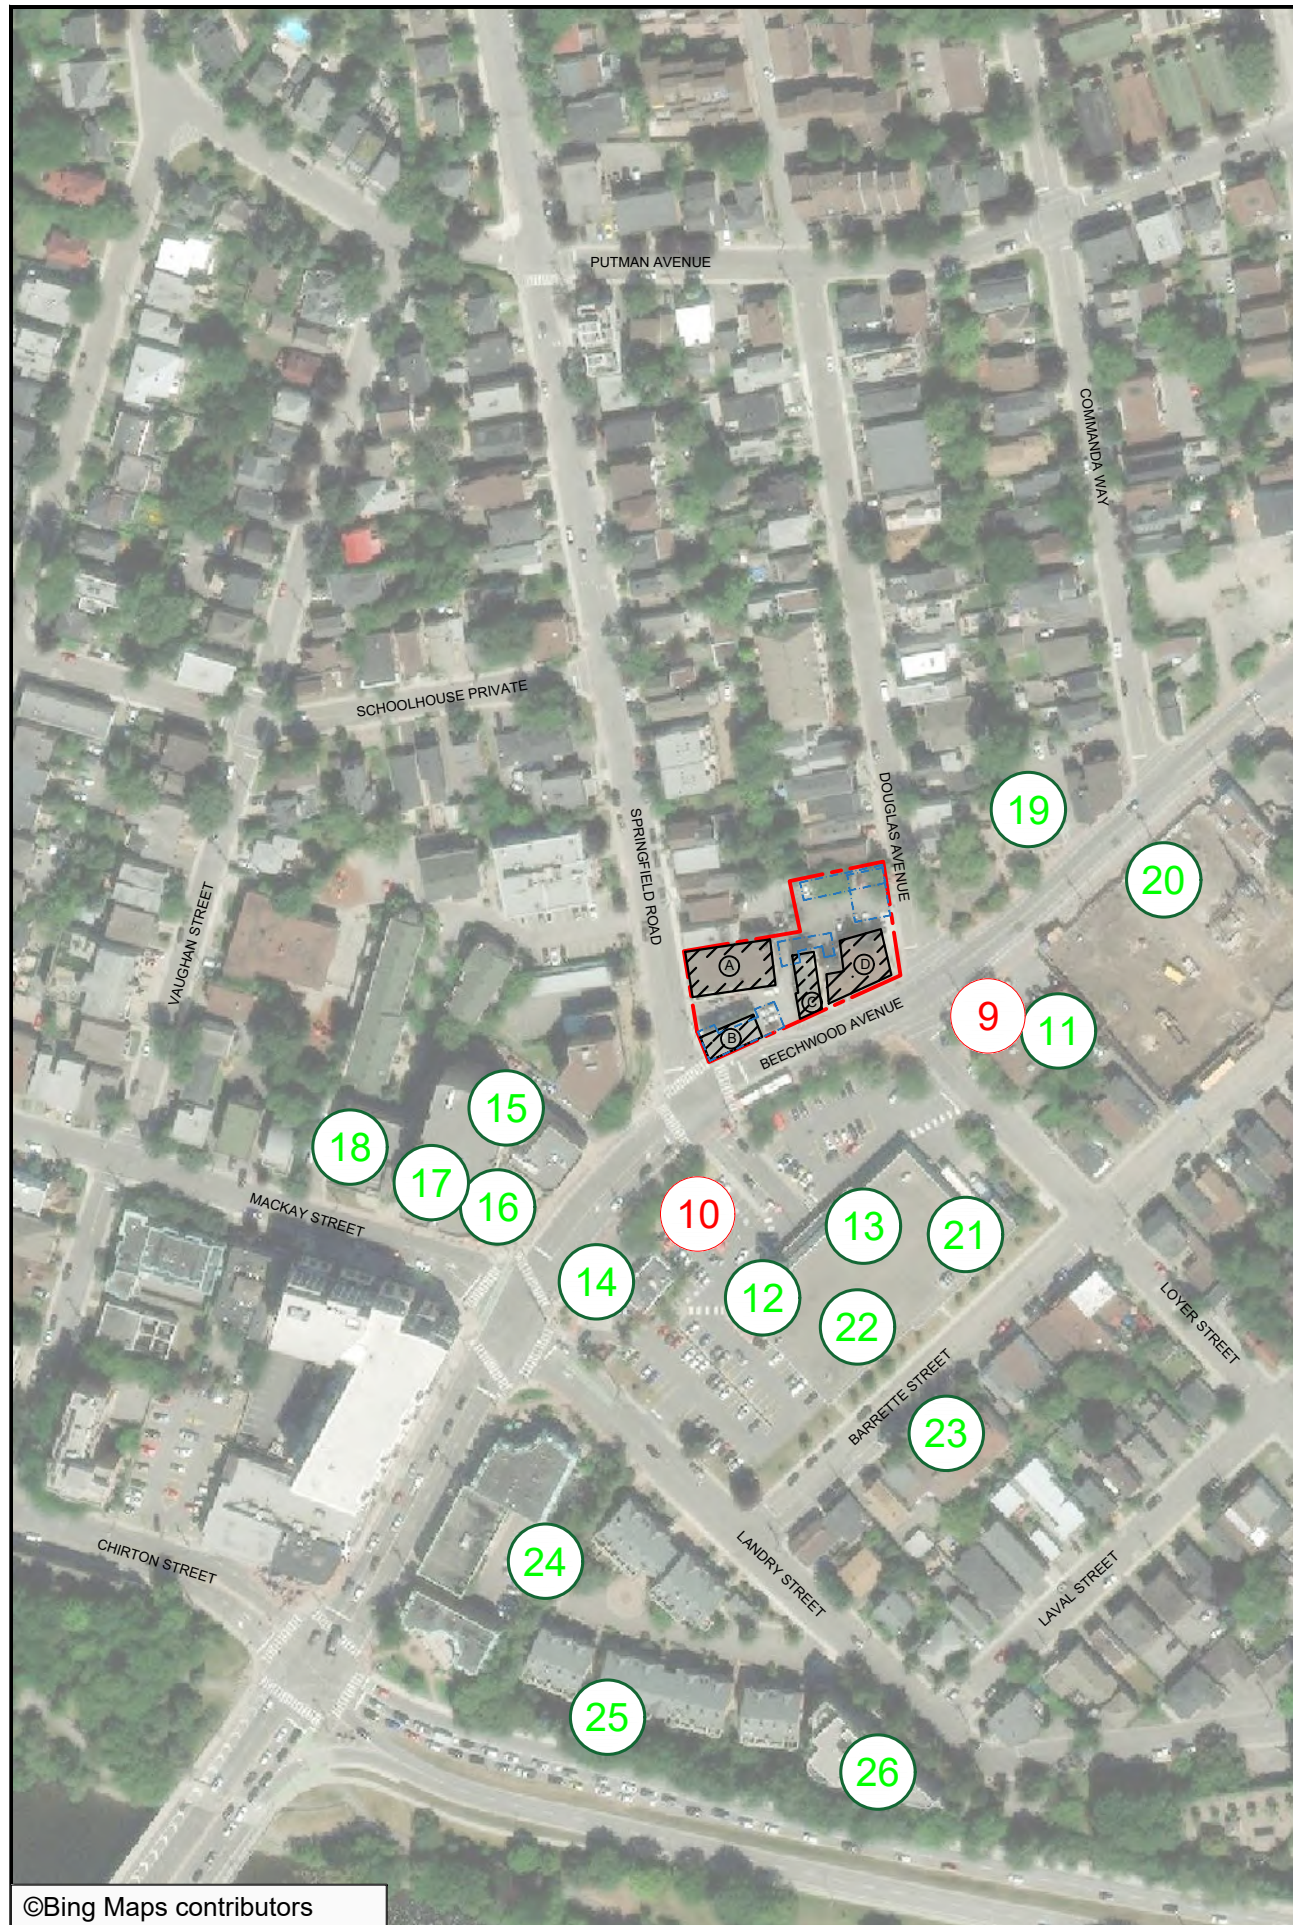
PROJECT NUMBER: 321299	SCALE: AS SHOWN
DRAWN BY: KL	REVIEWED BY: SY
DATE: MARCH 2023	FIGURE NUMBER: 5

PCA Designation	Location of Potentially Contaminating Activity	Potentially Contaminating Activity	Location of PCA (On-Site or Off-Site)	Contributing to an APEC at the Site (Yes/No)	Media Potentially Impacted (Ground Water, Soil and/or Sediment)
PCA-8	Pavement and parking areas located throughout the Phase One Property	Item 48 - Salt Manufacturing, Processing and Bulk Storage	On-Site	Yes	Soil and Groundwater
PCA-9	30 m southeast of the Phase One Property.	Item 28 - Gasoline and Associated Products Storage in Fixed Tanks	Off-Site	Yes	Groundwater
PCA-10	26 Beechwood Avenue	Item 37 - Operation of Dry Cleaning Equipment (where chemicals are used)	Off-Site	Yes	Groundwater
PCA-11	64 Beechwood Avenue	Other - Spill	Off-Site	No	Groundwater
PCA-12	95 m southwest of the Phase One Property	Item 59 - Wood Treating and Preservative Facility and Bulk Storage of Treated and Preserved Wood Products	Off-Site	No	Groundwater

PCA-13	45 m south of the Phase One Property.	Other - Upholstering Activities	Off-Site	No	Groundwater
PCA-14	20 Beechwood Avenue.	Item 28 - Gasoline and Associated Products Storage in Fixed Tanks	Off-Site	No	Groundwater
PCA-15	420 McKay Street	Other - Hazardous Waste Generation	Off-Site	No	Groundwater
PCA-16	420 McKay Street	Item 28 - Gasoline and Associated Products Storage in Fixed Tanks	Off-Site	No	Groundwater
PCA-17	420 McKay Street	Other - Office Fitting and Showcase Factory	Off-Site	No	Groundwater
PCA-18	90 m west of the Phase One Property	Item 59 - Wood Treating and Preservative Facility and Bulk Storage of Treated and Preserved Wood Products	Off-Site	No	Groundwater
PCA-19	63 Beechwood Avenue (presumed to have been located 50 m northeast of the Phase One Property)	Item 37 - Operation of Dry Cleaning Equipment (where chemicals are used)	Off-Site	No	Groundwater
PCA-20	94 Beechwood Avenue	Other - Hazardous Waste Generation	Off-Site	No	Groundwater
