Phase I - Environmental Site Assessment

1137 Ogilvie Road and 1111 Cummings Avenue
Ottawa, Ontario

April 27, 2021

Report: PE5231-1

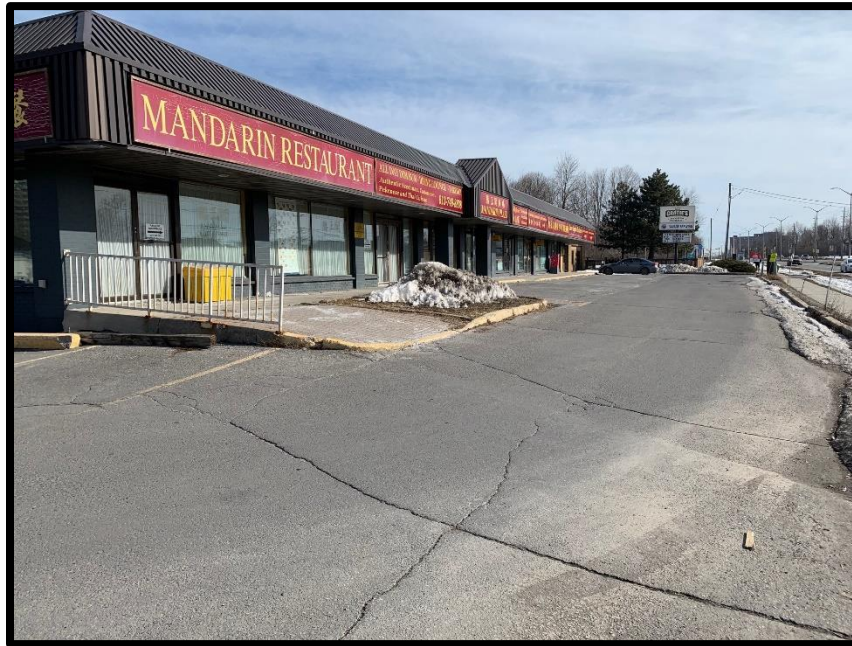
Photograph 1: View of the front of the commercial restaurant and grocery store addressed 1137 Ogilvie Road on the Phase I Property, facing east.

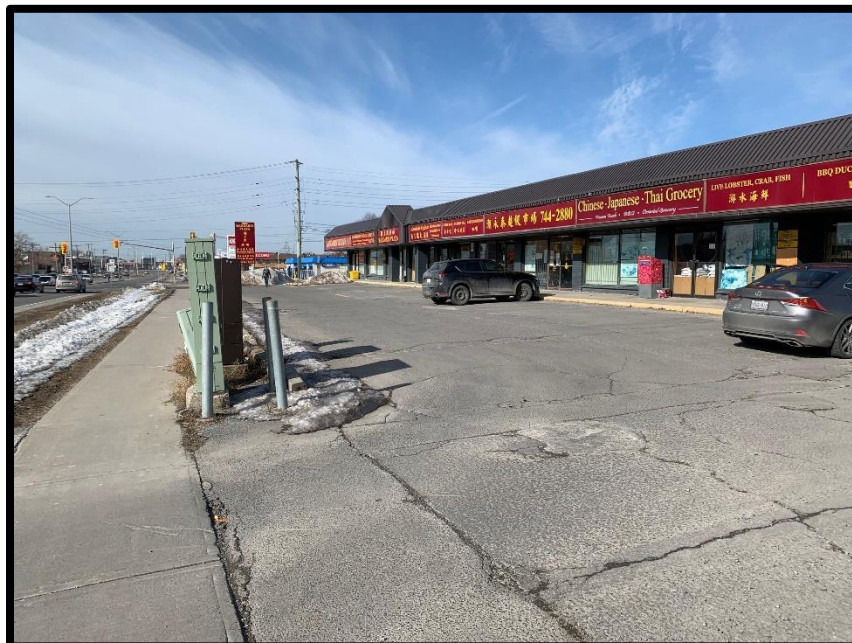
Photograph 2: View of the front of the commercial restaurant and grocery store addressed 1137 Ogilvie Road on the Phase I Property, facing west.

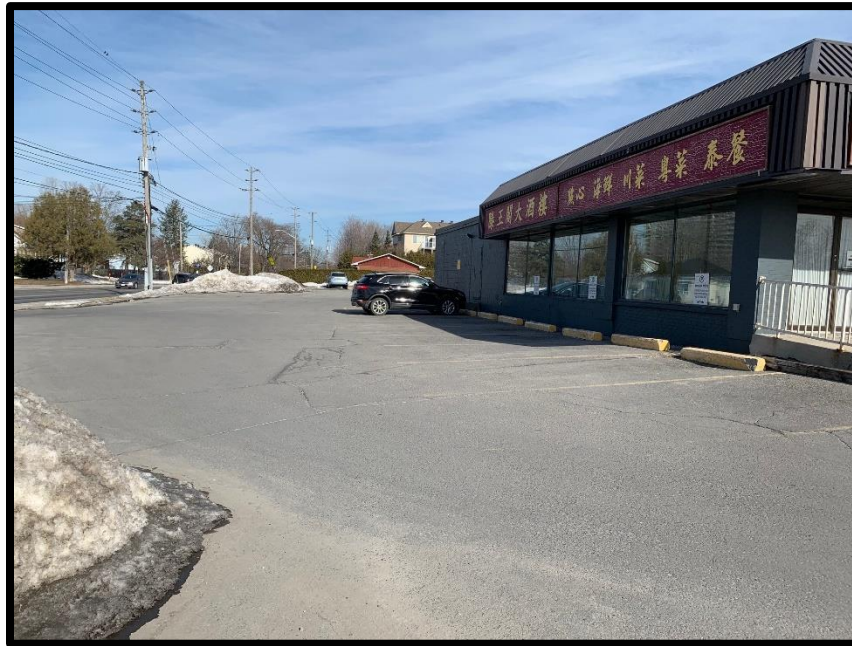
Photograph 3: View of the side of the commercial restaurant and grocery store addressed 1137 Ogilvie Road on the Phase I Property, facing north.

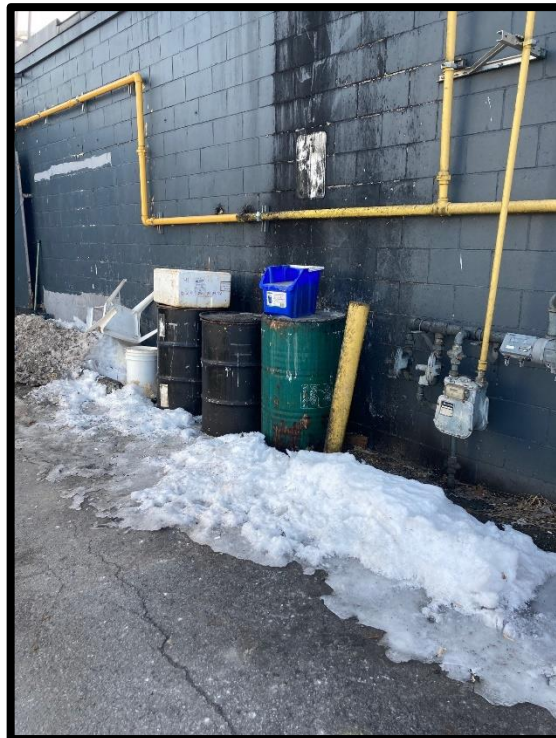
Photograph 4: View of the rear of the building at 1137 Ogilvie Road, grease contained in metal drums.

on the exterior of the Phase I Property and were noted to contain grease associated with the function of the subject structure as a restaurant. No environmental concerns were identified with respect to waste management practices on the Phase I Property.

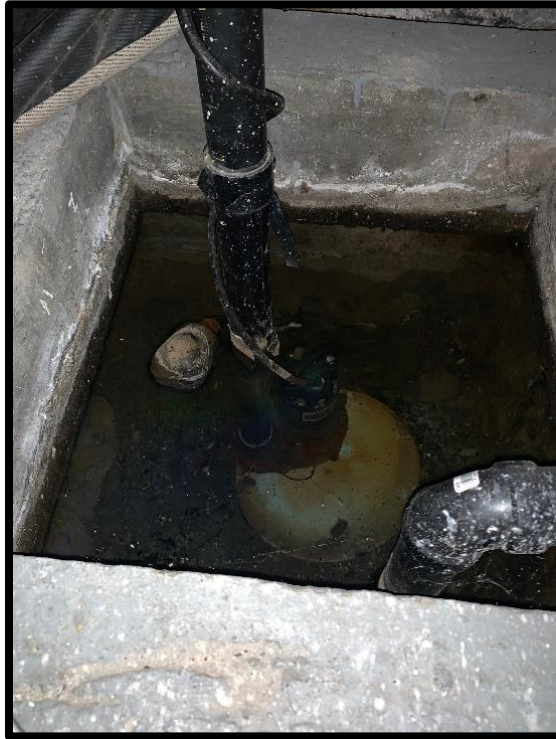
Photograph 5: View of the sump pit with sheen located in the basement of the 1137 Ogilvie Road.

Wastewater discharged from the Phase I Property includes wash water and sewage. Several floor drains were located throughout the subject building, both in the basement and the main floor, no water was observed in the floor drains. A sump pit was identified in the basement of the Phase I Property, the water was noted to contain a sheen but had no odor. The sheen noted on the water within the sump pit further supports the areas of potential concern caused by the surrounding existing/historic retail fuel outlets.

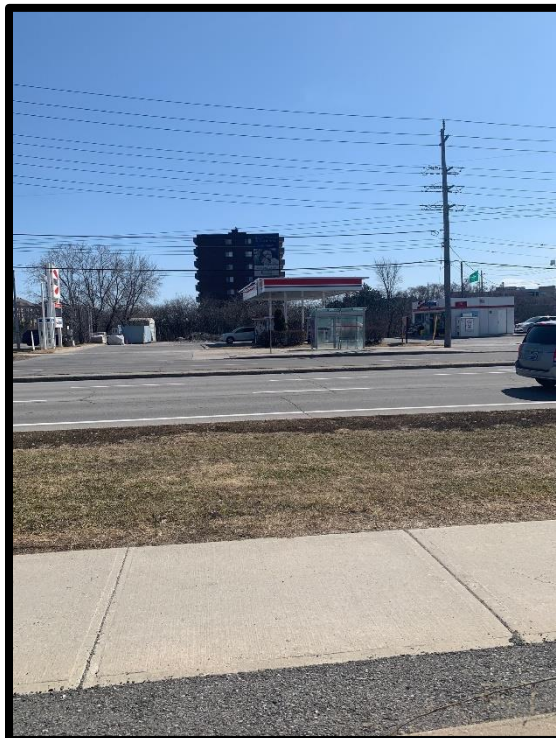
Photograph 6: View of the retail fuel outlet south of the Phase I Property across Ogilvie Road.

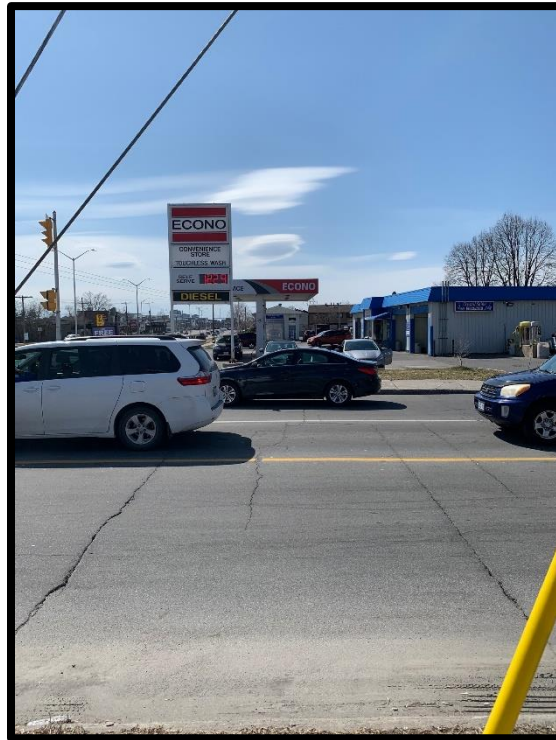
Photograph 7: View of the retail fuel outlet south of the Phase I Property across Ogilvie Road.
