## Phase I Environmental Site Assessment

Vacant Land  
Trim Road and Portobello Boulevard  
Ottawa, Ontario

January 20, 2018

Report: PE4111-1

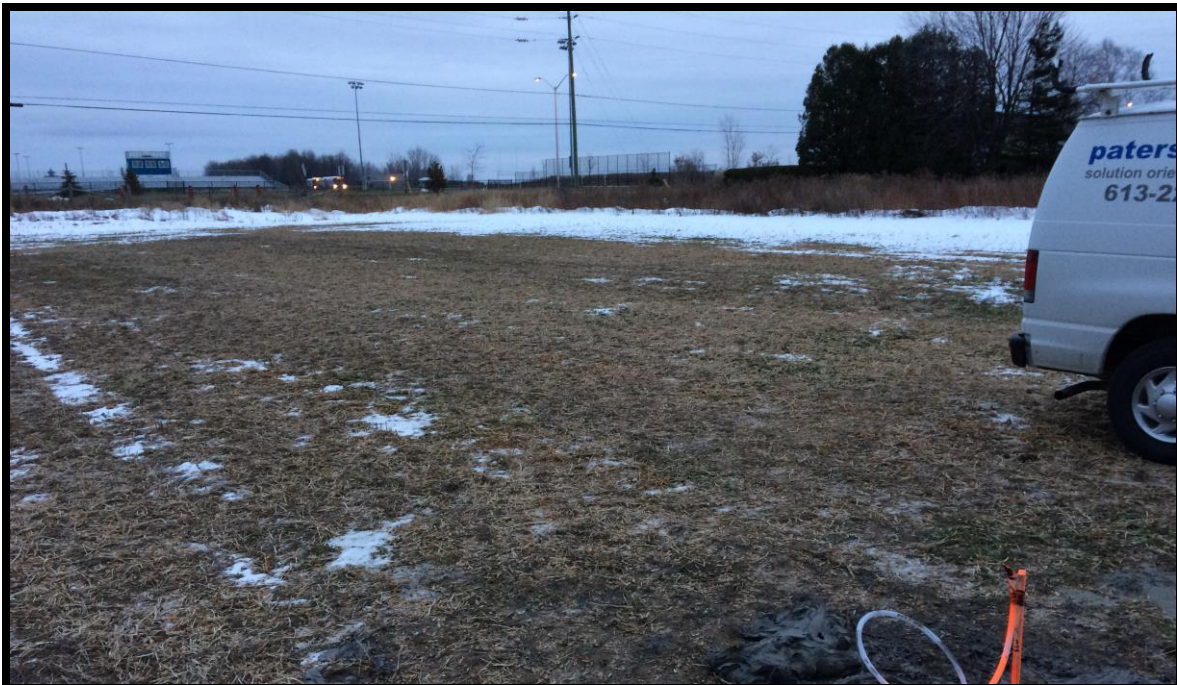
Photograph 4: View of eastern portion of the site, adjacent to Trim Road. Photograph taken facing northeast.
