Phase I Environmental Site Assessment

Vacant Land
Trim Road and Portobello Boulevard
Ottawa, Ontario

January 20, 2018

Report: PE4111-1

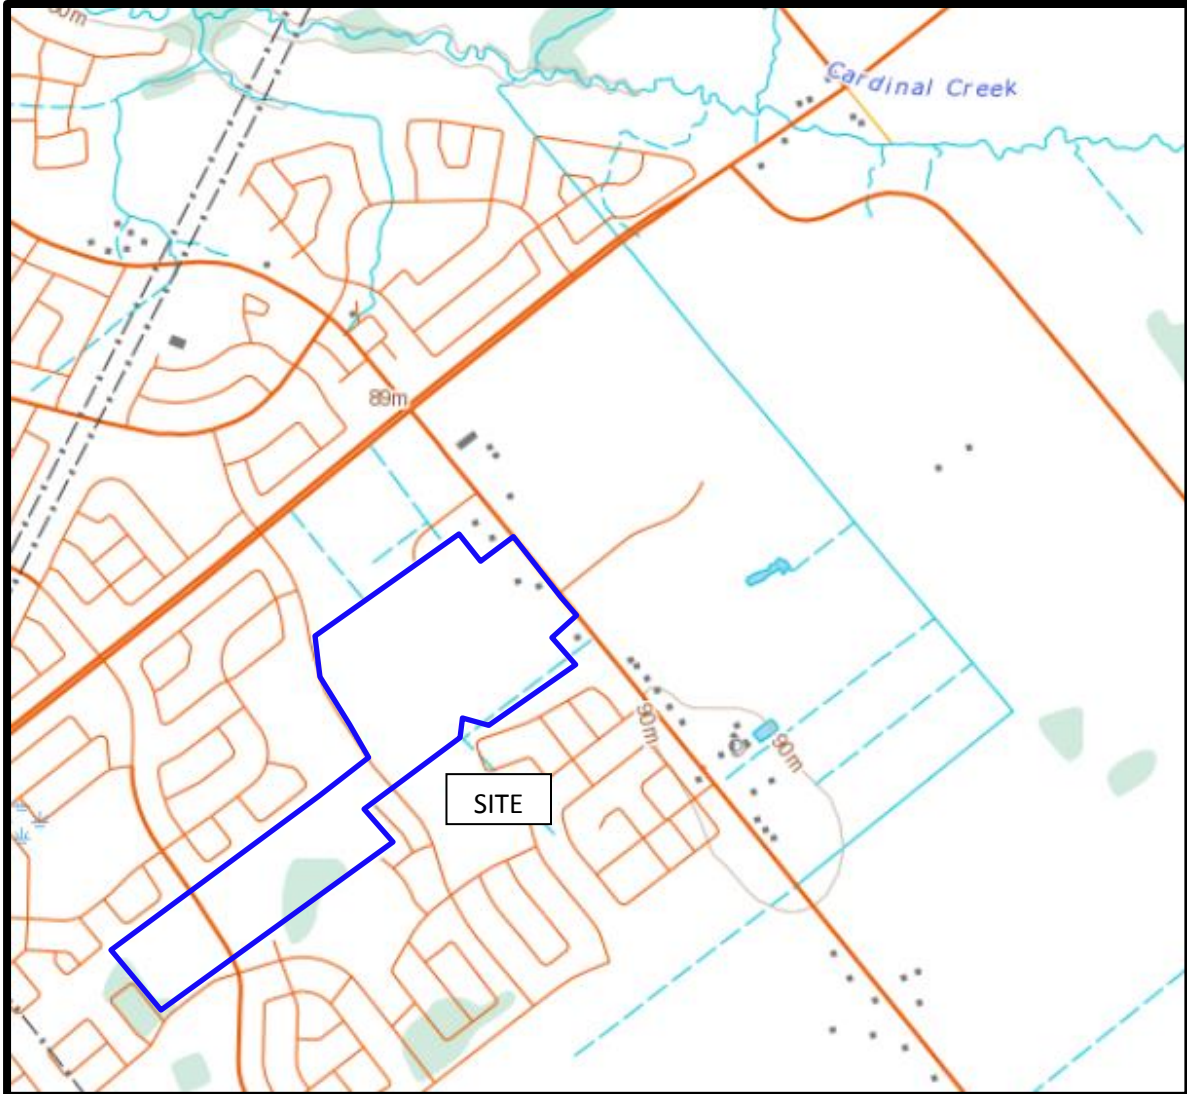
FIGURE 2
TOPOGRAPHIC MAP

Topographic maps were obtained from Natural Resources Canada – The Atlas of Canada website and from the City of Ottawa website. The topographic maps indicate that the regional topography in the general area of the site slopes gently downward towards the northeast. According to the maps, the nearest water body is Cardinal Creek located approximately 1,175m northeast of the subject site. An illustration of the referenced topographic map is presented on Figure 2 – Topographic Map, appended to this report.

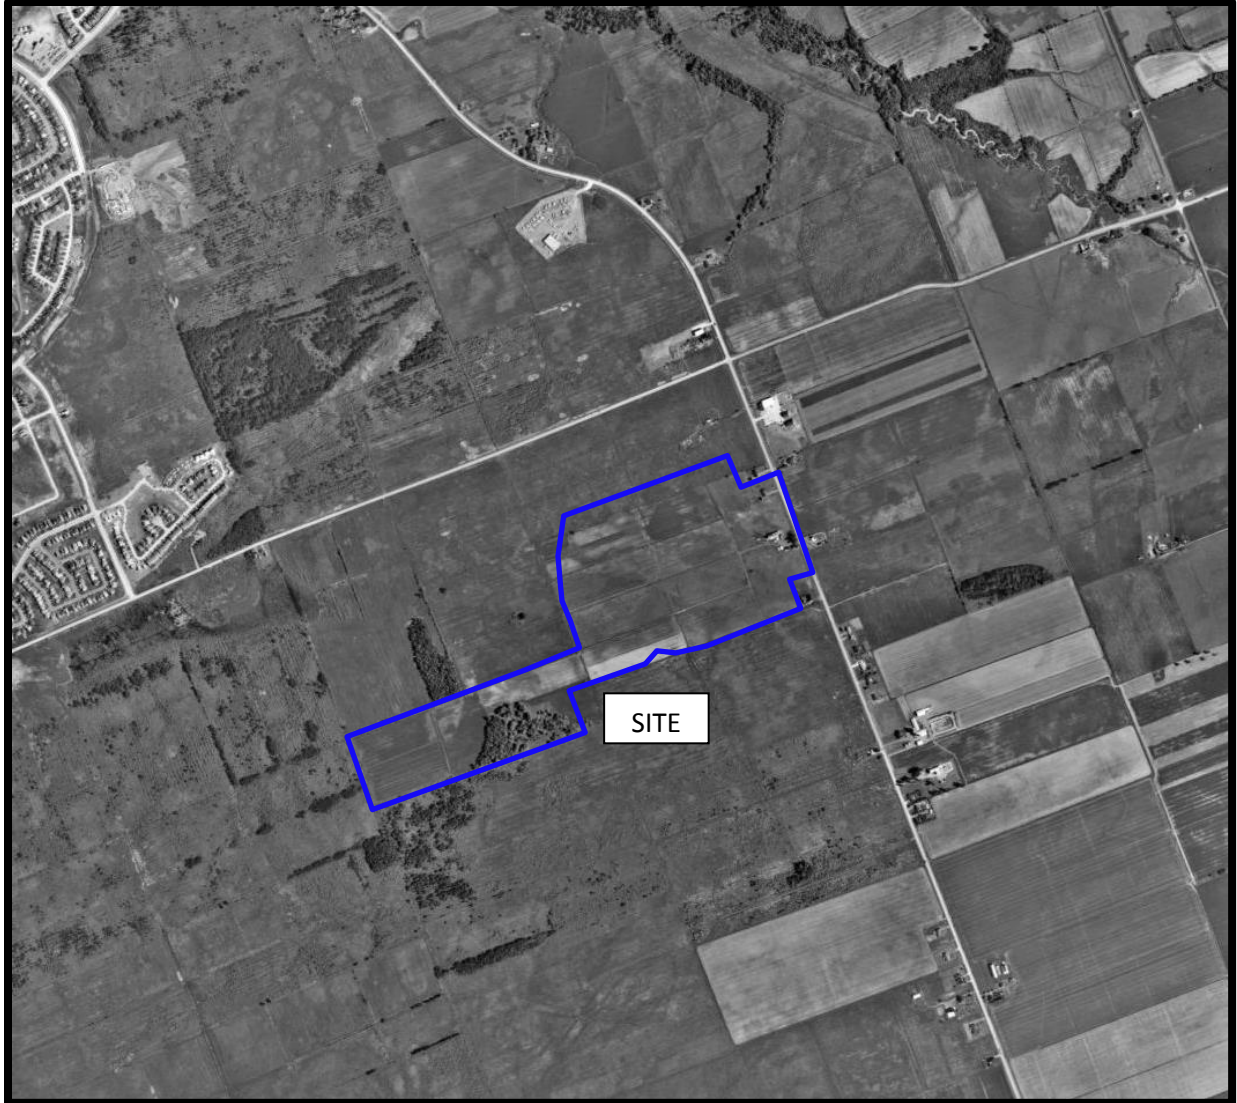
AERIAL PHOTOGRAPH
1991

| 1991 | (City of Ottawa website) No significant changes have been made to the subject site. Residential dwellings have been developed adjacent to the subject site along Trim Road. |

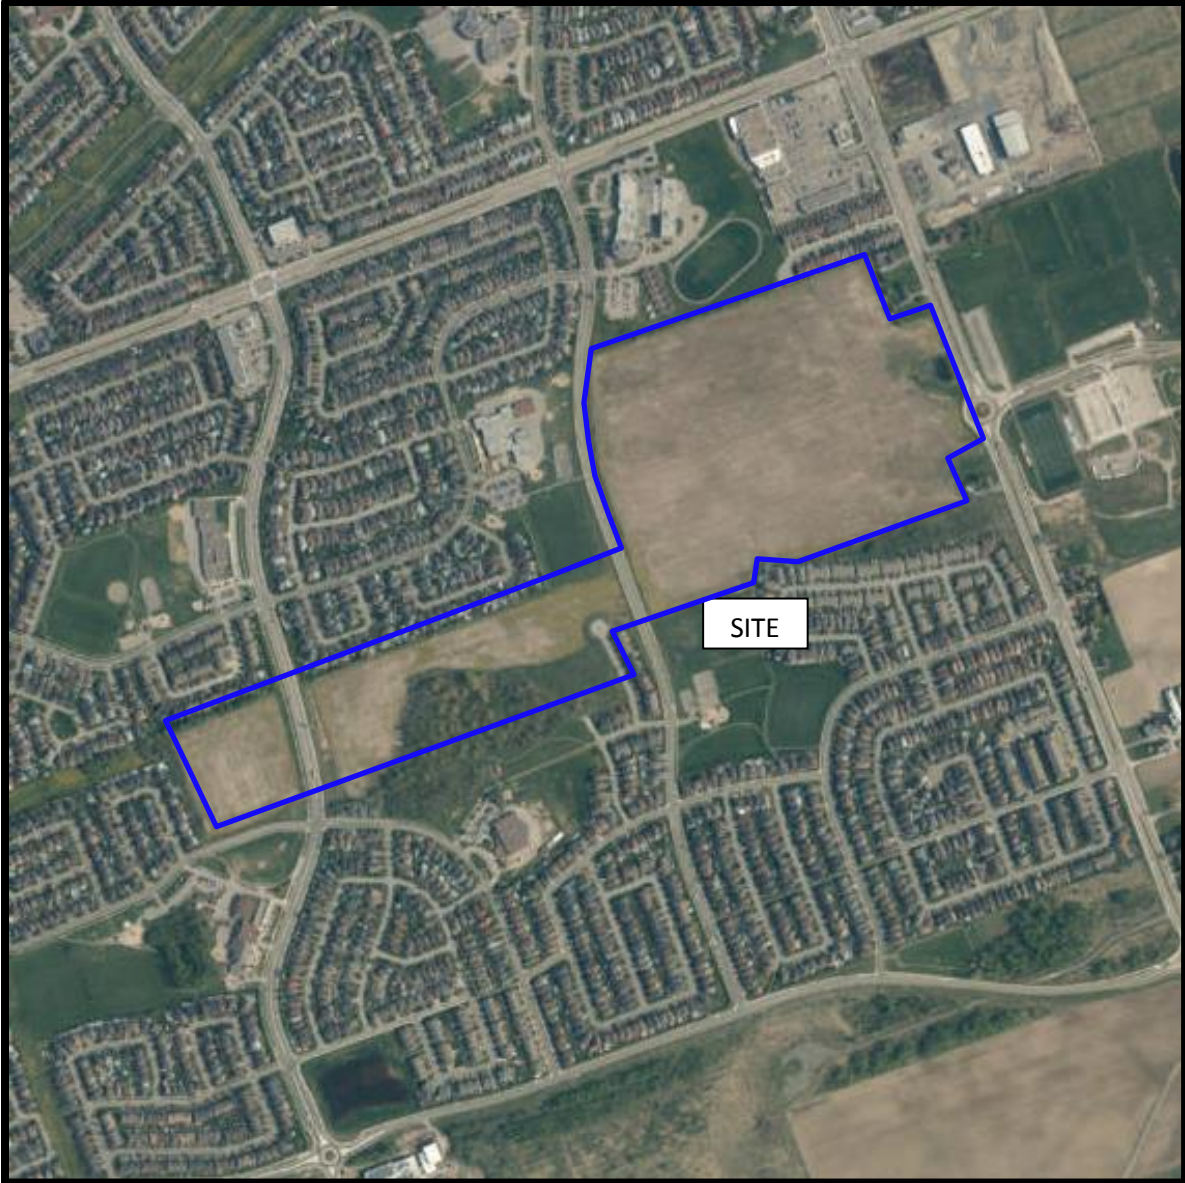
AERIAL PHOTOGRAPH
2017

2017 (City of Ottawa website) The subject site and neighbouring properties appear as they do today. Residential dwellings have been constructed south (north of Montmère Avenue and east of Provence Avenue) and north (along Scala Avenue) of the subject site. The City of Ottawa's Trim Road Garage Depot is visible further to the northeast, on the east side of Trim Road (2035 Trim Road and 5300 Innes Road).

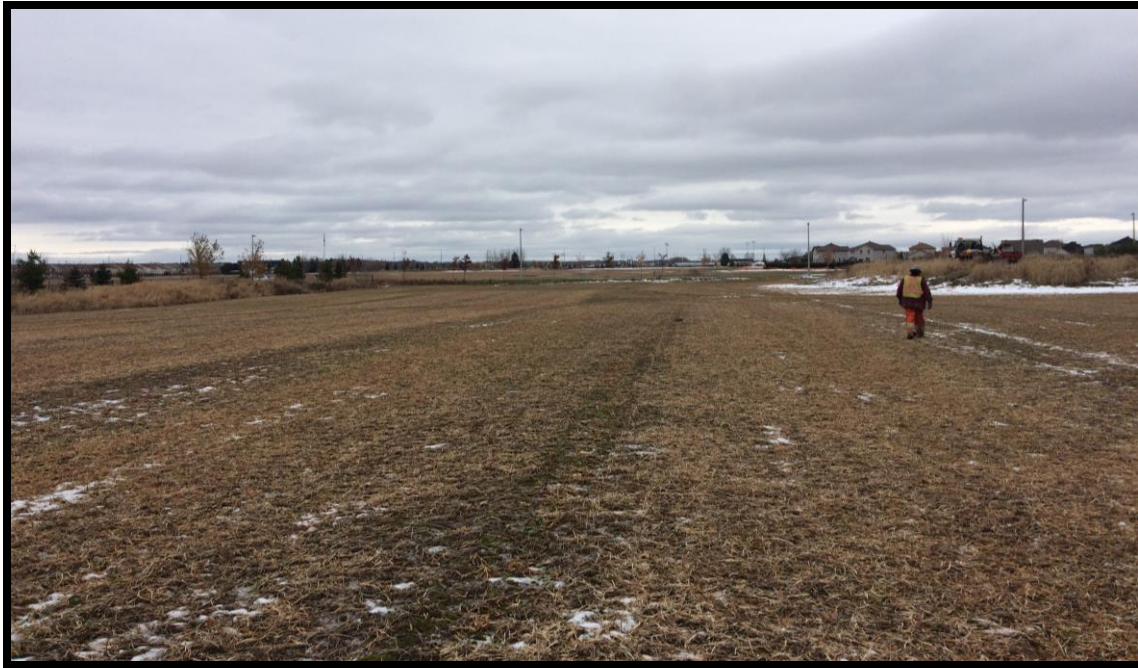
Photograph 1: View of the southwestern portion of the site, facing east. Photograph depicts an agricultural field, the main land cover on the site.

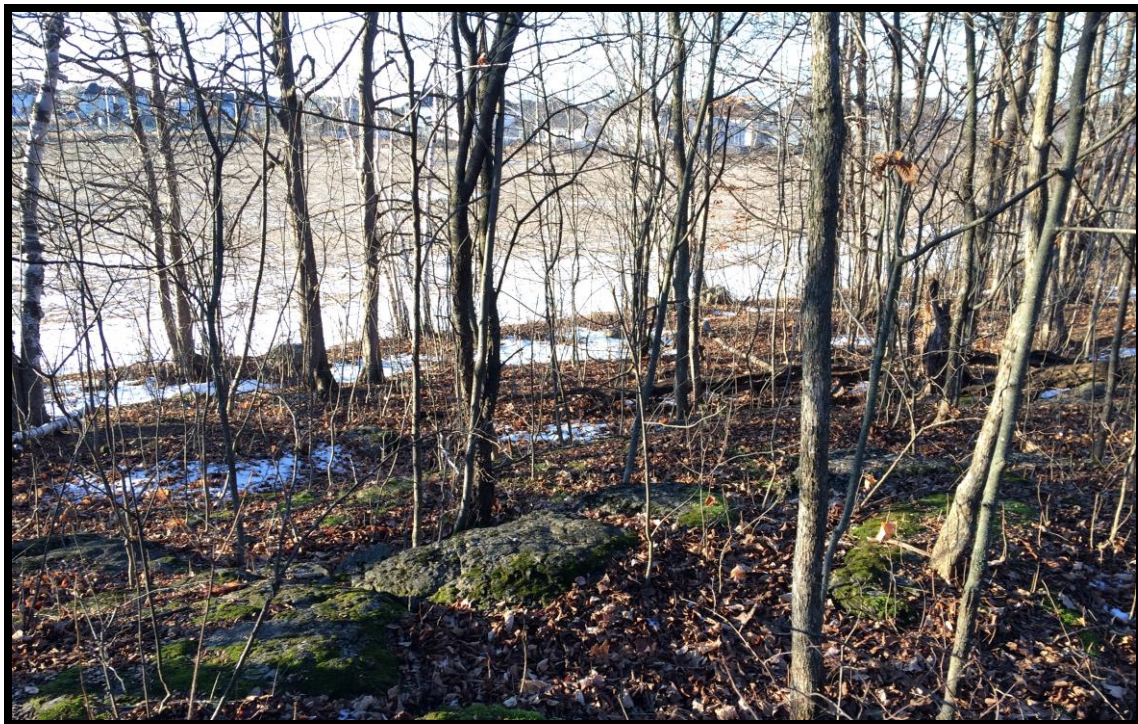
Photograph 2: View of the forested area with outcropping bedrock on the southwest portion of the subject site, facing north.

The subject site is generally flat and undeveloped agriculture land. A small forested ridge with outcropping bedrock is located on the southern portion of the site, north of the Lalande Conservation Park and east of Portobello Boulevard. Drainage consists primarily of infiltration with some sheet flow to catch-basins along adjacent roads. The adjacent properties are generally at grade with the subject site. The site was snow covered at the time of the site visit, however, site photographs were taken by Paterson personnel from the geotechnical department in November, prior to the arrival of snow.

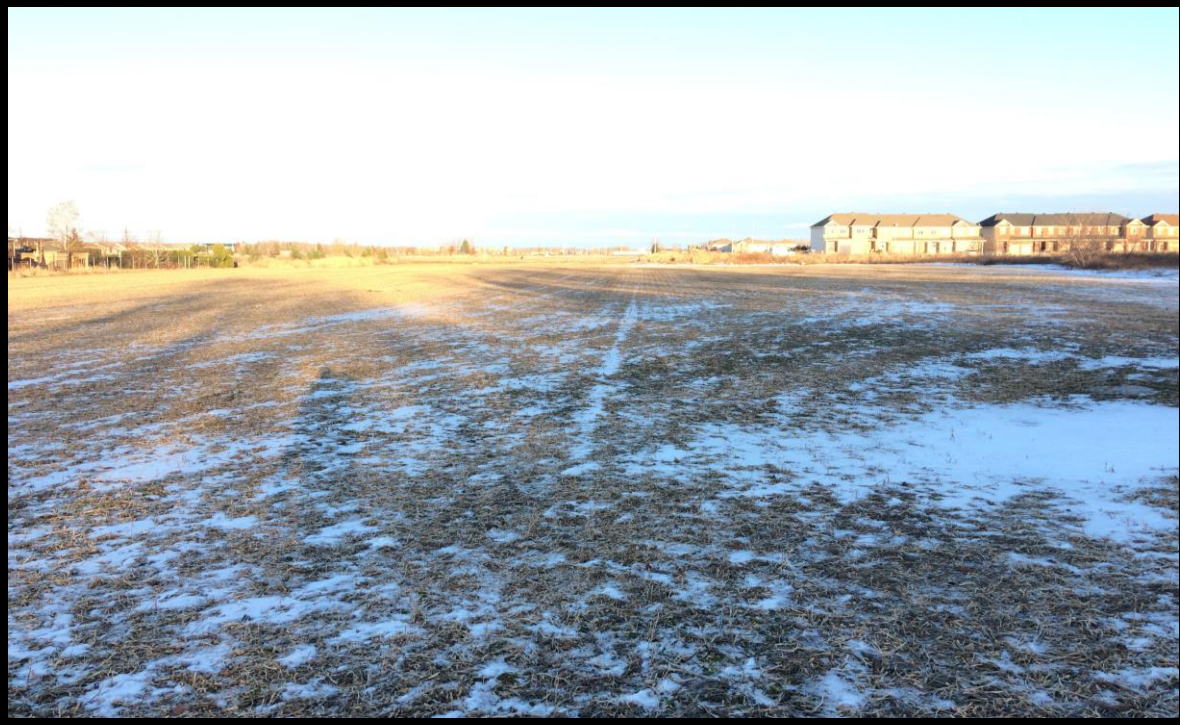
Photograph 3: View of the central portion of the subject site, facing southwest.

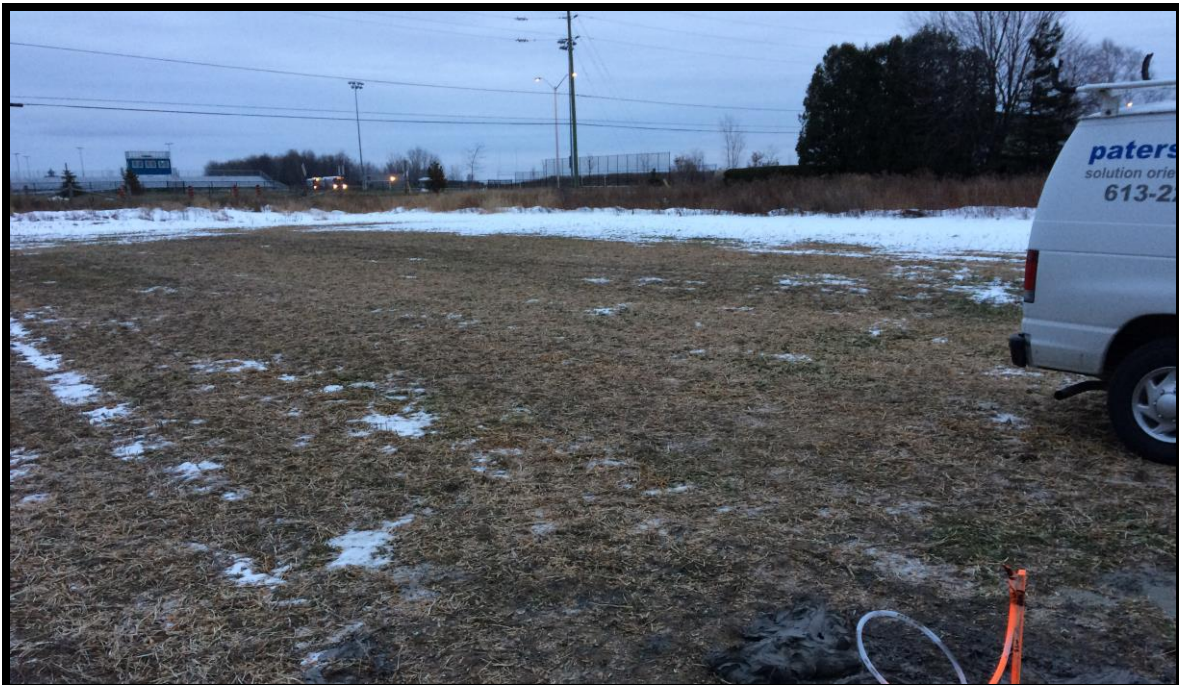
Photograph 4: View of eastern portion of the site, adjacent to Trim Road. Photograph taken facing northeast.

It is suspected that building debris, currently covered by vegetation, is located in the vicinity of the former house and farm buildings along Trim Road. No other unidentified substances or fill material on the exterior of the subject property at the time of this assessment. These remnant building materials are not considered to pose a significant risk to the subject land.
