Phase I – Environmental Site Assessment

10 Garrison Street
Ottawa, Ontario

Prepared for Farzin Fararooni

Report: PE6473-1
May 14, 2024

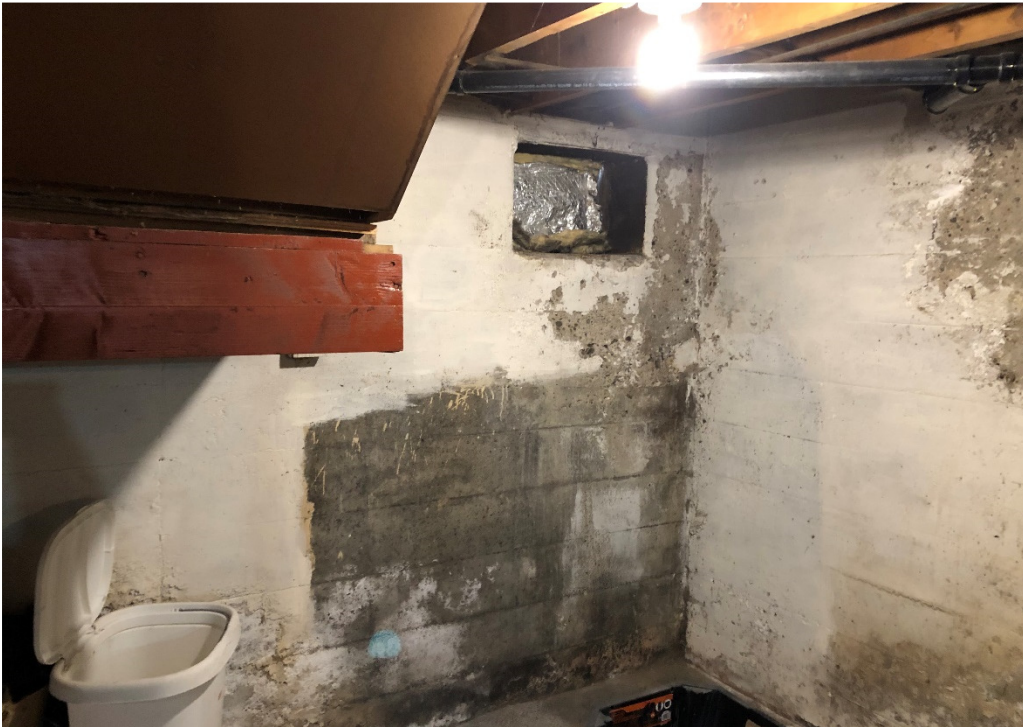
No vent and fill pipes, aboveground fuel storage tanks, or evidence indicating the presence of any underground fuel storage tanks were observed within the subject building at the time of the site inspection. A former coal chute access in the basement/foundation wall was observed at the rear of the dwelling, along the southwest corner of the building. The floor slab at the location of the former coal chute was in good condition at the time of the site inspection, some discoloration was observed.

Photograph 1: Southwest corner of basement, former coal chute location.

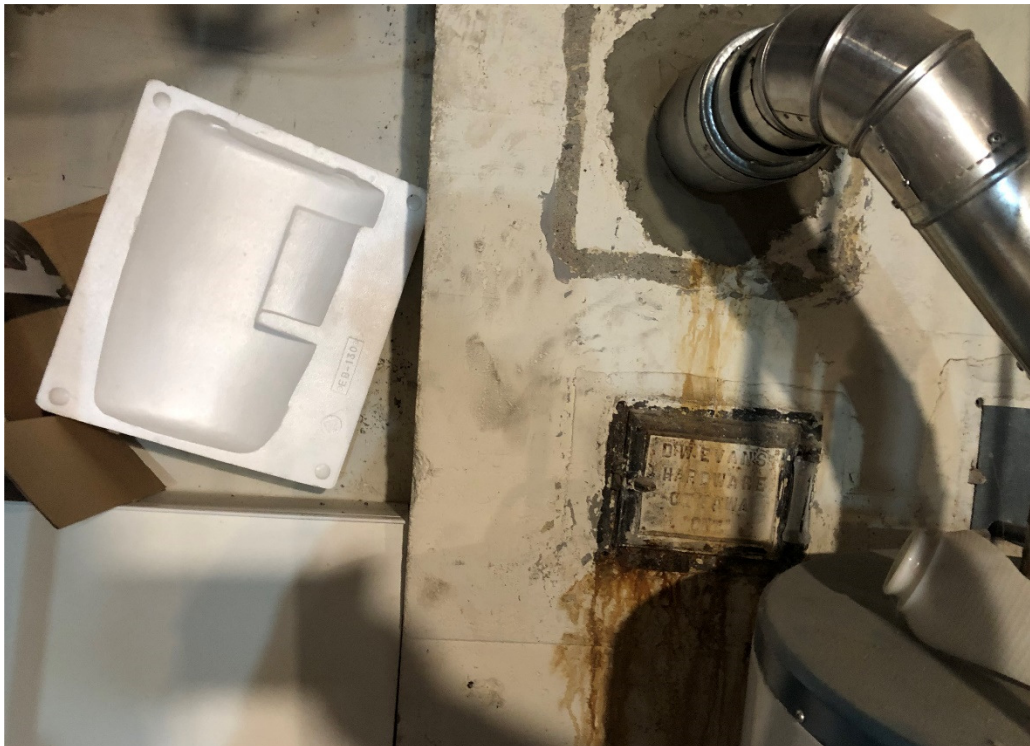
At the time of the site inspection, no vent and fill pipes, above ground fuel storage tanks (ASTs), or evidence indicating the presence of any underground fuel storage tanks (USTs) were observed on the exterior of the Phase I Property. At the rear of the dwelling, a former coal chute was observed, and associated chimney stack.

Photograph 2: Eastern portion of the basement, former chimney.

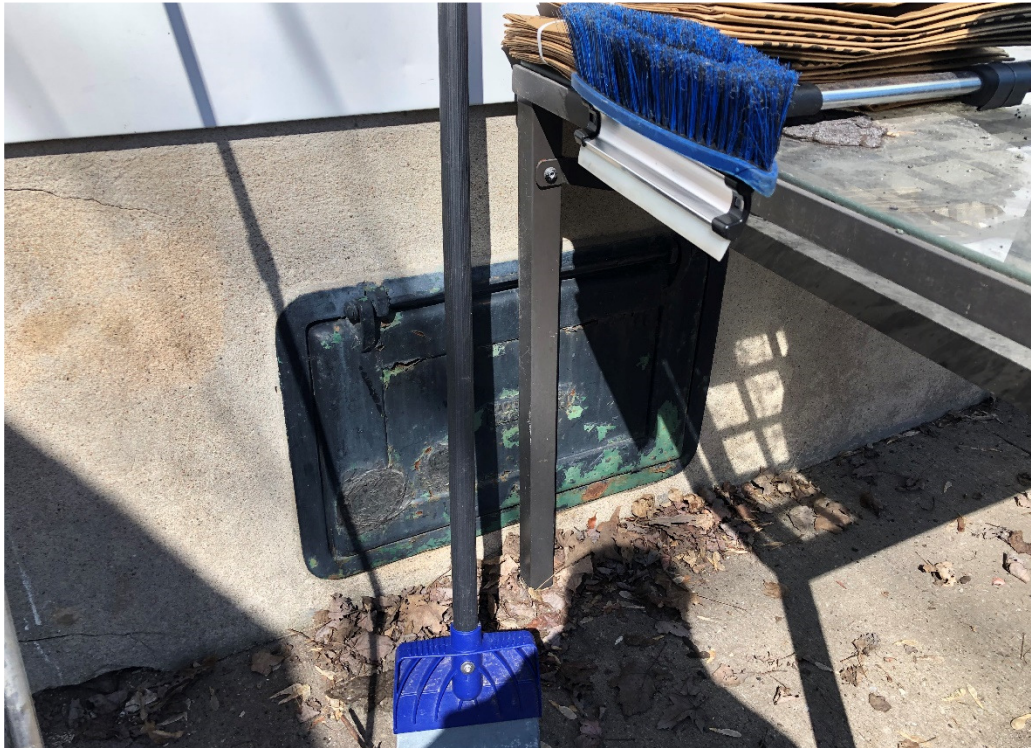
Photograph 3: View of the former coal chute from the exterior of the dwelling, looking north.

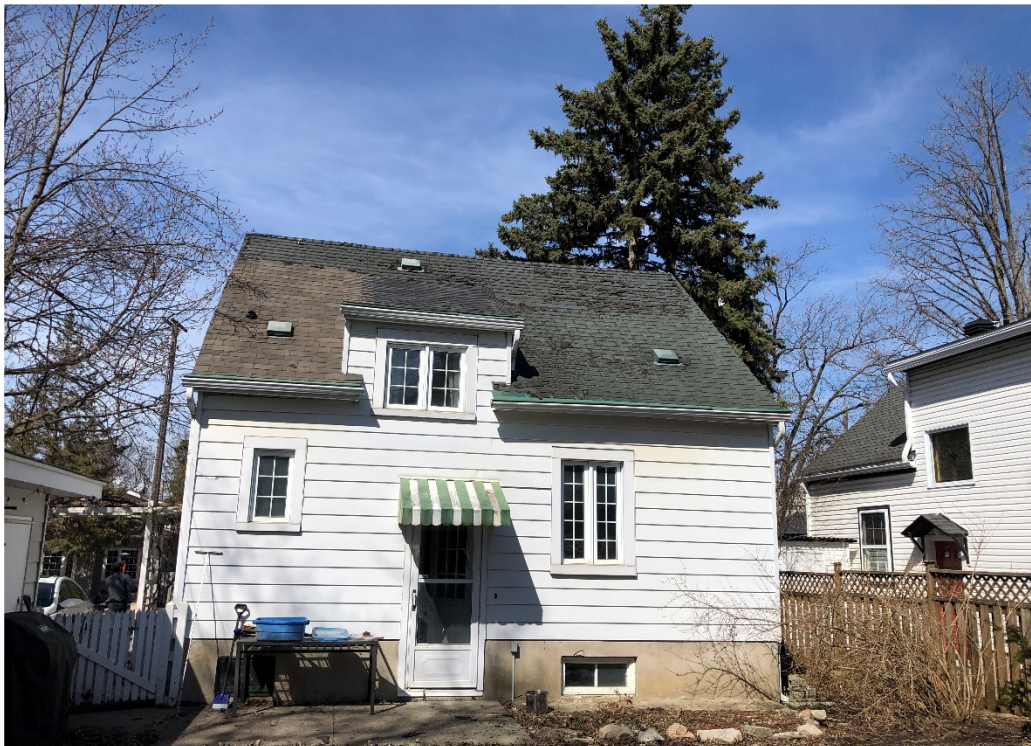
Photograph 4: View of the rear of the residential dwelling, looking north.

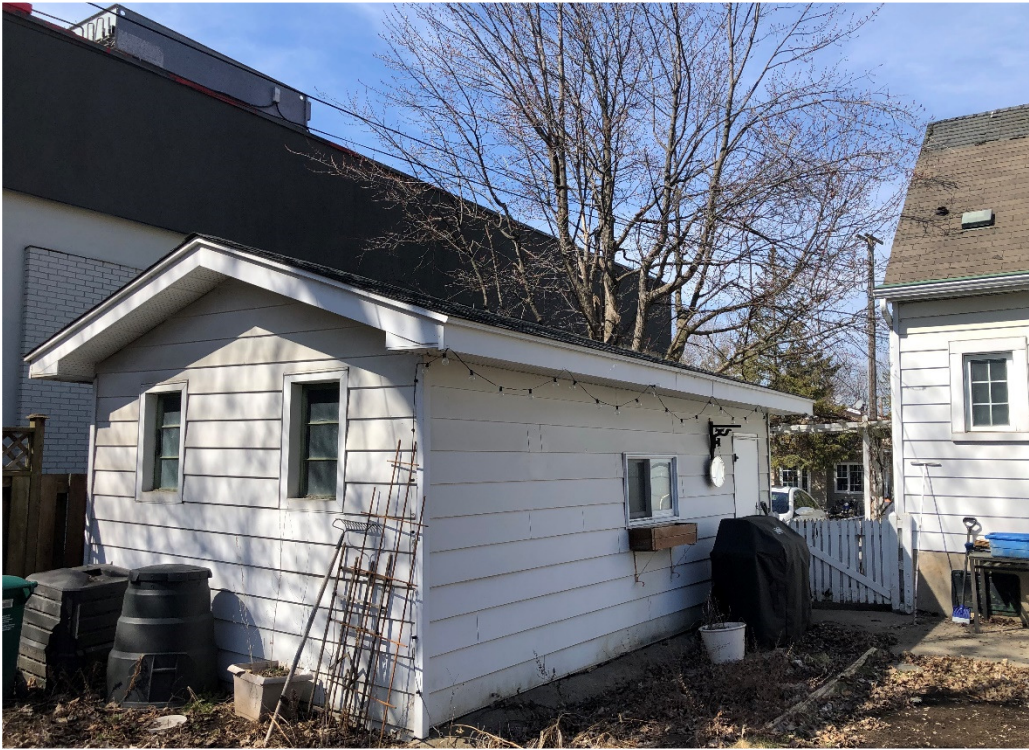
At the time of the site inspection, domestic waste and recyclable materials were observed to be stored in plastic bins on the exterior of the detached garage and are reportedly collected by the municipality on a weekly basis. No environmental concerns were identified with respect to waste management practices on the Phase I Property.

Photograph 5: View of the detached one-car garage, looking northwest.

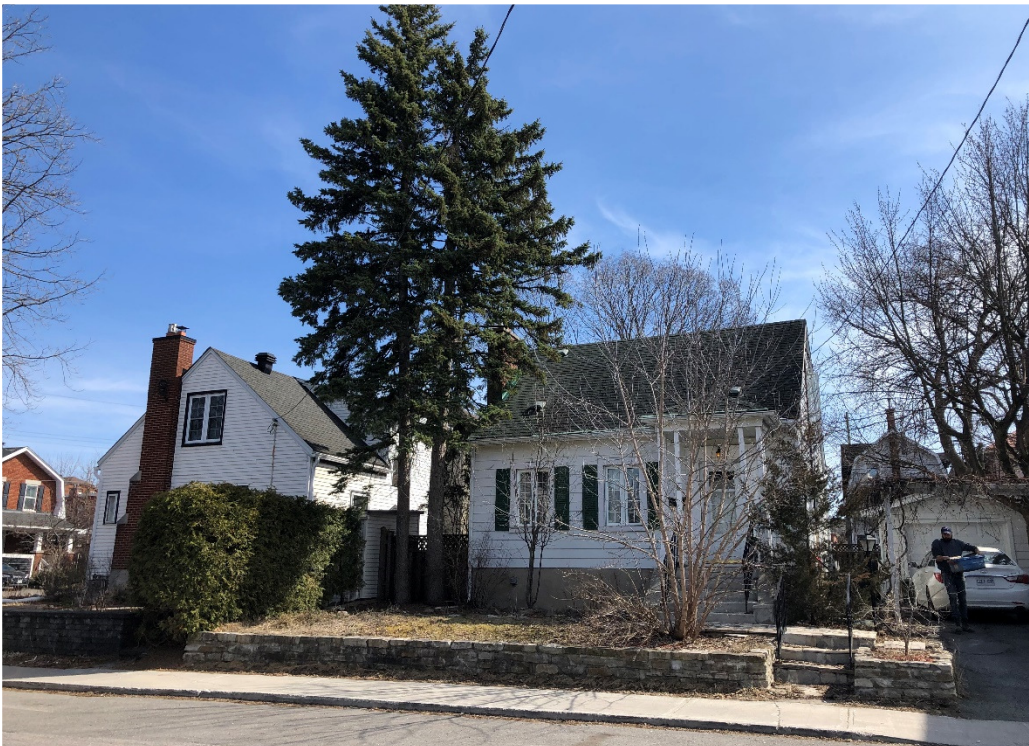
foundation and is finished on the exterior with vinyl siding in addition to a sloped, shingled roof. The building is currently heated via a natural gas-fired furnace, located in the basement.

Photograph 6: View of the front of the residential dwelling, looking south.

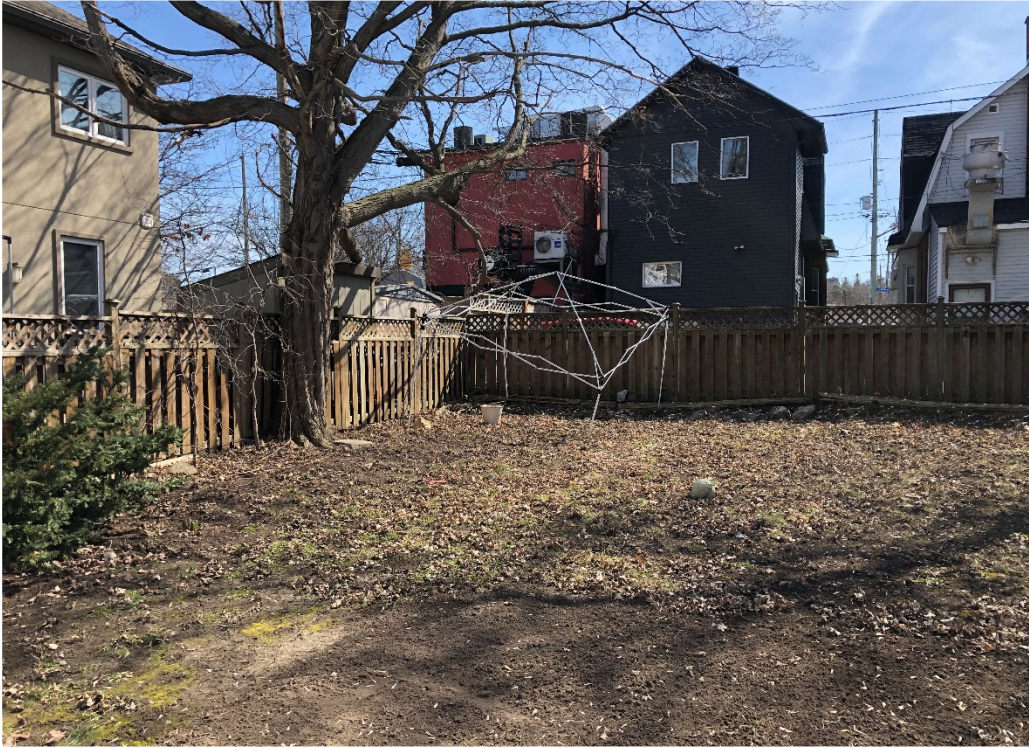
No ponded water, stressed vegetation, surficial staining, or any other indications of potential sub-surface contamination were observed on the Phase I Property at time of the site inspection.

Photograph 9: View looking south from the rear yard.
