Phase II – Environmental Site Assessment

50 Bayswater Avenue and 1088 Somerset Street West

Prepared for Manor Park Management

Report: PE5971-2 Date: July 6, 2023

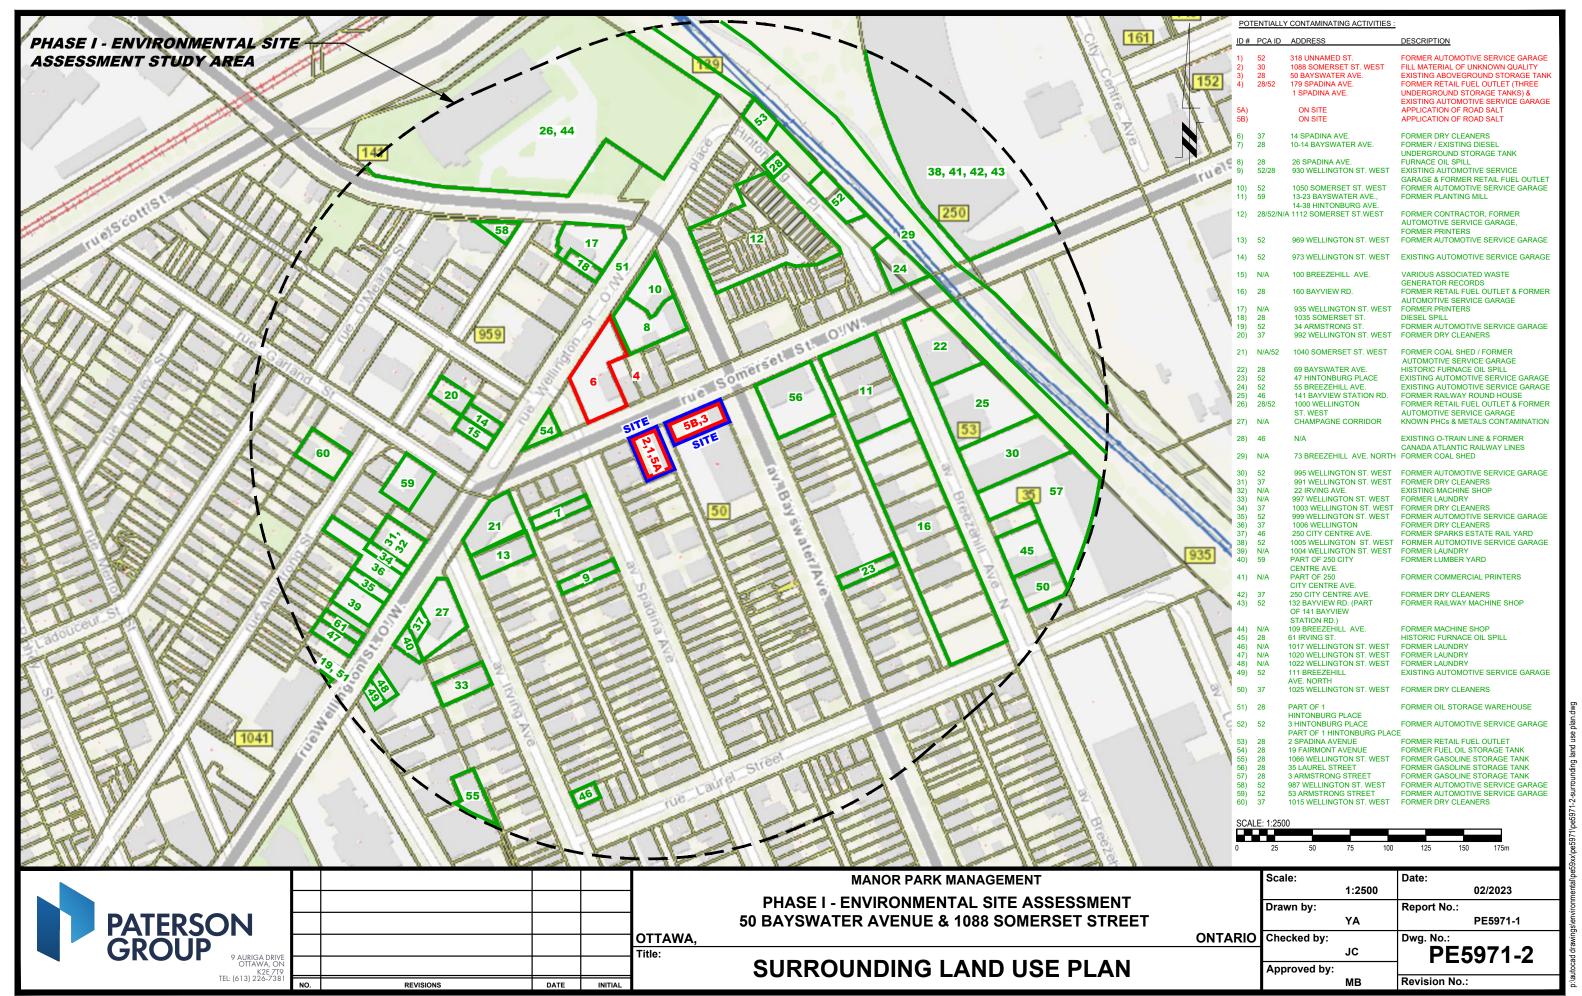
Drawing PE5971-2 – Surrounding Land Use Plan

Neighbouring land use in the Phase I Study Area consists of primarily commercial and residential land use. The property addressed 1 Spadina Avenue, approximately 20 m north of the Phase I Property is currently occupied by an automotive service garage that is considered to represent an APEC on the Phase I Property. Land use within the Phase I Study Area is a mix of residential and commercial. Current land use and PCAs identified in the Phase I Study Area are presented on Drawing PE5971-2 – Surrounding Land Use Plan.

An additional 55 PCAs identified within the Phase I Study Area as shown on Drawing PE5971-1 – Surrounding Land Use Plan. The remaining PCAs identified within the Phase I Study Area are not considered to represent an environmental concern on the Phase I Property due to their respective separation distances and/or cross/down gradient orientations with respect to the Phase I Property.

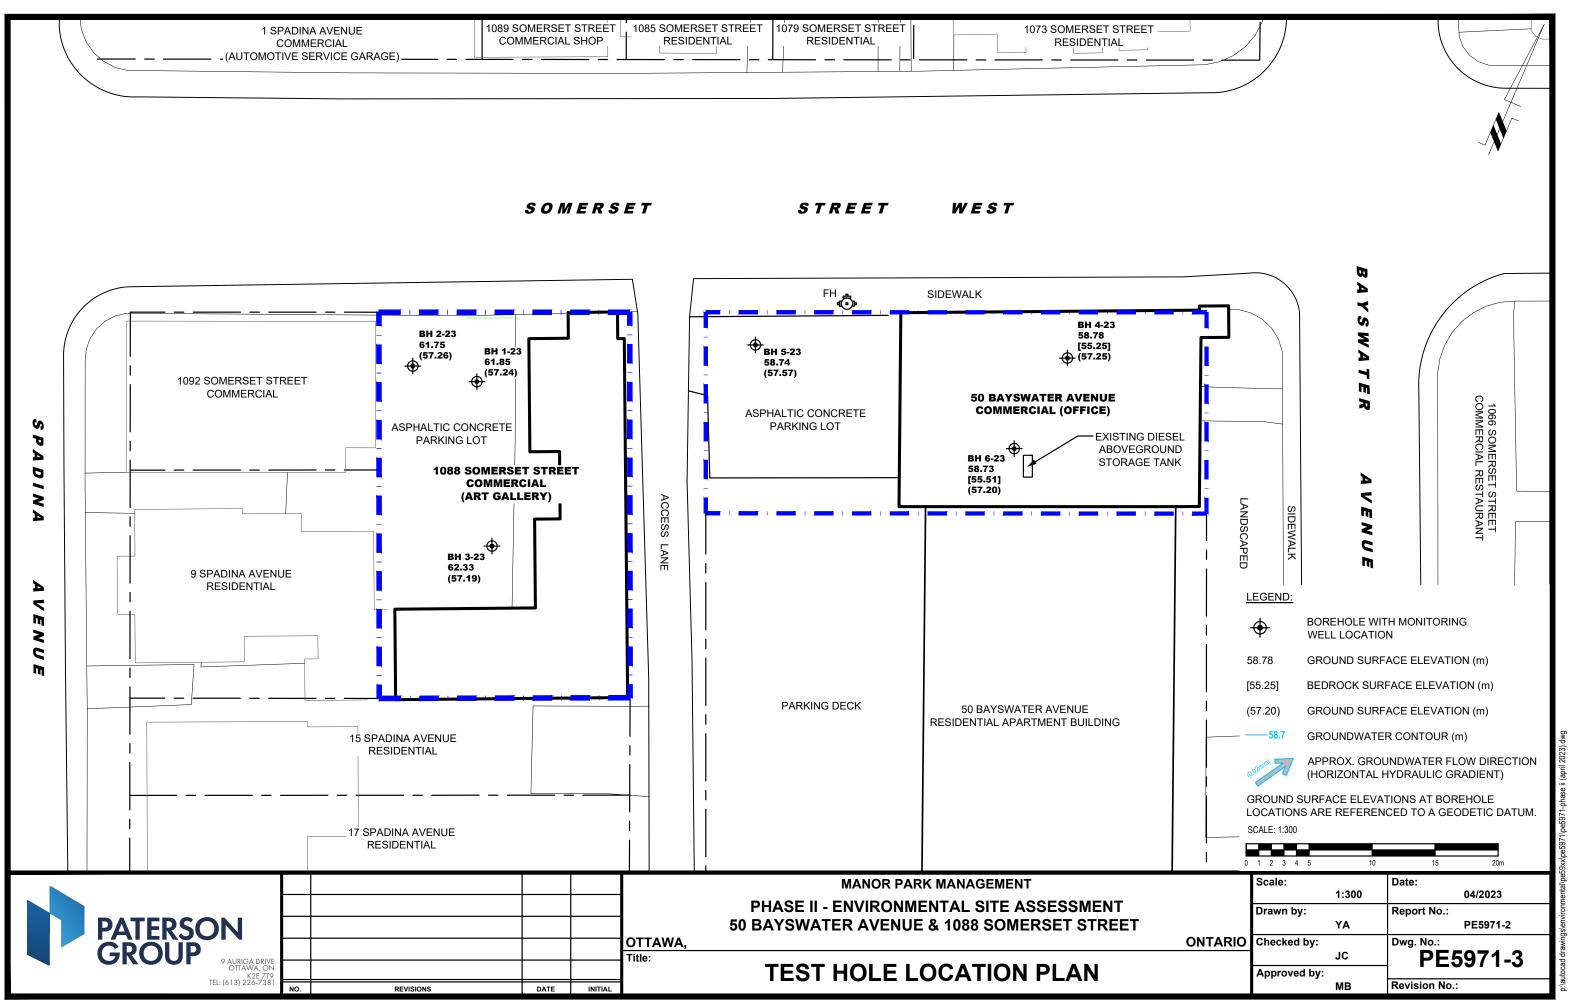
Drawing PE5971-3 – Test Hole Location Plan

Based on the groundwater elevations measured during the sampling events, groundwater contour mapping was completed. Groundwater contours are shown on Drawing PE5971-3 – Test Hole Location Plan. Based on the contour mapping, groundwater flow at the Phase II Property is in an easterly direction, although these levels likely had not stabilized. It should be noted that groundwater levels are expected to fluctuate throughout the year with seasonal variations.

Groundwater was encountered within the overburden at depths ranging from 4.28 to 5.14 mbgs. Based on the groundwater monitoring event, groundwater flow was measured in an easterly direction with a hydraulic gradient of 0.012 m/m, although these levels likely had not stabilized. It should be noted that groundwater levels are expected to fluctuate throughout the year with seasonal variations. Groundwater contours are shown on Drawing PE5971-1 – Test Hole Location Plan.

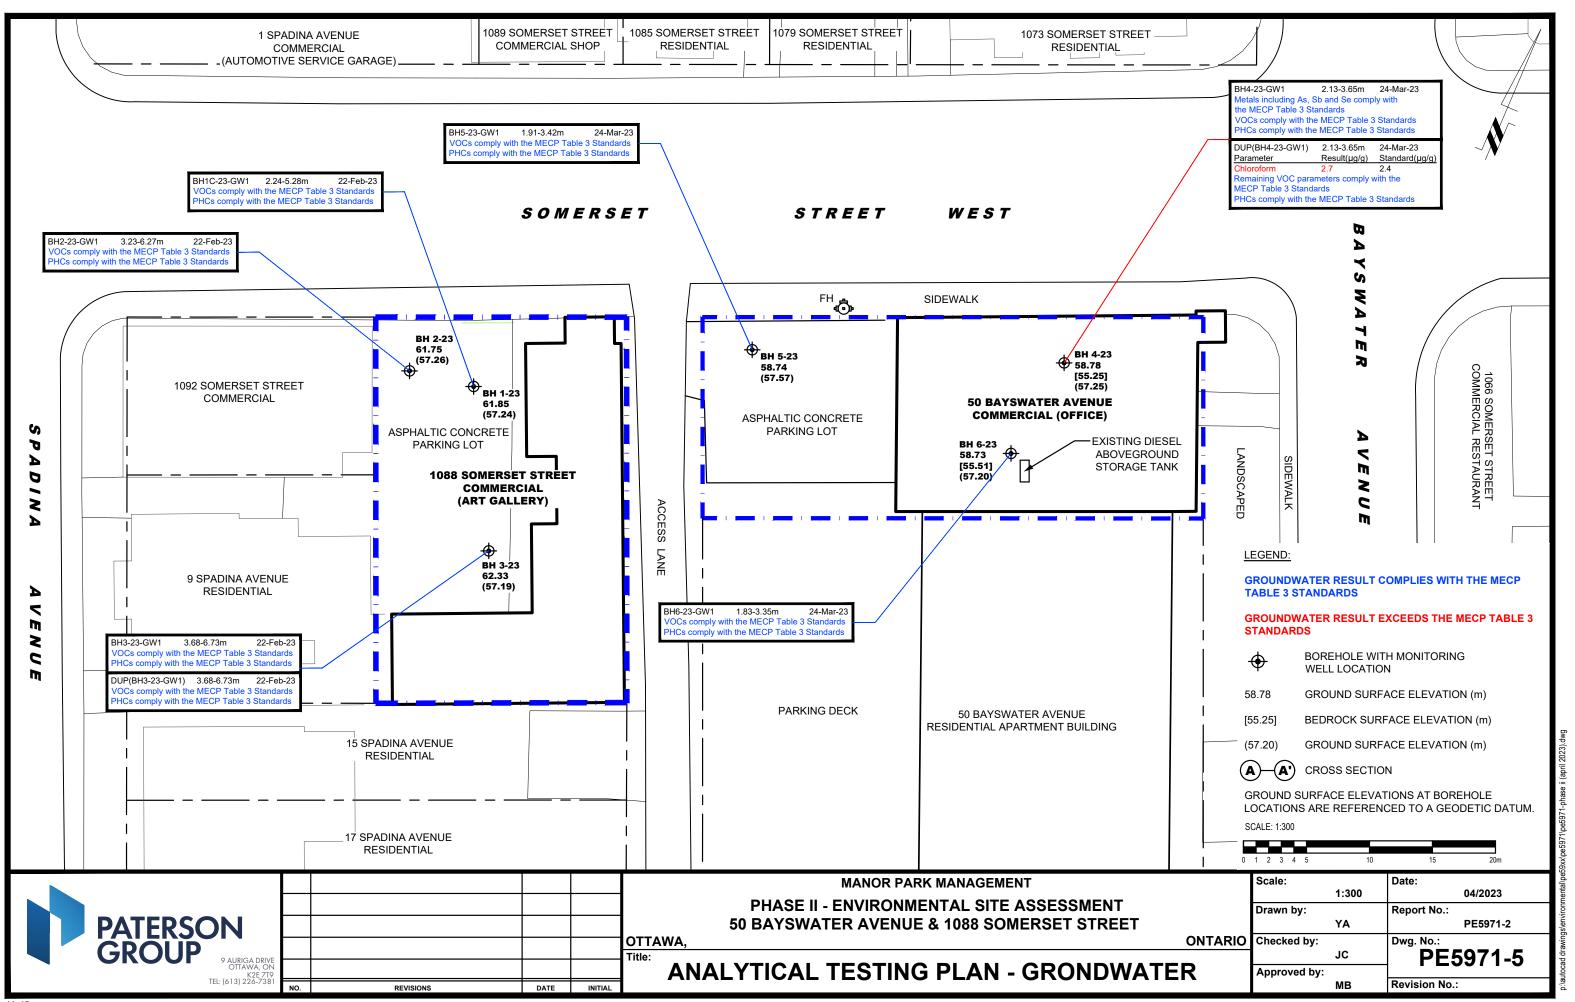
DRAWING PE5971-5 – ANALYTICAL TESTING PLAN – GROUNDWATER

Eight groundwater samples (including two duplicates) from monitoring wells installed in BH1-23 through BH6-23 were submitted for laboratory analysis of metals, PHCs (F1-F4) and/or VOCs. The groundwater samples were obtained from the screened intervals noted in Table 2. The results of the groundwater analytical testing are appended to this report. The laboratory Certificates of Analysis are provided in Appendix 1.
