**RE: TREE CONSERVATION REPORT FOR 50 BAYSWATER AVENUE AND 1088 SOMERSET STREET WEST, OTTAWA**

This Tree Conservation Report (TCR) was prepared by IFS Associates Inc. (IFS) on behalf of Manor Park Holdings in support of a site plan control application for the construction of two multi-storey commercial/residential buildings at 50 Bayswater Avenue and 1088 Somerset Street in Ottawa. The need for this report is related to trees protected under the City of Ottawa's Tree Protection By-law (By-law No. 2020-340). The By-law reflects Section 4.8.2. of the City of Ottawa's Official Plan which calls for the retention of the City's urban forestry canopy and, in particular, large healthy trees.

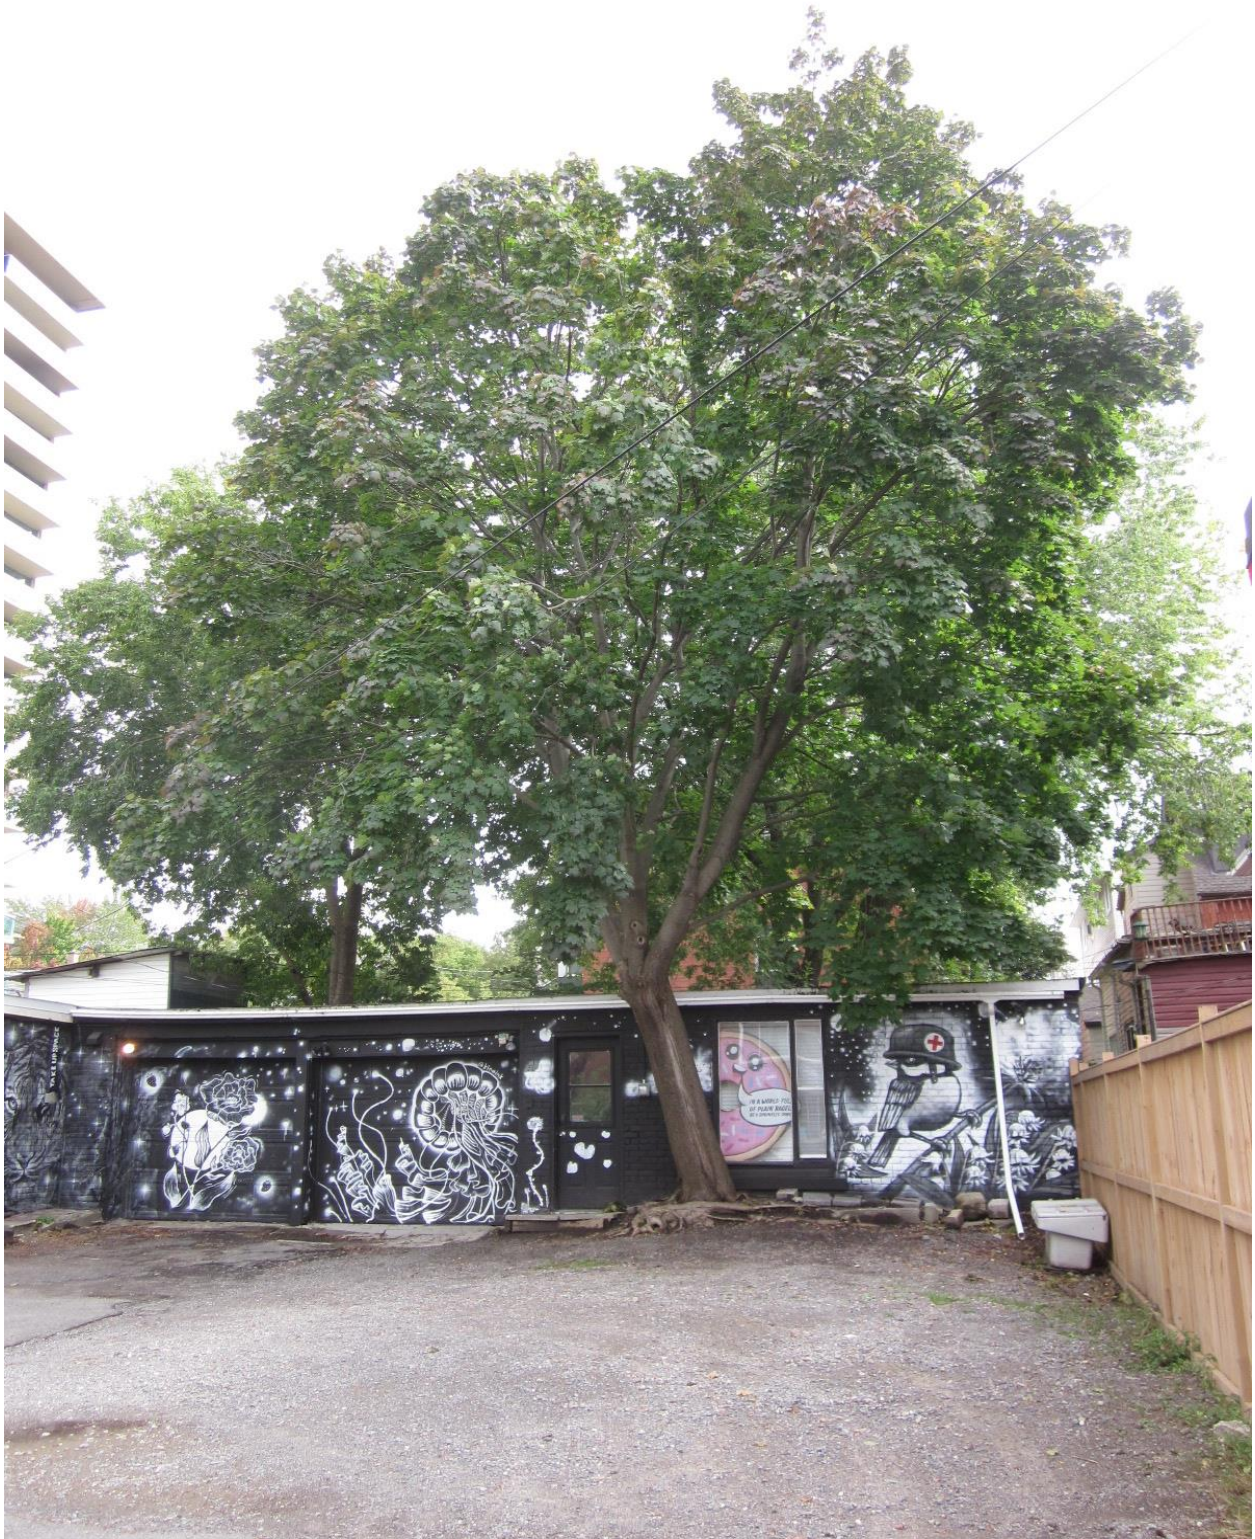
5	Norway maple ( <i>Acer platanoides</i> )	Private	49.9	Fair; mature; tri-dominant stems at 3.25m – central with two competing laterals; central stem bisects at 4.5m (with strong union); very weak union between central and northwest lateral; seam on northwest side of lower bole from grade to 2.5m has healed; several exposed, severed roots and multiple girdling roots; introduced invasive species; <b>to be removed</b> (conflicts with construction)
6	Manitoba maple ( <i>Acer negundo</i> )	Neighbour	+/-30 & +/- 50	Poor; mature; double-stemmed at grade – dominant stem with competing lateral towards southeast; central stem bisects at 3m; major wounds on both stems at +/- 1.5m; naturalized species; <b>to be preserved and protected</b>

Picture 4. Tree #5, private Norway maple at 1088 Somerset Street

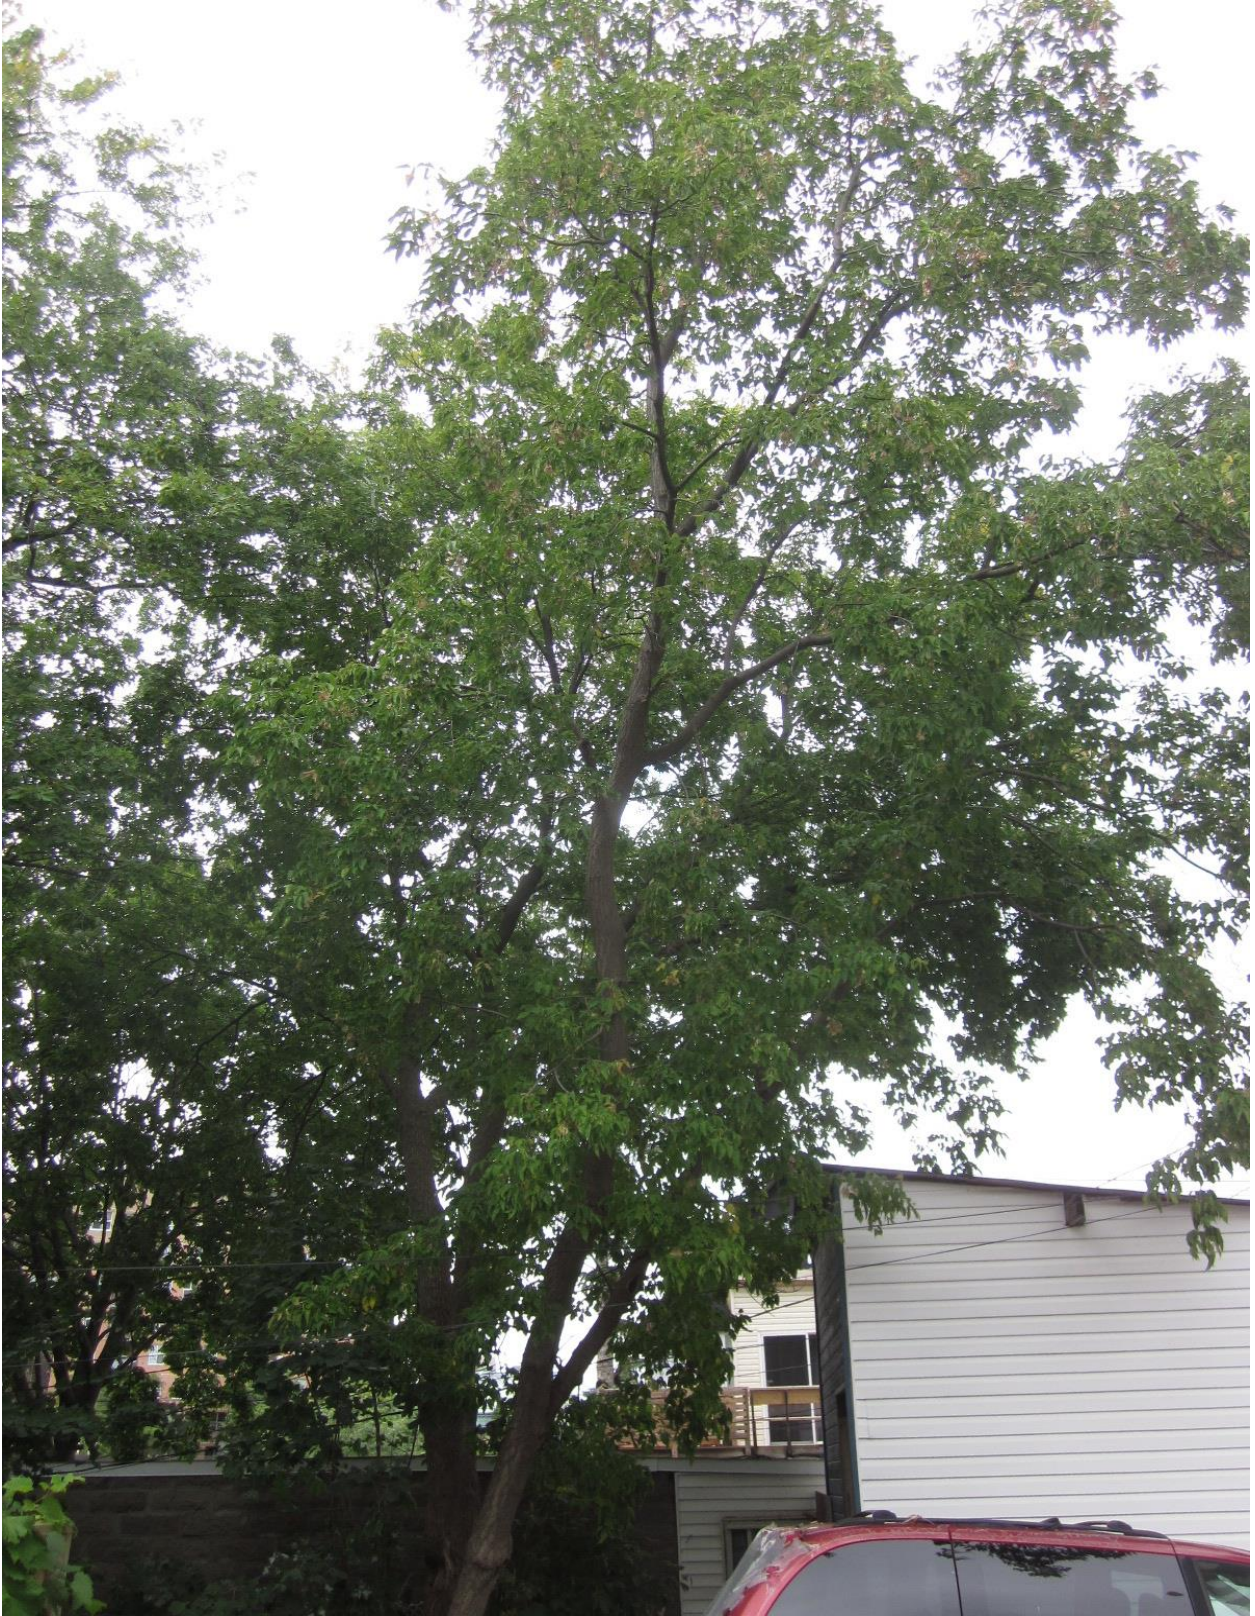
Picture 5. Tree #6, neighbouring Manitoba maple at 1088 Somerset Street
