File: PE4028-LET.01

Subject: Phase I – Environmental Site Assessment Update

2175 Prince of Wales Drive

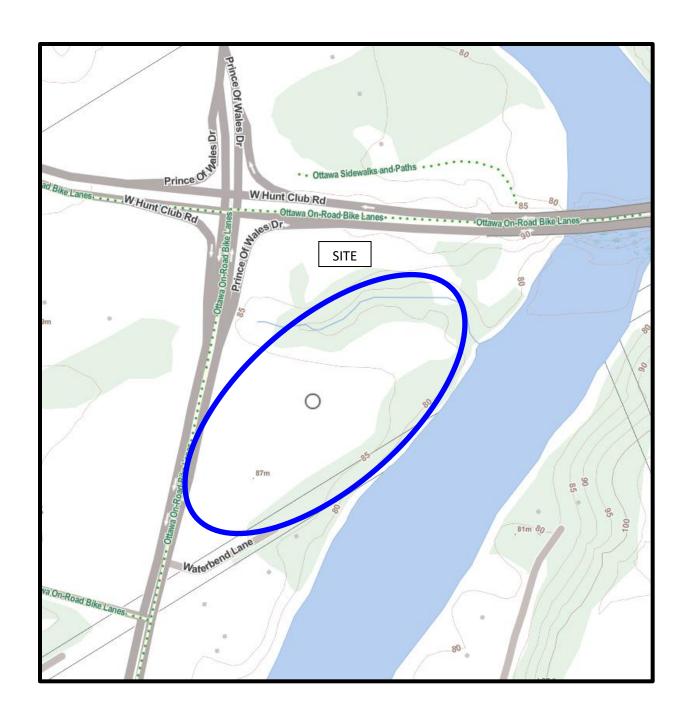
# FIGURE 2 TOPOGRAPHIC MAP

A topographic map of the Phase I Property was obtained from the Natural Resources Canada – The Atlas of Canada website and reviewed as part of this assessment. The topographic map indicates that the general elevation of the Phase I Property is approximately 87 m above sea level, while the regional topography within the greater area is depicted as sloping down gently towards to the east, in the general direction of the Rideau River. An illustration of the referenced topographic map has been appended to this report.

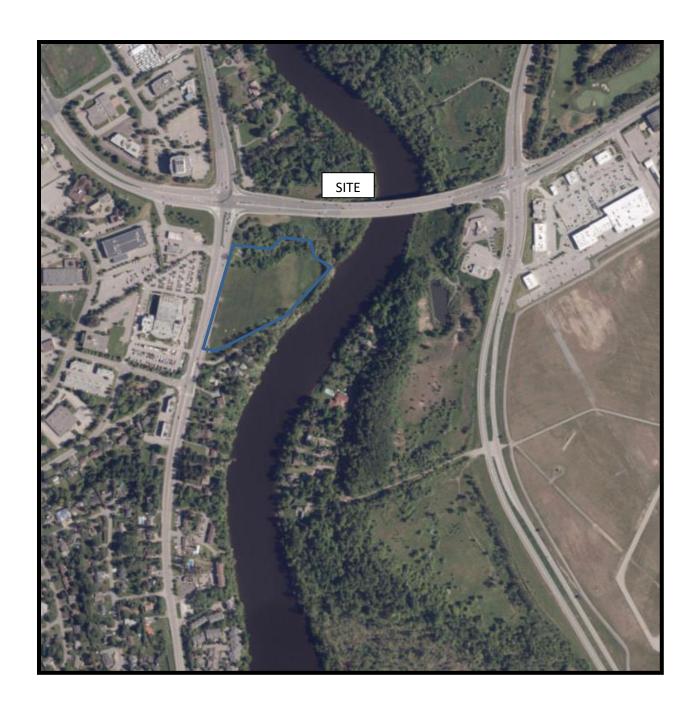
AERIAL PHOTOGRAPH 2022

No significant changes are apparent with respect to the Phase I Property since the time of the previous aerial photograph. The neighbouring properties also appear unchanged, with the exception of an addition which has been constructed on the west side of the church immediately west of the Phase I Property.

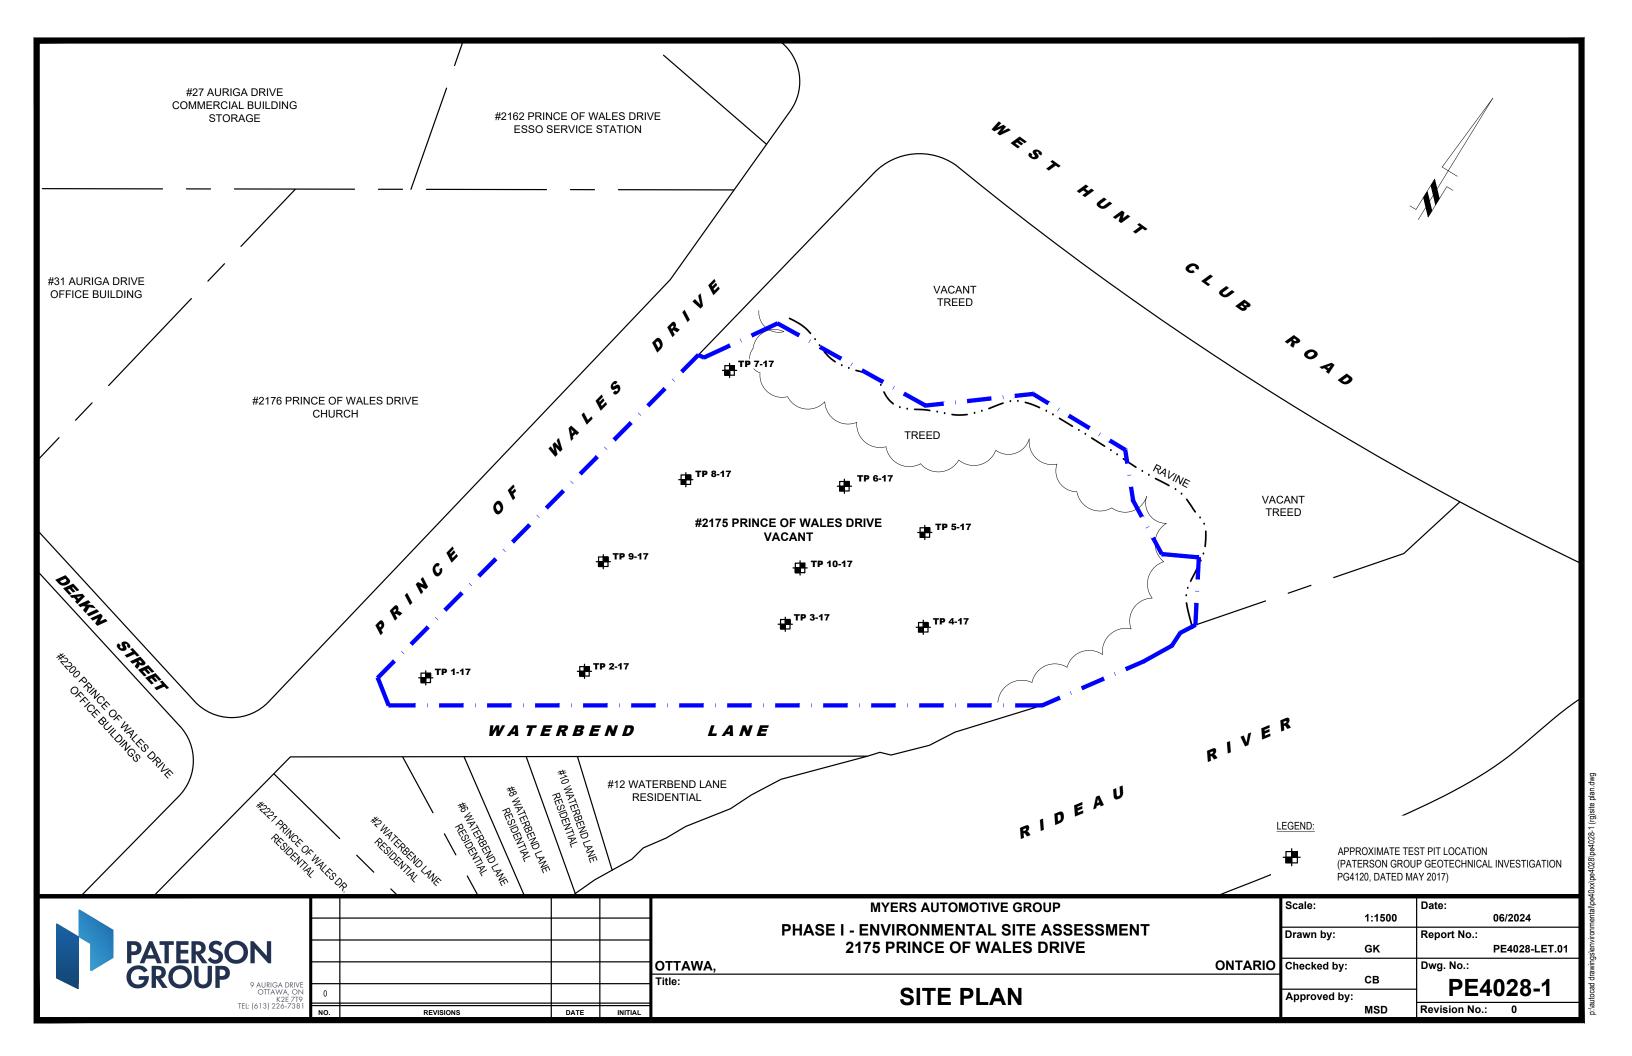
A depiction of the Phase I Property is presented on Drawing PE4028-1R – Site Plan, appended to this letter.

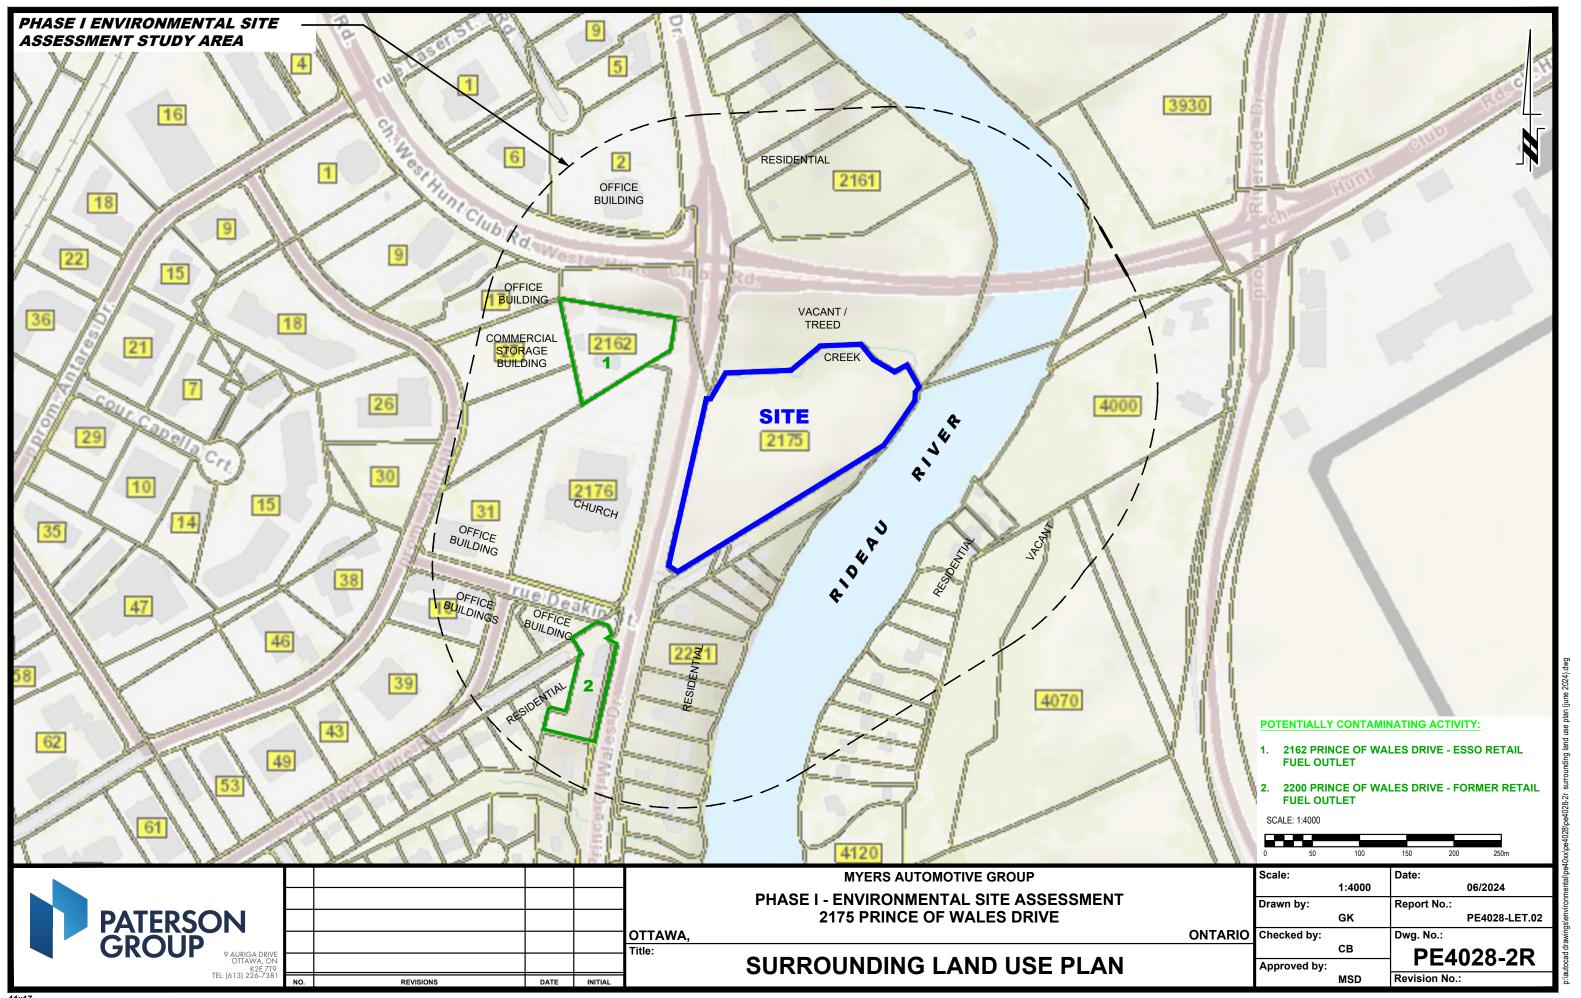
Although the presence of the retail fuel outlet does represent a potentially contaminating activity within the Phase I Study Area, due to the inferred cross-gradient orientation, and the separation distance with respect to the subject site, it is not considered to represent an APEC on the subject site. No other concerns were noted with the current use of the surrounding properties. Property use within the Phase I Study Area is shown on drawing PE4028-2R – Surrounding Land Use Plan.
