# **Phase One Environmental Assessment Update**

2095 Dilworth Road, Ottawa, Ontario

**Dilworth Development Inc.**  
Final Report

May 17, 2024  
02402048.000

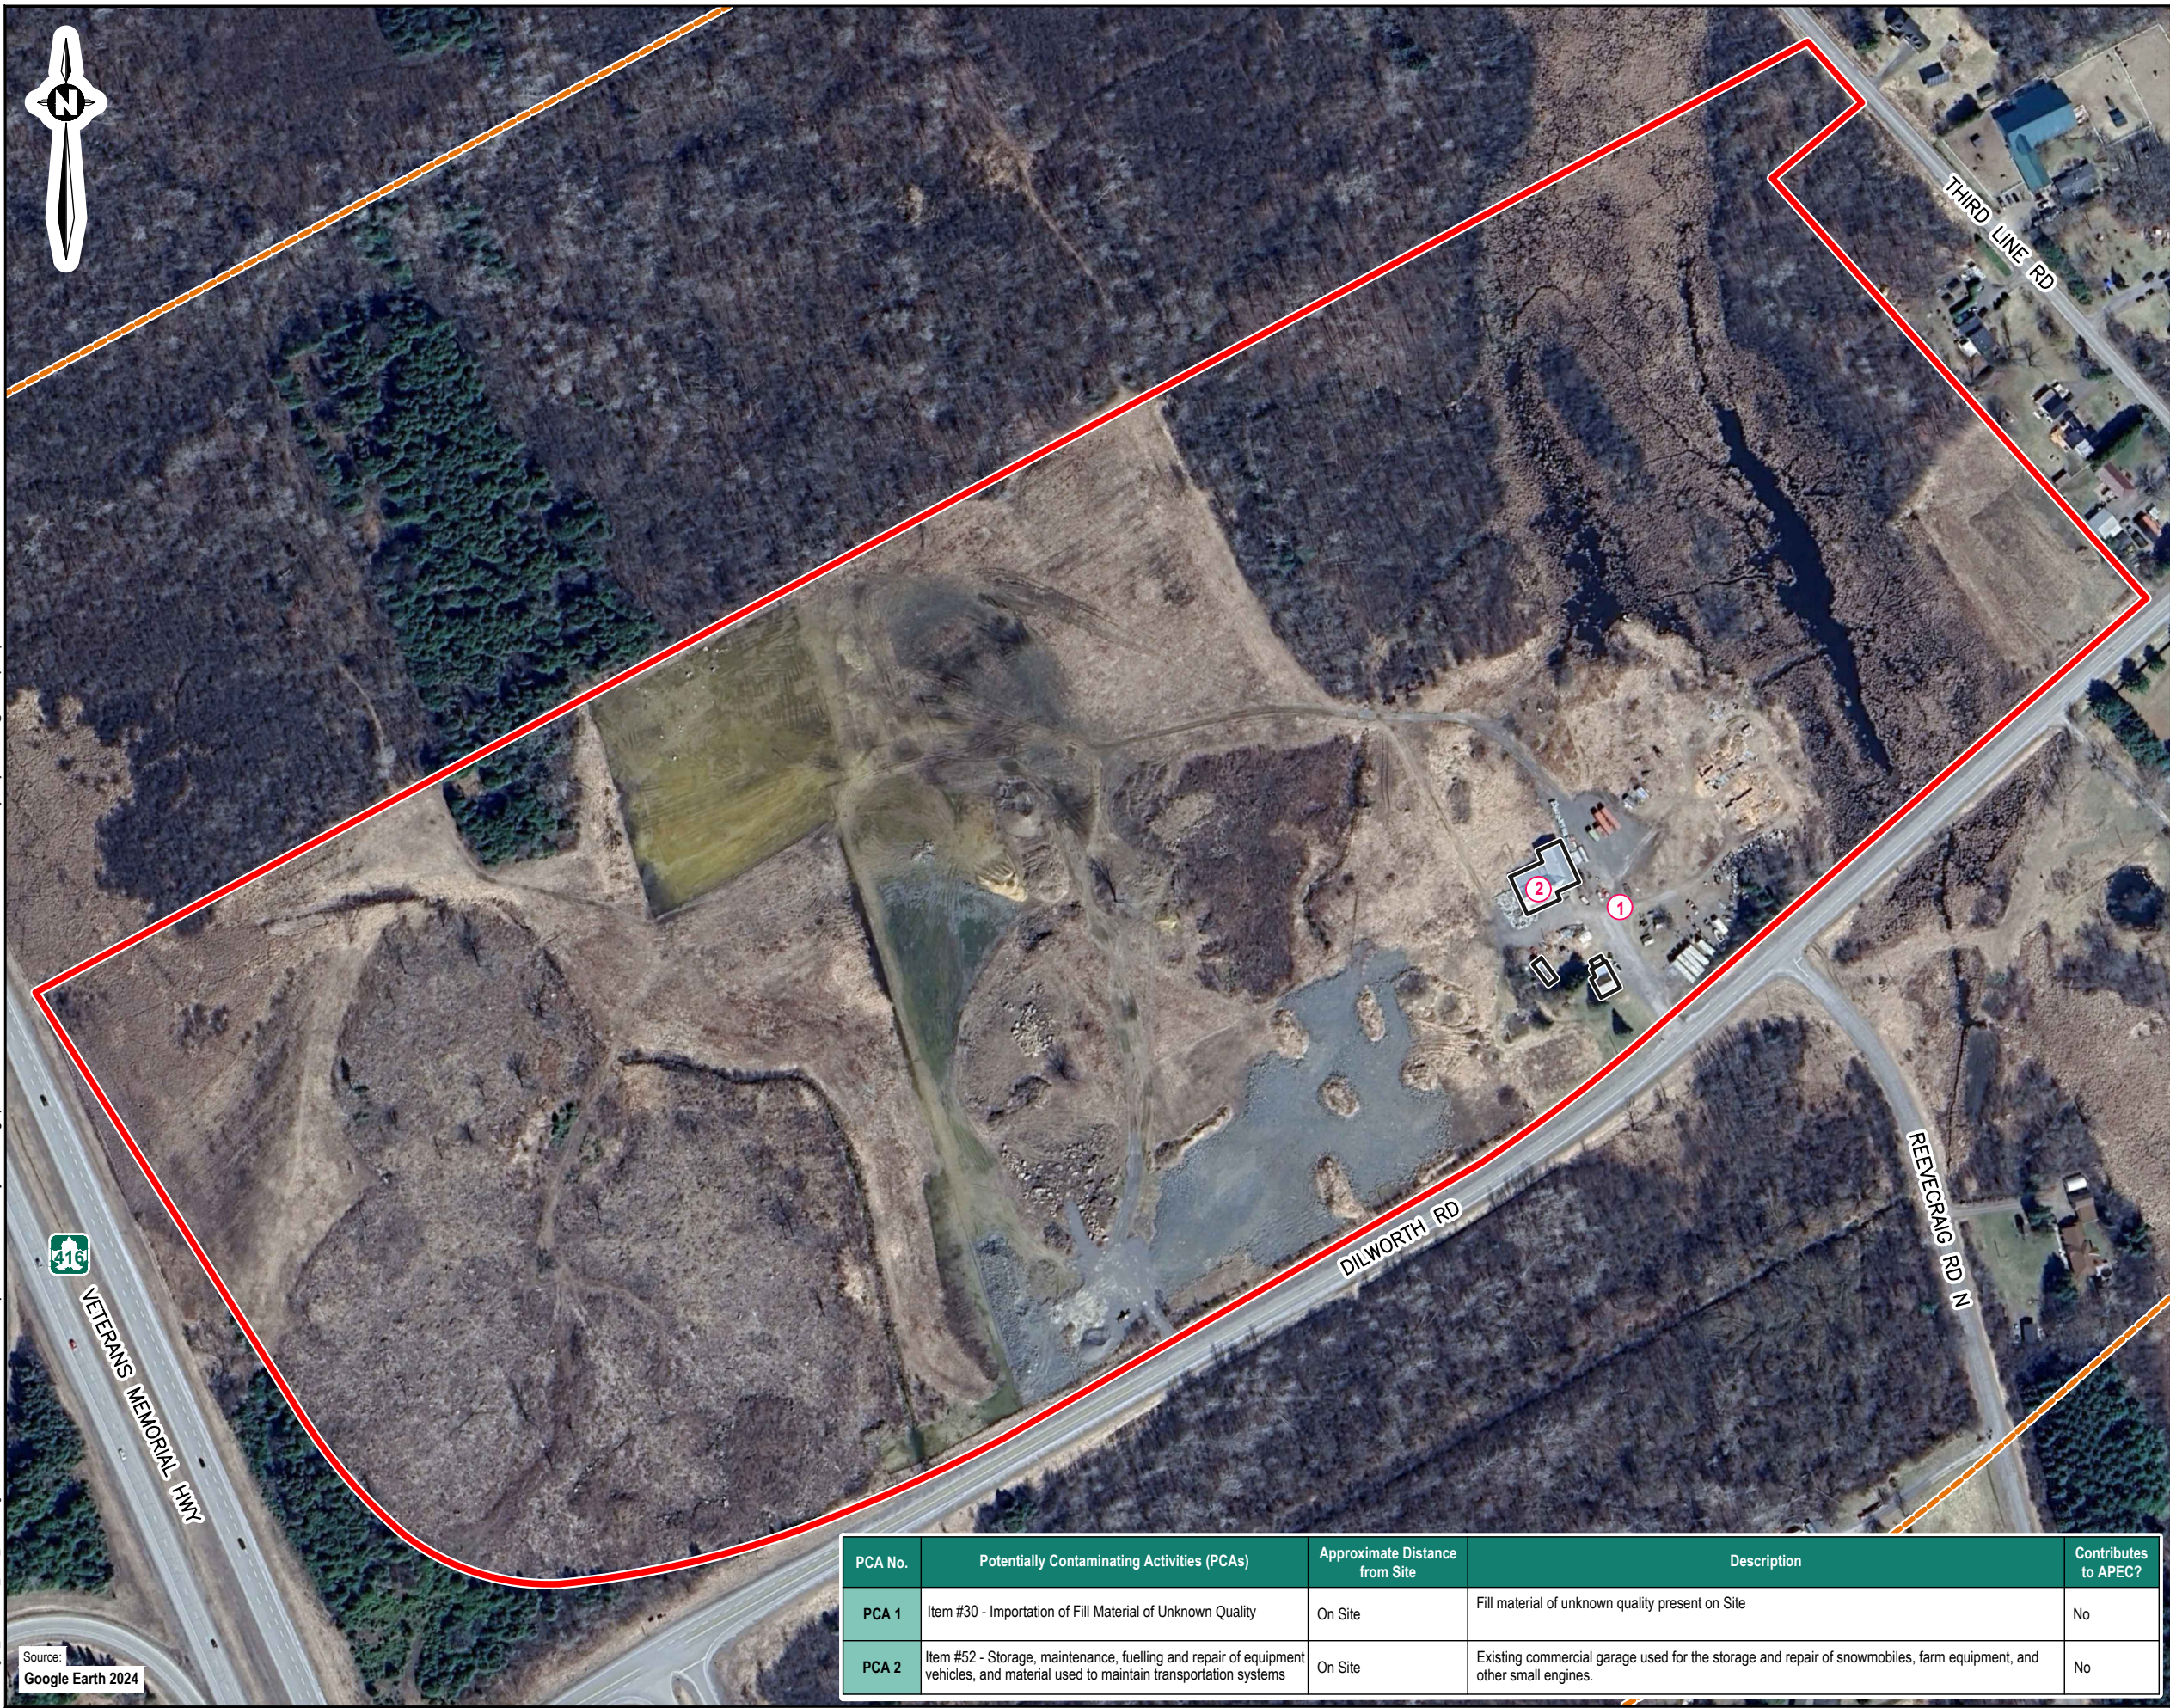
**2**

| PCA No. | Potentially Contaminating Activities (PCAs) | Approximate Distance from Site | Description | Contributes to APEC? |
|---|---|---|---|---|
| PCA 2 | Item #52 - Storage, maintenance, fuelling and repair of equipment vehicles, and material used to maintain transportation systems | On Site | Existing commercial garage used for the storage and repair of snowmobiles, farm equipment, and other small engines. | No |

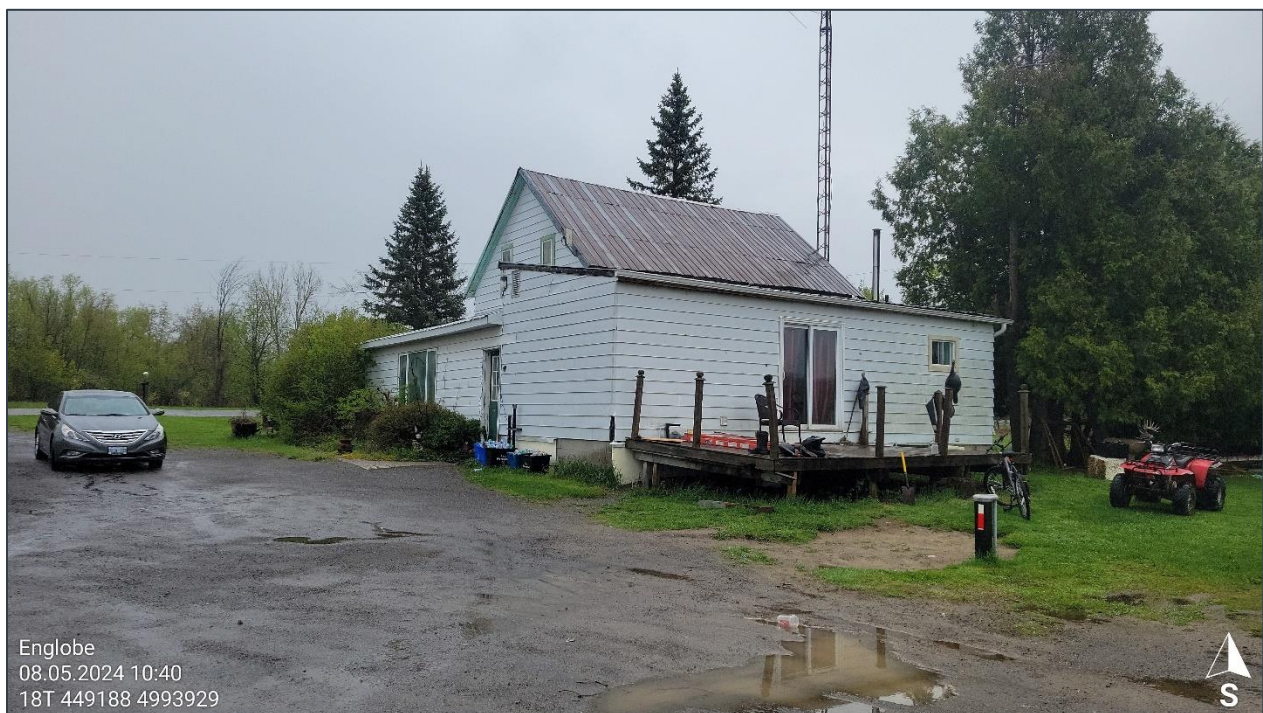
Photograph 2: Residential house

The residential house is a two-storey building, located near the east most entrance to the Site in the southeast portion of the property, constructed with vinyl siding, a concrete block foundation, and a peaked metal roof. The building has an approximate footprint of 160 m<sup>2</sup>, one basement level, and was constructed prior to 1920. Potable water is provided to the building from the north-adjacent domestic supply well; electricity is provided via overhead lines; the building does not appear to be serviced with gas; heating is provided via underground lines from an exterior wood burning stove located approximately 15 m northwest of the building; and although a septic tank access port could not be located, it is inferred that sewage is serviced via an underground septic tank system located to the west of the house on-site (DST, 2021).

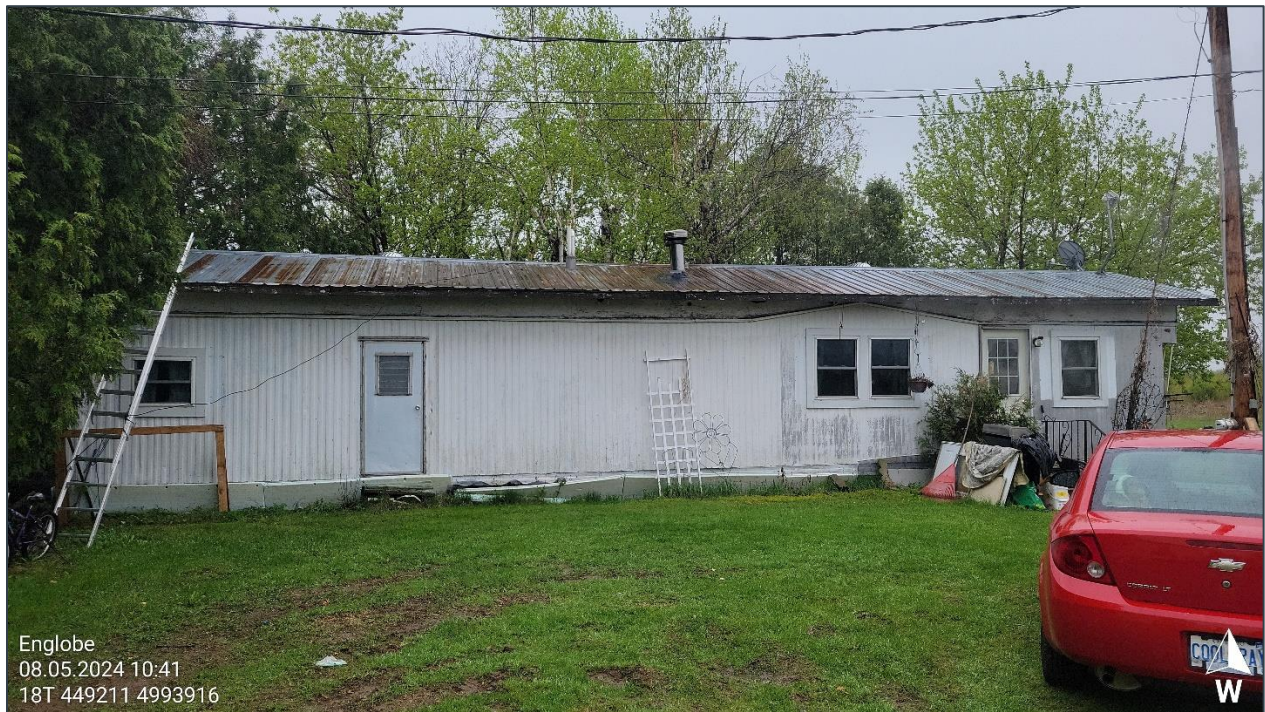
Photograph 3: Residential trailer home

The residential trailer home is a one-storey building, located west of the residential house, constructed with vinyl siding, a concrete slab-on-grade foundation, and a peaked metal roof. The building has an approximate footprint of 85 m<sup>2</sup> and was constructed in 1976. Potable water is provided to the building from the on-Site domestic supply well; electricity is inferred to be provided via underground lines from the residential house; propane is provided from a west-adjacent propane AST.

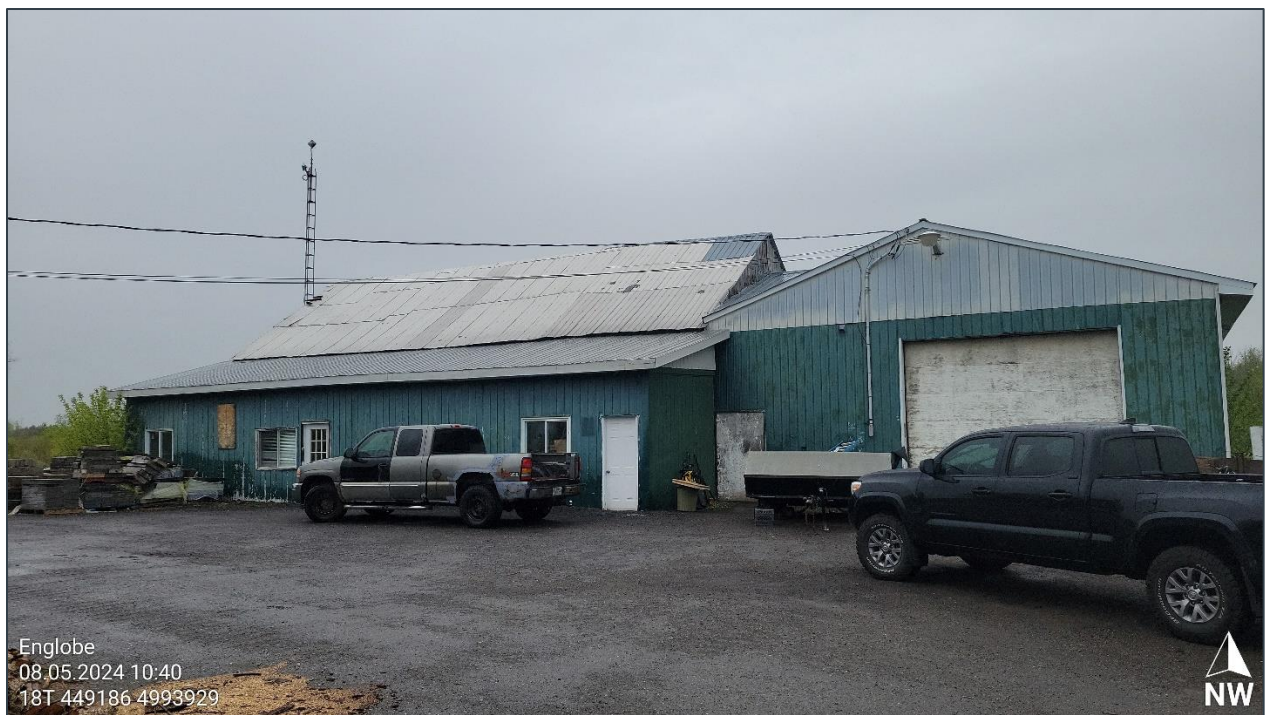
Photograph 4: Commercial service garage

The commercial service garage is a one-story building, located approximately 20 meters north of the residential trailer home, constructed with metal siding, a concrete slab-on-grade foundation, and a peaked metal roof. The building has an approximate footprint of 625 m<sup>2</sup> and was constructed prior to 1920. Electricity is provided via overhead lines; the building does not appear to be serviced with gas; heating is provided by the exterior wood burning stove, via underground lines; and it is unclear if the building is serviced with water or sewage services.

Englobe did not observe any stains or corrosion during the Site reconnaissance; however, DST's previous Phase One ESA noted that stains were observed on the concrete slab floor throughout the service garage, and that the concrete slab appeared to be in good condition.

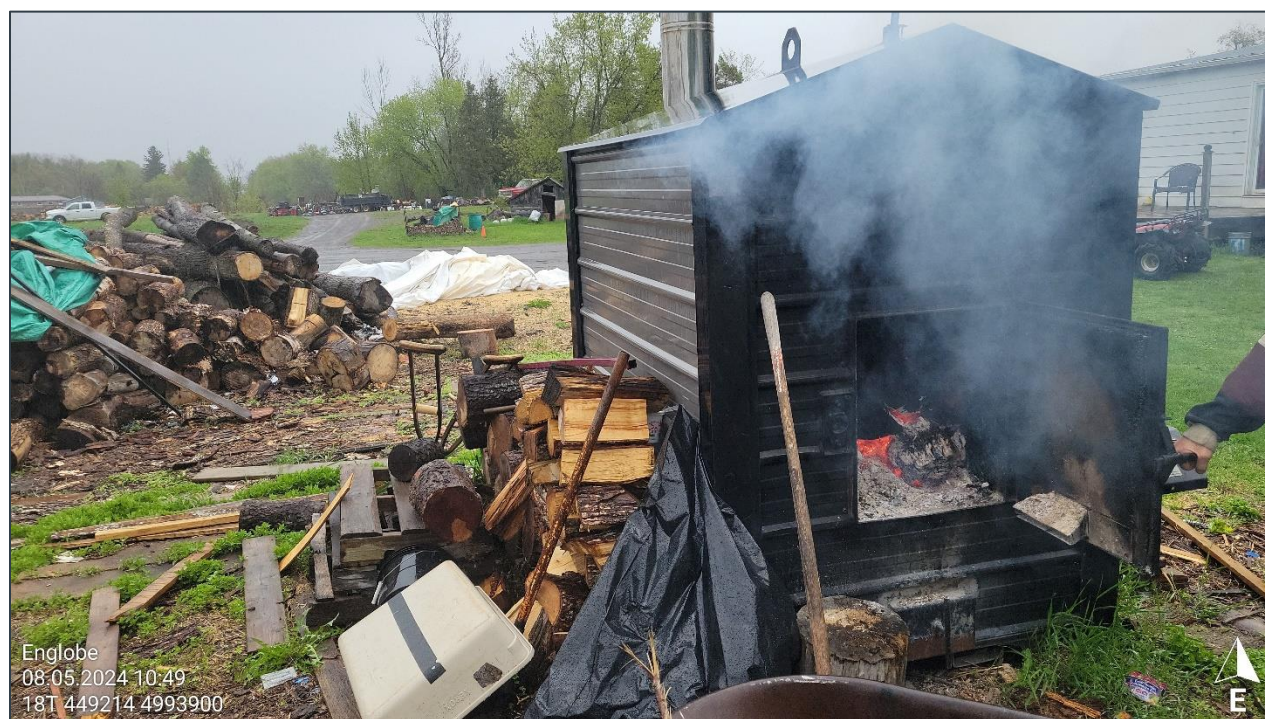
Photograph 8: Exterior wood burning stove

During the Site reconnaissance, Englobe observed one external wood stove, approximately 15 m northwest of the residential house, one air conditioning unit west-adjacent to the residential house, and one window-mounted air conditioning unit on the west side of the residential trailer home.

- PCA 1: Undefined No 1 - Exterior wood burning stove: large exterior wood burning stove used to heat the residential house and the service garage observed approximately 15 m northwest of the residential house.

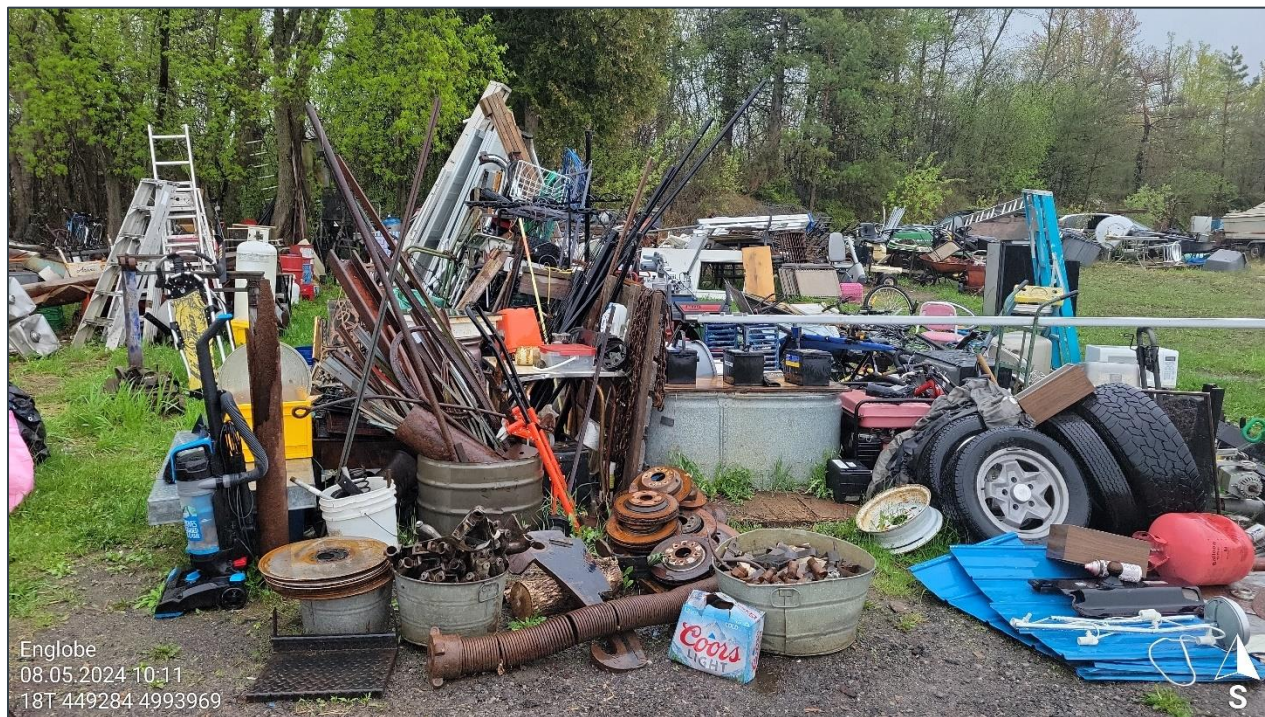
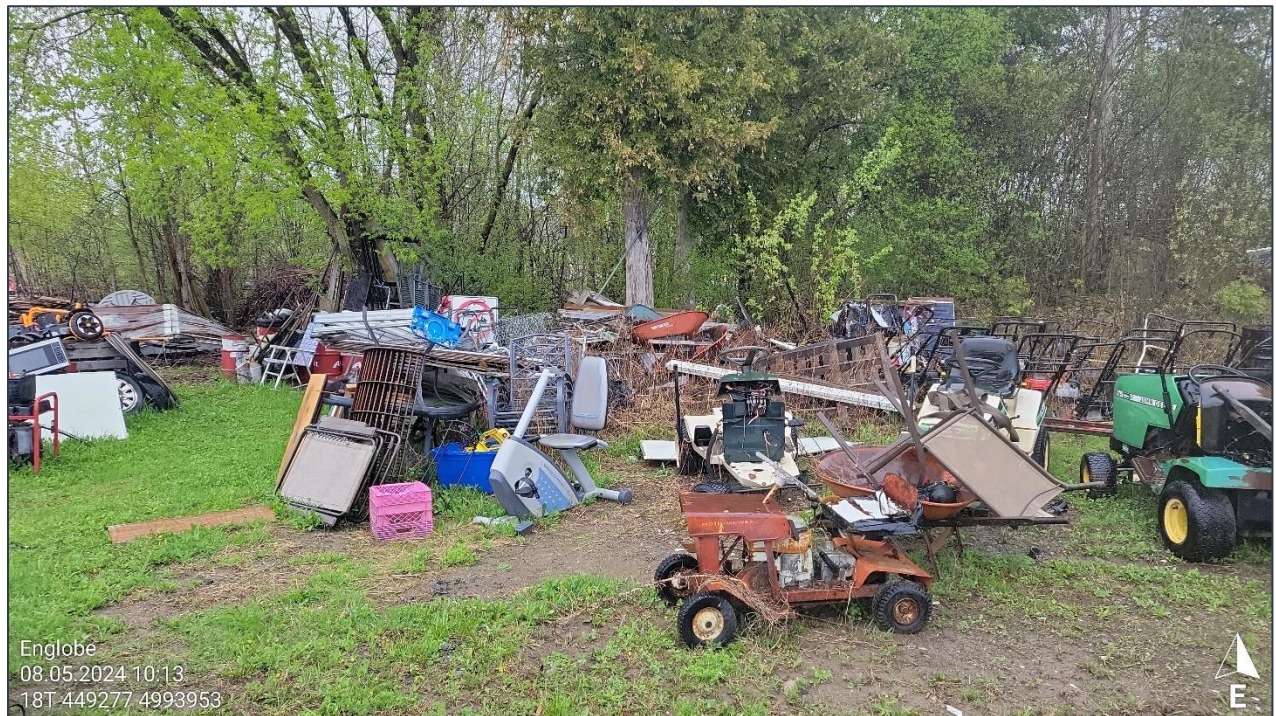
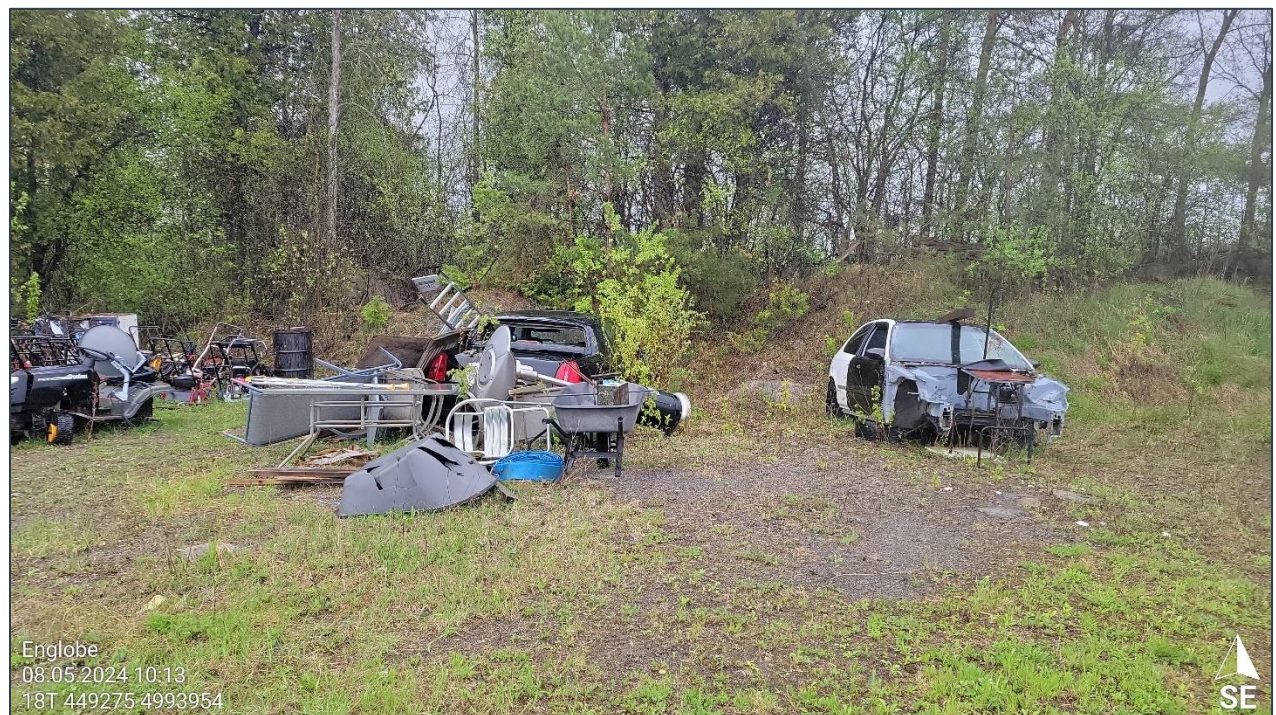
During the Site reconnaissance, Englobe observed a significant quantity of metal debris, old metal storage containers, lawn mowers, tires, snow blowers, wood piles, and old farm equipment located approximately 70 m northeast of the residential house.

Photograph 9: Debris stored on-Site

Photograph 10: Debris stored on-Site

Photograph 11: Debris stored on-Site

Photograph 12: Debris stored on-Site
