**Phase One Environmental Site Assessment**

**2095 Dilworth Road**

**Kars, Ontario**

**DST File No.: 02101208.000**

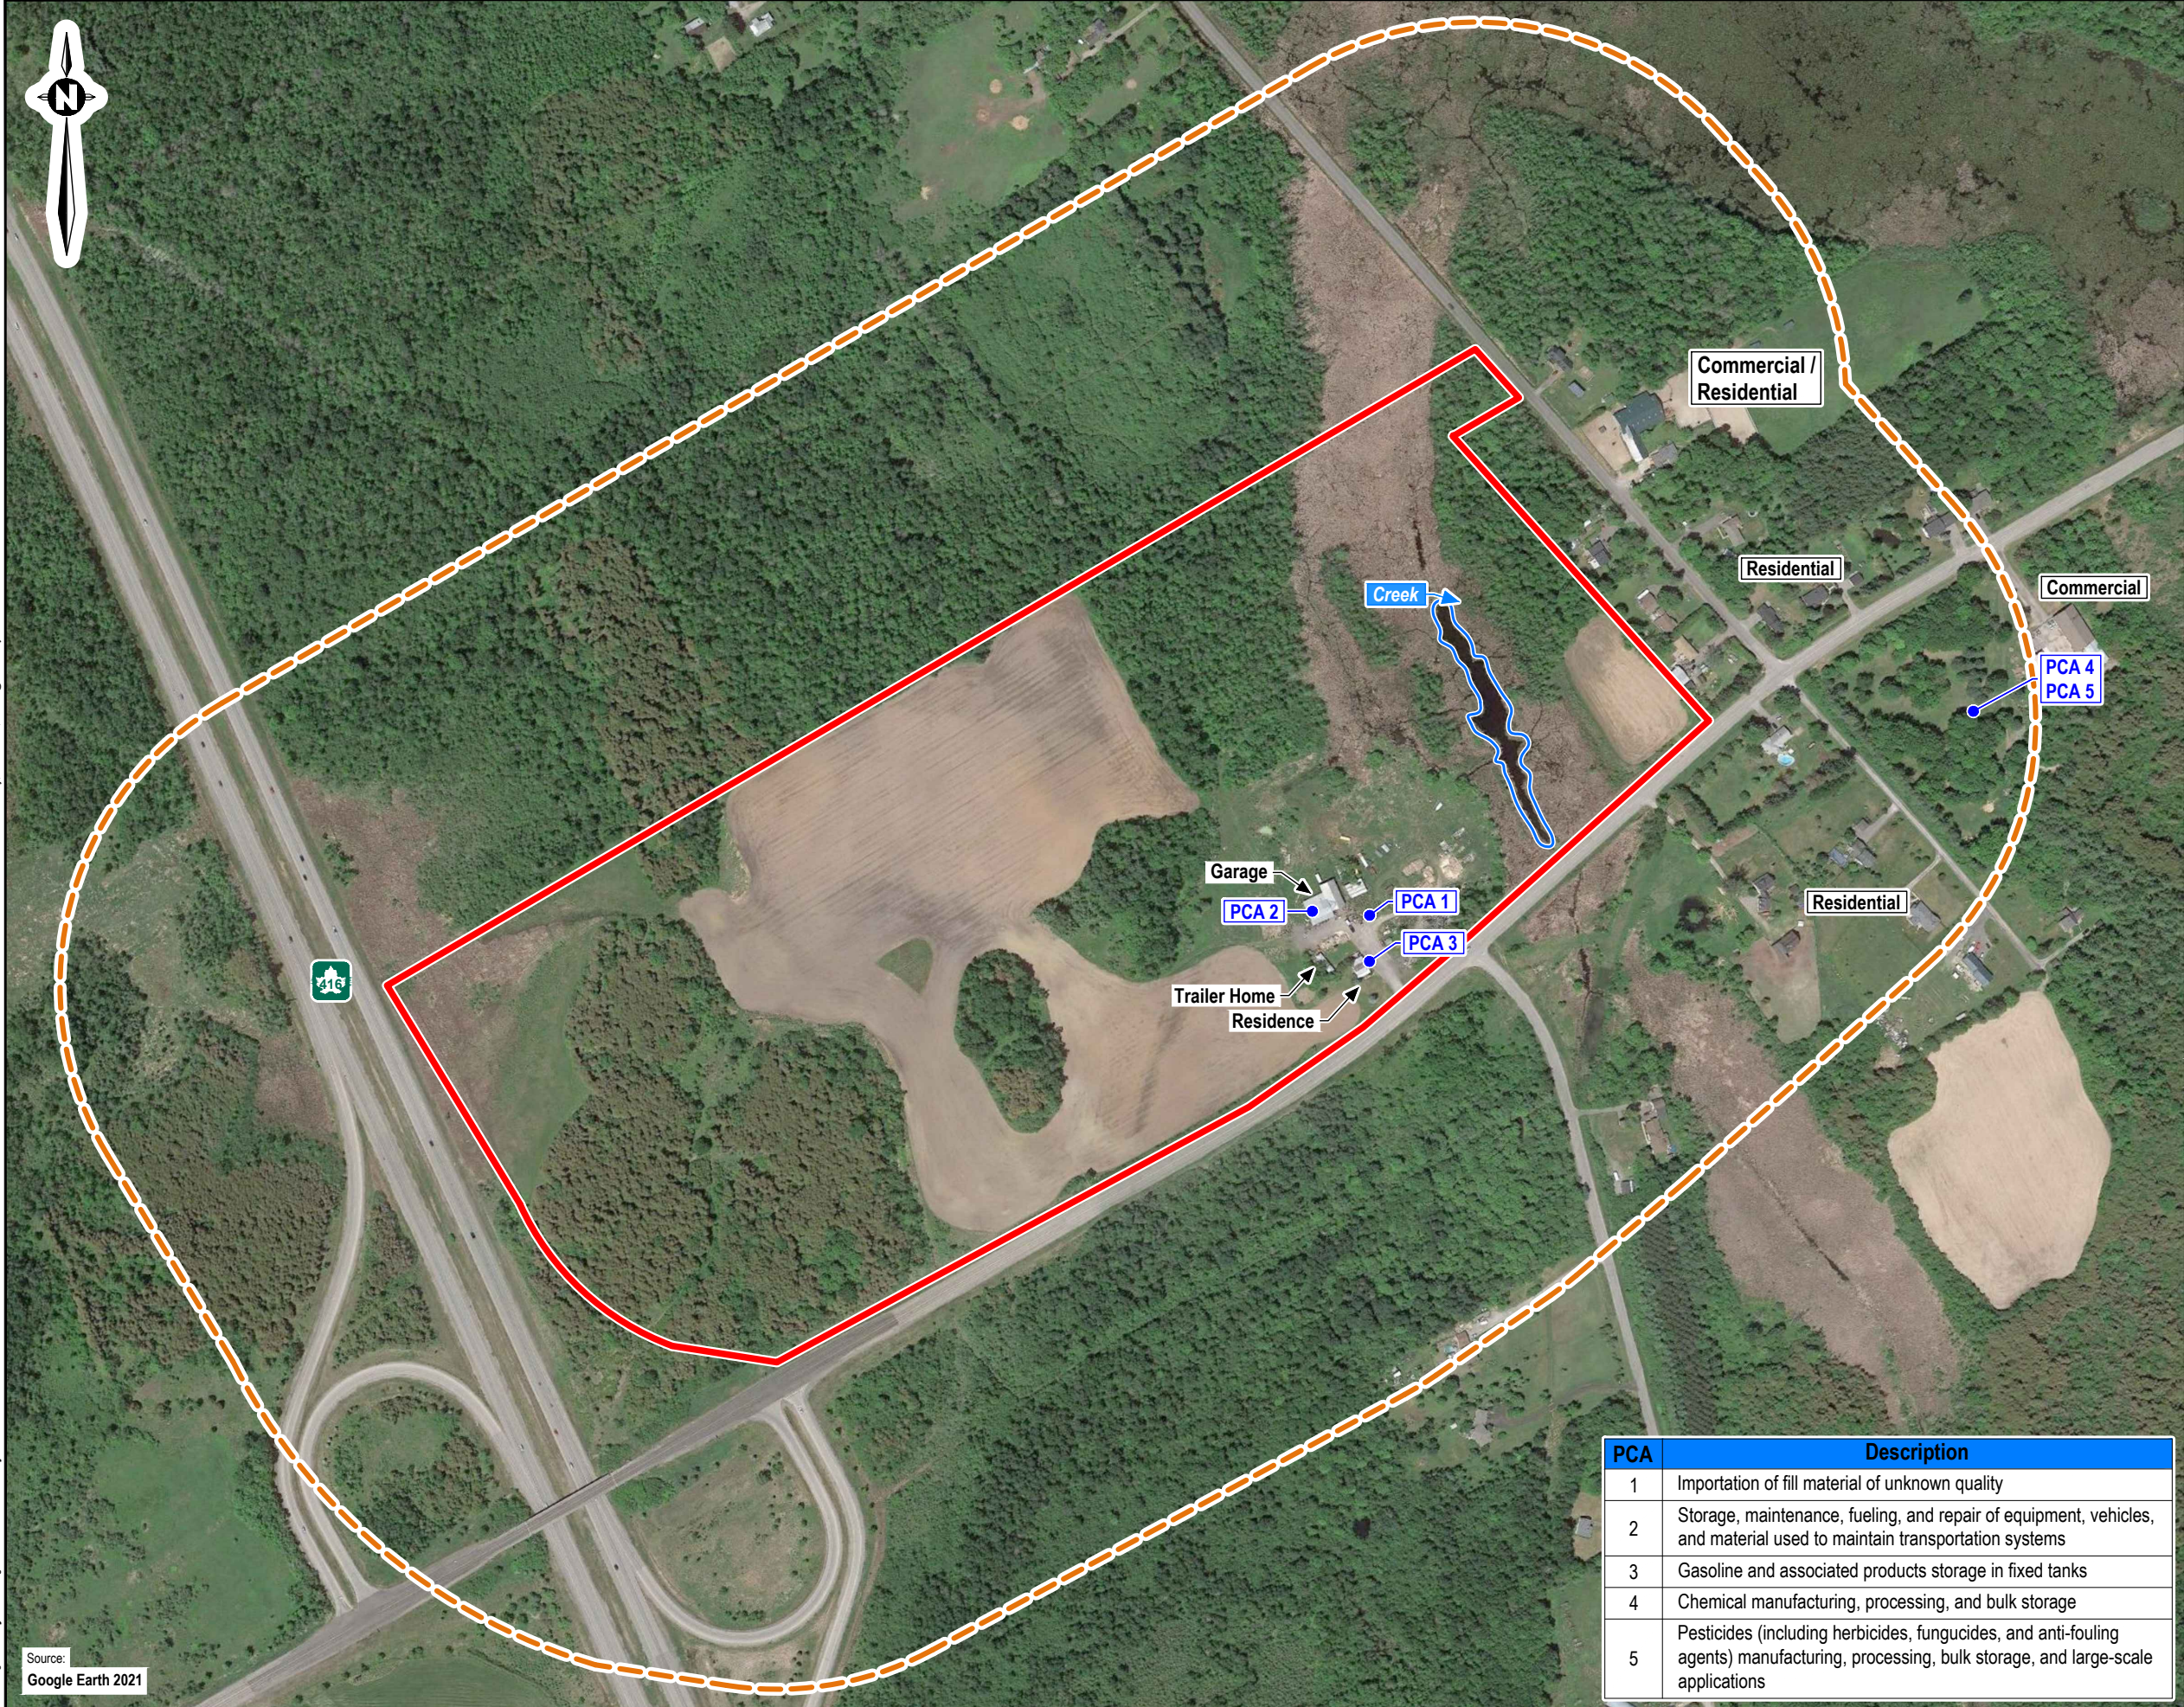
Through observation and records review of the properties surrounding the Site during the Site reconnaissance, and review of records and aerial photographs, the following PCAs were observed at other properties within the Phase One Study Area, as shown on Figure 2 in Appendix A:

PCA	Description
1	Importation of fill material of unknown quality
2	Storage, maintenance, fueling, and repair of equipment, vehicles, and material used to maintain transportation systems
3	Gasoline and associated products storage in fixed tanks
4	Chemical manufacturing, processing, and bulk storage
5	Pesticides (including herbicides, fungicides, and anti-fouling agents) manufacturing, processing, bulk storage, and large-scale applications

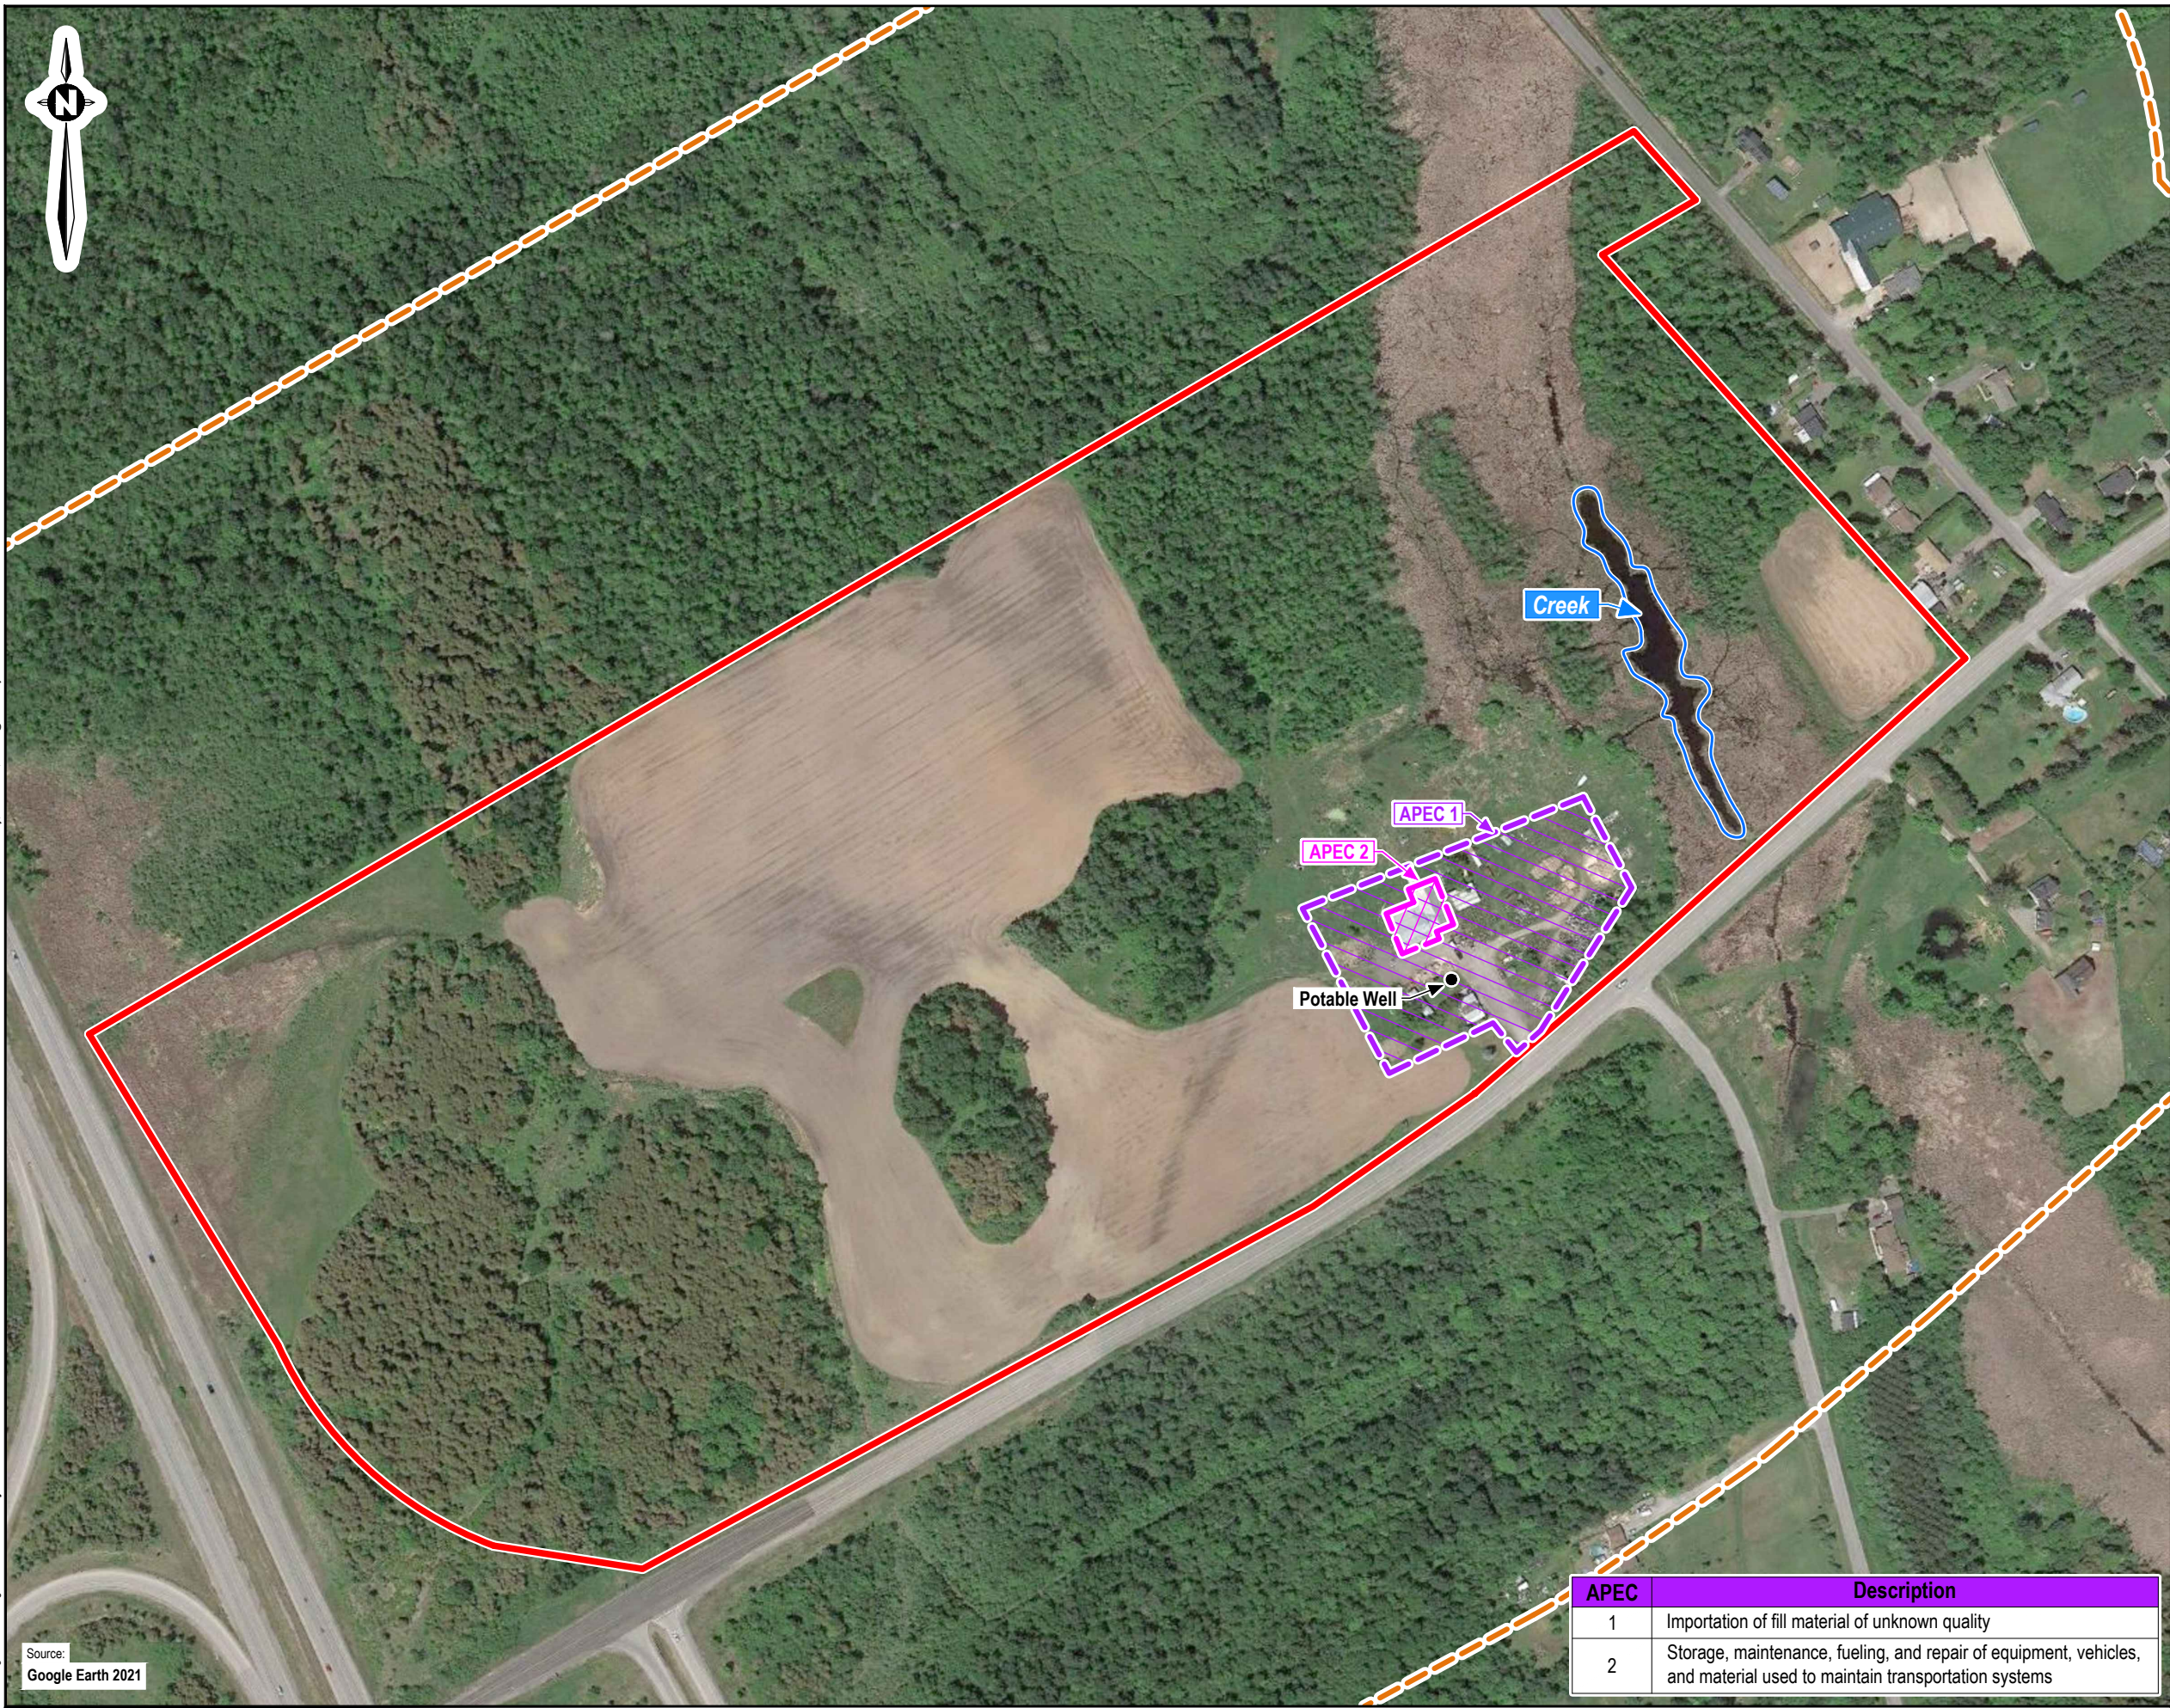
APEC	Location of APEC	Area of Potential Environmental Concern	Contaminants of Potential Concern (COPCs)	Media Potentially Impacted
<b>APEC 1</b> Fill material of unknown quality likely present on Site	Developed portion of the property	PCA Item #30 – Importation of Fill Material of Unknown Quality	- Metals - Polycyclic aromatic hydrocarbons (PAHs)	Soil
<b>APEC 2</b> Existing commercial garage	Within the area of the on-Site garage	PCA Item #52 - Storage, maintenance, fuelling and repair of equipment, vehicles, and material used to maintain transportation systems	- Petroleum hydrocarbons - Volatile organic compounds (VOCs)	Soil and groundwater

APEC	Description
1	Importation of fill material of unknown quality
2	Storage, maintenance, fueling, and repair of equipment, vehicles, and material used to maintain transportation systems

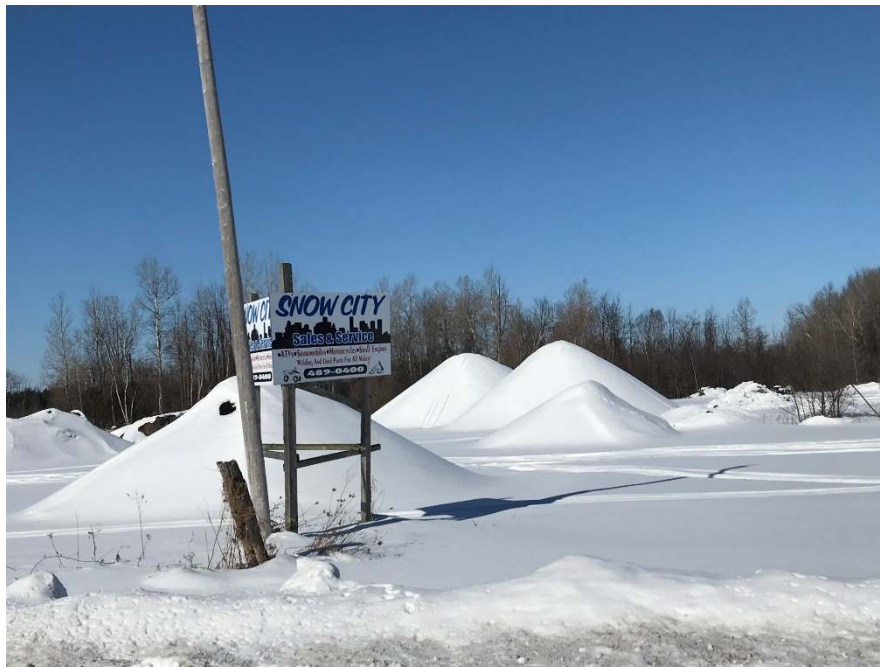
**Photograph 15:** Stockpiled material southwest of main house

The presence of structures on Site indicates the presence of fill material of an unknown origin in the developed portion of the Phase One Property. Also, various stockpiles of topsoil were observed to the west of the garage at the time of the Site reconnaissance.

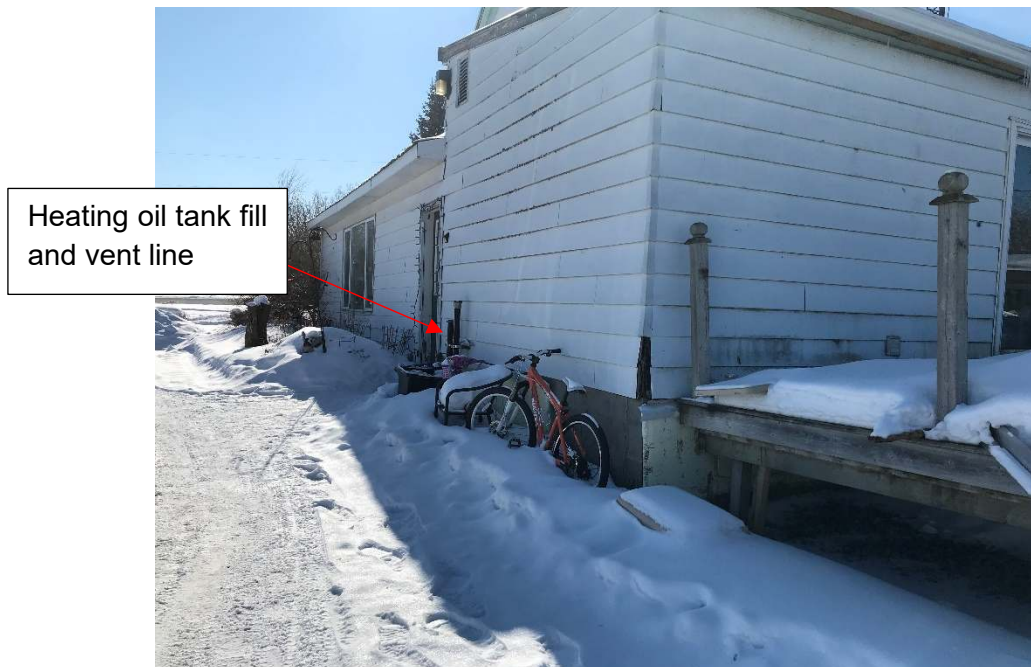
**Photograph 24:** Main house, northeast corner

Heating oil tank fill  
and vent line

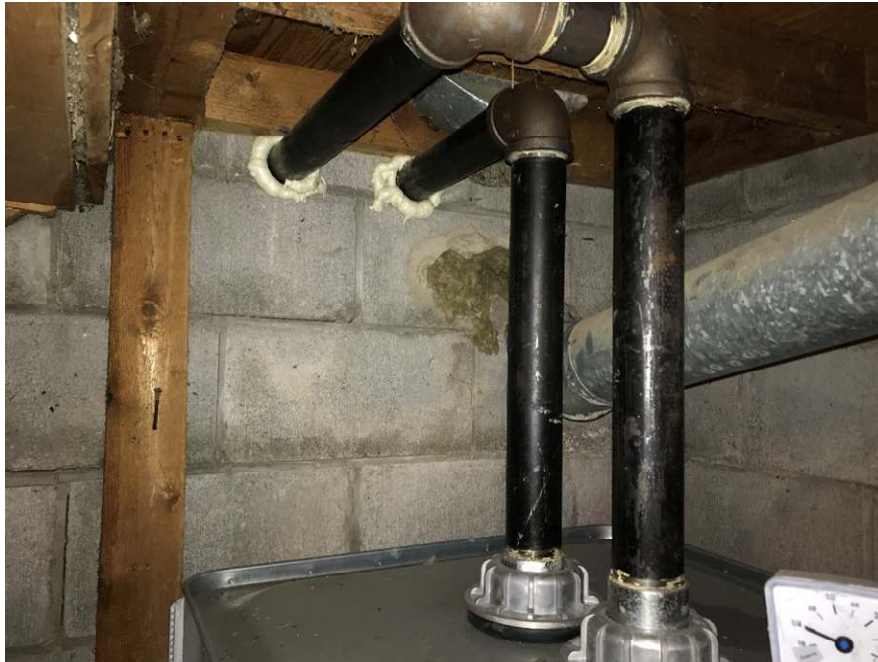
**Photograph 29:** Heating oil tank, fill and vent lines

An aboveground storage tank (AST) containing heating oil was observed in the basement of the two-storey residence at the time of the Site reconnaissance. DST was informed by Mr. Cureston that a previous oil tank was installed in 2004 and removed and replaced with the existing tank in January 2020. No evidence of leaks or corrosion of the existing tank was observed by DST. Also, no staining was observed in the basement of the residence.

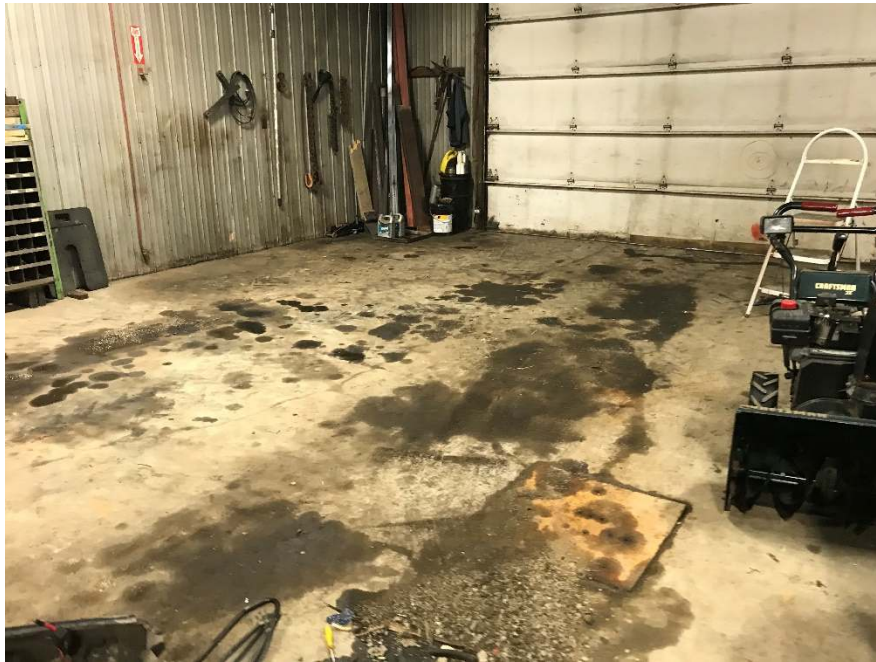
**Photograph 51:** Garage interior staining

There was staining observed in various areas on the concrete floors within the garage, likely due to fluids leaking or spilling during the repair and maintenance of the snowmobiles and small engines performed in the garage. It should be noted, however, that the concrete floor slab within the garage was observed to be in good condition.
