**Hydrogeological Investigation,
Terrain Analysis, and Groundwater
Impact Assessment
Zoning Amendment
6158 Rideau Valley Drive
Ottawa, Ontario**

Millers Farm
6158 Rideau Valley Drive North
Manotick, Ontario
K4M 1B3

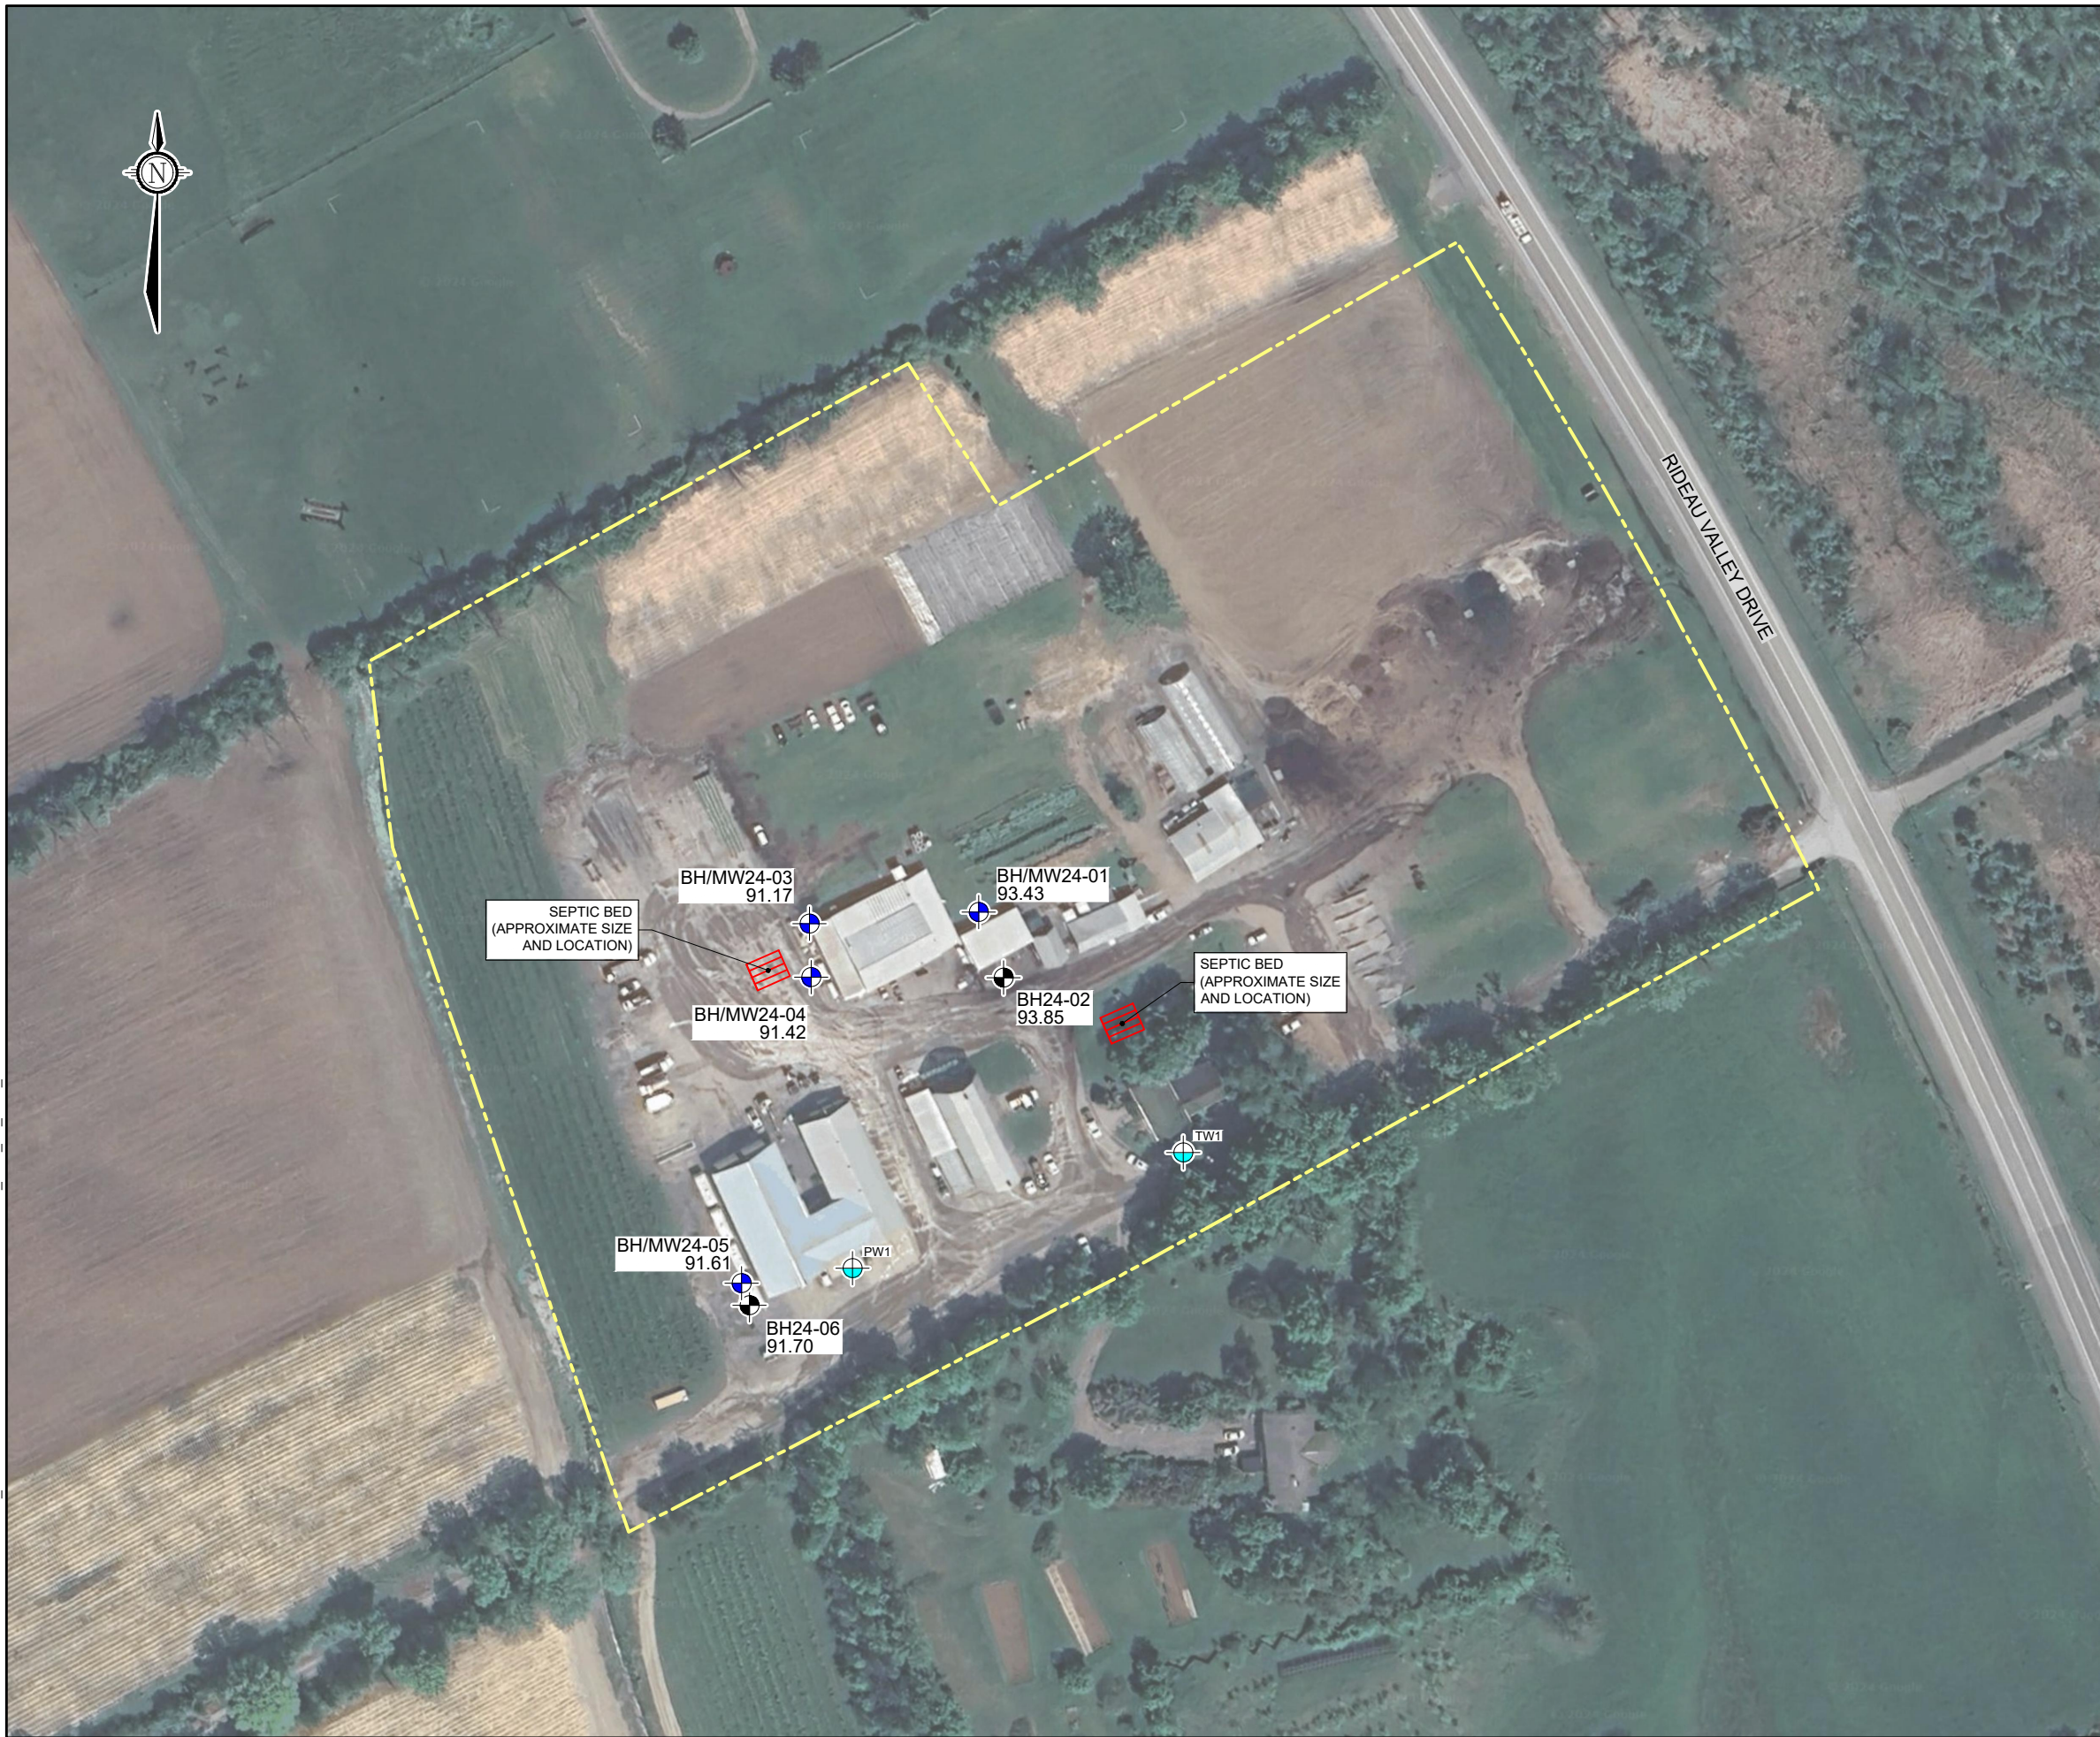
BH/ MW # — BOREHOLE/ MONITORING WELL ID
 XX.XX — GROUND SURFACE ELEVATION, IN METRES

The location of these monitoring wells is shown in Figure 2, Appendix A. The details of these monitoring wells are provided in Table 1.

Two existing wells located on the Site were reviewed as part of the hydrogeological investigation, herein referred to as 'TW1' and 'PW1'. The MECP water well record for TW1 is provided in Appendix D and the construction details are summarized in Table 3, below. The water well record was unavailable for PW1 at the time of this investigation. The approximate locations of the water wells are provided on the Detailed Site Plan, Figure 2.

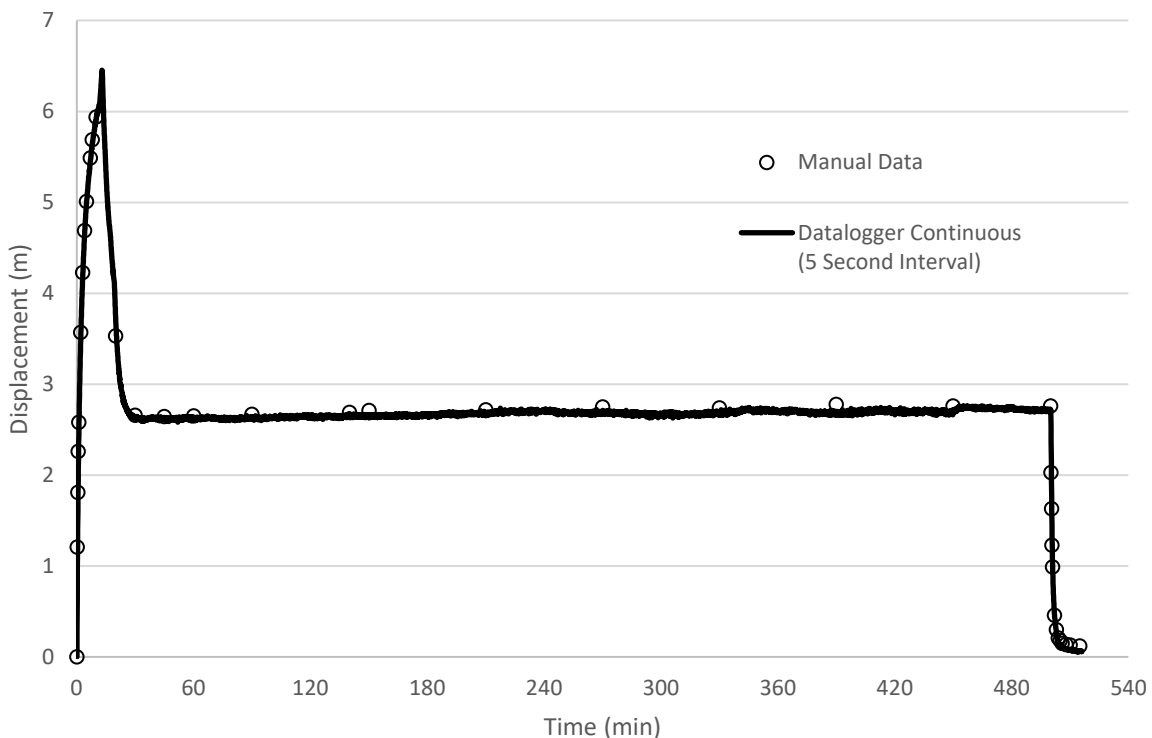
Pumping Test Data (TW1): Drawdown and Recovery

Water Levels TW23-1

Static : 9.38 m below top of casing

Water level and flow rate measurements were taken at regular intervals throughout the pumping test. Water levels were also taken during the recovery phase of the pumping test (after the pump was turned off) for a total of 20 minutes. The pumping test drawdown and recovery graph is provided in Appendix E.

During the eight-hour pumping test, the water level decreased approximately 2.76 metres, from a static water level of 8.69 metres below ground surface. Frequent flow rate measurements confirmed that the pumping was maintained at a constant rate of approximately 38 litres per minute, excluding the first 20 minutes of the test. The pumping test withdrew a total volume of approximately 18,200 litres, and the well recovered 95 % after the pump was turned off within approximately 15 minutes.
