Phase One Environmental Site Assessment Zoning By-Law Amendment Application 6158 Rideau Valley Drive Ottawa, Ontario

> September 4, 2024 Project: 100011.082

GEMTEC Consulting Engineers and Scientists Limited
32 Steacie Drive
Ottawa, ON, Canada
K2K 2A9

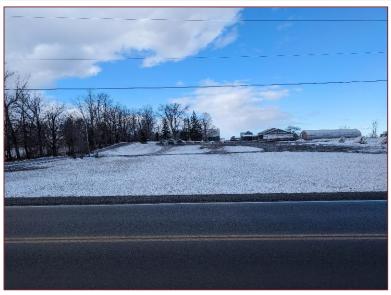
Photograph L1 – Looking west. View of the Site from Rideau Valley Drive. All the structures at the Site can be seen on the photo in the background and landscaping operations can be seen in the front.

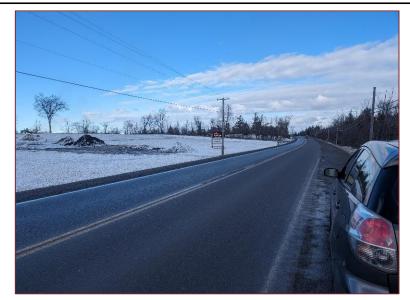
Photograph L2 – Looking north along the Rideau Valley Drive. The Site is to the left of the Rideau Valley Drive. Roadside drainage ditches are located on both sides of the Rideau Valley Drive.

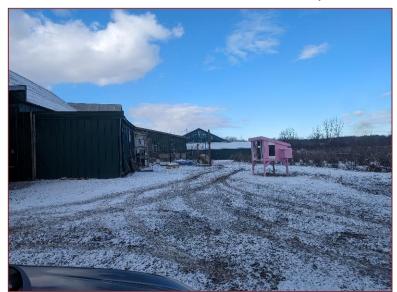
Photograph L4 – Looking west. Chicken coops and the area behind Structure 4 (Material Storage), Structure 5 (Material Storage), Structure 9 (Salt Storage) and Structure 3 (Material Storage in the background).

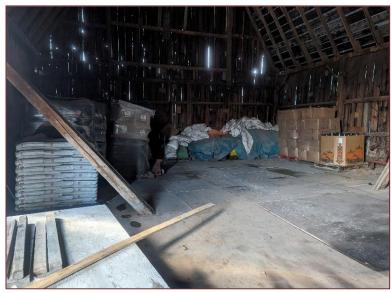
Photograph L5 – Looking south and the inside view of Structure 1 (Two Storey Barn).

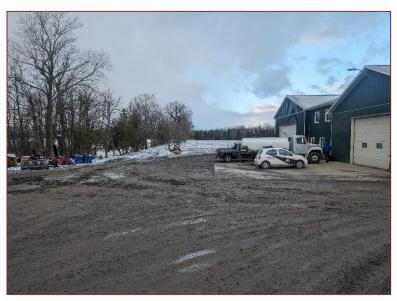
Photograph L7 – Looking west. Structure 7 (Building Workshop) with the bay doors can be seen to the right.

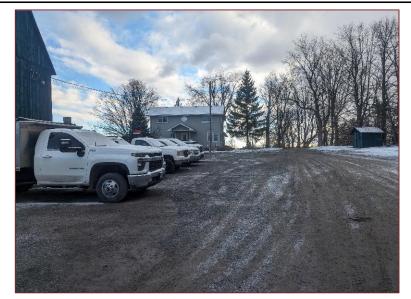
Photograph L6– Looking east along the gravel graded driveway/roadway leading into the Site. Structure 2 (Office Building) and Structure 1 (Two Storey Barn on the left) can be seen.

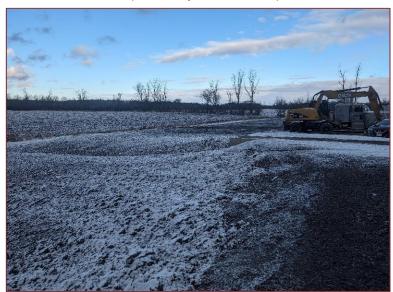
No evidence of stockpiled fill material or fill with debris was observed on the Site except for material that was placed east of the McIntyre Scobie Drain. Please see Figure A.2, Appendix A for the location of the placement of this excess soil which was imported from 3505 Prince of Wales Drive in Ottawa, Ontario. This imported excess soil does not create an APEC on-Site because GEMTEC understands that no exceedances were identified compared to MECP Table 1 Agricultural or Other Property Use (Agri) Excess Soil Quality Standards (ESQS), Table 2.1 Agri ESQS and Table 8.1 Agri ESQS. The details of the soil analytical data are not discussed and summarized as part of this report as the report was not available to GEMTEC for review.

Photograph L8 – Looking north along the area where the imported soil was placed. Tractor wash area can be seen on the right and McIntyre Scobie Drain can be seen on the left.

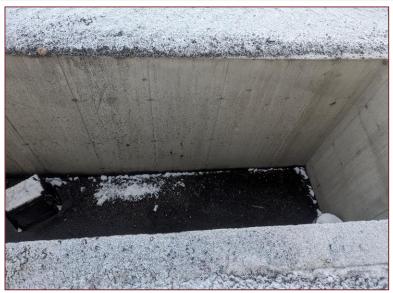
Photograph L9 – Looking north and a view of the tractor wash area. No signs of spills, staining or odors were noted at this location.

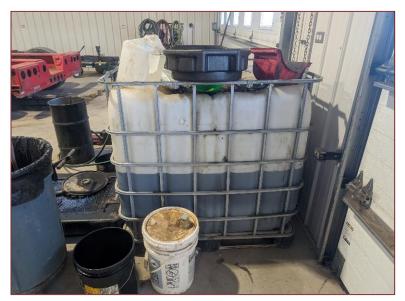
Photograph L11 – Looking east inside the Structure 7 (Building Workshop). An oil tote was present inside the Structure 7. No signs of spills, staining or odors were noted at this location.

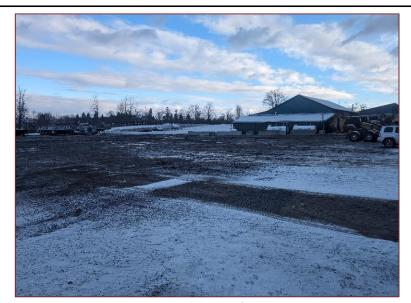
Three ASTs are used for refuelling farm equipment. These ASTs are located to the west of the building line of Storage Shed (Structure 3). The ASTs appeared to be in a good working condition with no staining and spills on the ground. The ASTs were protected by concrete barriers.

Photograph L10 – Looking north and a view of the gravel graded parking area and ASTs. ASTs are located along the west building line of Structure 3 (Material Storage). The Structure 9 (Salt Storage) can be seen in the background on the right.

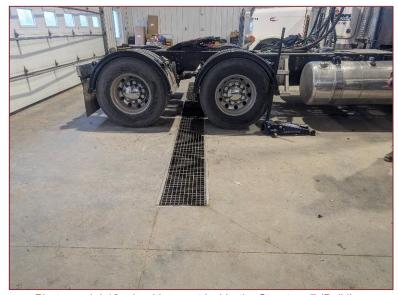
APEC 1 – Presence of Oil Water Separator and general maintenance of farm equipment at Structure 7.

Building Workshop (Structure 7) is used for general maintenance of farm equipment and has floor drains which are associated with an oil water separator which is located along the western building line of the Building Workshop. Concrete slab on grade was in a good condition with minimal cracking.

Photograph L12 – Looking west inside the Structure 7 (Building Workshop). A photo of the drain discharging into an oil water separator. Concrete flooring was in a good shape with minimal cracking.

Based on the identification of three APECs on the Site, it is recommended that a subsurface investigation be carried out to adequately characterize soil and groundwater conditions in support of the proposed works in accordance with O.Reg 153/04, as amended.

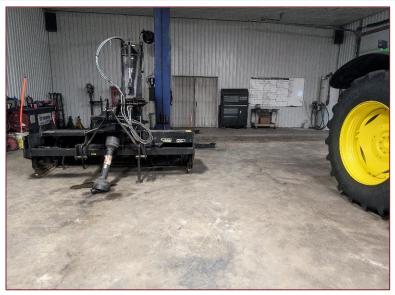
Photograph L13 – Looking west inside the Structure 7 (Building Workshop). A photo of the hydraulic lift.

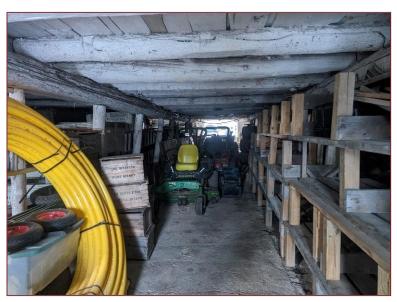
Photograph L15 – Looking north inside the Structure 3 (Material Storage). Concrete flooring was in a good shape with minimal cracking. No signs of spills, staining or odors were noted at this location.

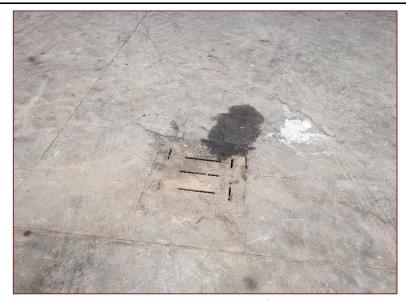
Photograph L14 – Looking west inside the Structure 7 (Building Workshop). A photo of the drain.

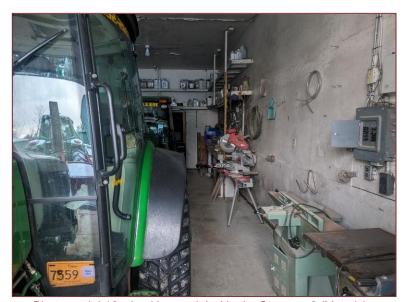
Photograph L16 – Looking north inside the Structure 3 (Material Storage). Concrete flooring was in a good shape with minimal cracking. No signs of spills, staining or odors were noted at this location.

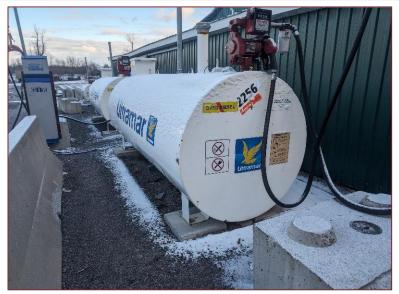
Through the review of information (aerial photographs and Site reconnaissance), the Site has three Aboveground Storage Tanks (ASTs). No evidence of staining, spills or odours were noted at the time of the Site reconnaissance. This APEC is limited to the western building line of Storage Shed (Structure 3). The COPCs are PHC F1-F4, PAHs, and Benzene, Toluene, Ethylbenzene and Xylene (BTEX) in soil and groundwater.

Photograph L17 – Looking north at the ASTs along the west building line of Structure 3 (Material Storage). The ASTs were in good working condition and there were no signs of spills, staining or odors were noted at this location.

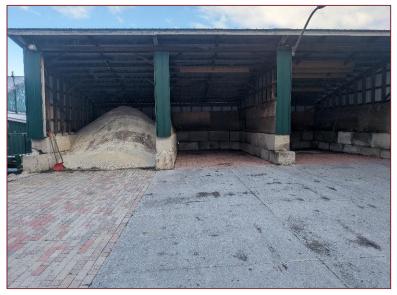
Photograph L19 - Looking north towards Structure 9 (Salt Storage).

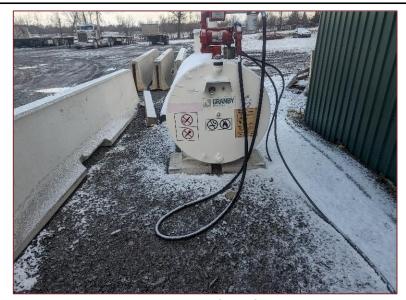
18	North	Looking north at one of the ASTs along the west building line of Structure 3 (Material Storage). The ASTs were in good working condition and there were no signs of spills, staining or odors were noted at this location.
19	North	Looking north towards Structure 9 (Salt Storage).
20	North	Looking north inside Structure 4 (Material Storage).
21	Northeast	Looking north inside Structure 6 (Sales Shop/Millers Farm Market and Garden Centre). Concrete flooring was in a good condition with minimal cracking.
22	North	Looking north inside Structure 8 (greenhouse).
23	South	Looking south towards Structure 2 (Residential Building). A septic tank can be seen in front of the Residential Building.
24	Northwest	Looking northwest. From left to right is Structure 3 (Material Storage), Structure 9 (Salt Storage), Structure 5 (Material Storage), and Structure 4 (Material Storage).

Photograph L18 – Looking north at one of the ASTs along the west building line of Structure 3 (Material Storage). The ASTs were in good working condition and there were no signs of spills, staining or odors were noted at this location.

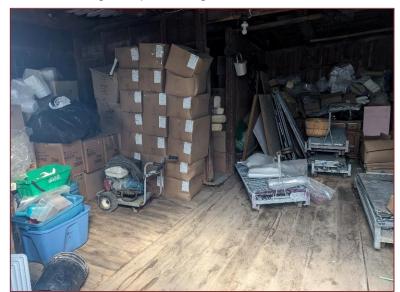
Photograph L20 – Looking north inside Structure 4 (Material Storage).

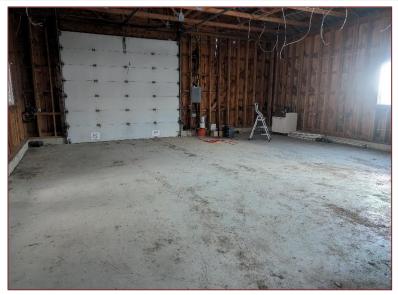
Photograph L21 – Looking north inside Structure 6 (Sales Shop). Concrete flooring was in a good shape with minimal cracking.

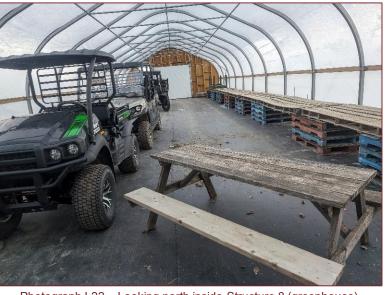
Photograph L22 – Looking north inside Structure 8 (greenhouse).

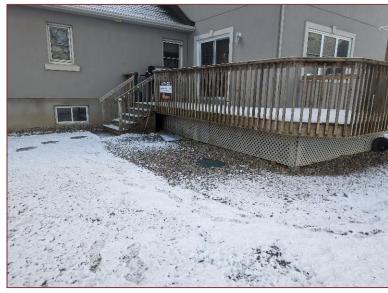
The Site is serviced by a water well and a septic system (located to the north of Residential Building (Structure 2)). The adjacent properties were assumed to be provided with domestic water well in a similar manner as the Site. The storm water is believed to either infiltrate the ground surface or flow towards McIntyre Scobie Drain or drainage ditches located along Rideau Valley Drive.

Photograph L23 – Looking south towards Structure 2 (Office Building). A septic tank can be seen in front of the Office Building.

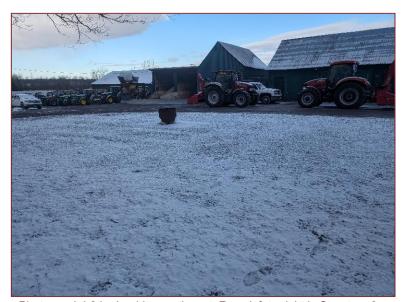
Photograph L24 – Looking northwest. From left to right is Structure 3 (Material Storage), Structure 9 (Salt Storage), Structure 5 (Material Storage), and Structure 4 (Material Storage).
