## Phase Two Environmental Site Assessment

593, 601 & 603 Laurier Ave W  
Ottawa, Ontario

LRL File No.: 240447

October 18, 2024

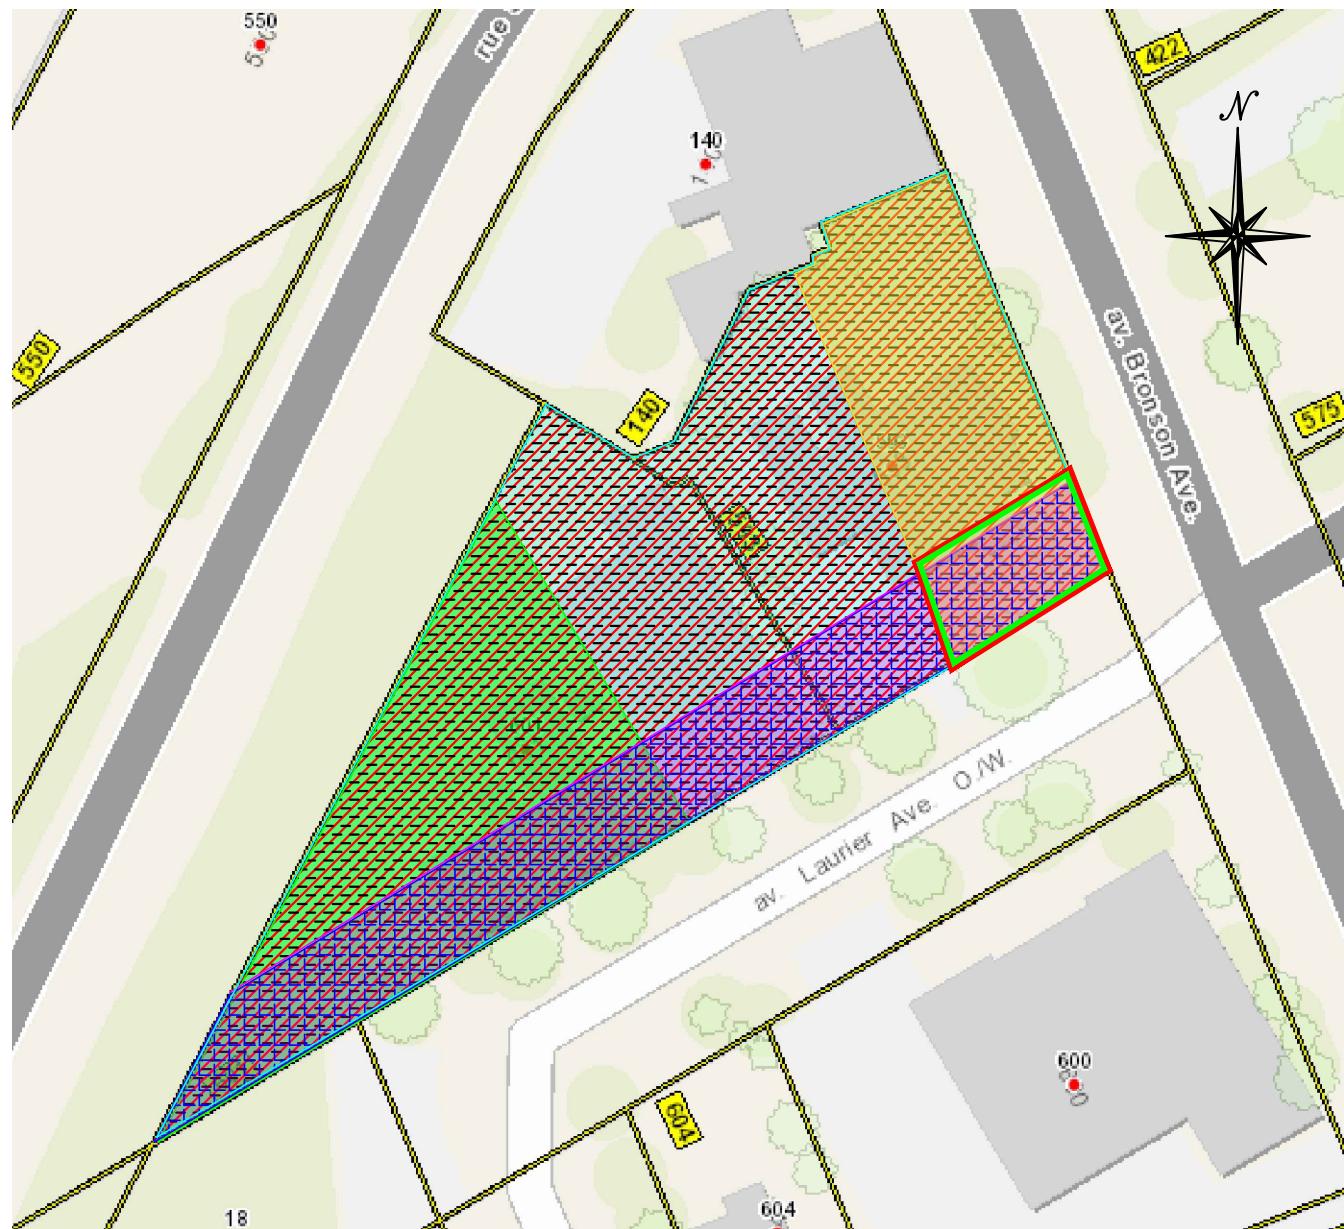
**FIGURE 3**

**APEC Summary**

APEC 1: Spill (Hydraulic Oil)		APEC 3: Waste Generator		APEC 5: Waste Generator		APEC 7: Scott's Manufacturing Directory		APEC 9: Fill Material of Unknown Quality
	APEC 2: Spill (Furnace Oil)		APEC 4: Waste Generator		APEC 6: Waste Generator		APEC 8: Petroleum Storage Tank and Oil Heating

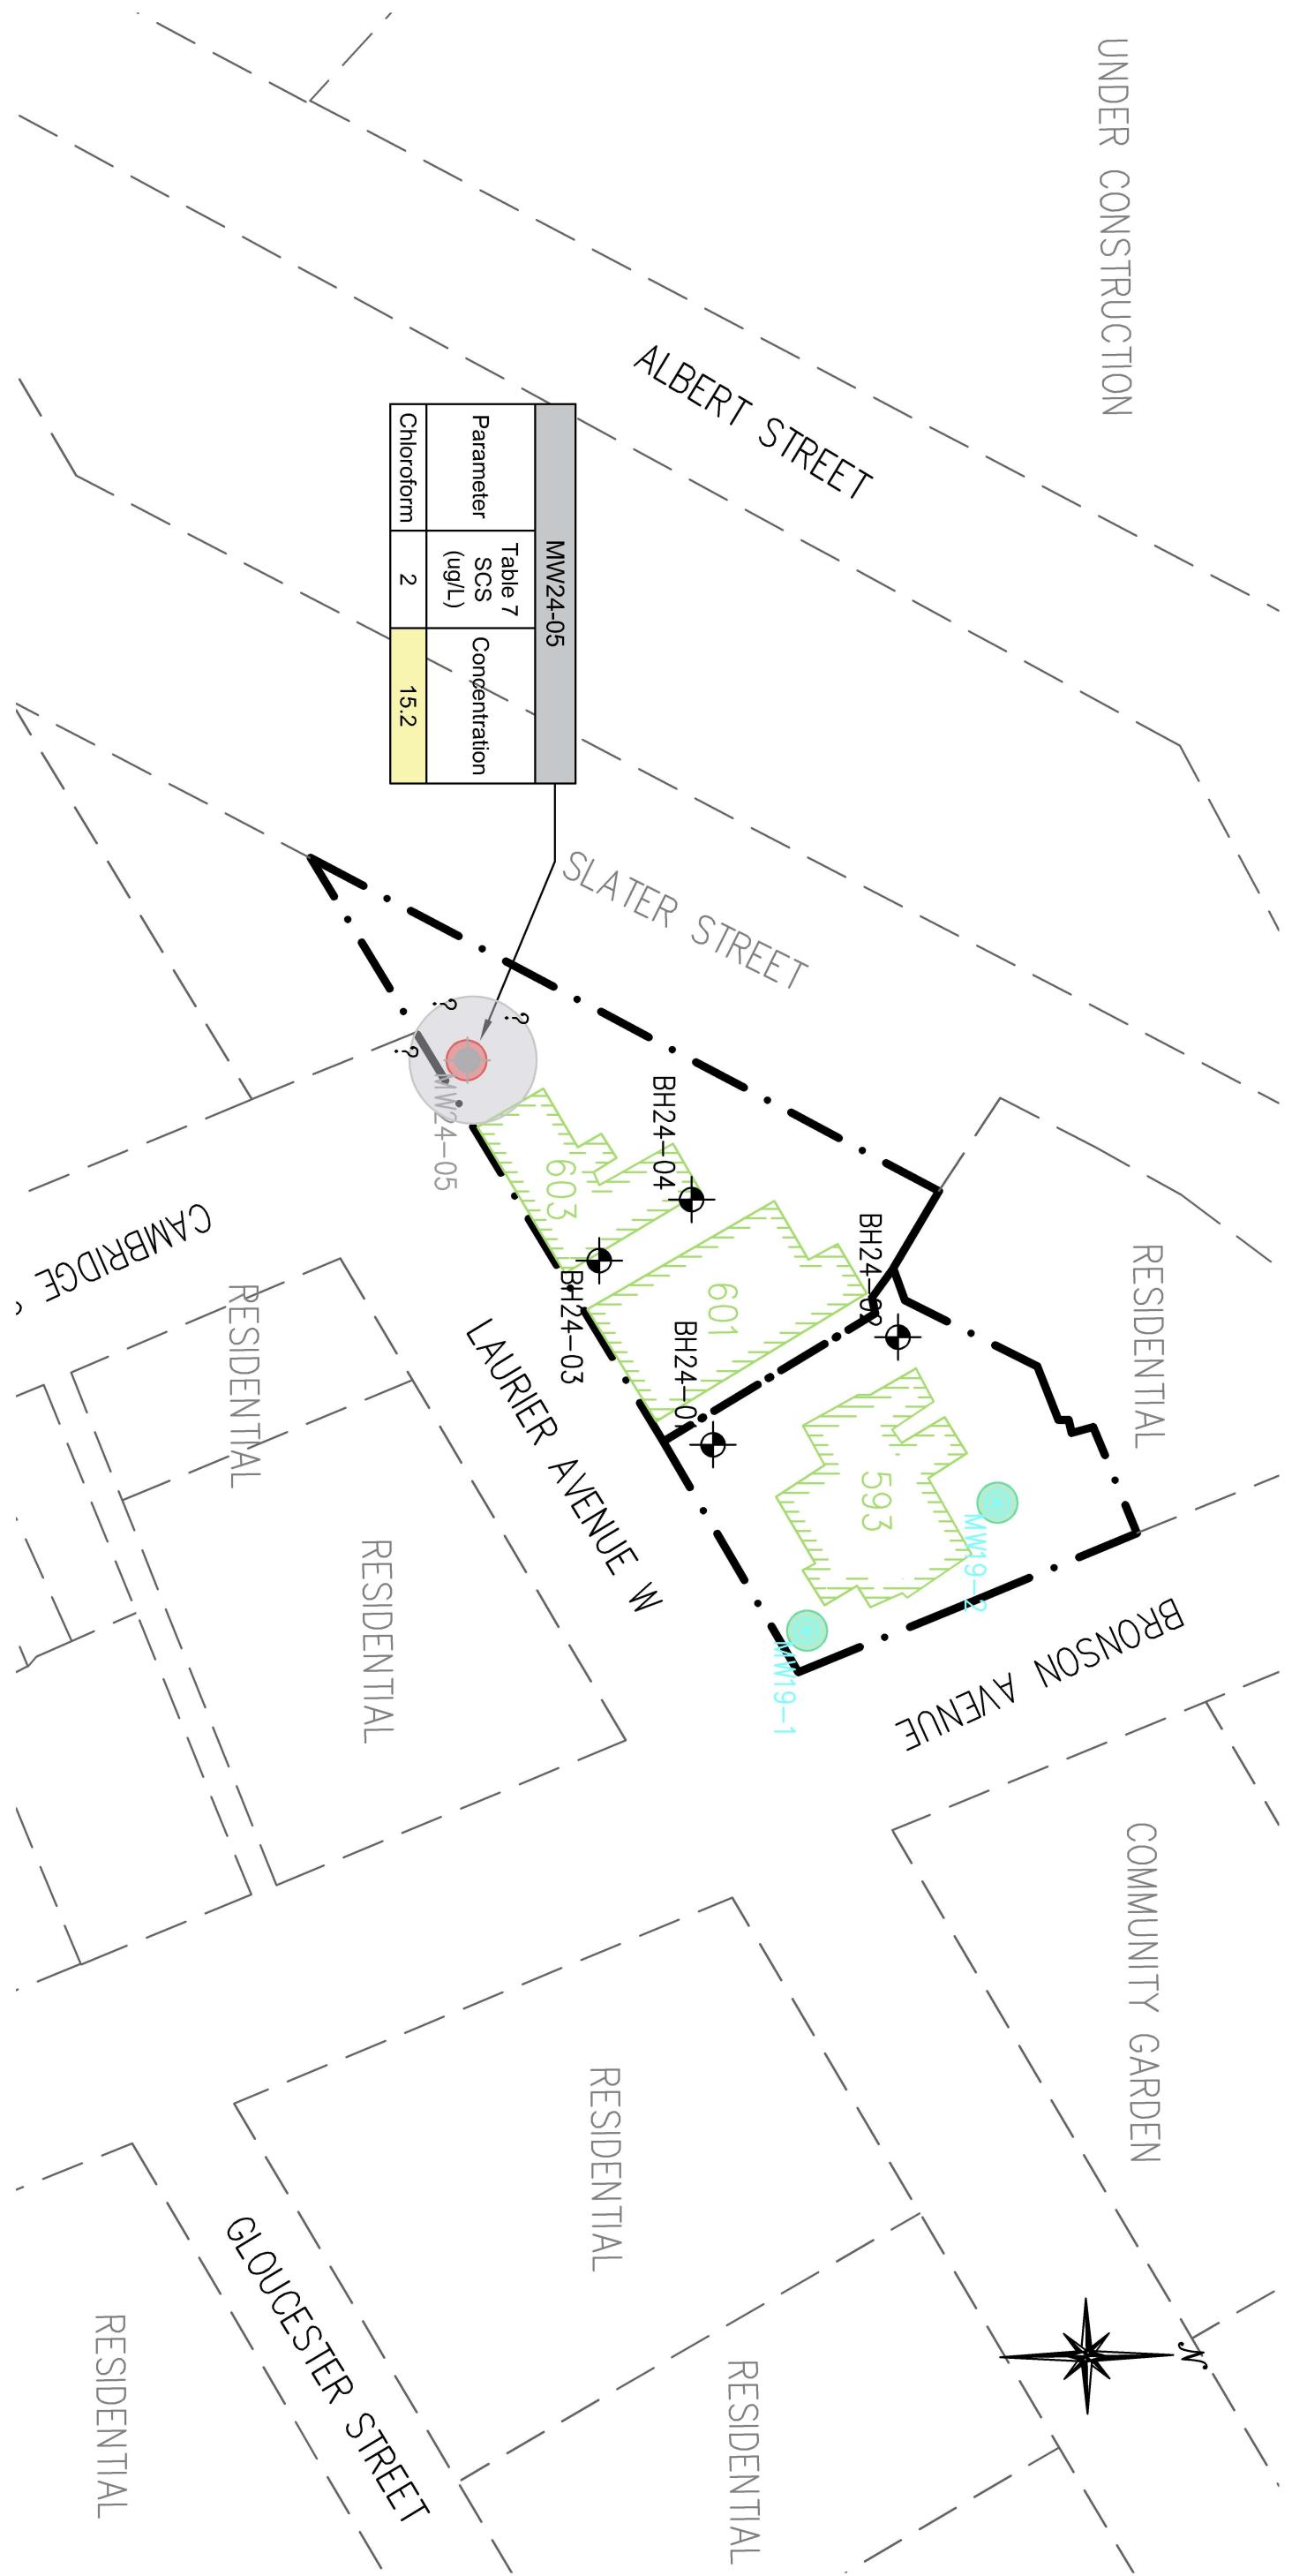
<b>FIGURE 7A</b>
------------------

<b>LRL</b> ENGINEERING   INGÉNIERIE	CLIENT HERITAGE INVESTMENTS LTD.	DRAWING TITLE VOC EXCEEDANCES - GROUNDWATER
	DESIGNED BY: _____	DRAWN BY: _____
	_____	APPROVED BY: _____
PROJECT	_____	_____

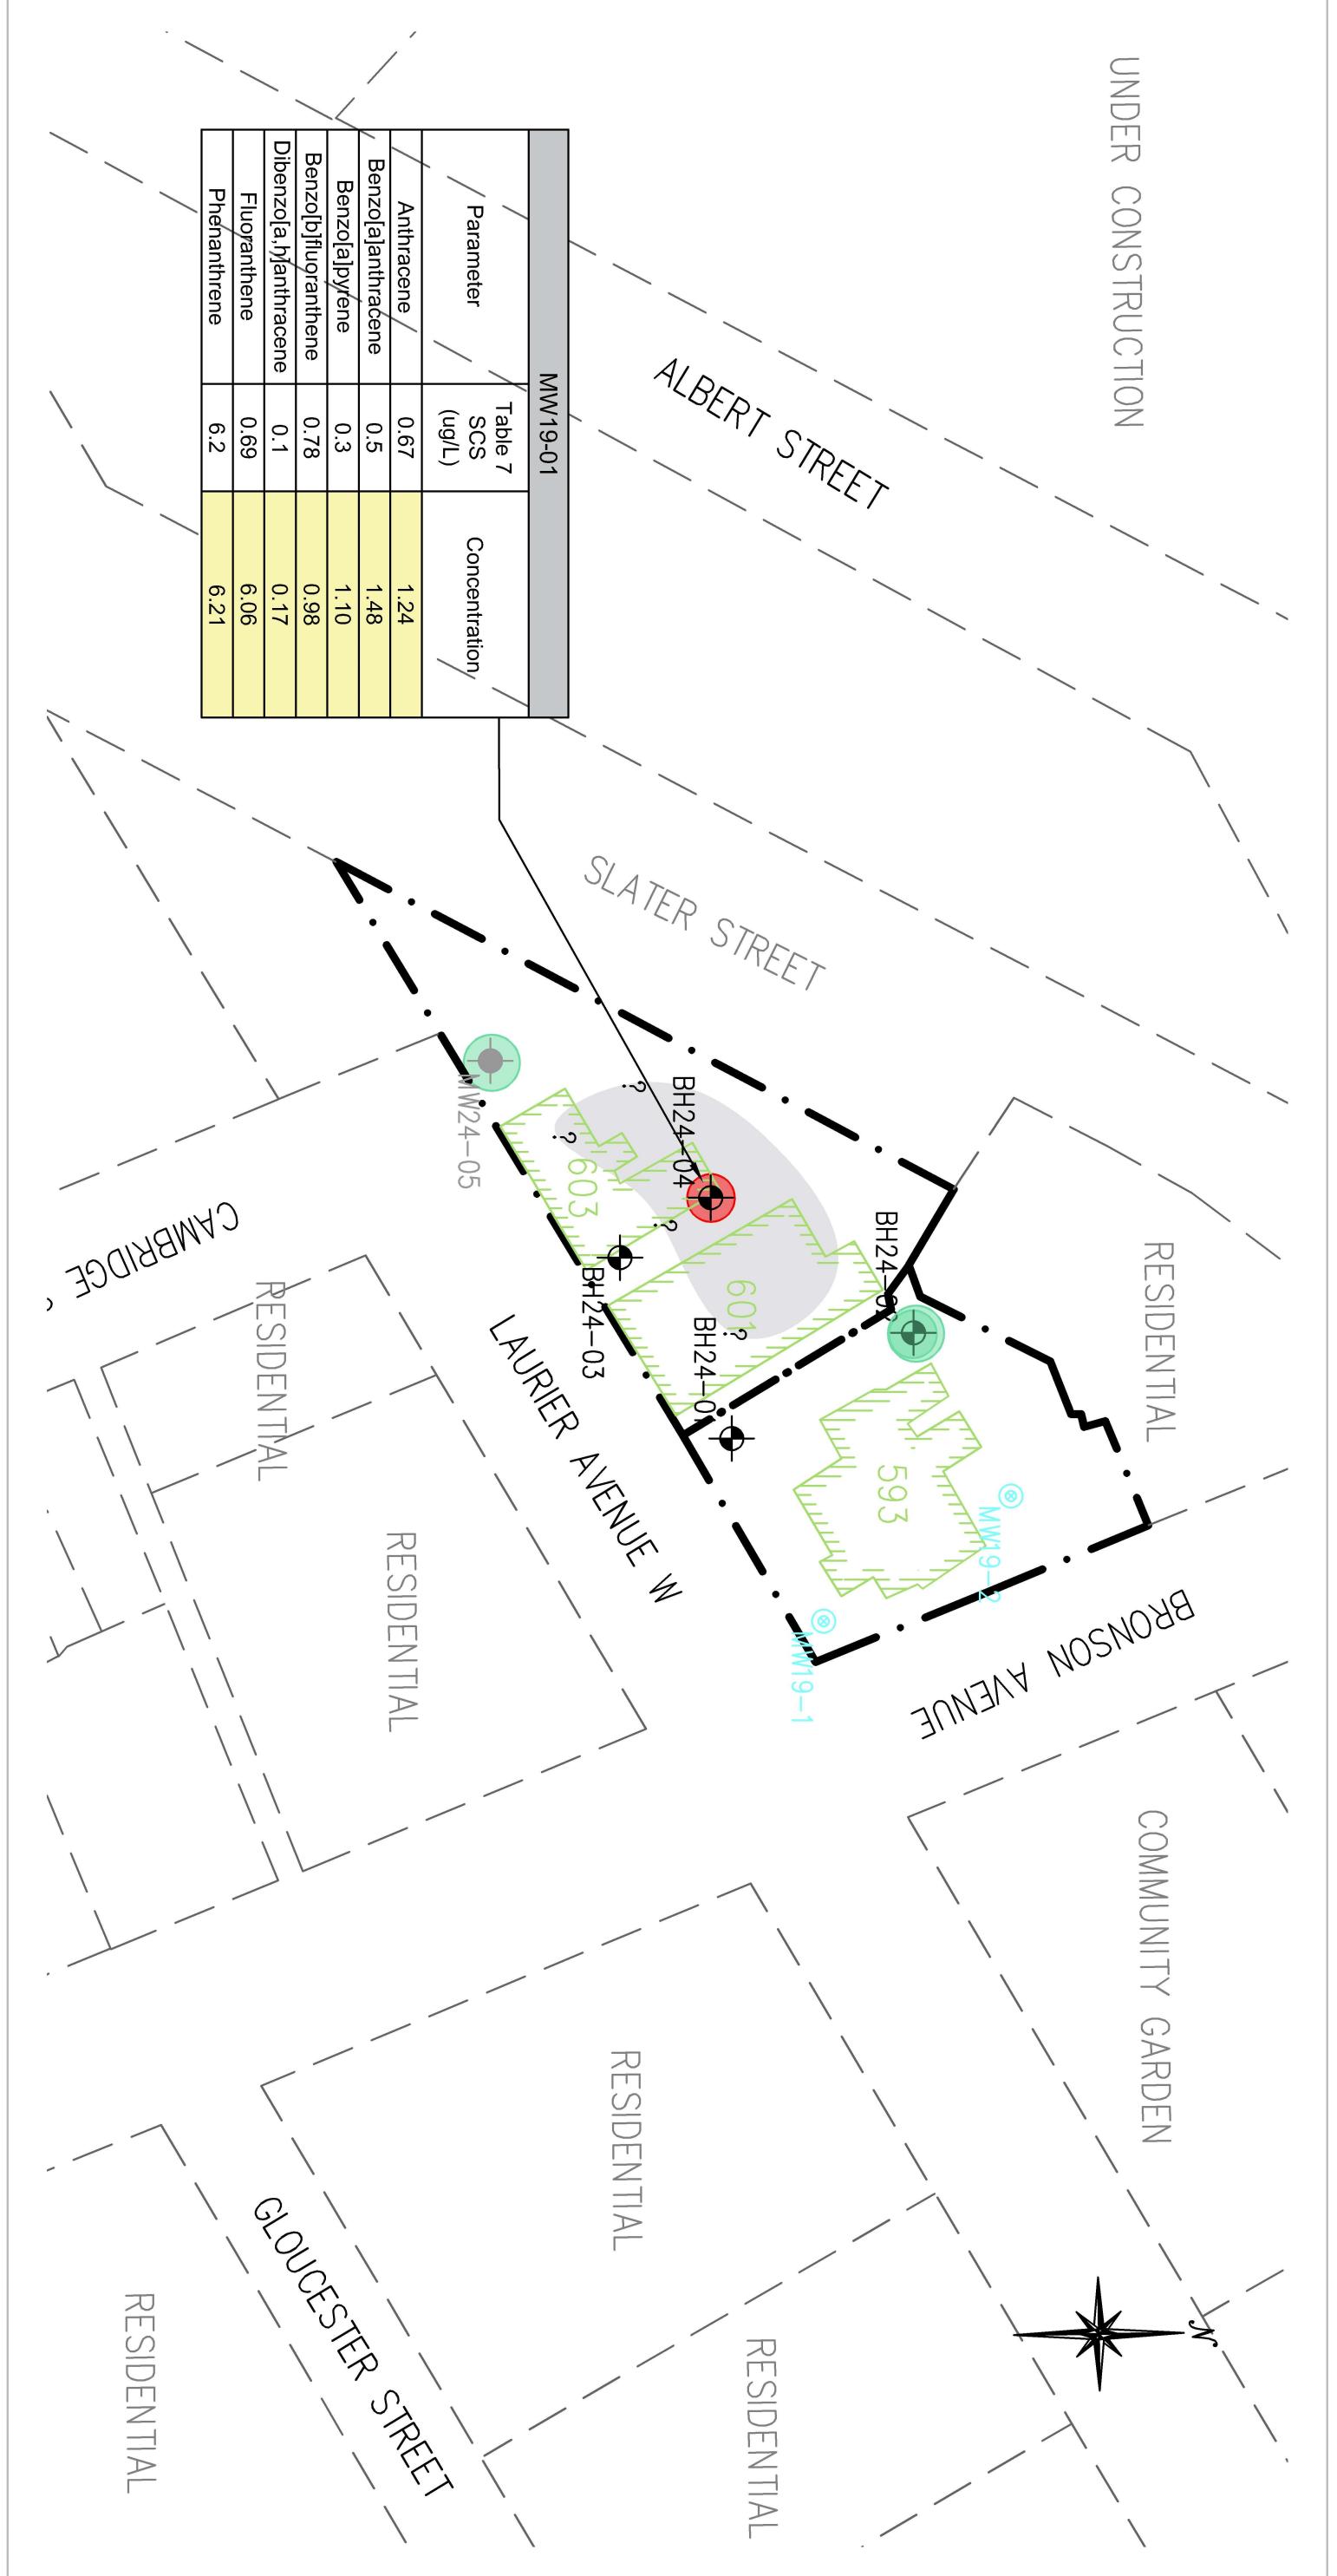
Legend		CLIENT		DRAWING TITLE	
Subject Sites	—	HERITAGE INVESTMENTS LTD.		2024 PAH EXCEEDANCES - SOIL	
Neighboring Property Extents	—	DESIGNED BY:	DRAWN BY:	APPROVED BY:	
Existing Buildings	—	—	—	—	
Borehole / Monitoring Well - Meets table 7 SCS	●	PROJECT	—	—	
Borehole / Monitoring Well - Exceeds Table 7 SCS	●	—	—	—	
Borehole / Monitoring Well - Fully Delineted	?	—	—	—	
Extents of Contamination Plume Not Fully Delineted	—	—	—	—	
Concentration Exceeding Table 7 SCS	—	—	—	—	
		01	FINAL	J.A.	09/25/2024
No.		REVISIONS	BY	DATE	
<b>LRL</b> <small>ENGINEERING   INGENIERIE</small> <small>5430 Caronk Road, Ottawa, ON K1J 9G2</small> <small>www.lrl.ca (613) 842-3434</small>					
<b>ENVIRONMENTAL SITE ASSESSMENT</b> <b>PHASE TWO</b> <b>593, 601 &amp; 603 LAURIER AVENUE W</b> <b>OTTAWA, ONTARIO</b>					
<b>FIGURE8C</b> <small>PROJECT NO.</small> <small>240447</small> <small>DATE</small> <small>SEPTEMBER 2024</small>

As presented in **Table C**, PAH parameters were detected in Sample 4-SS1, collected from borehole BH24-04 at depth of between 0.0 and 0.6 m bgs. Select PAH parameters were reported with concentrations above the applicable Table 7 site condition standards, which are summarized as follows:

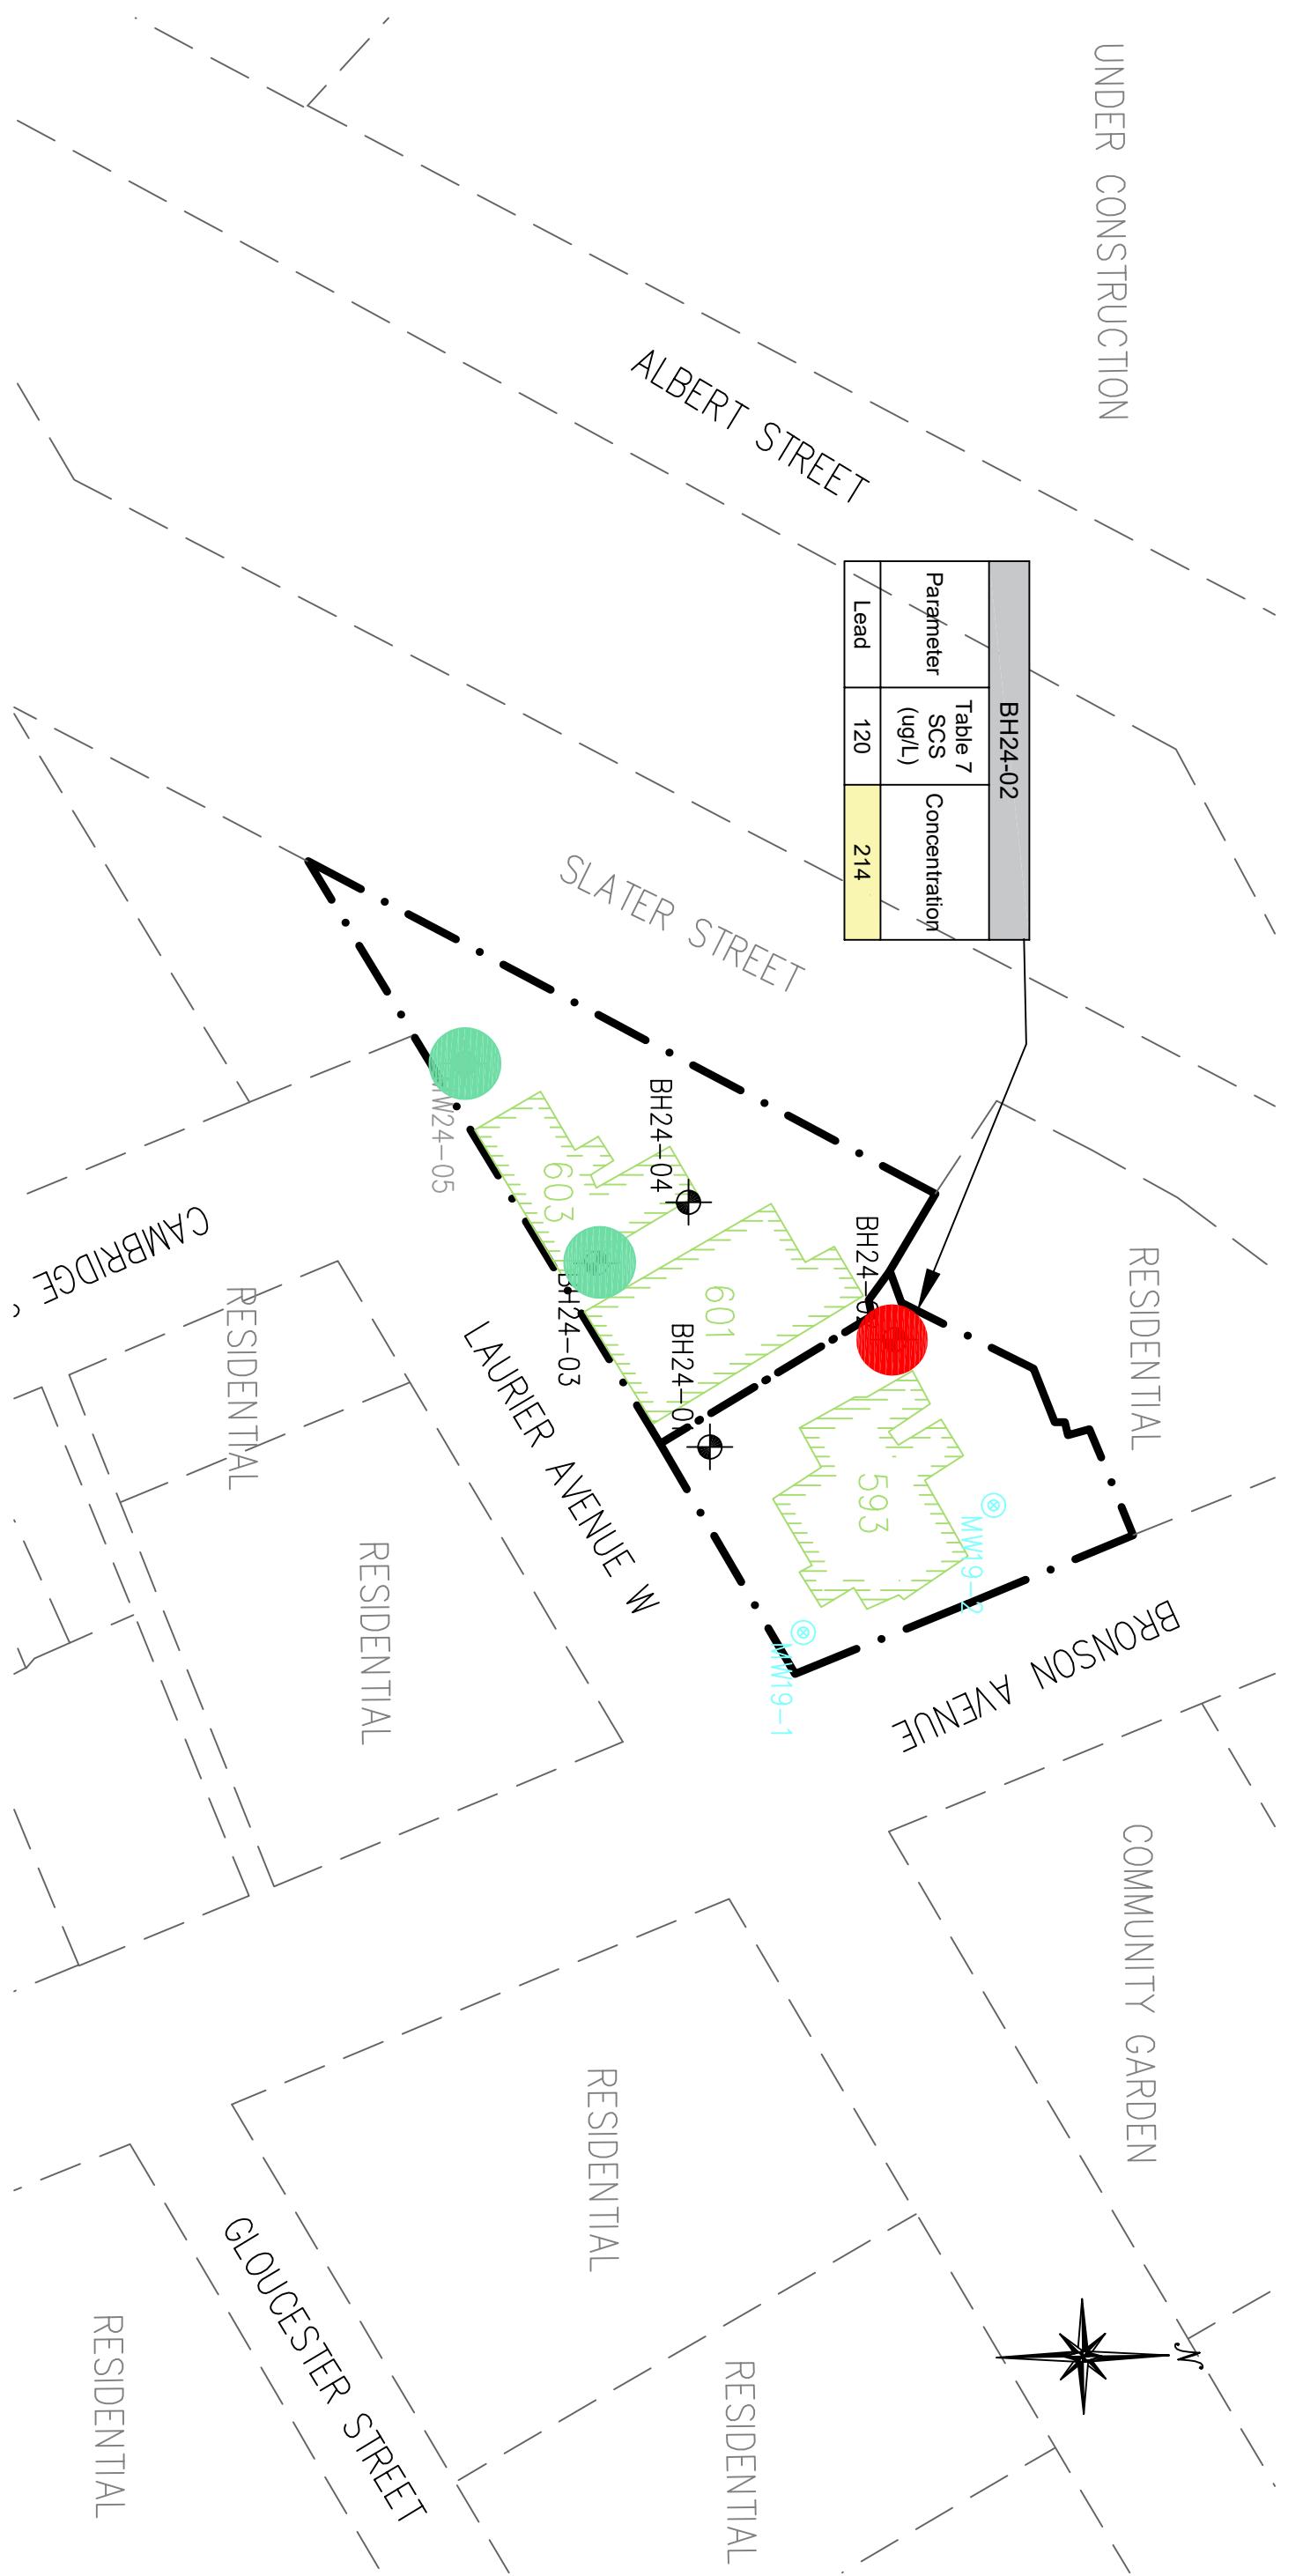
BH24-02	
Parameter	Table 7 SCS (ug/L)
Lead	120 <span style="background-color: yellow;">214</span>

CLIENT	DRAWING TITLE		
HERITAGE INVESTMENTS LTD.	2024 METALS EXCEEDANCES - SOIL		
DESIGNED BY:	DRAWN BY:	APPROVED BY:	
—	—	—	
PROJECT	J.A.	J.L.	
PHASE TWO			
ENVIRONMENTAL SITE ASSESSMENT			
593, 601 & 603 LAURIER AVENUE W			
OTTAWA, ONTARIO

Various metal-based parameters were detected in the soil samples submitted for analysis, although no exceedances to the Table 7 site condition standard were encountered with one (1) exception. Sample 2-SS1, collected from borehole BH24-2 from depths of between 0.0 and 0.6 m bgs had a concentration of lead of 214 µg/g, surpassing the Table 7 site condition standard of 120 µg/g.
