**Phase One Environmental Site Assessment  
Proposed Residential Development  
1174 Carp Road  
Ottawa, Ontario**

GEMTEC Project: 101785.004

November 21, 2024  
GEMTEC Project: 101785.004

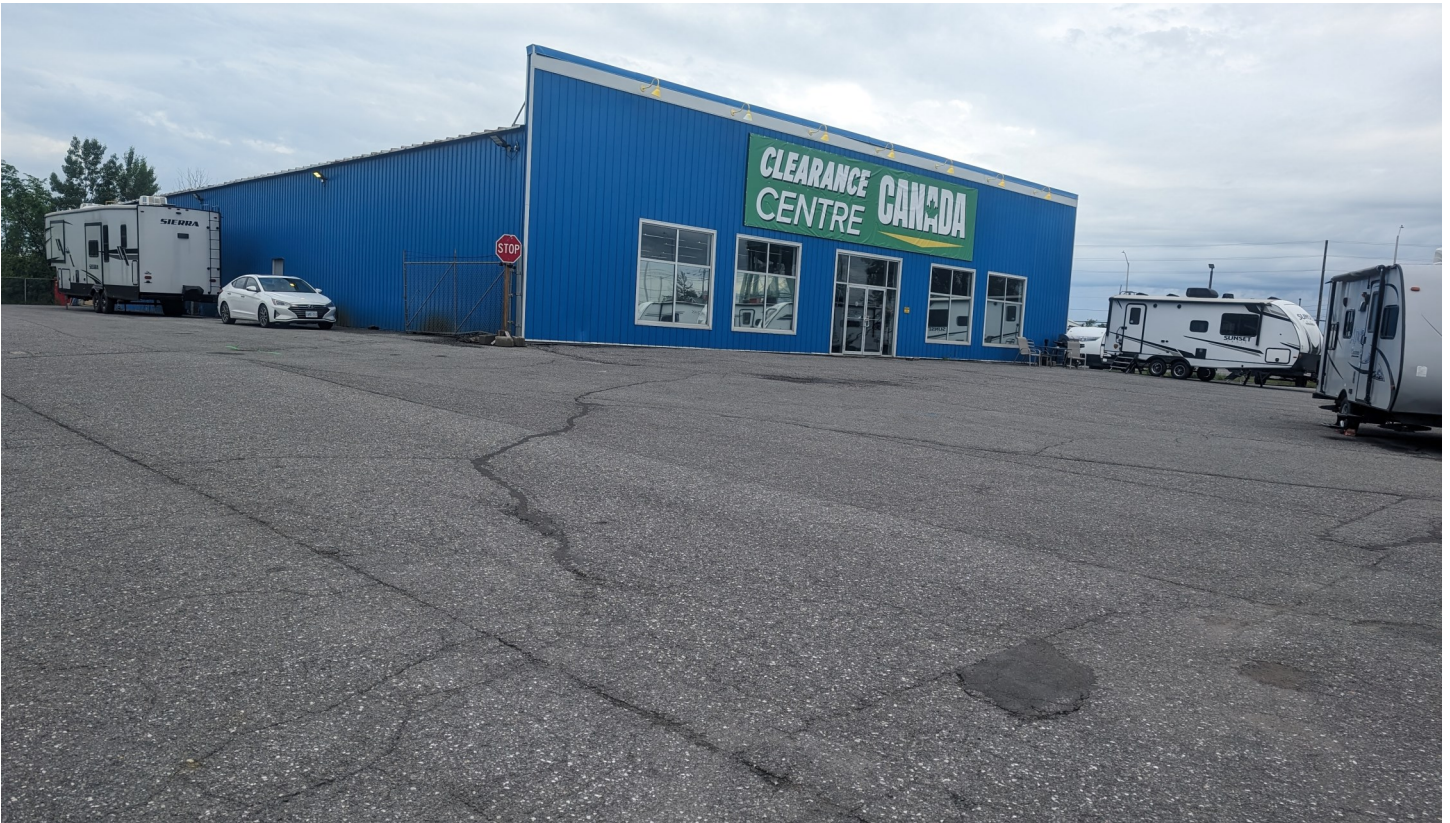
Photo K1 - Looking northeast towards the on-Site structure. The outside area is used for the parking/storage of RVs.

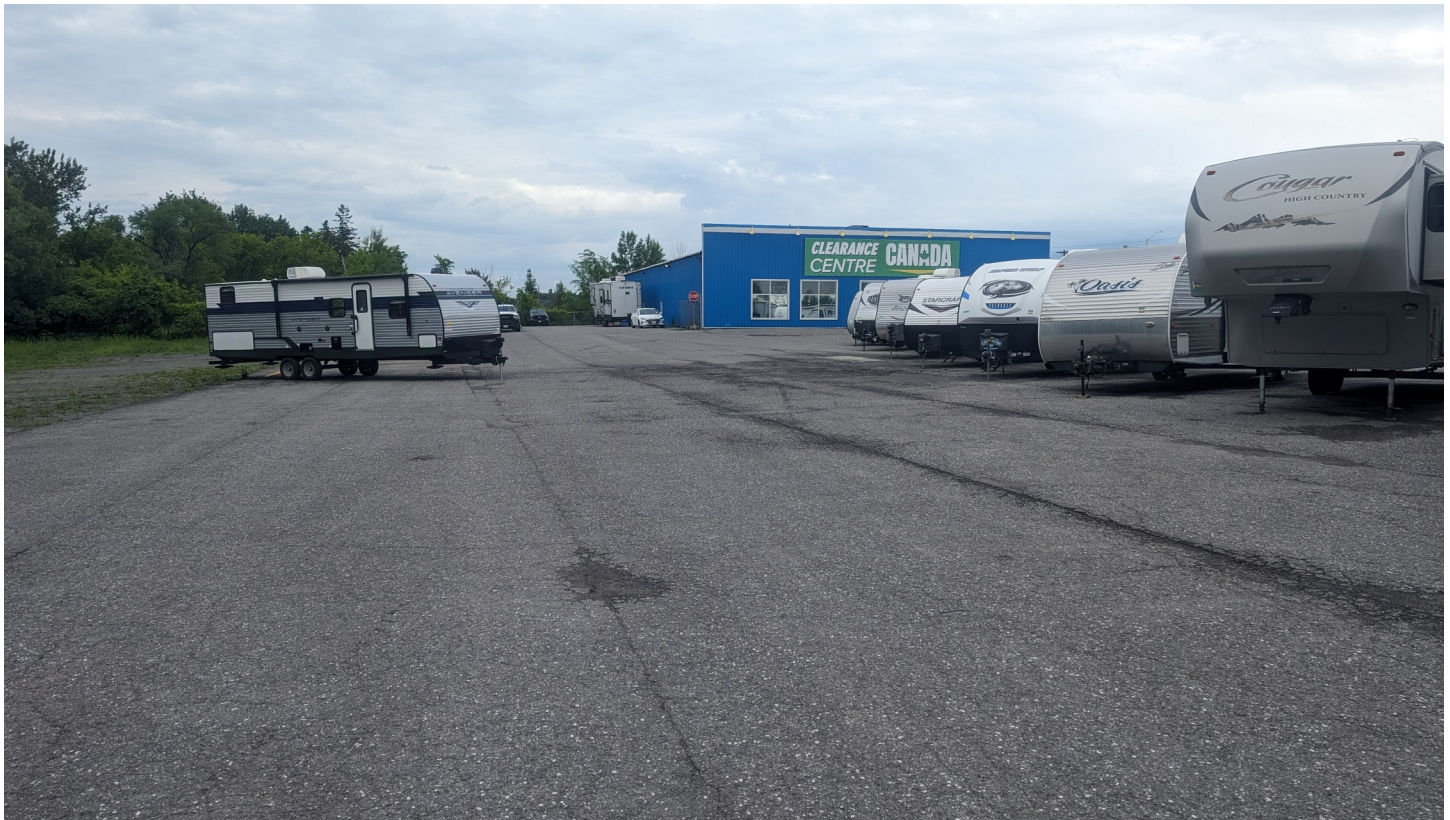
Photo K2 - Looking west towards the on-Site structure.

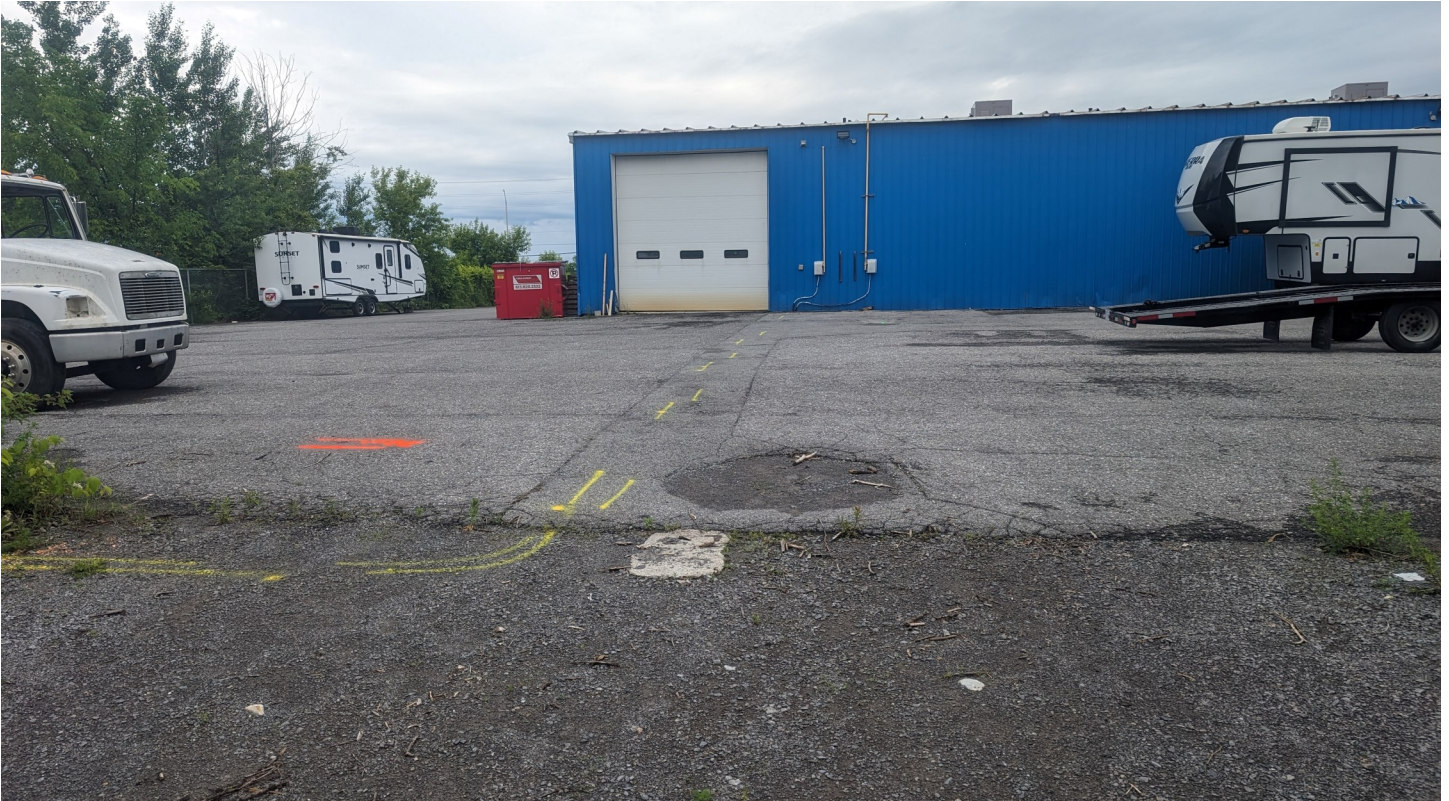
Photo K3 - Looking north towards the south building line of the on-Site structure. Abandoned gas lines were noted from the location of ASTs (noted as part of the review of aerial photographs between 2005 and 2022).

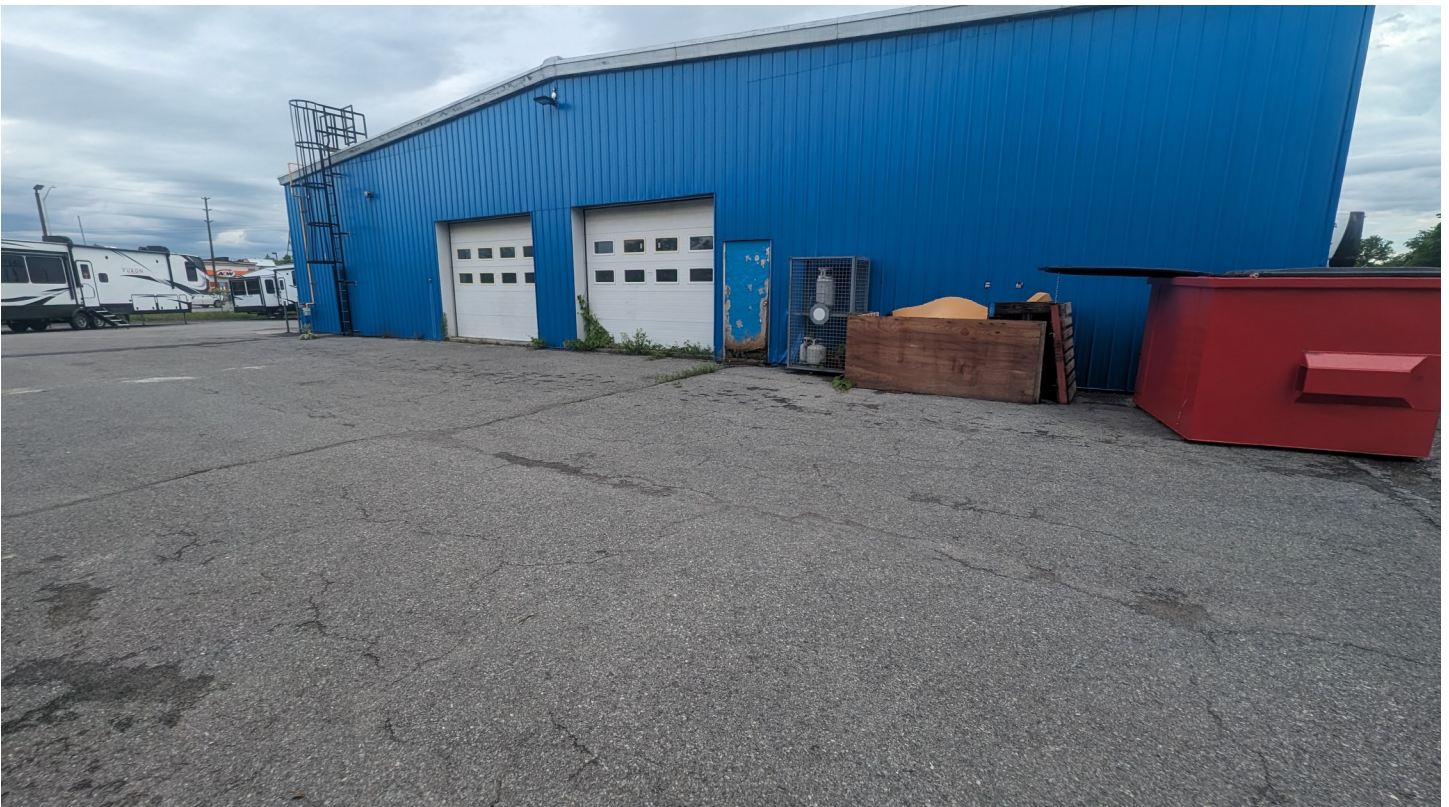
Photo K4 - Looking east towards the west building line of the on-Site structure. Gas meter can be seen to the left. Two bay doors were centrally located along the building line and propane cylinder storage.

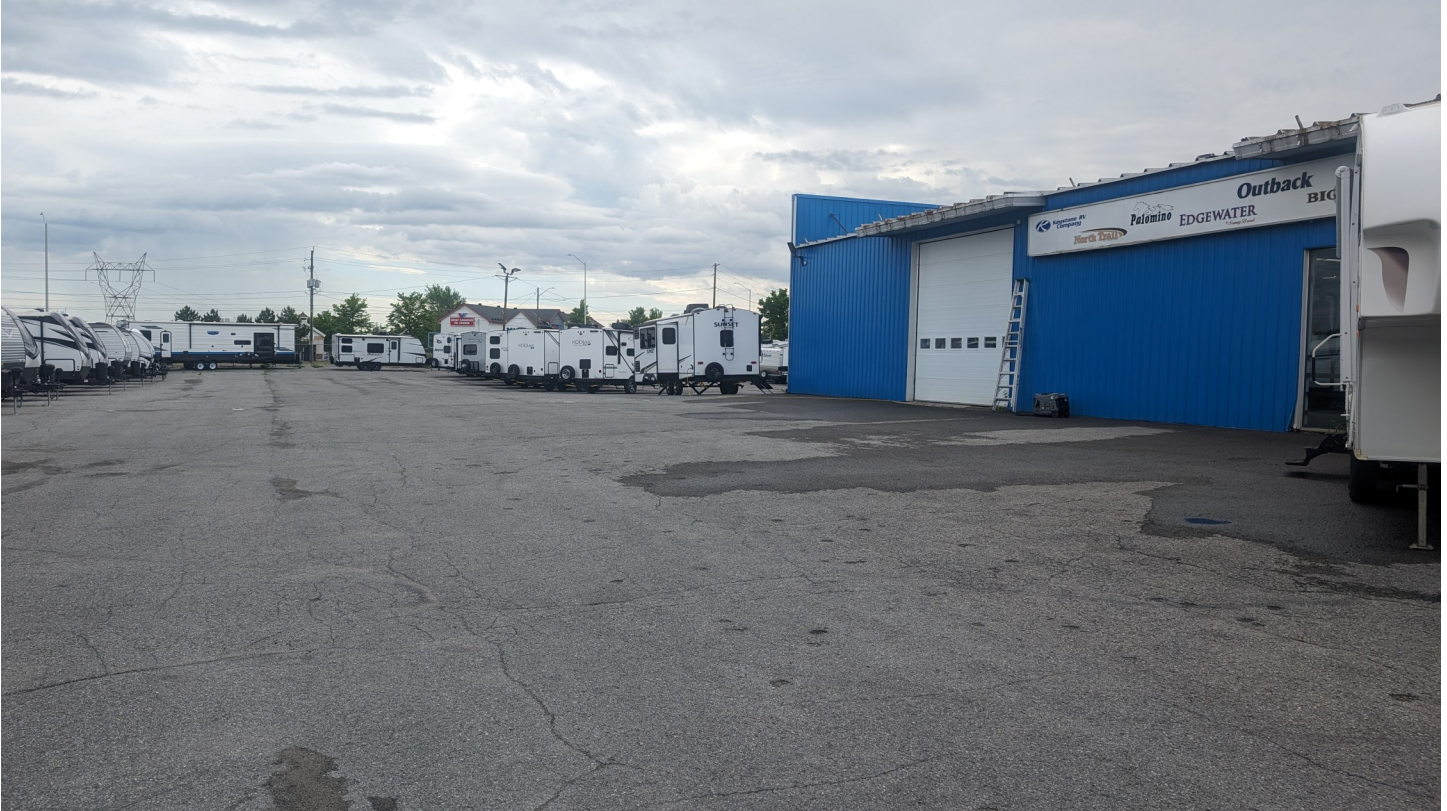
Photo K5 - Looking east/southeast towards the north building line of the on-Site structure. Another bay door was noted. Parked RVs can be seen in the background.

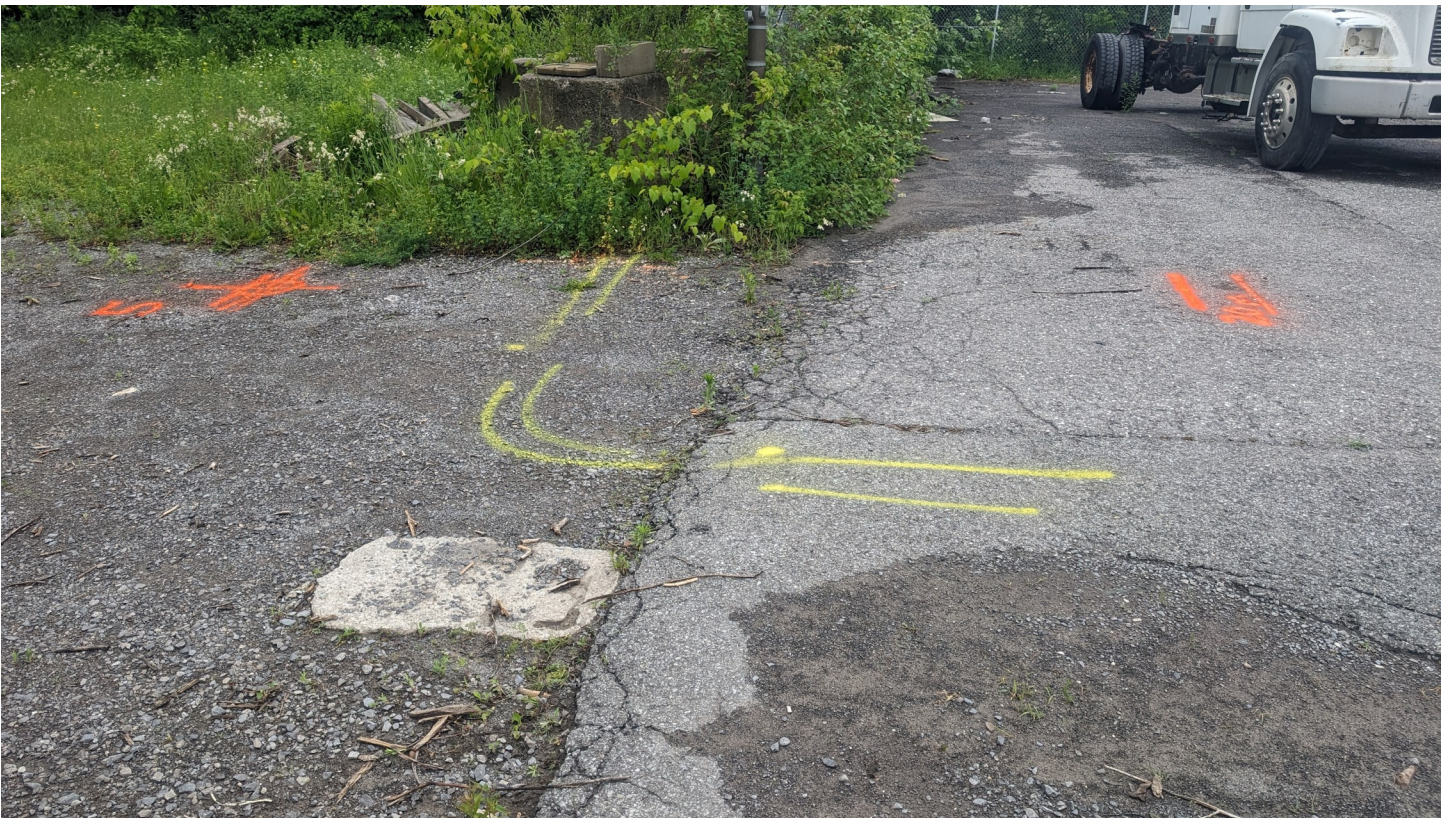
K6	West	Looking west towards the approximate location of the AST (identified as part of the review of aerial photograph between 2005 and 2022). Abandoned gas lines were noted from the location of AST.
K7	North	Monitoring well was located inside the on-Site structure. The concrete floor was in a good condition with minimal cracking.

Photo K6 - Looking west towards the approximate location of the AST (identified as part of the review of aerial photograph between 2005 and 2022). Abandoned gas lines were noted from the location of AST.

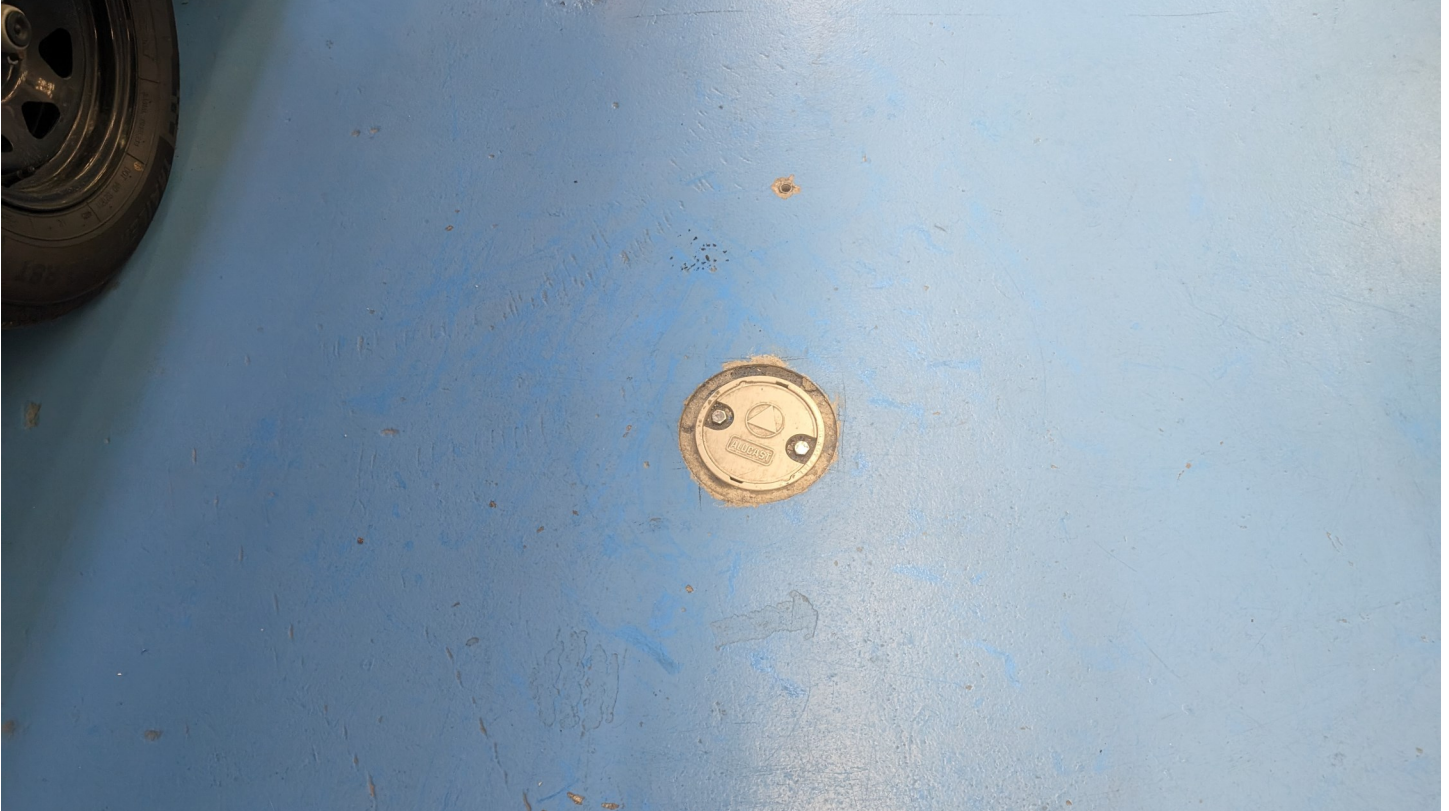
Photo K7 - Monitoring well was located inside the on-Site structure. The concrete floor was in a good condition with minimal cracking.

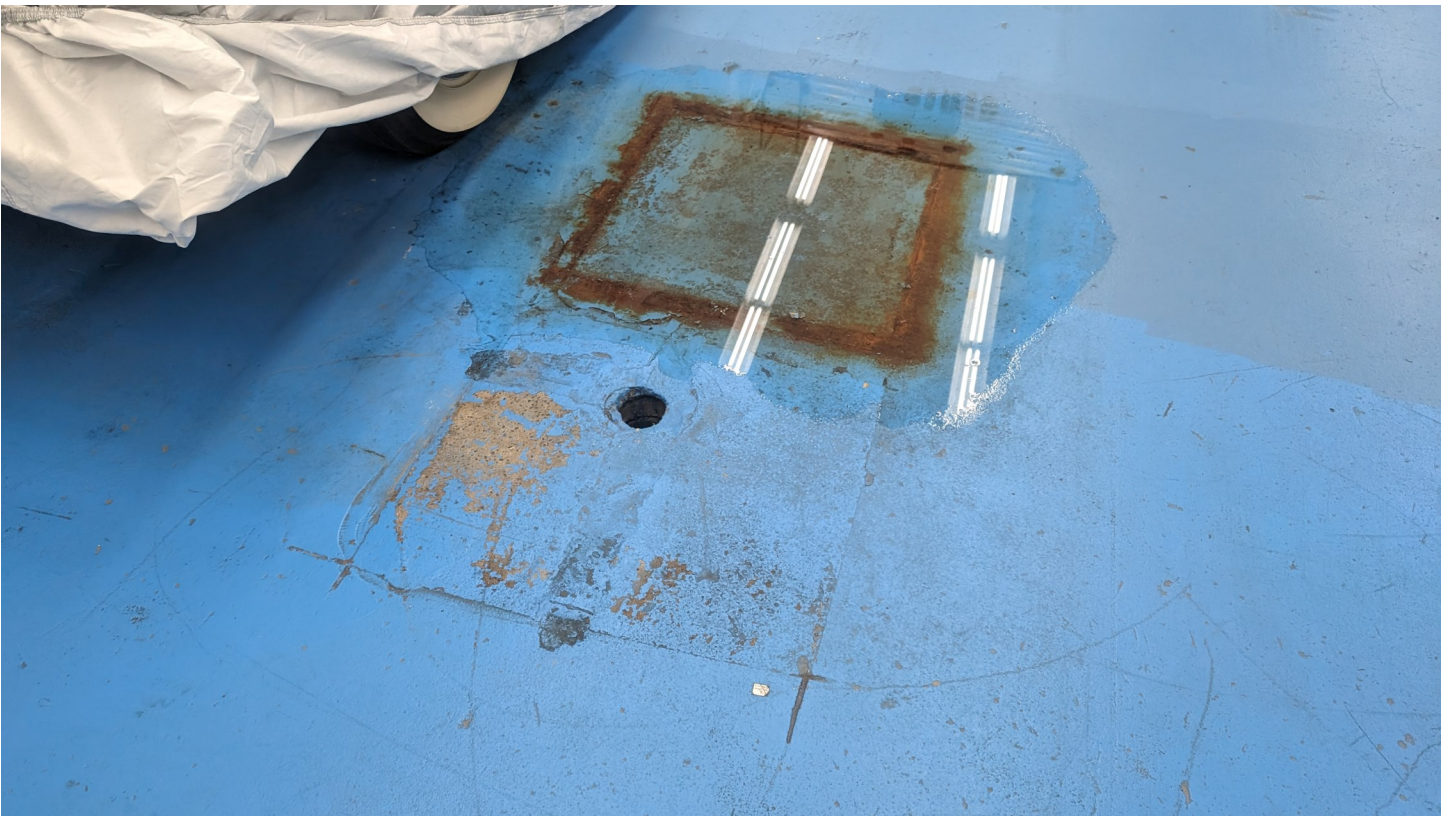
During the Site reconnaissance, GEMTEC noted a concrete filled pit, potentially related to an oil/water separator. The COPCs are PHC F1-F4, and VOCs in soil and groundwater.

Photo Number	Compass Orientation	Description
K8	North	A cut out (potential location of the former oil water separator) was noted in the floor of the building.
K9	South	Tool storage along the south building line of the on-Site structure. This area was used for repairs.
K10	North	Chemicals (basic repair shop products and general cleaning products) were stored on shelves and some water spillage was noted at the Site.
K11	East	The concrete floor was in a good condition with minimal cracking.
K12	East	The office space inside the on-Site structure.
K13	West	A monitoring well installed during prior environmental investigations was noted at the Site.
K14	Northeast	Looking northeast along Hazeldean Road towards the intersection of Hazeldean Road and Carp Road. Petro Canada can be seen in the background. The fenced area can be seen to the right which is part of the Site.
K15	North	A pole mounted transformer (off-Site) was noted along Hazeldean Road.

Photo K8 - A cut out (potential location of the former oil water separator ) was noted in the floor of the building.

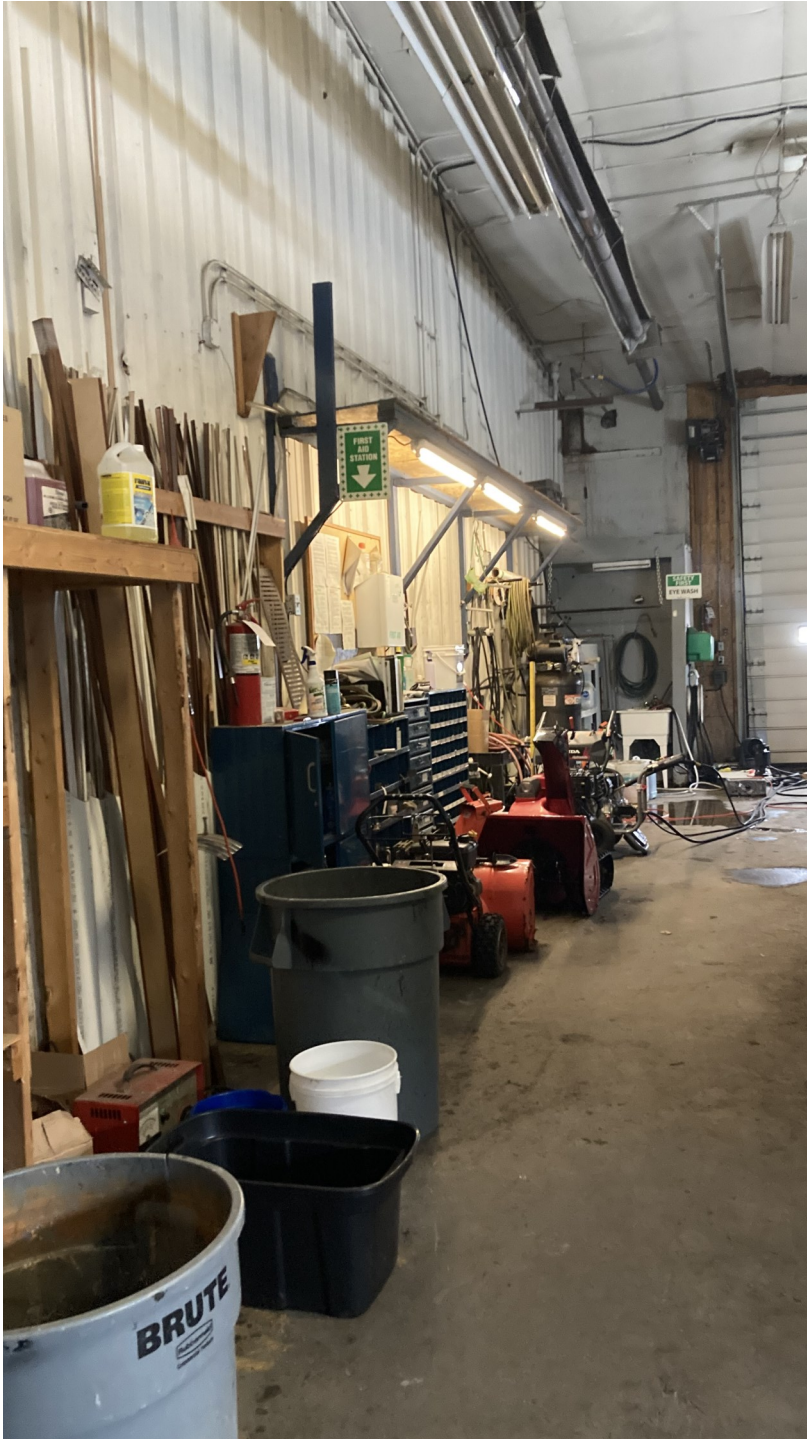
Photo K9 - Tool storage along the south building line of the on-Site structure. This area was used for repairs.

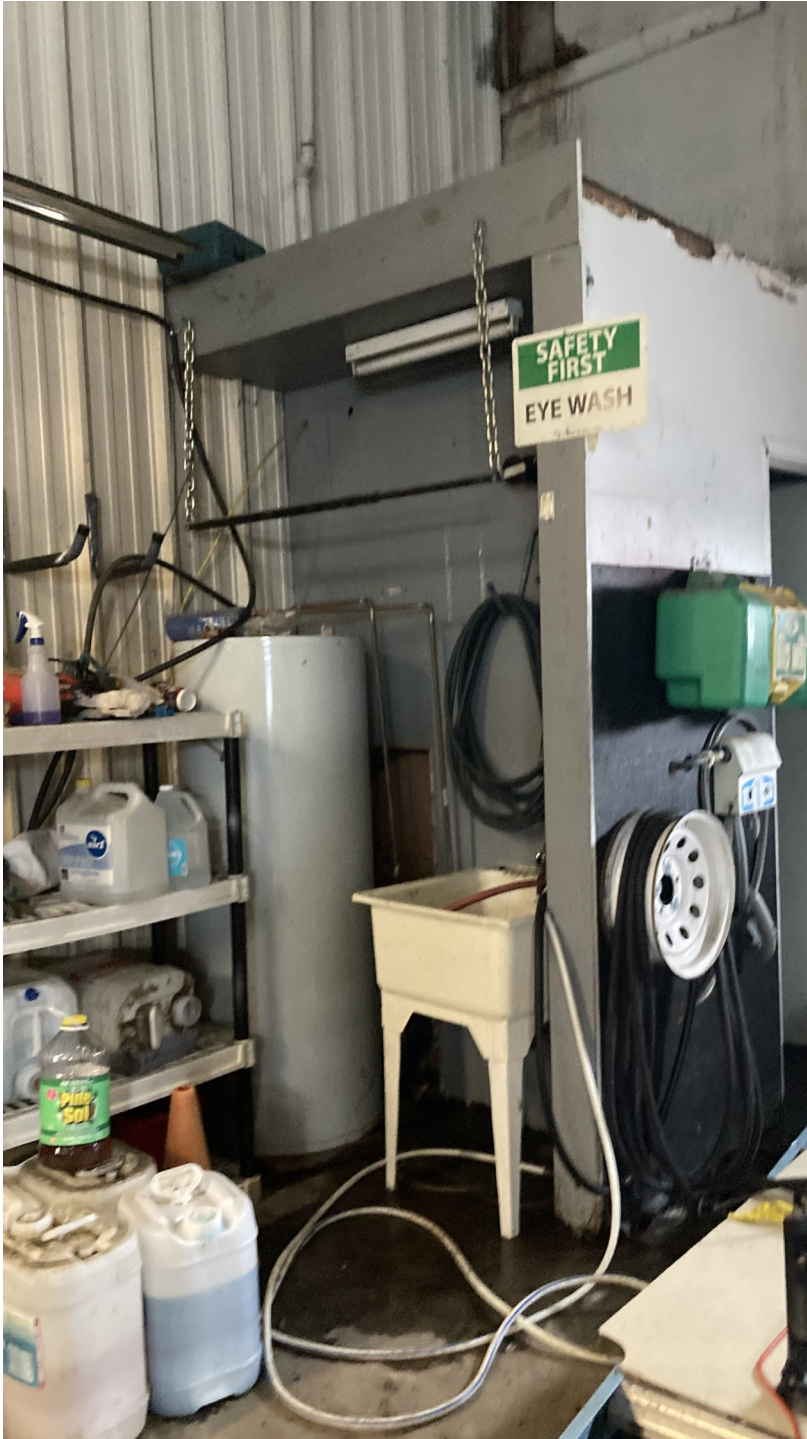
Photo K10 - Chemicals (basic repair shop products and general cleaning products) were stored on shelves and some water spillage was noted at the Site.

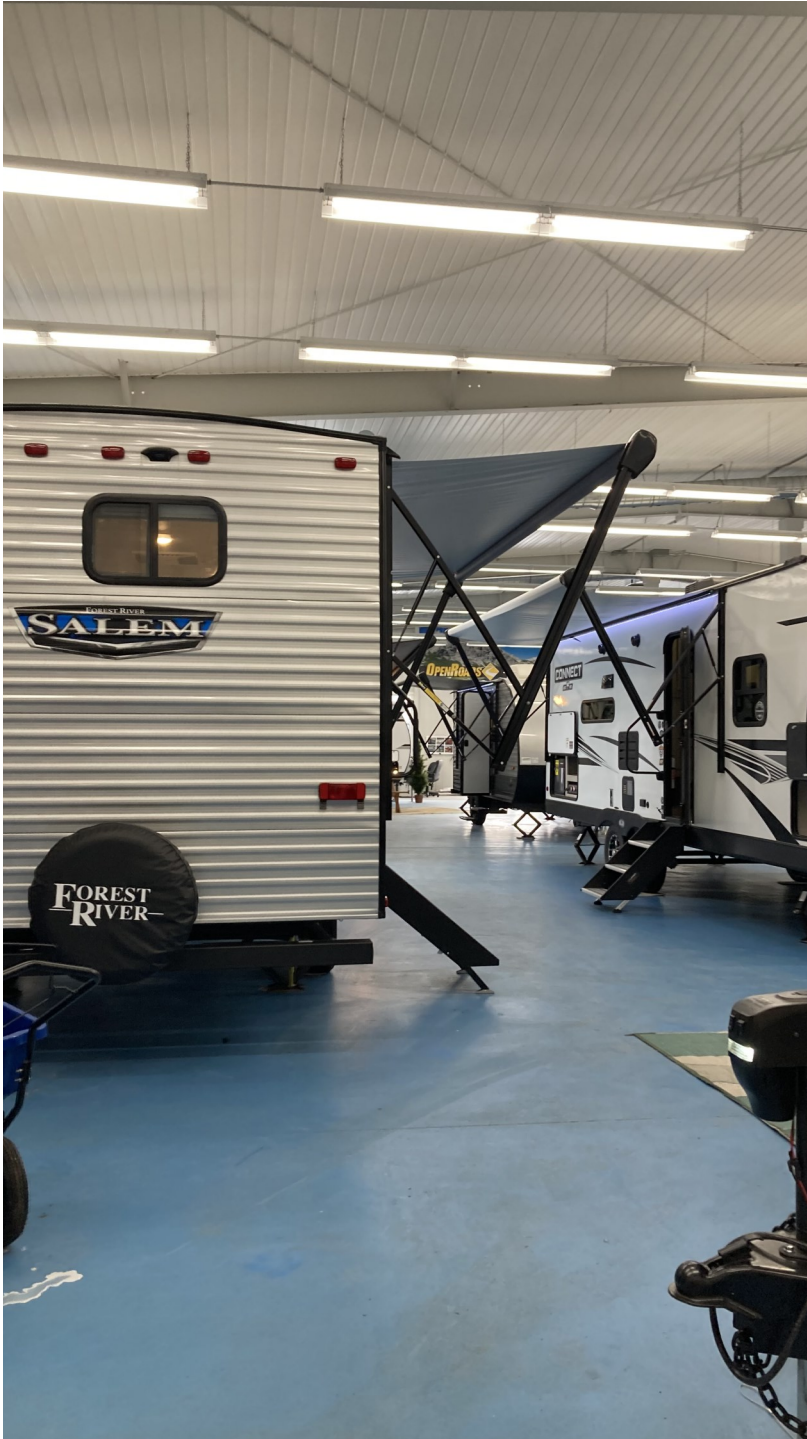
Photo K11 - The concrete floor was in a good condition with minimal cracking.

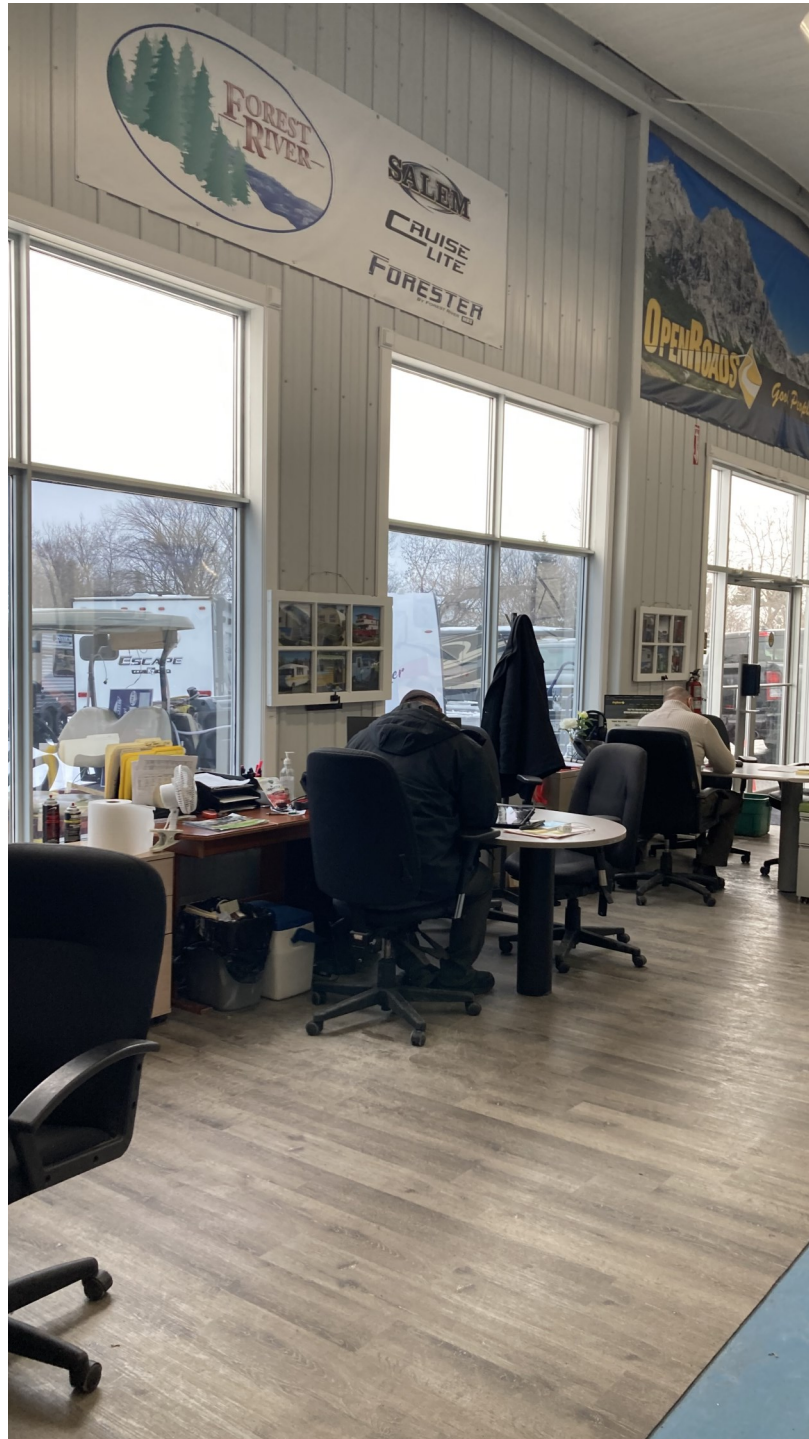
Photo K12 - The office space inside the on-Site structure.

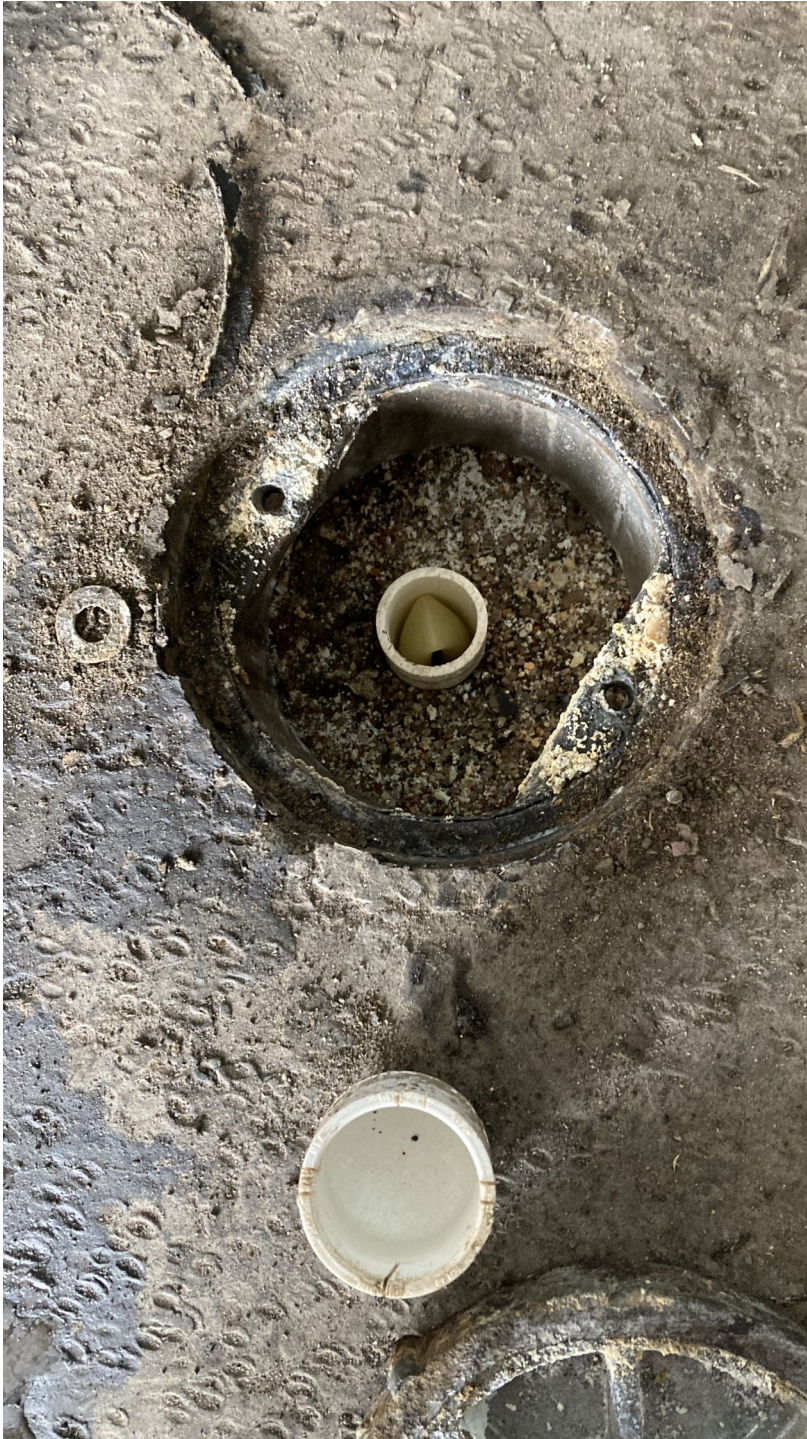
Photo K13 - A monitoring well installed during prior environmental investigations was noted at the Site.

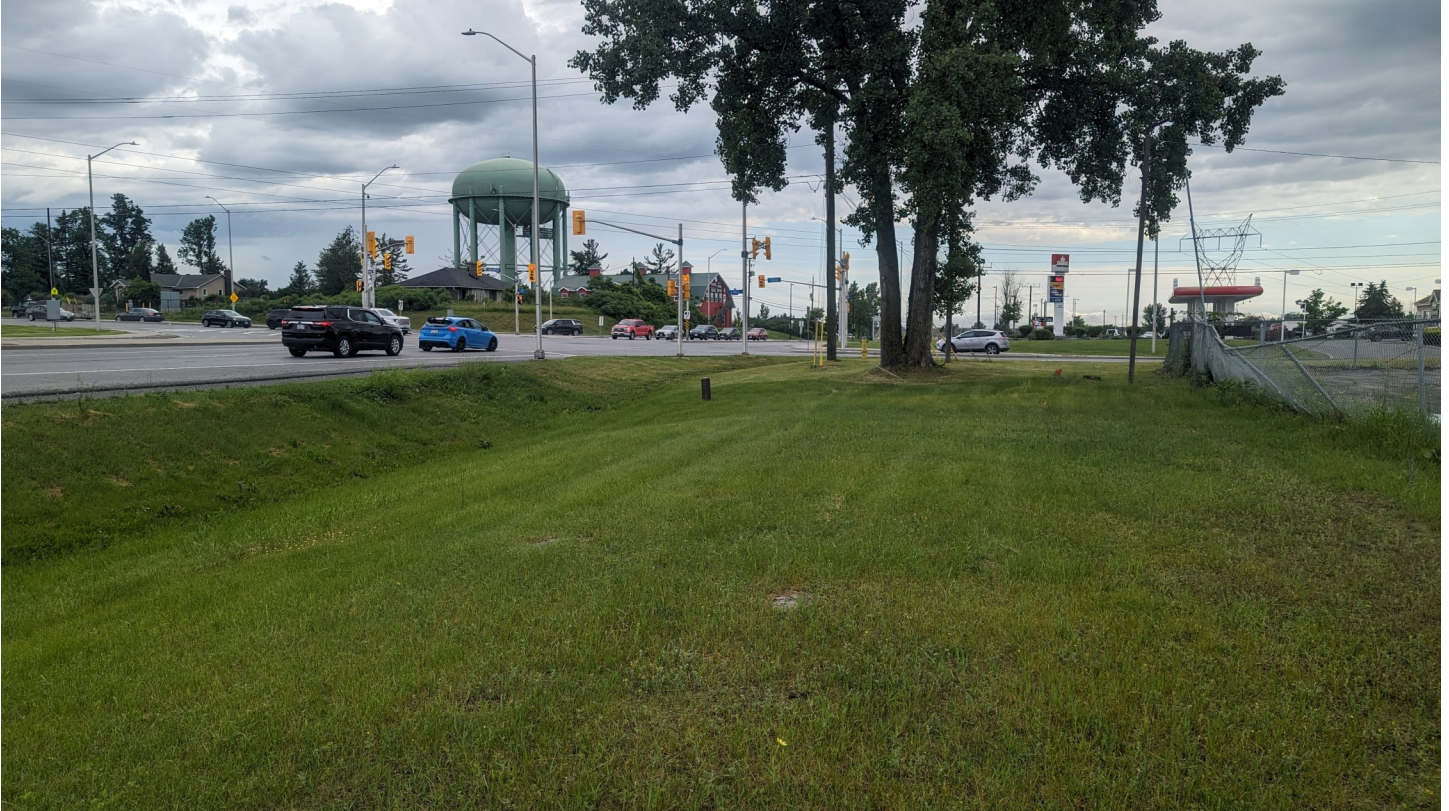
Photo K14 - Looking northeast along Hazeldean Road towards the intersection of Hazeldean Road and Carp Road. Petro Canada can be seen in the background. The fenced area can be seen to the right which is part of the Site.

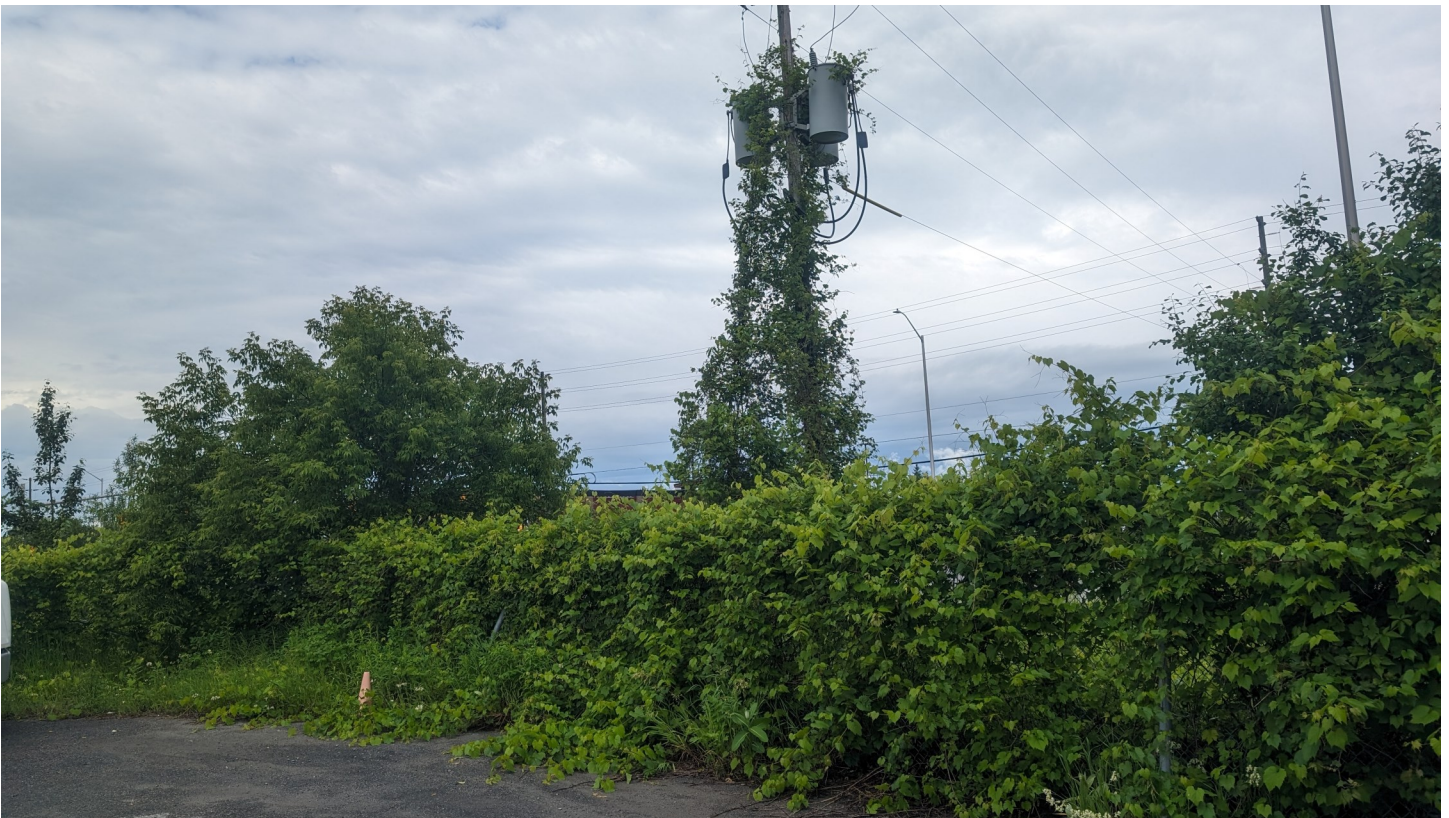
Photo K15 - A pole mounted transformer (off-Site) was noted along Hazeldean Road.

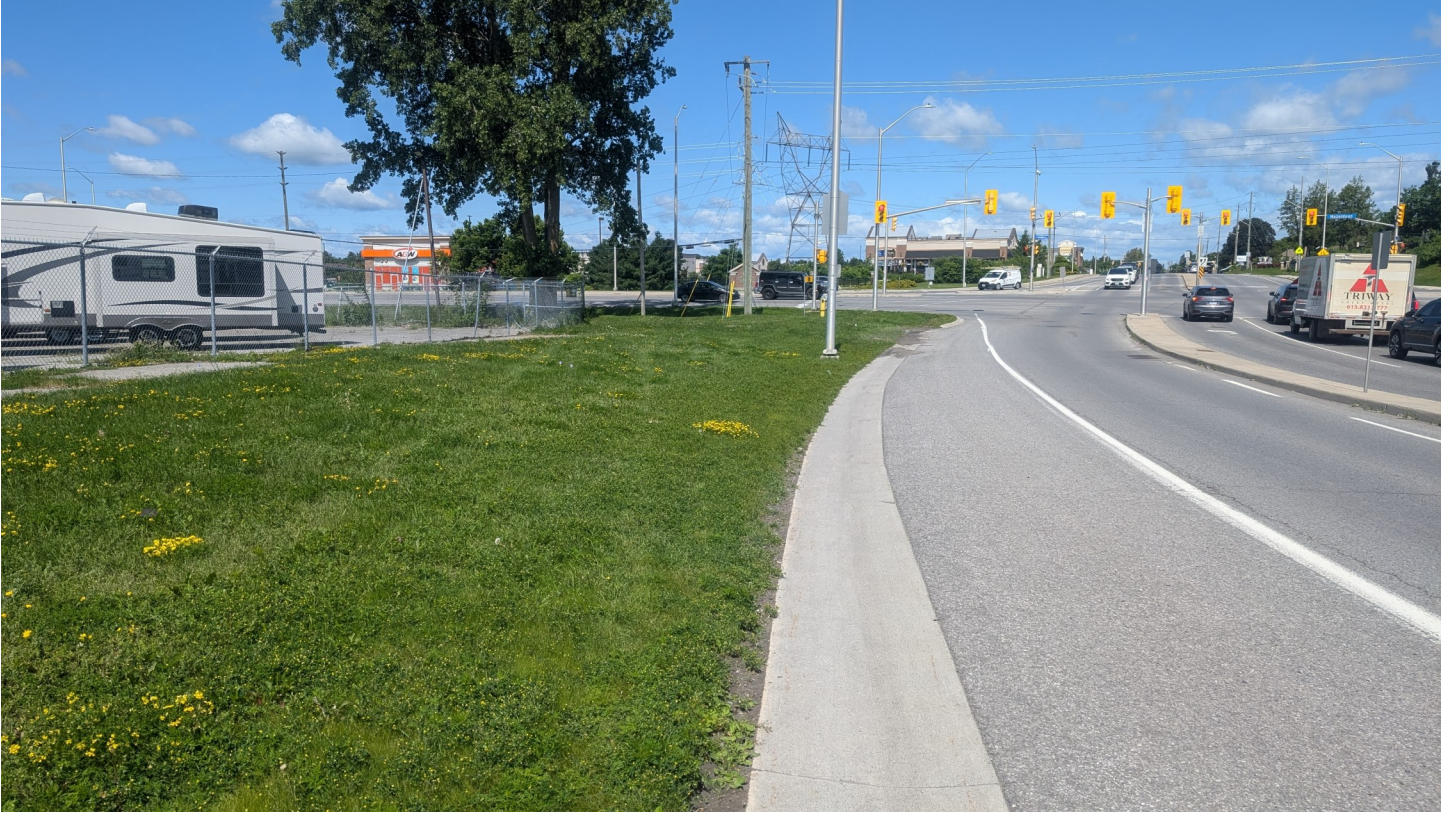
Photo K16 - Looking north along Carp Road towards the intersection of Carp Road and Hazeldean Road. Commercial property at land parcel of 6303 Hazeldean Road can be seen in the background.
