# **Phase II – Environmental Site Investigation**

1440 Blair Towers Place  
Ottawa, Ontario

**Report: PE6304-2R**

**Date: January 26, 2024**

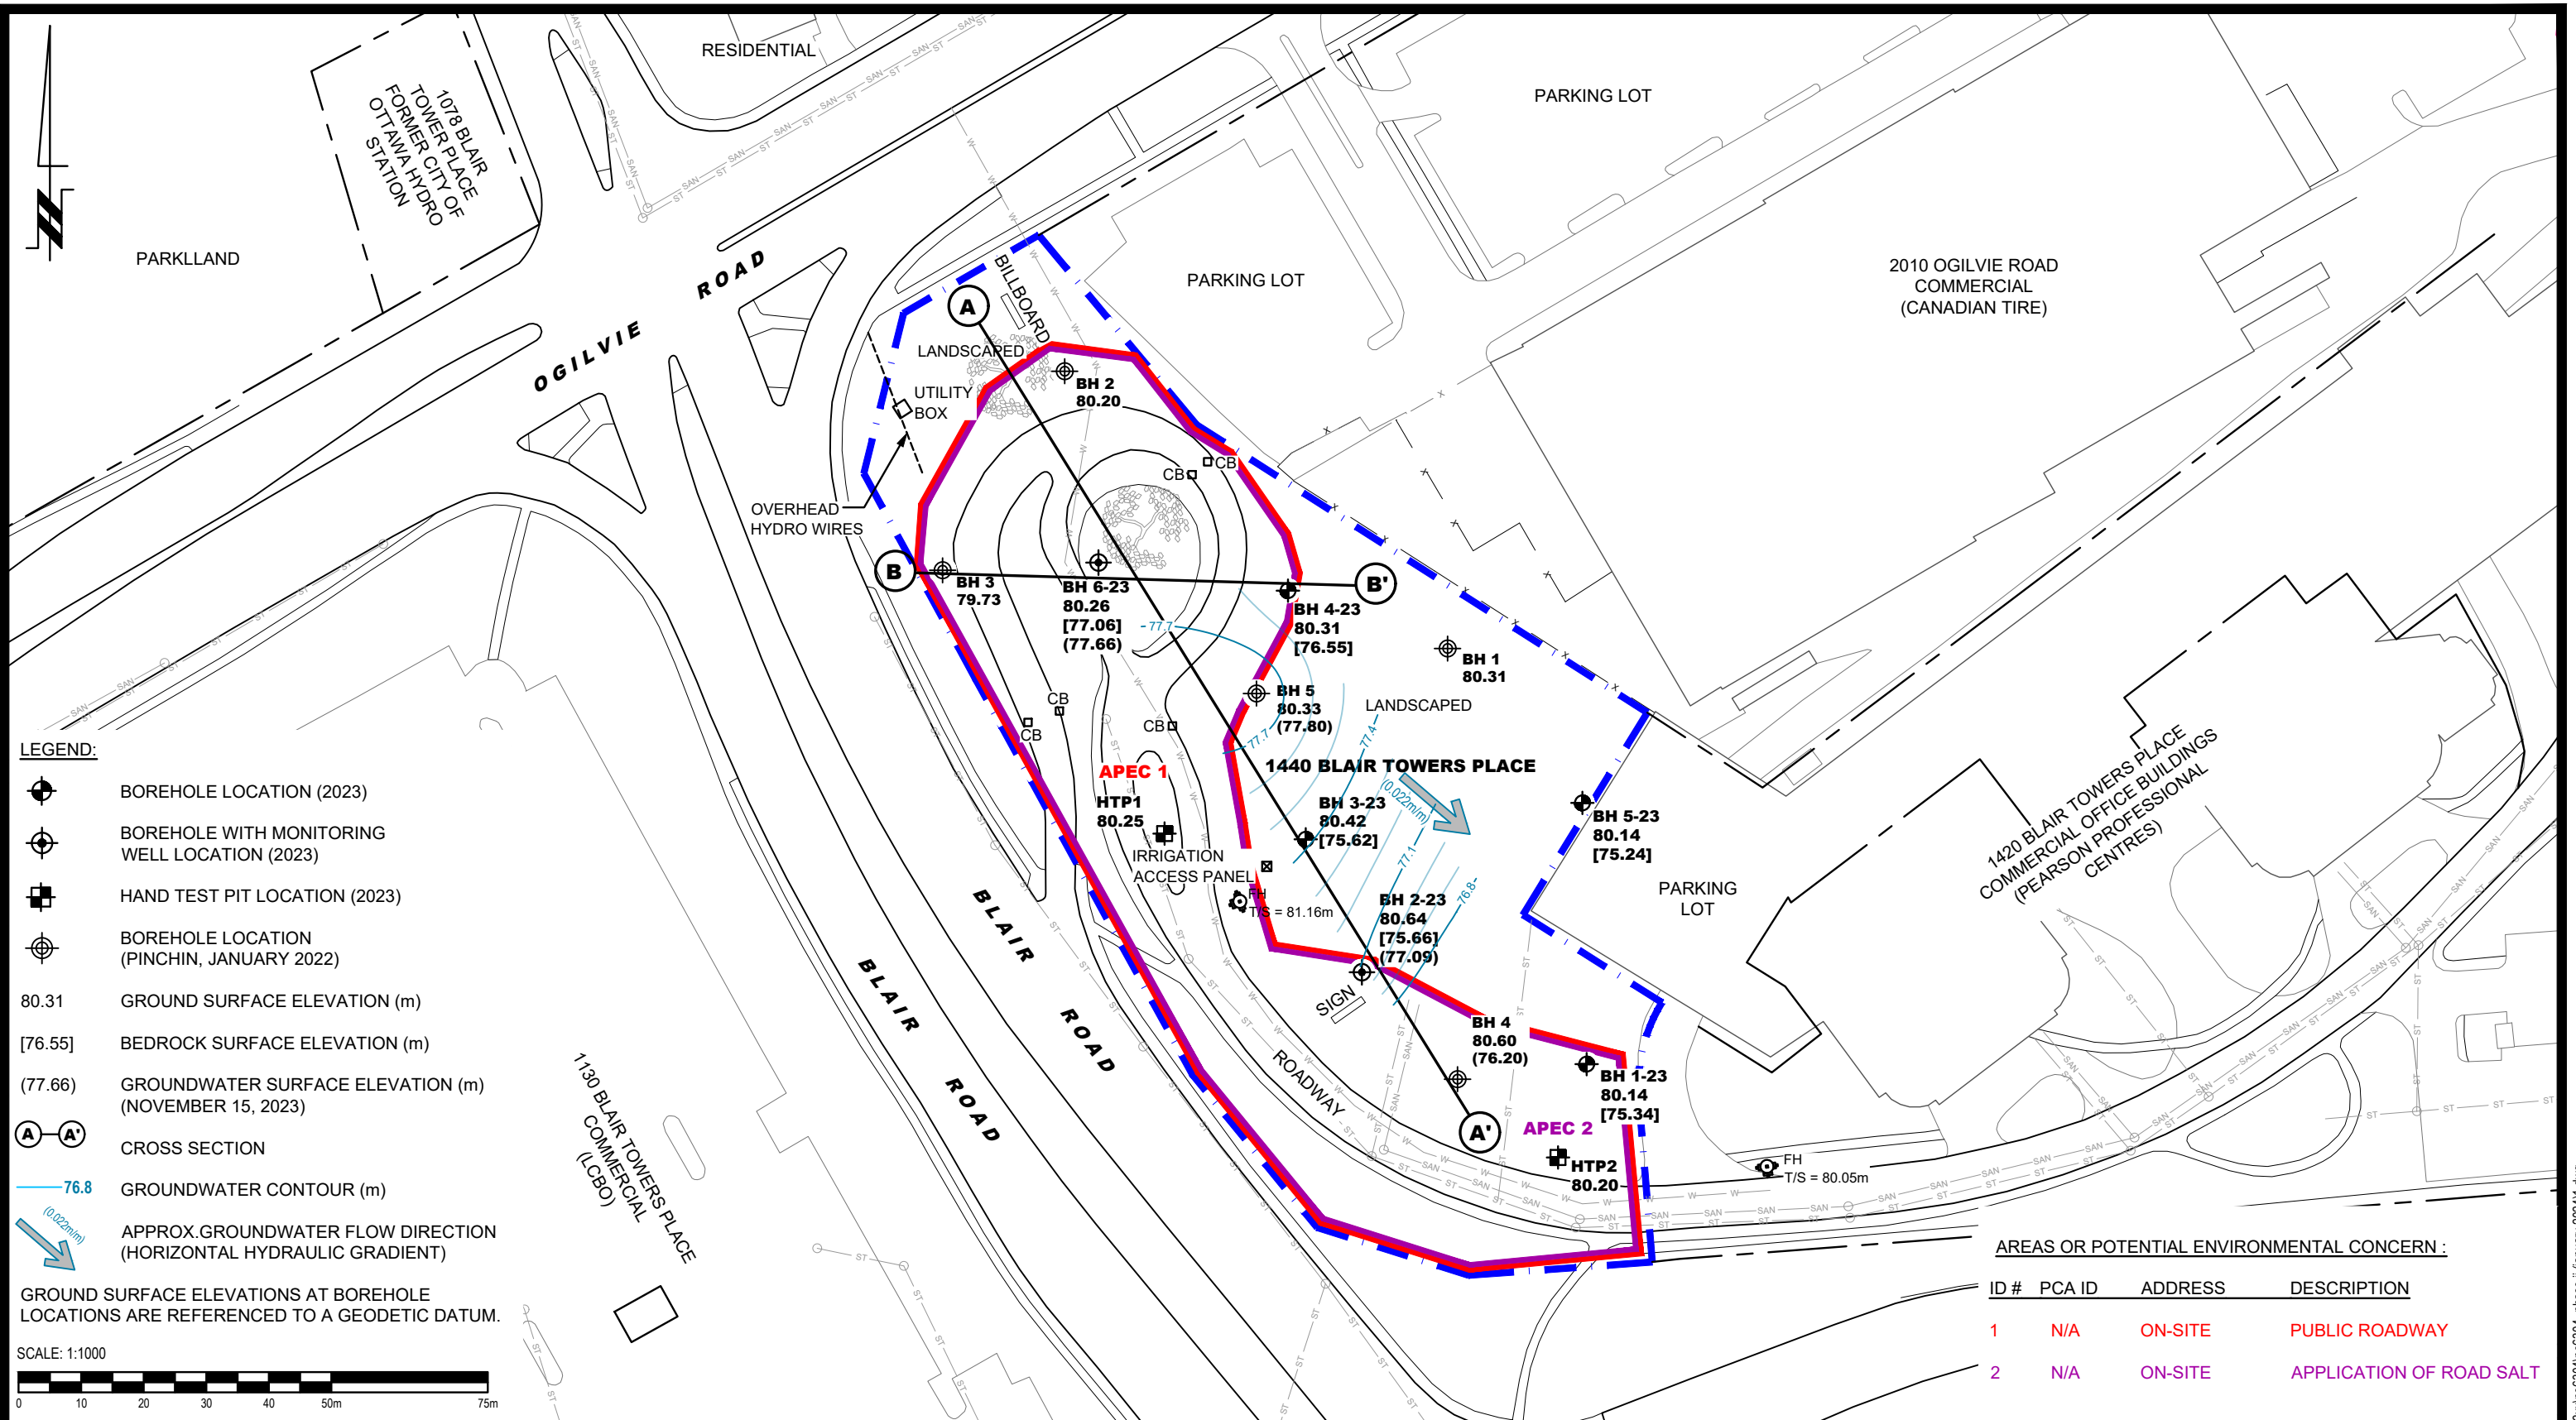
**TEST HOLE LOCATION PLAN**

- BOREHOLE LOCATION (2023)
- BOREHOLE WITH MONITORING WELL LOCATION (2023)
- HAND TEST PIT LOCATION (2023)
- BOREHOLE LOCATION (PINCHIN, JANUARY 2022)
- 80.31 GROUND SURFACE ELEVATION (m)
- [76.55] BEDROCK SURFACE ELEVATION (m)
- (77.66) GROUNDWATER SURFACE ELEVATION (m) (NOVEMBER 15, 2023)
- A-A' CROSS SECTION

Based on the groundwater elevations measured during the sampling events, groundwater contour mapping was completed. Groundwater contours are shown on Drawing PE6304-3 – Test Hole Location Plan. Based on the contour mapping, groundwater flow at the subject site is in a southeasterly direction. It should be noted that groundwater levels are expected to fluctuate throughout the year with seasonal variations.

It should be noted that groundwater levels are expected to fluctuate throughout the year with seasonal variations. Groundwater contours are shown on Drawing PE6304-3 – Test Hole Location Plan.

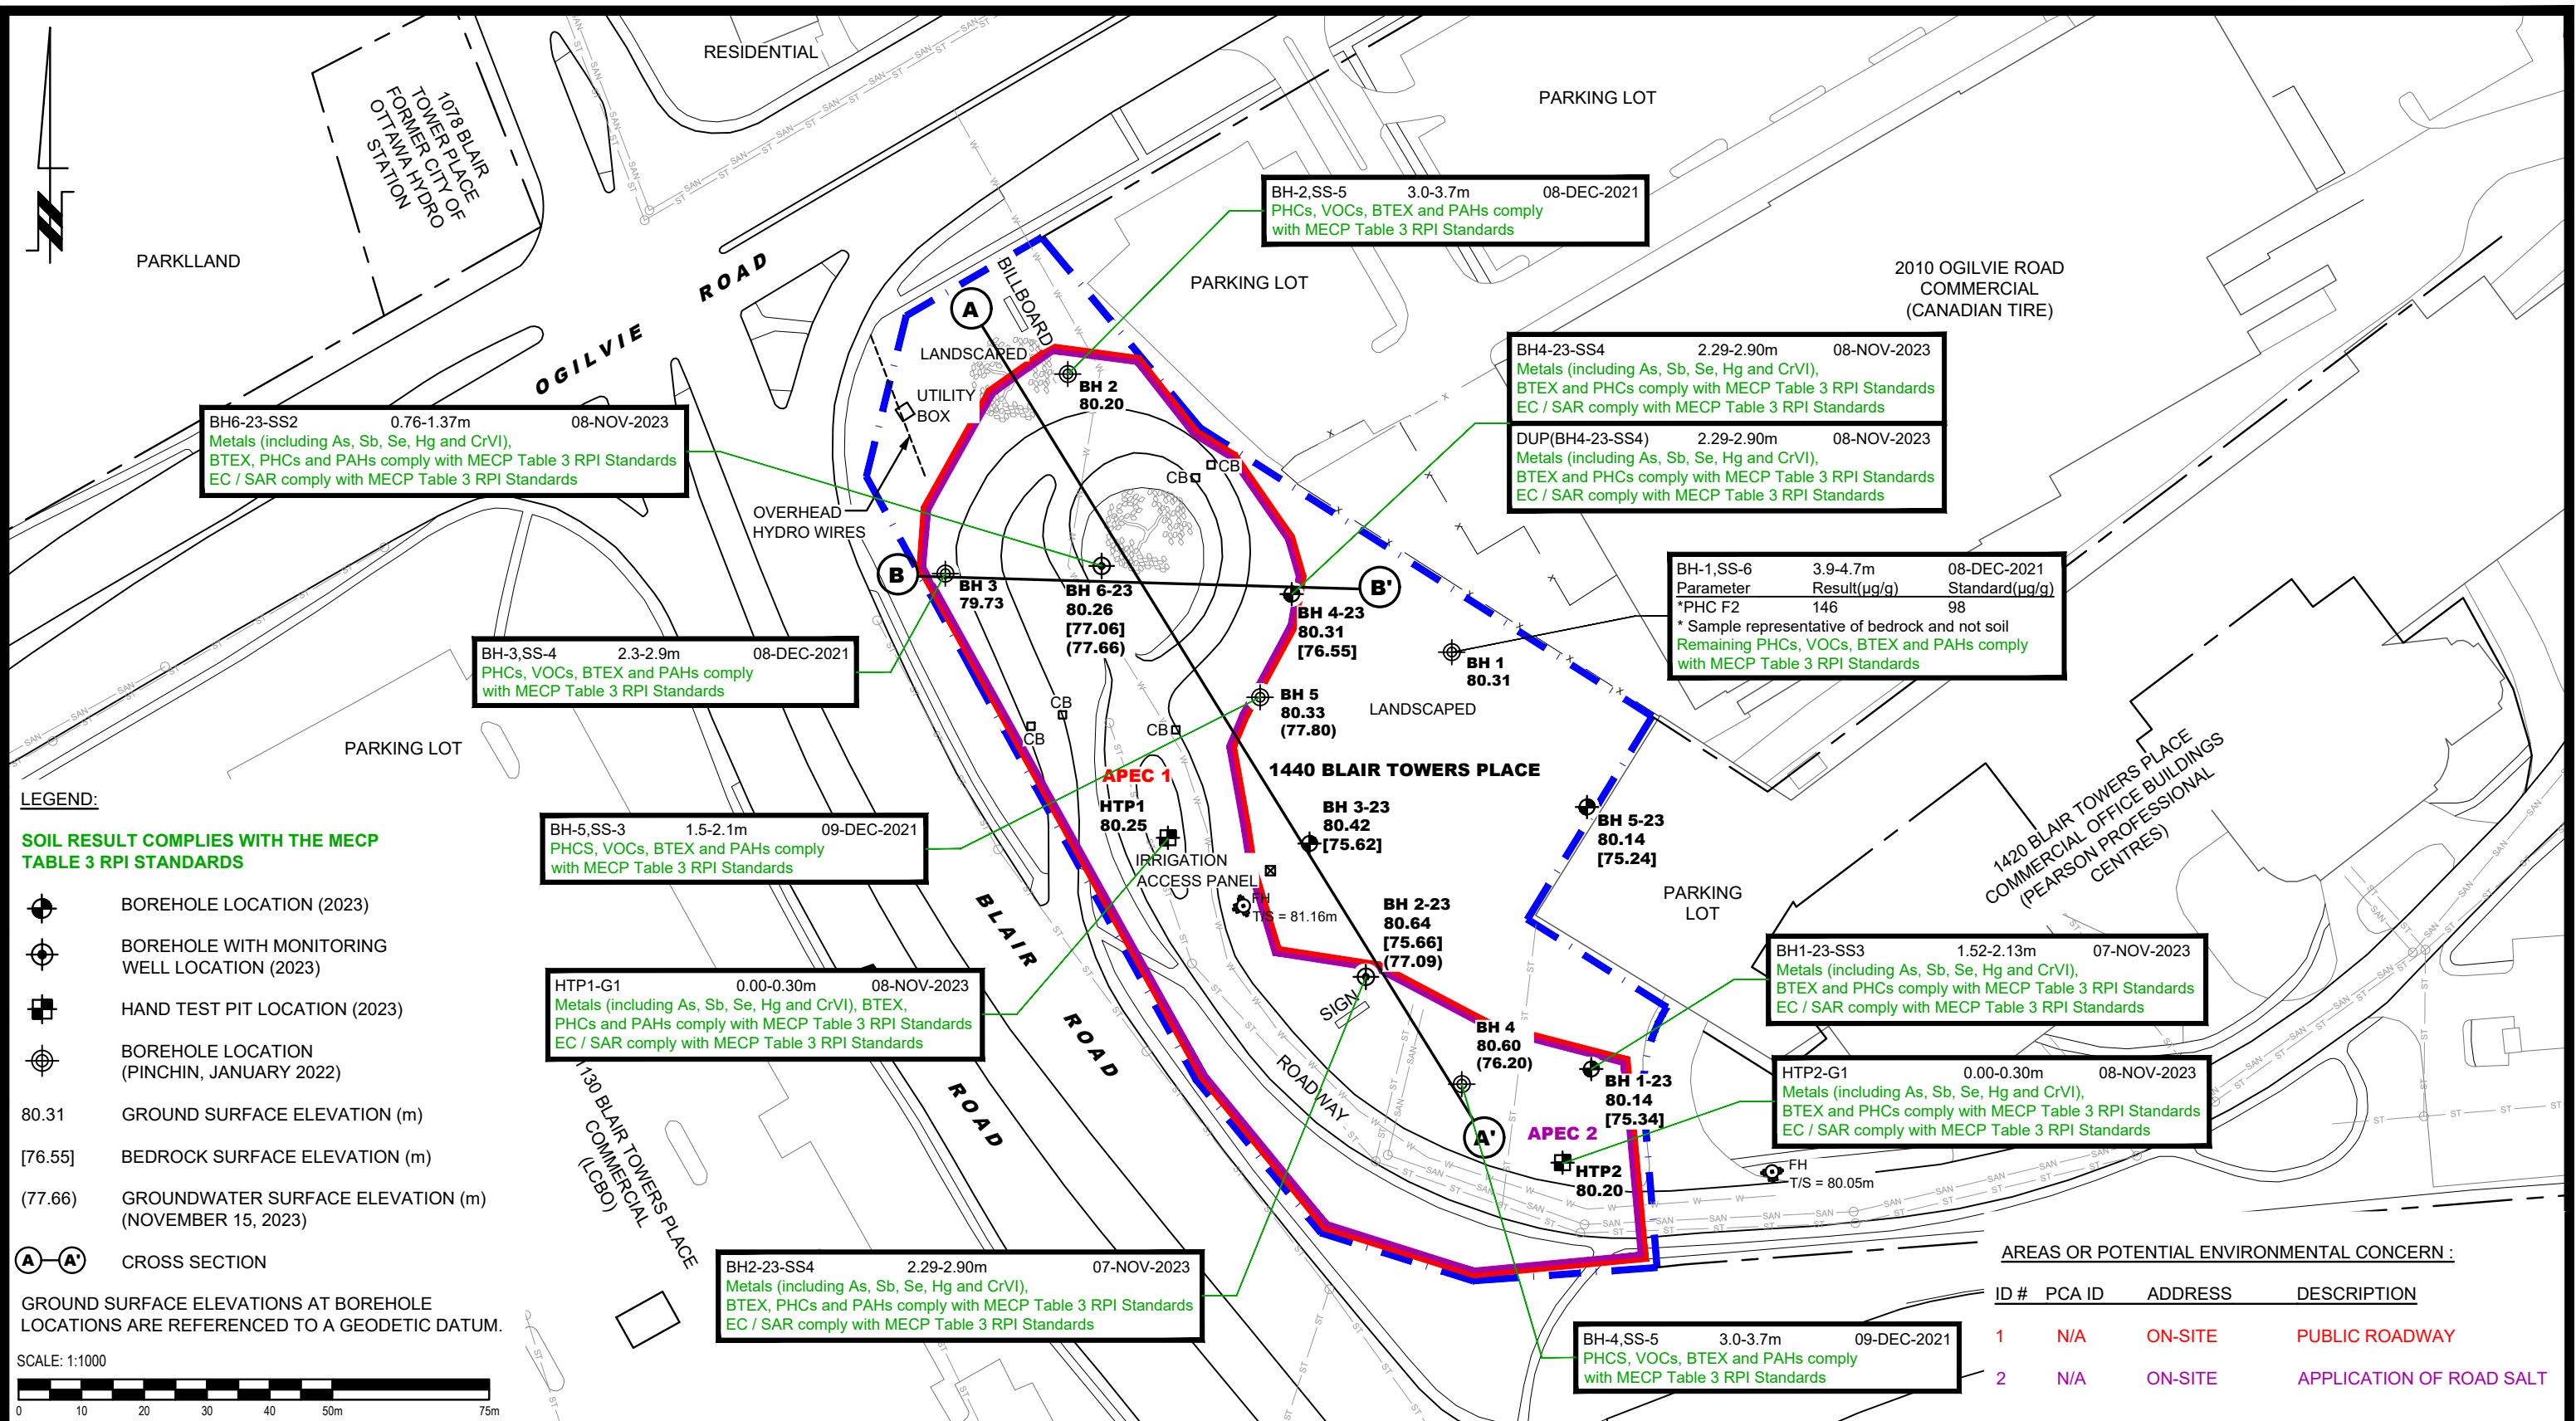
**ANALYTICAL TESTING PLAN - SOIL**

SOIL RESULT COMPLIES WITH THE MECP TABLE 3 RPI STANDARDS

BH6-23-SS2 0.76-1.37m 08-NOV-2023  
 Metals (including As, Sb, Se, Hg and CrVI), BTEX, PHCs and PAHs comply with MECP Table 3 RPI Standards  
 EC / SAR comply with MECP Table 3 RPI Standards

BH4-23-SS4 2.29-2.90m 08-NOV-2023  
 Metals (including As, Sb, Se, Hg and CrVI), BTEX and PHCs comply with MECP Table 3 RPI Standards  
 EC / SAR comply with MECP Table 3 RPI Standards  
 DUP(BH4-23-SS4) 2.29-2.90m 08-NOV-2023  
 Metals (including As, Sb, Se, Hg and CrVI), BTEX and PHCs comply with MECP Table 3 RPI Standards  
 EC / SAR comply with MECP Table 3 RPI Standards

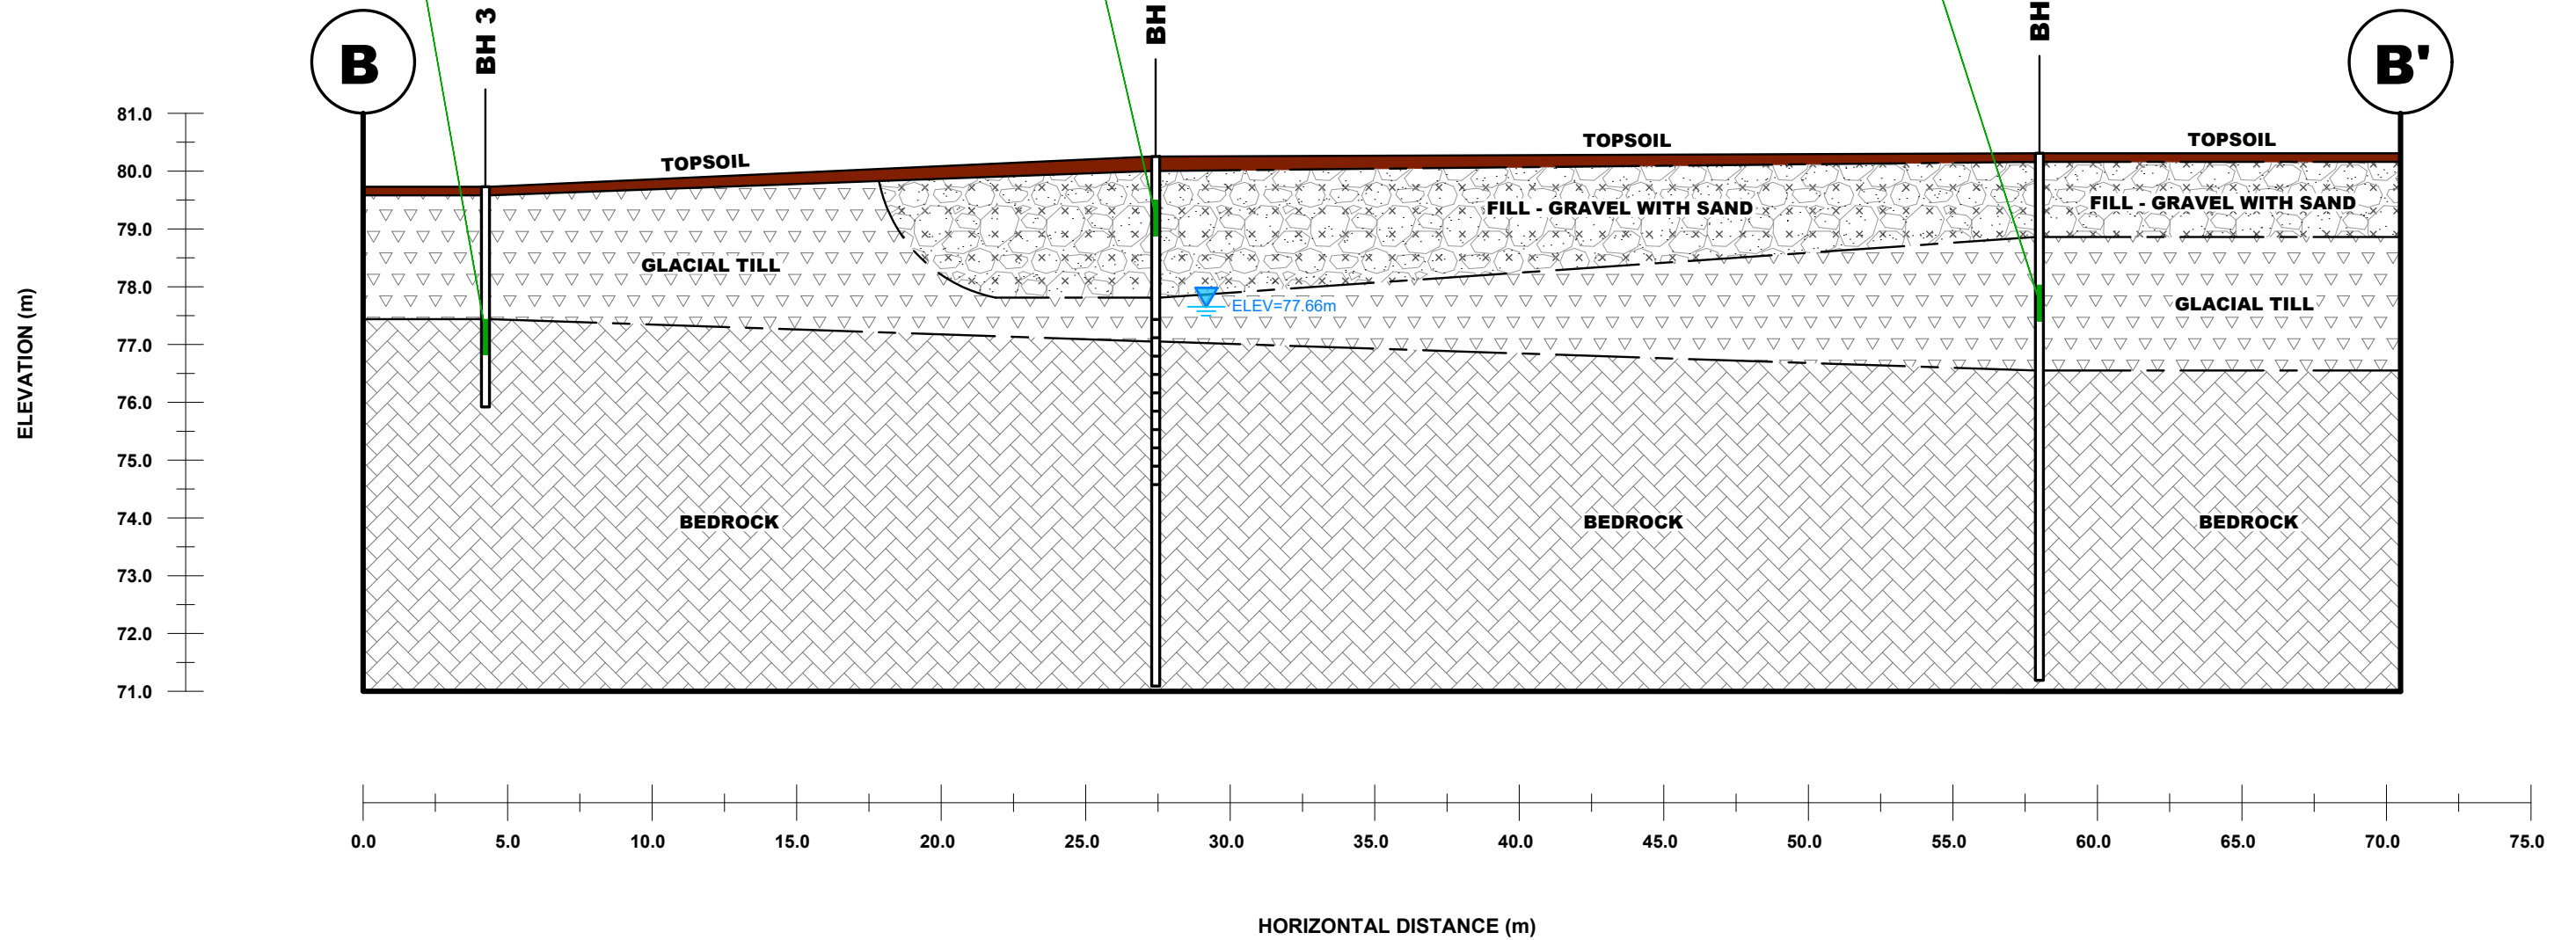
LE GROUPE MAURICE  
 PHASE II - ENVIRONMENTAL SITE ASSESSMENT  
 1440 BLAIR TOWER PLACE  
 OTTAWA, ONTARIO  
 Title: CROSS SECTION B-B' - SOIL

SOIL RESULT COMPLIES WITH THE MECP TABLE 3 RPI STANDARDS

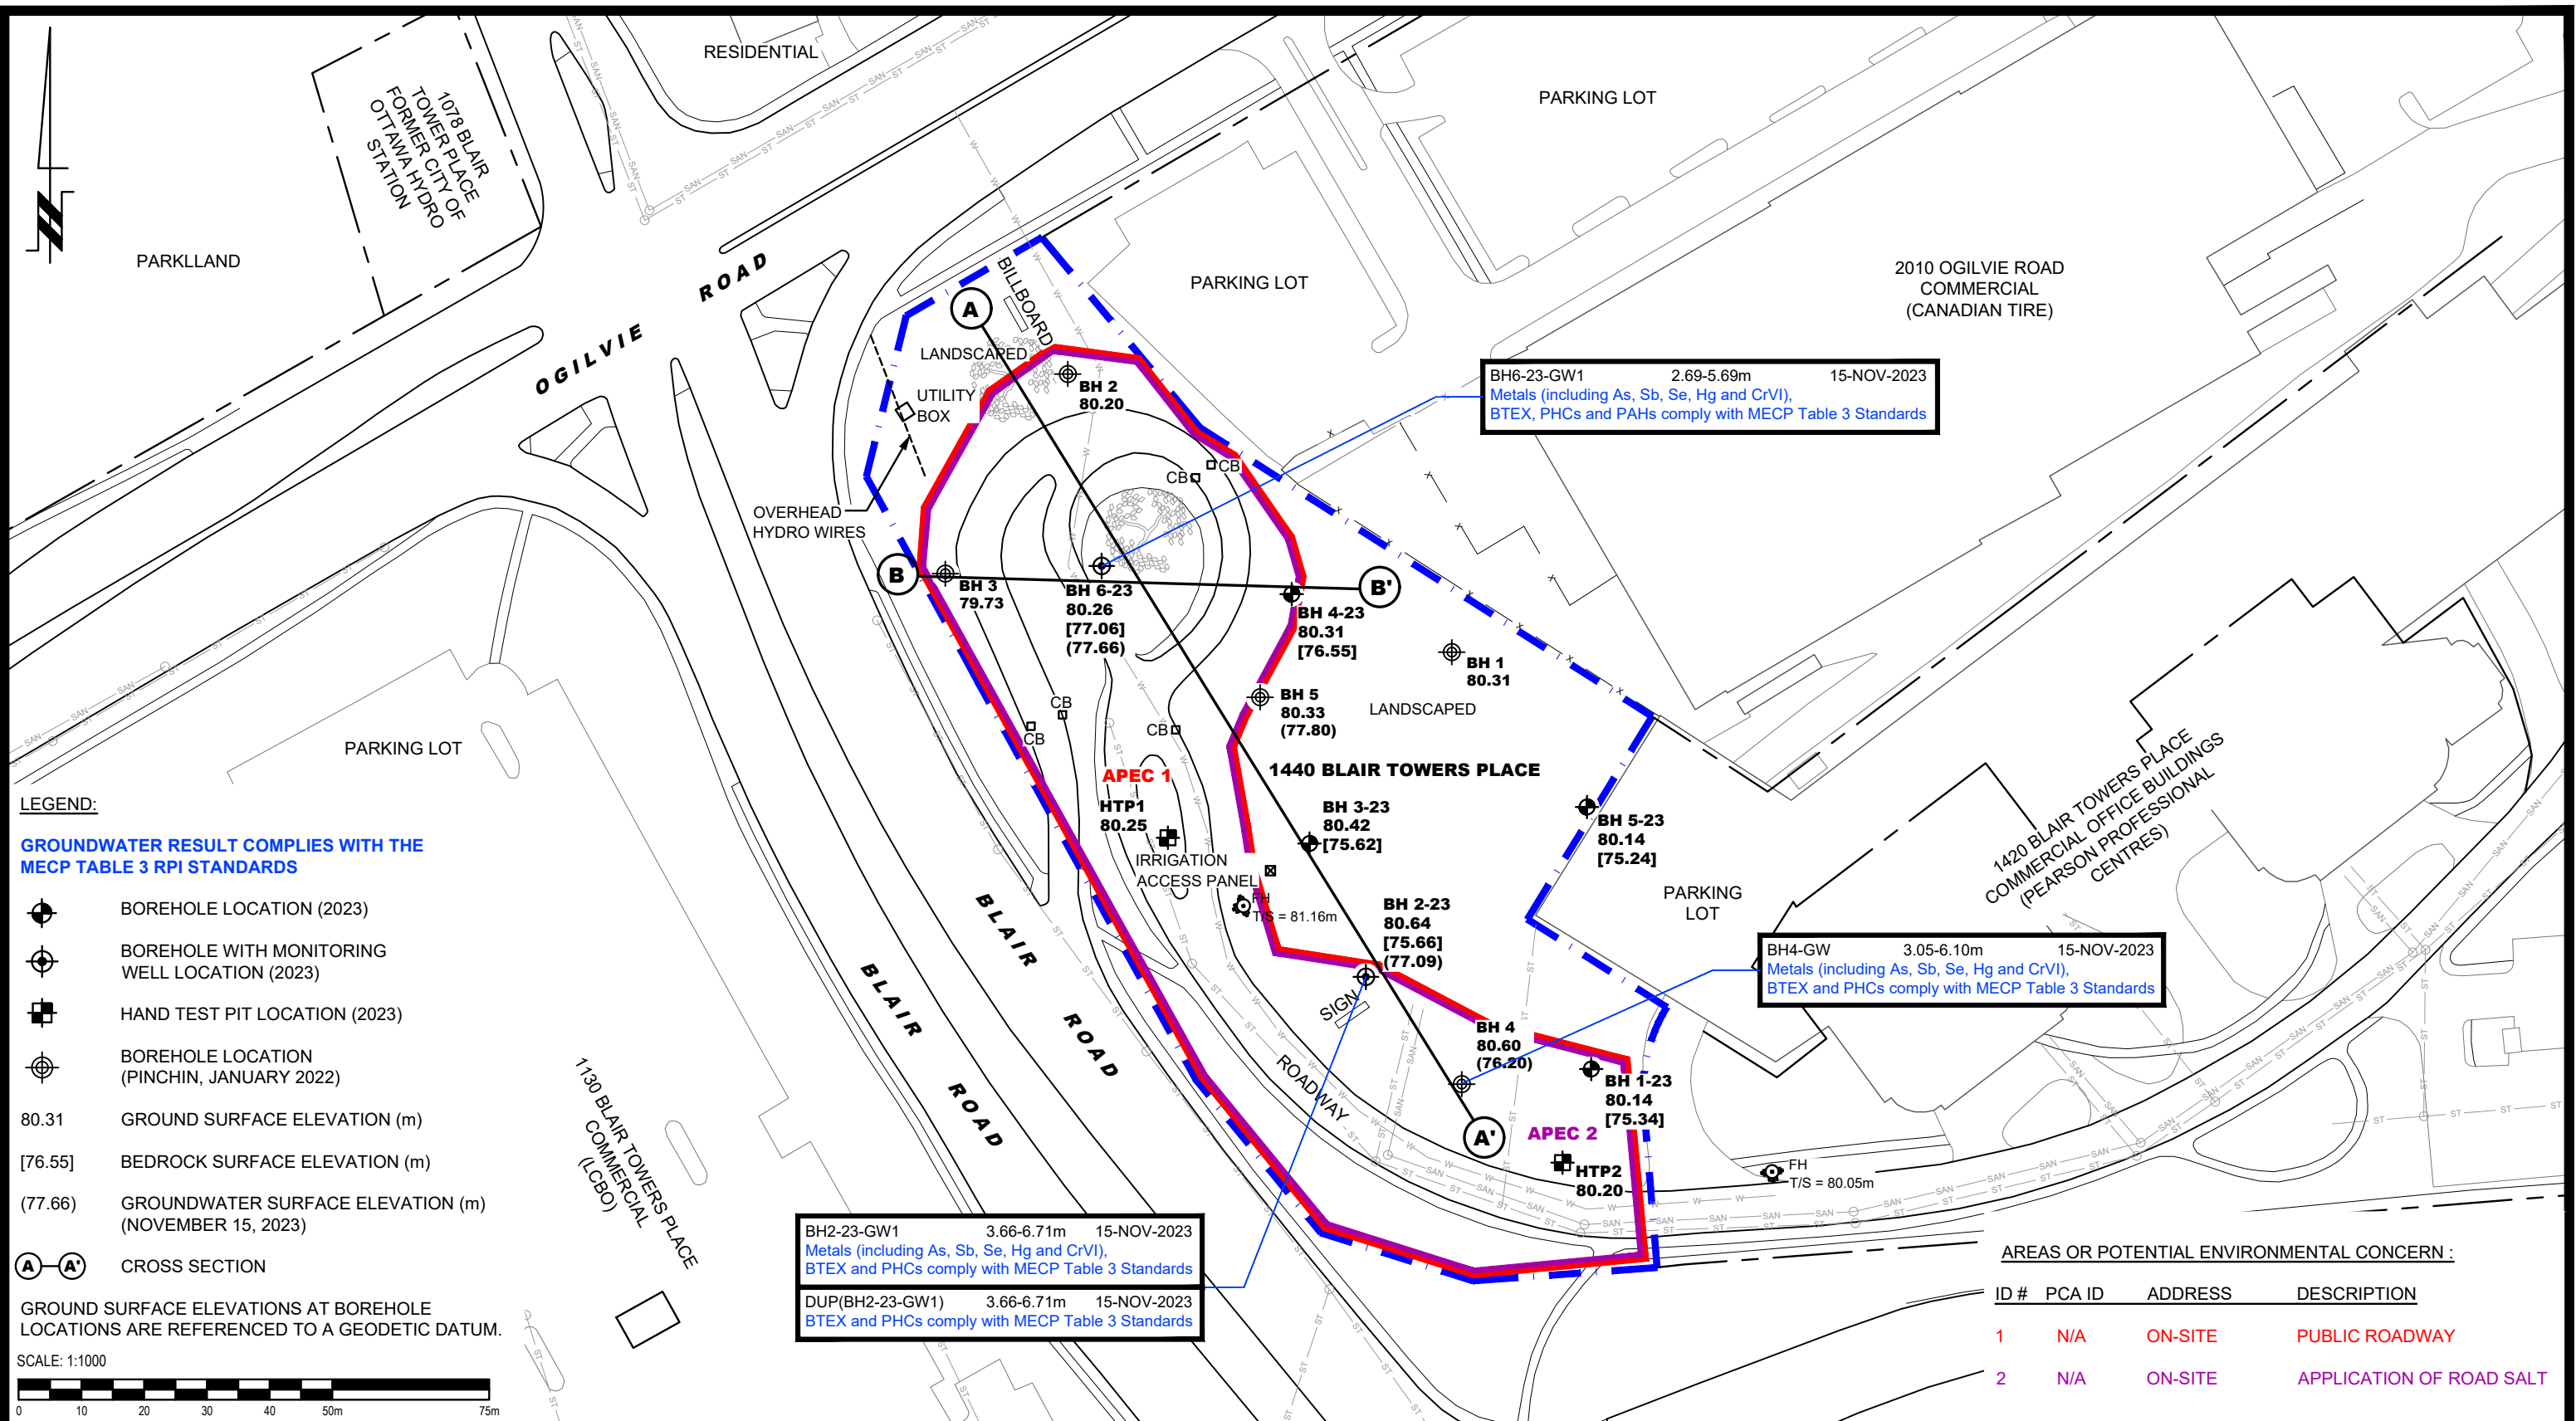
Title: **ANALYTICAL TESTING PLAN - GROUNDWATER**

BH2-23-GW1 3.66-6.71m 15-NOV-2023  
 Metals (including As, Sb, Se, Hg and CrVI),  
 BTEX and PHCs comply with MECP Table 3 Standards

DUP(BH2-23-GW1) 3.66-6.71m 15-NOV-2023  
 BTEX and PHCs comply with MECP Table 3 Standards

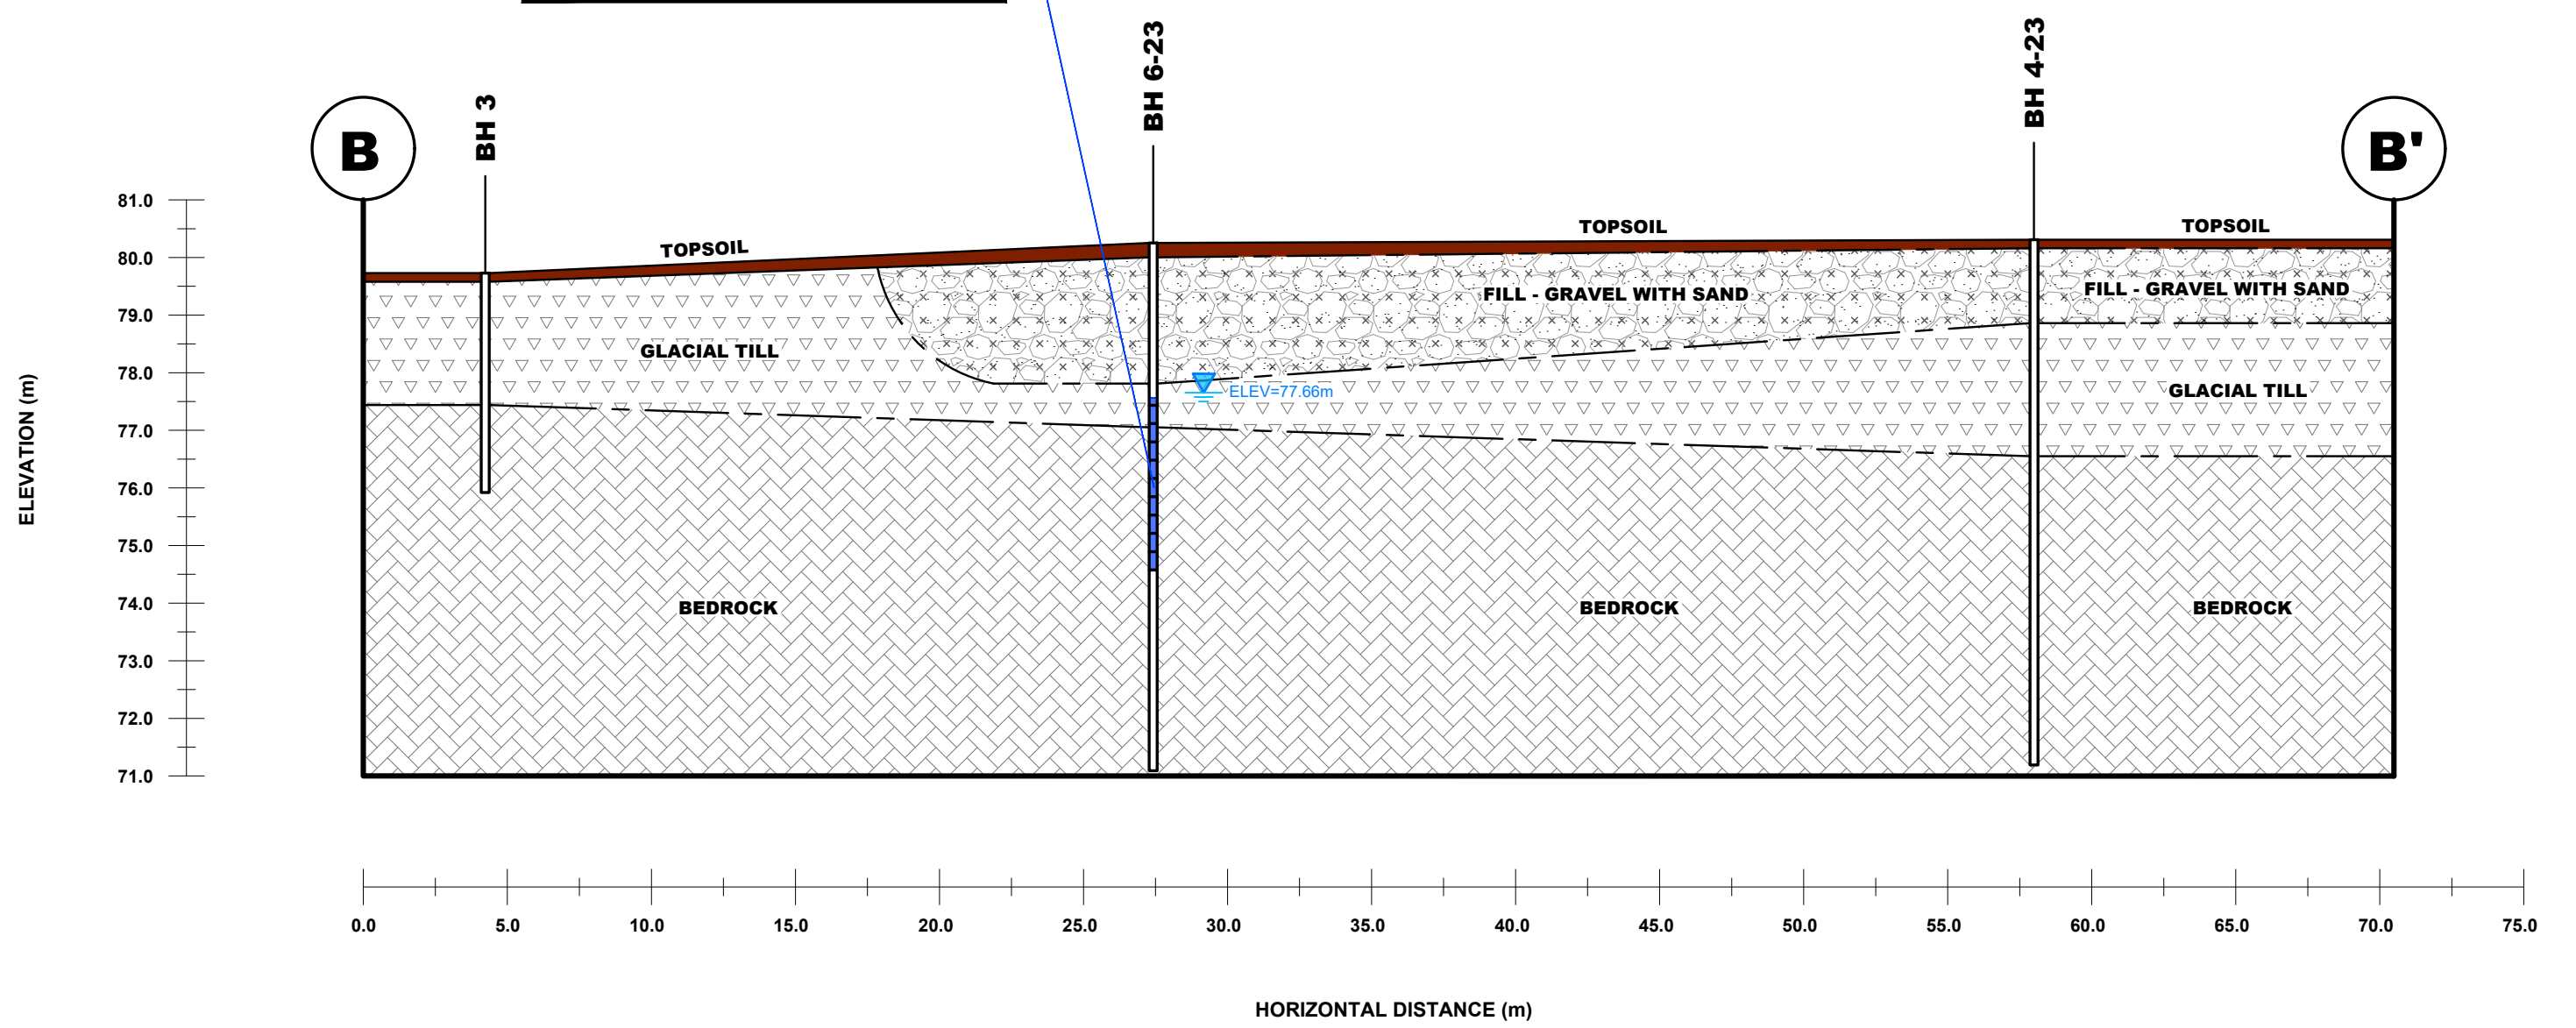
LE GROUPE MAURICE  
 PHASE II - ENVIRONMENTAL SITE ASSESSMENT  
 1440 BLAIR TOWER PLACE  
 OTTAWA, ONTARIO  
 Title: **CROSS SECTION B-B' - GROUNDWATER**

GROUNDWATER RESULT COMPLIES WITH THE MECP TABLE 3 RPI STANDARDS
