Phase Two Environmental Site Assessment 6659 Franktown Road, Ottawa, Ontario

Phase Two Environmental Site Assessment

OTT-00243705-B0

2023-08-11

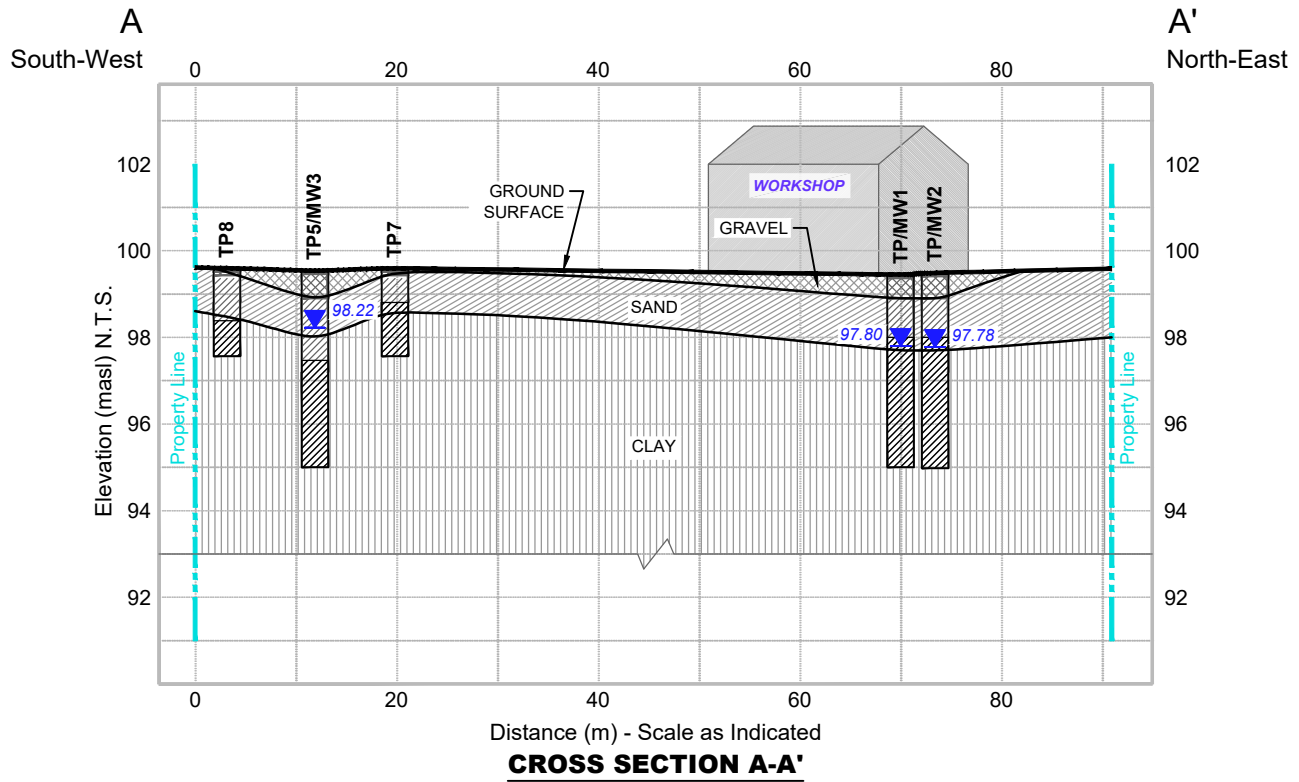
TP1A	Depth (mbgs)	14-Nov-17							
		B	T	E	X	F1	F2	F3	F4
	0.9	<0.02	<0.02	<0.02	<0.05	<7	<4	<8	<6
TP2B	Depth (mbgs)	14-Nov-17							
		B	T	E	X	F1	F2	F3	F4
	2.1	<0.02	<0.02	<0.02	<0.05	<7	<4	<8	<6
TP3A	Depth (mbgs)	14-Nov-17							
		B	T	E	X	F1	F2	F3	F4
	0.9	<0.02	<0.02	<0.02	<0.05	<7	<4	<8	<6
TP3B	Depth (mbgs)	14-Nov-17							
		B	T	E	X	F1	F2	F3	F4
	1.8	<0.02	<0.02	<0.02	<0.05	<7	<4	<8	<6
TP5B	Depth (mbgs)	14-Nov-17							
		B	T	E	X	F1	F2	F3	F4
	1.8	<0.02	<0.02	<0.02	<0.05	68	412	202	<6
TP6A	Depth (mbgs)	14-Nov-17							
		B	T	E	X	F1	F2	F3	F4
	0.9	<0.02	<0.02	<0.02	<0.04	<7	<4	<8	<6
TP7B	Depth (mbgs)	14-Nov-17							
		B	T	E	X	F1	F2	F3	F4
	2	<0.02	<0.02	<0.02	<0.05	<7	<4	<8	<6
TP8B	Depth (mbgs)	14-Nov-17							
		B	T	E	X	F1	F2	F3	F4
	2.1	<0.02	<0.02	<0.02	<0.05	<7	<4	<8	<6
TP9B	Depth (mbgs)	14-Nov-17							
		B	T	E	X	F1	F2	F3	F4
	2.3	<0.02	<0.02	<0.02	<0.05	<7	<4	<8	<6

PARAMETERS	ABBREVIATION	REG 153/04 TABLE 2 STANDARDS
Benzene	B	0.21
Toluene	T	2.3
Ethylbenzene	E	1.1
Total Xylenes	X	3.1
F1	F1 (C6-C10)	55
F2	F2 (C10-C16)	98
F3	F3 (C16-C34)	300
F4	F4 (C34-C50)	2800

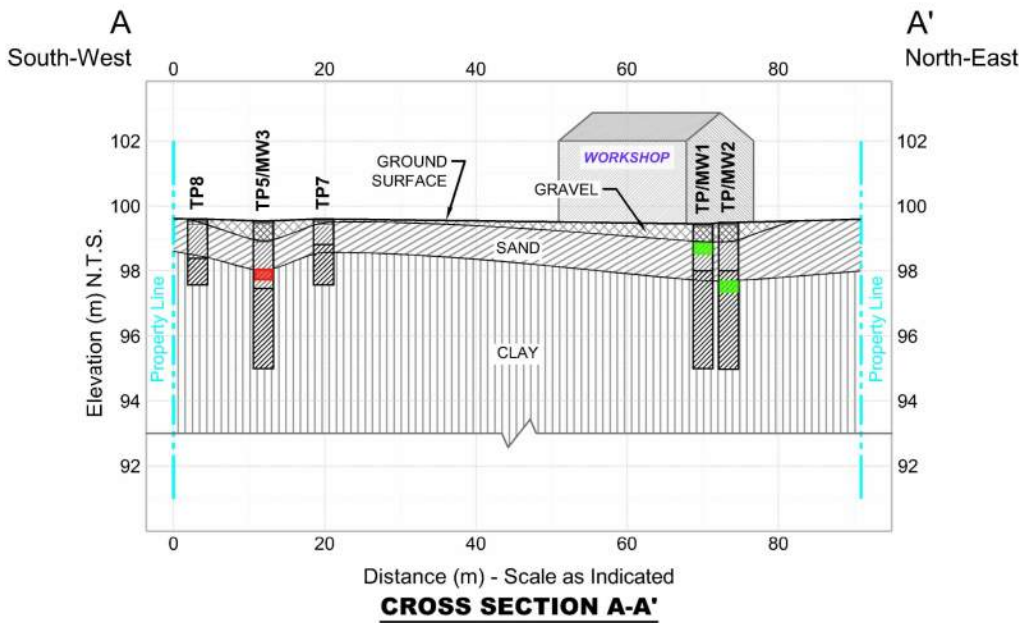
DATE AUGUST 2023		PROJECT: PHASE TWO ENVIRONMENTAL SITE ASSESSMENT		project no. OTT-00243705-B0	
DESIGN MM	CHECKED CK	ADDRESS: 6659 FRANKTOWN ROAD, OTTAWA, ONTARIO		scale 1:1000	
DRAWN BY AS		TITLE: SOIL CROSS SECTION A-A' – PHC & BTEX		FIG 9

A 0.15-0.6 m thick layer of gravel was found at the ground surface at TP1, TP2, TP3, TP4, TP5, TP6 and TP9. A 0.15 m thick surface layer of topsoil was found at TP7 and TP8. Below the topsoil a layer of sand was observed. No indications of petroleum impact were identified in the fill. Below any topsoil or gravel was a brown sand in all test pits. This extended to a depth of 0.3-1.8 m. Below the sand was a layer of grey silty clay. There were no visual or olfactory indications of petroleum impact to the native soil except for TP5 which was observed to have a slight petroleum odour within the grey silty clay layer.

Based on the field observations and analytical results obtained, a zone of PHC impacted soil was found in the central western part of the Phase Two property directly to the south of the fuel tanks. The lateral extent of the petroleum impacted soil has

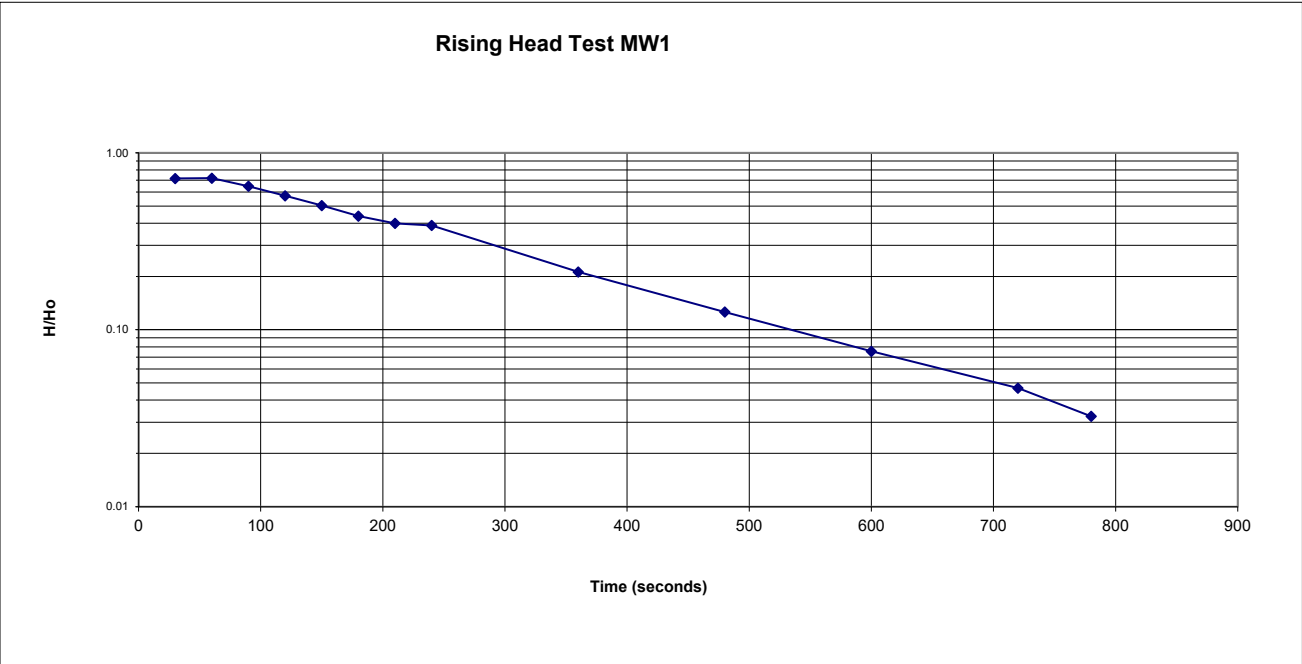
On August 2, 2023, a rising head test was conducted in one monitoring well (MW1). The rising head test requires that the static water level be measured in each monitoring well prior to the removal of groundwater. Groundwater is removed from the monitoring well using a pump. After the water level has been sufficiently lowered, an interface probe is lowered into the monitor as quickly as possible to measure the new water level. The time at which the new water level is measured is noted as time equal zero. Water level readings are subsequently taken at frequent intervals. Both the water levels and the time they were taken are recorded.

K= $\frac{r^2 \ln(L/R)}{2(T_o)(L)}$

K= 1.41E-06 m/sec or 1.41E-04 cm/sec
