Phase I Environmental Site Assessment

1305 Summerville Avenue
Ottawa, Ontario

October 30, 2018

Report: PE4432-1

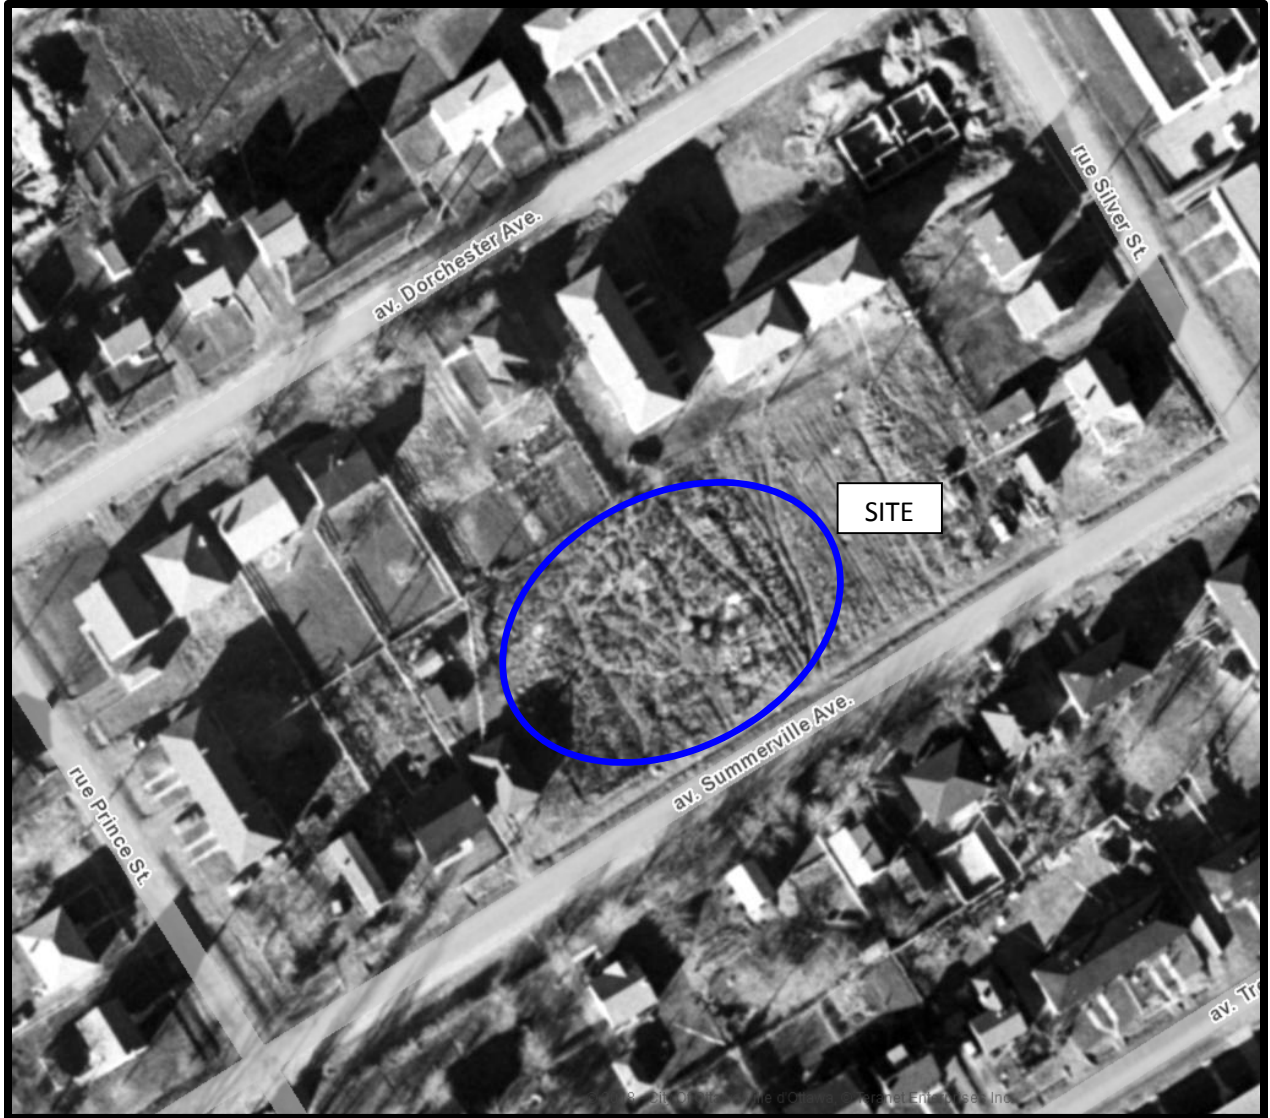
AERIAL PHOTOGRAPH
1958

| 1958 | (City of Ottawa Website) At this time, the subject site is vacant and appears overgrown. The subject area is developed as residential area with detached and semi-detached houses conforming to the current road layout. |

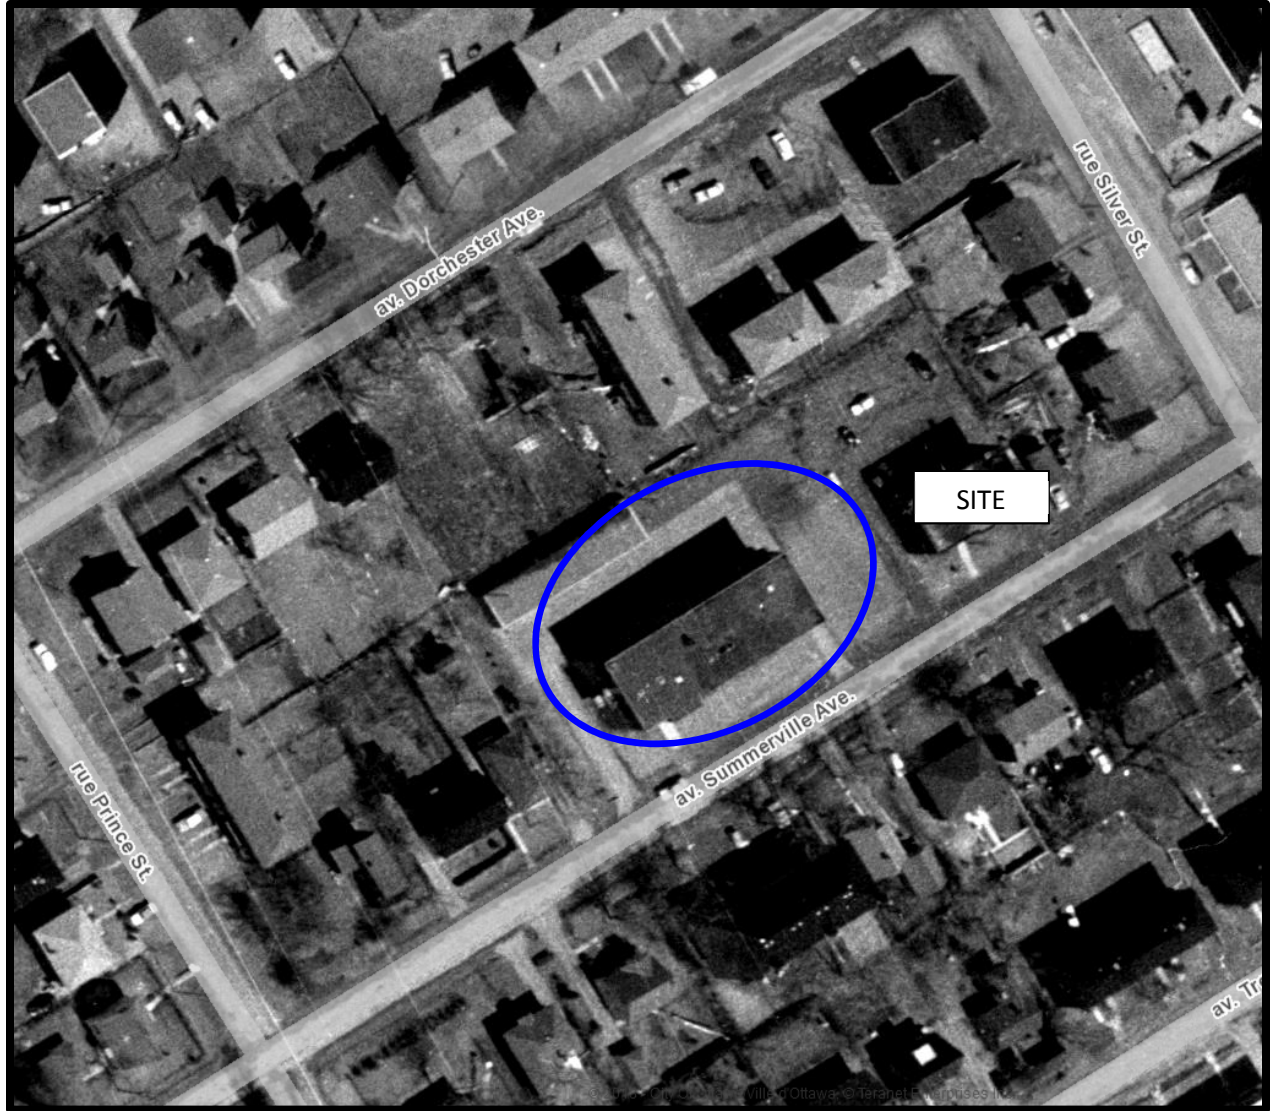
AERIAL PHOTOGRAPH
1965

| 1965 | (City of Ottawa Website) The subject site is occupied by a multi-tenant apartment building and a row of storage garages. No significant changes have been made to the surrounding properties. |

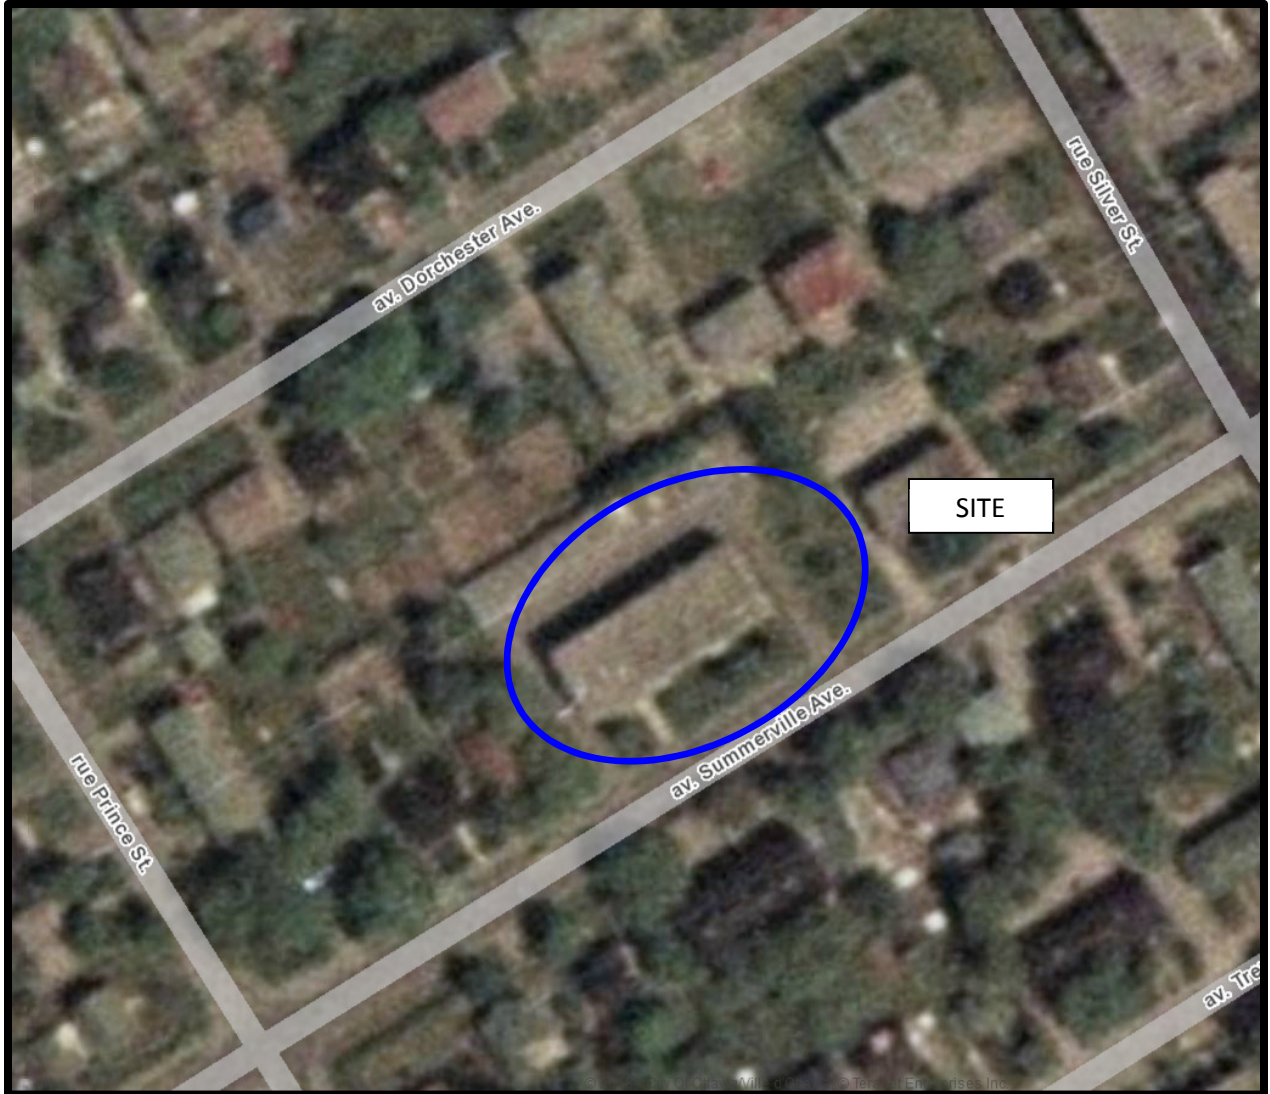
AERIAL PHOTOGRAPH
1976

| 1976 | (City of Ottawa Website) No significant changes have been made to the subject site or neighbouring properties |

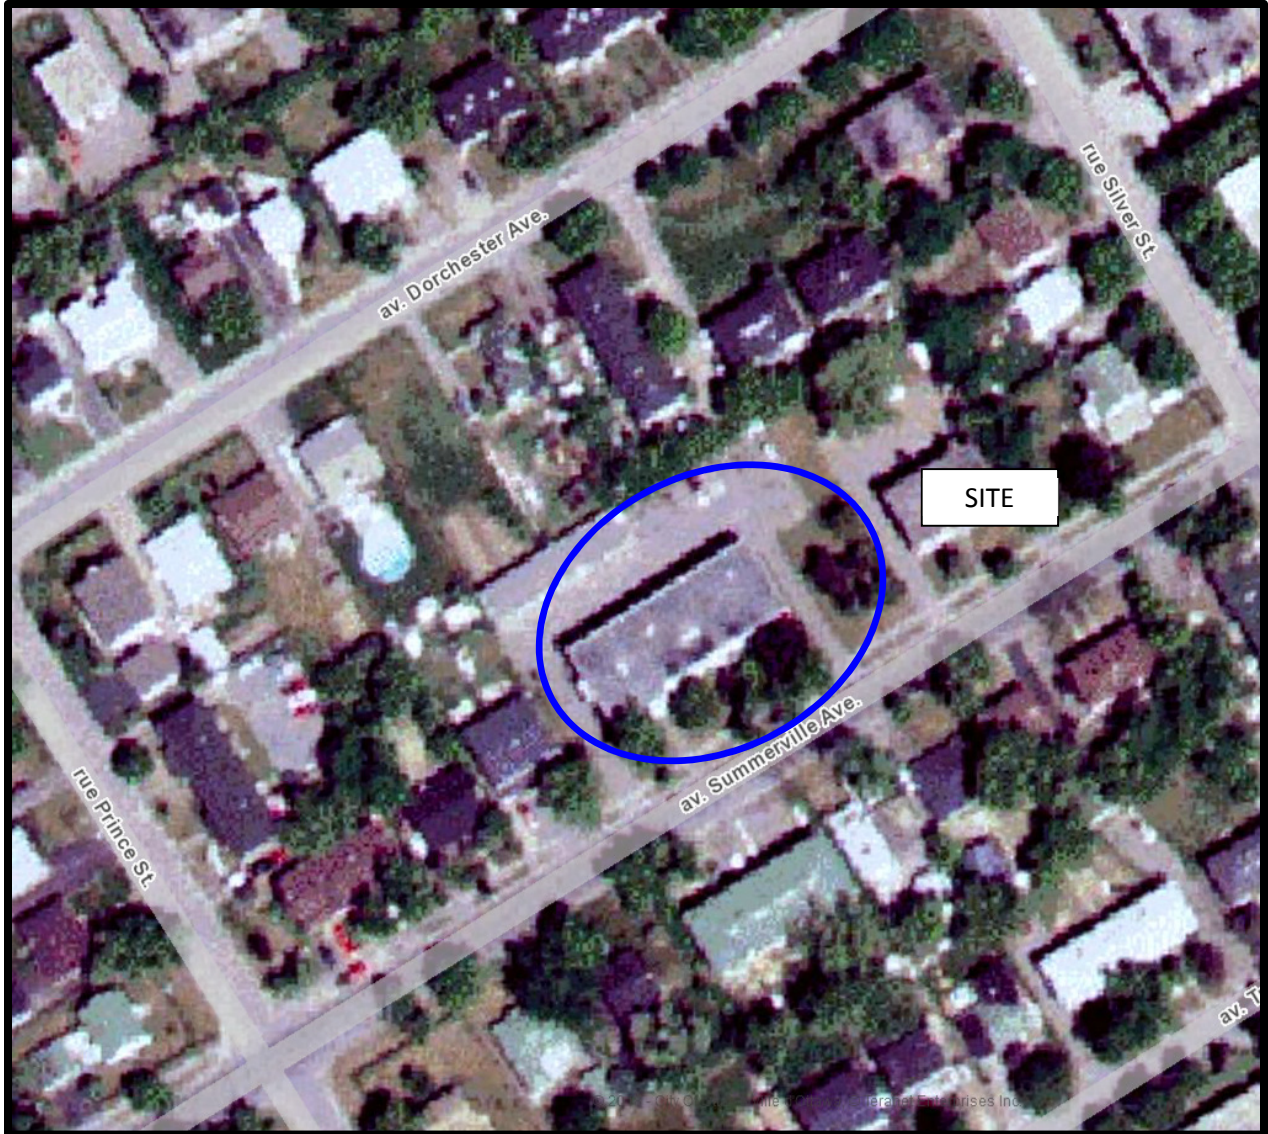
AERIAL PHOTOGRAPH
1999

| 1999 | (City of Ottawa Website) No significant changes have been made to the subject site or neighbouring properties |

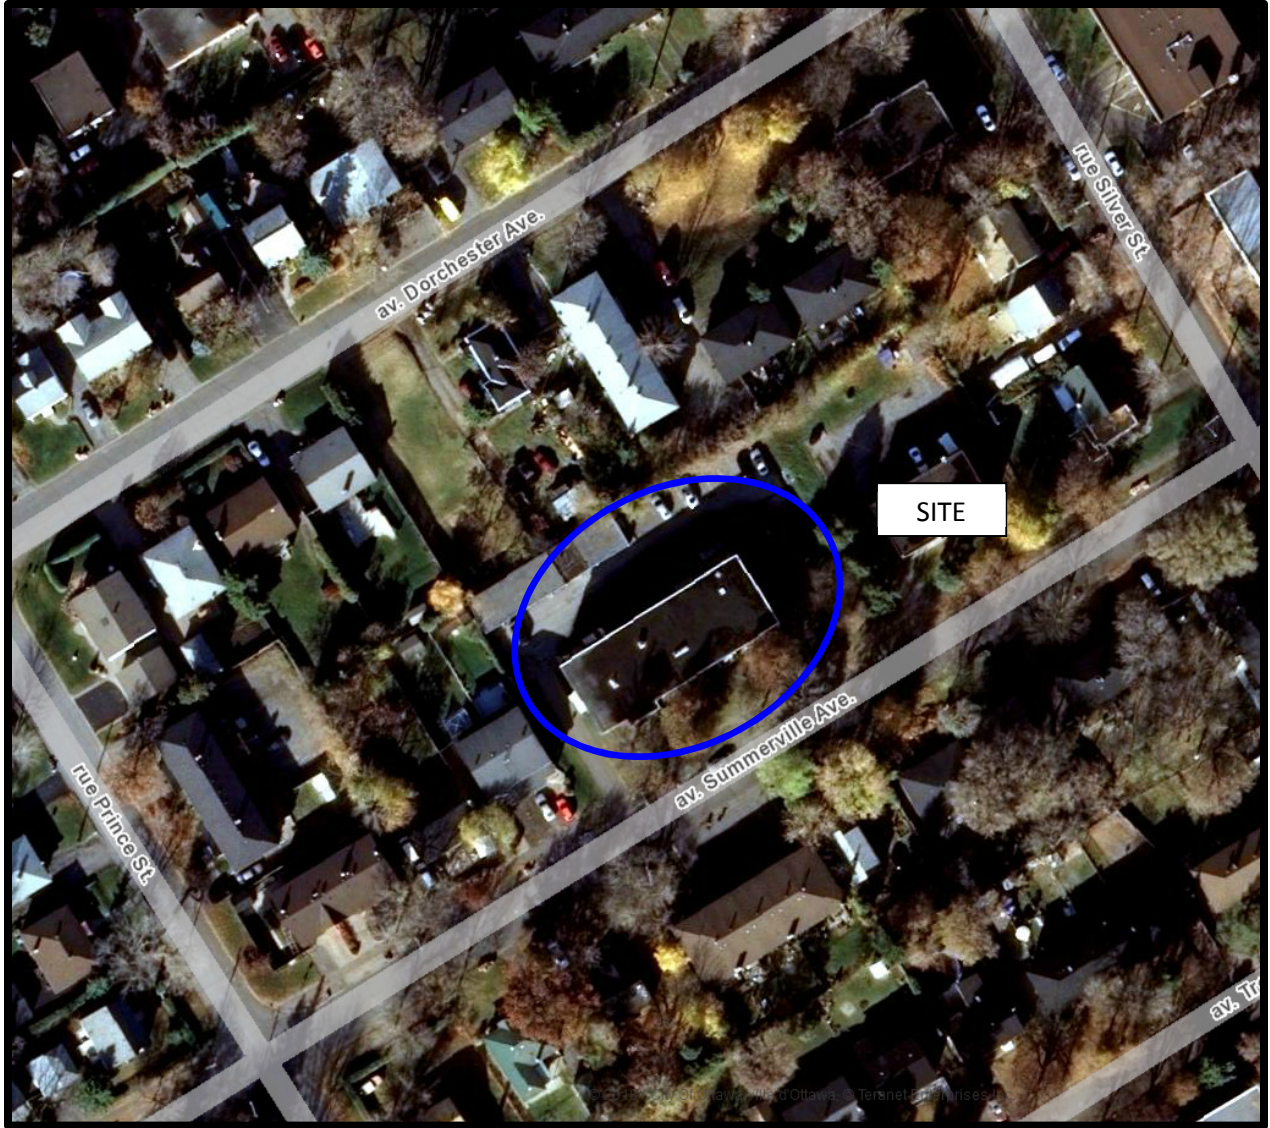
AERIAL PHOTOGRAPH
2008

| 2008 | (City of Ottawa Website) No significant changes have been made to the subject site or neighbouring properties |

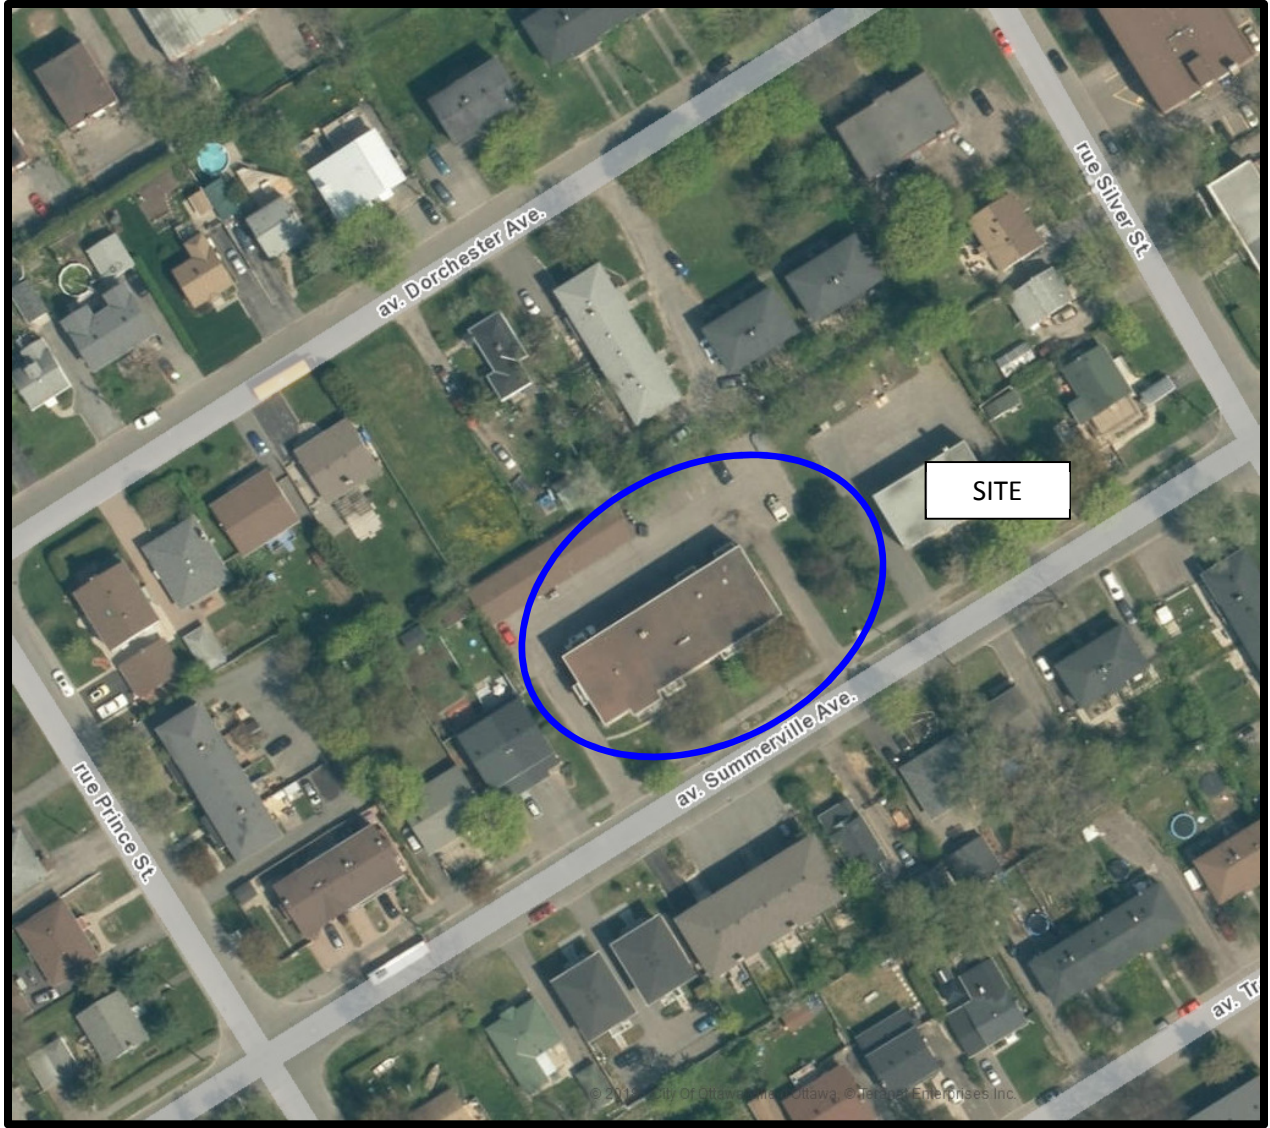
AERIAL PHOTOGRAPH
2017

| 2017 | (City of Ottawa Website) No significant changes have been made to the subject site or neighbouring properties |
