1412 Stittsville Main Street

PHASE TWO ENVIRONMENTAL SITE ASSESSMENT

Elite Living Properties

March 14,
2025

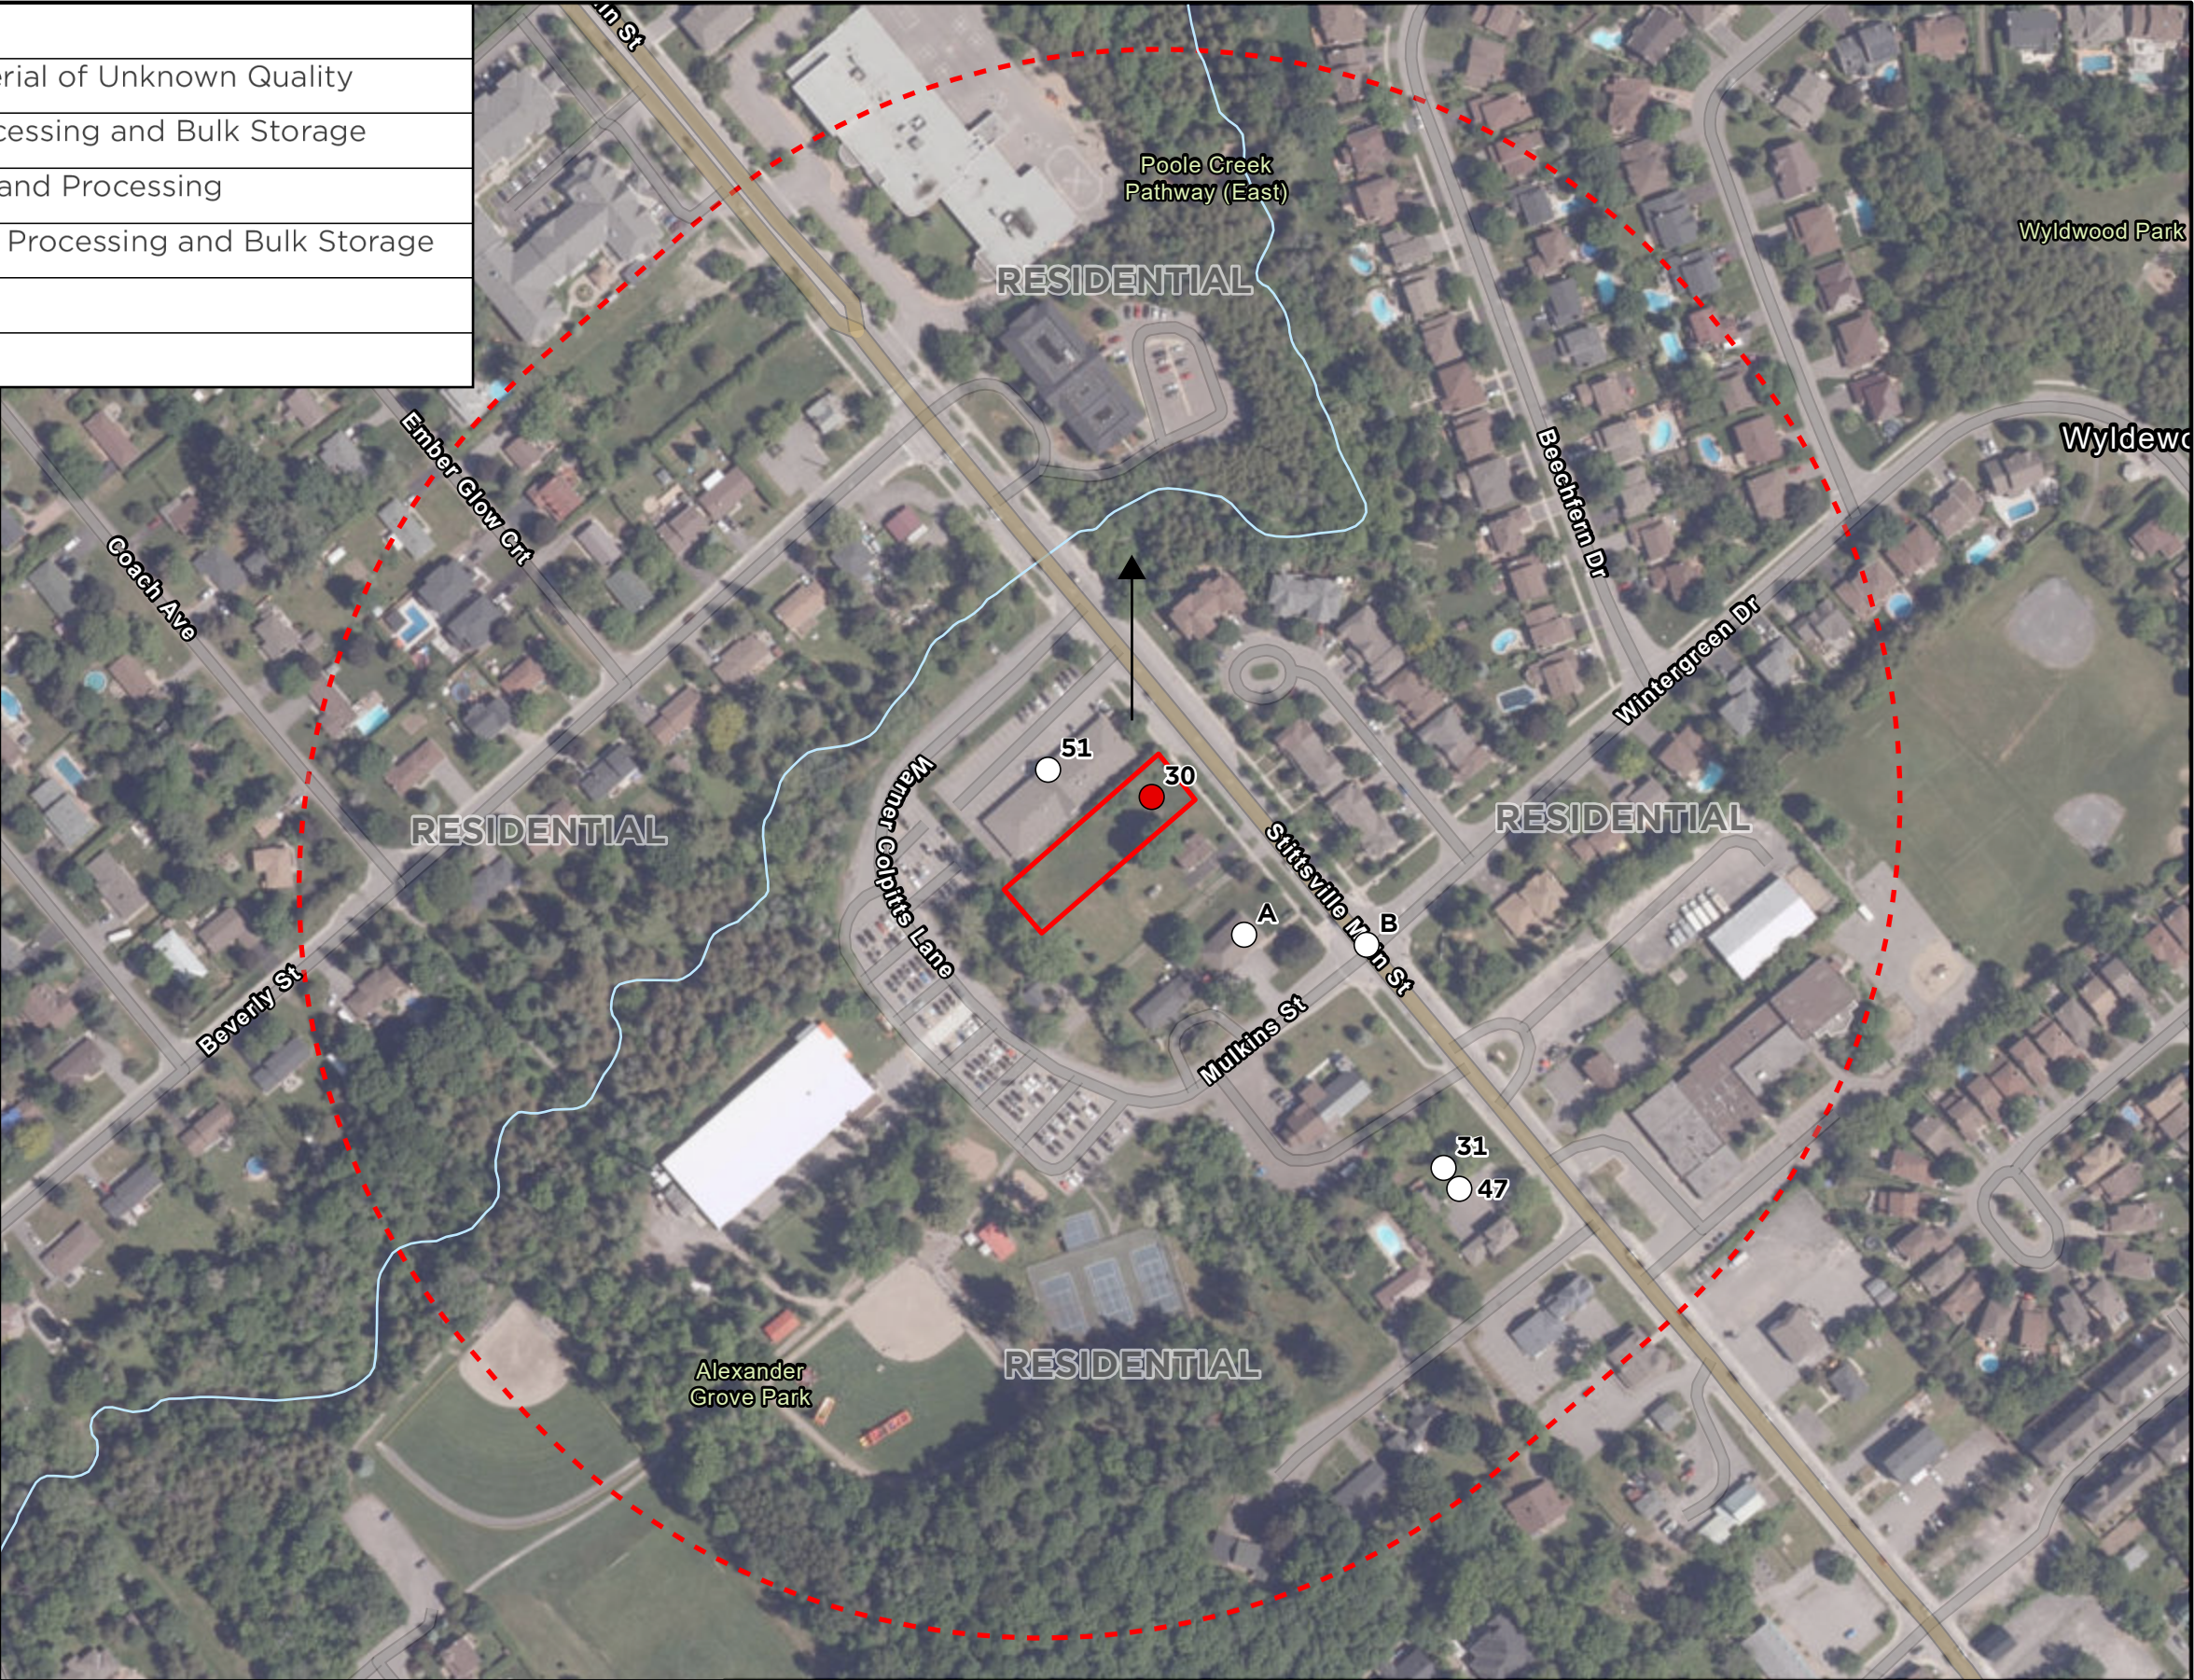
- The resulting Conceptual Site Model (CSM) and APEC are shown on Figures 2 and 3, respectively.
- The Phase One ESA recommended the preparation of a Phase Two ESA.

- SITE
- STUDY AREA (250 M)
- PCA RESULTING IN APEC
- PCA NOT RESULTING IN APEC
- WATERCOURSE
- INFERRED REGIONAL GROUNDWATER FLOW DIRECTION

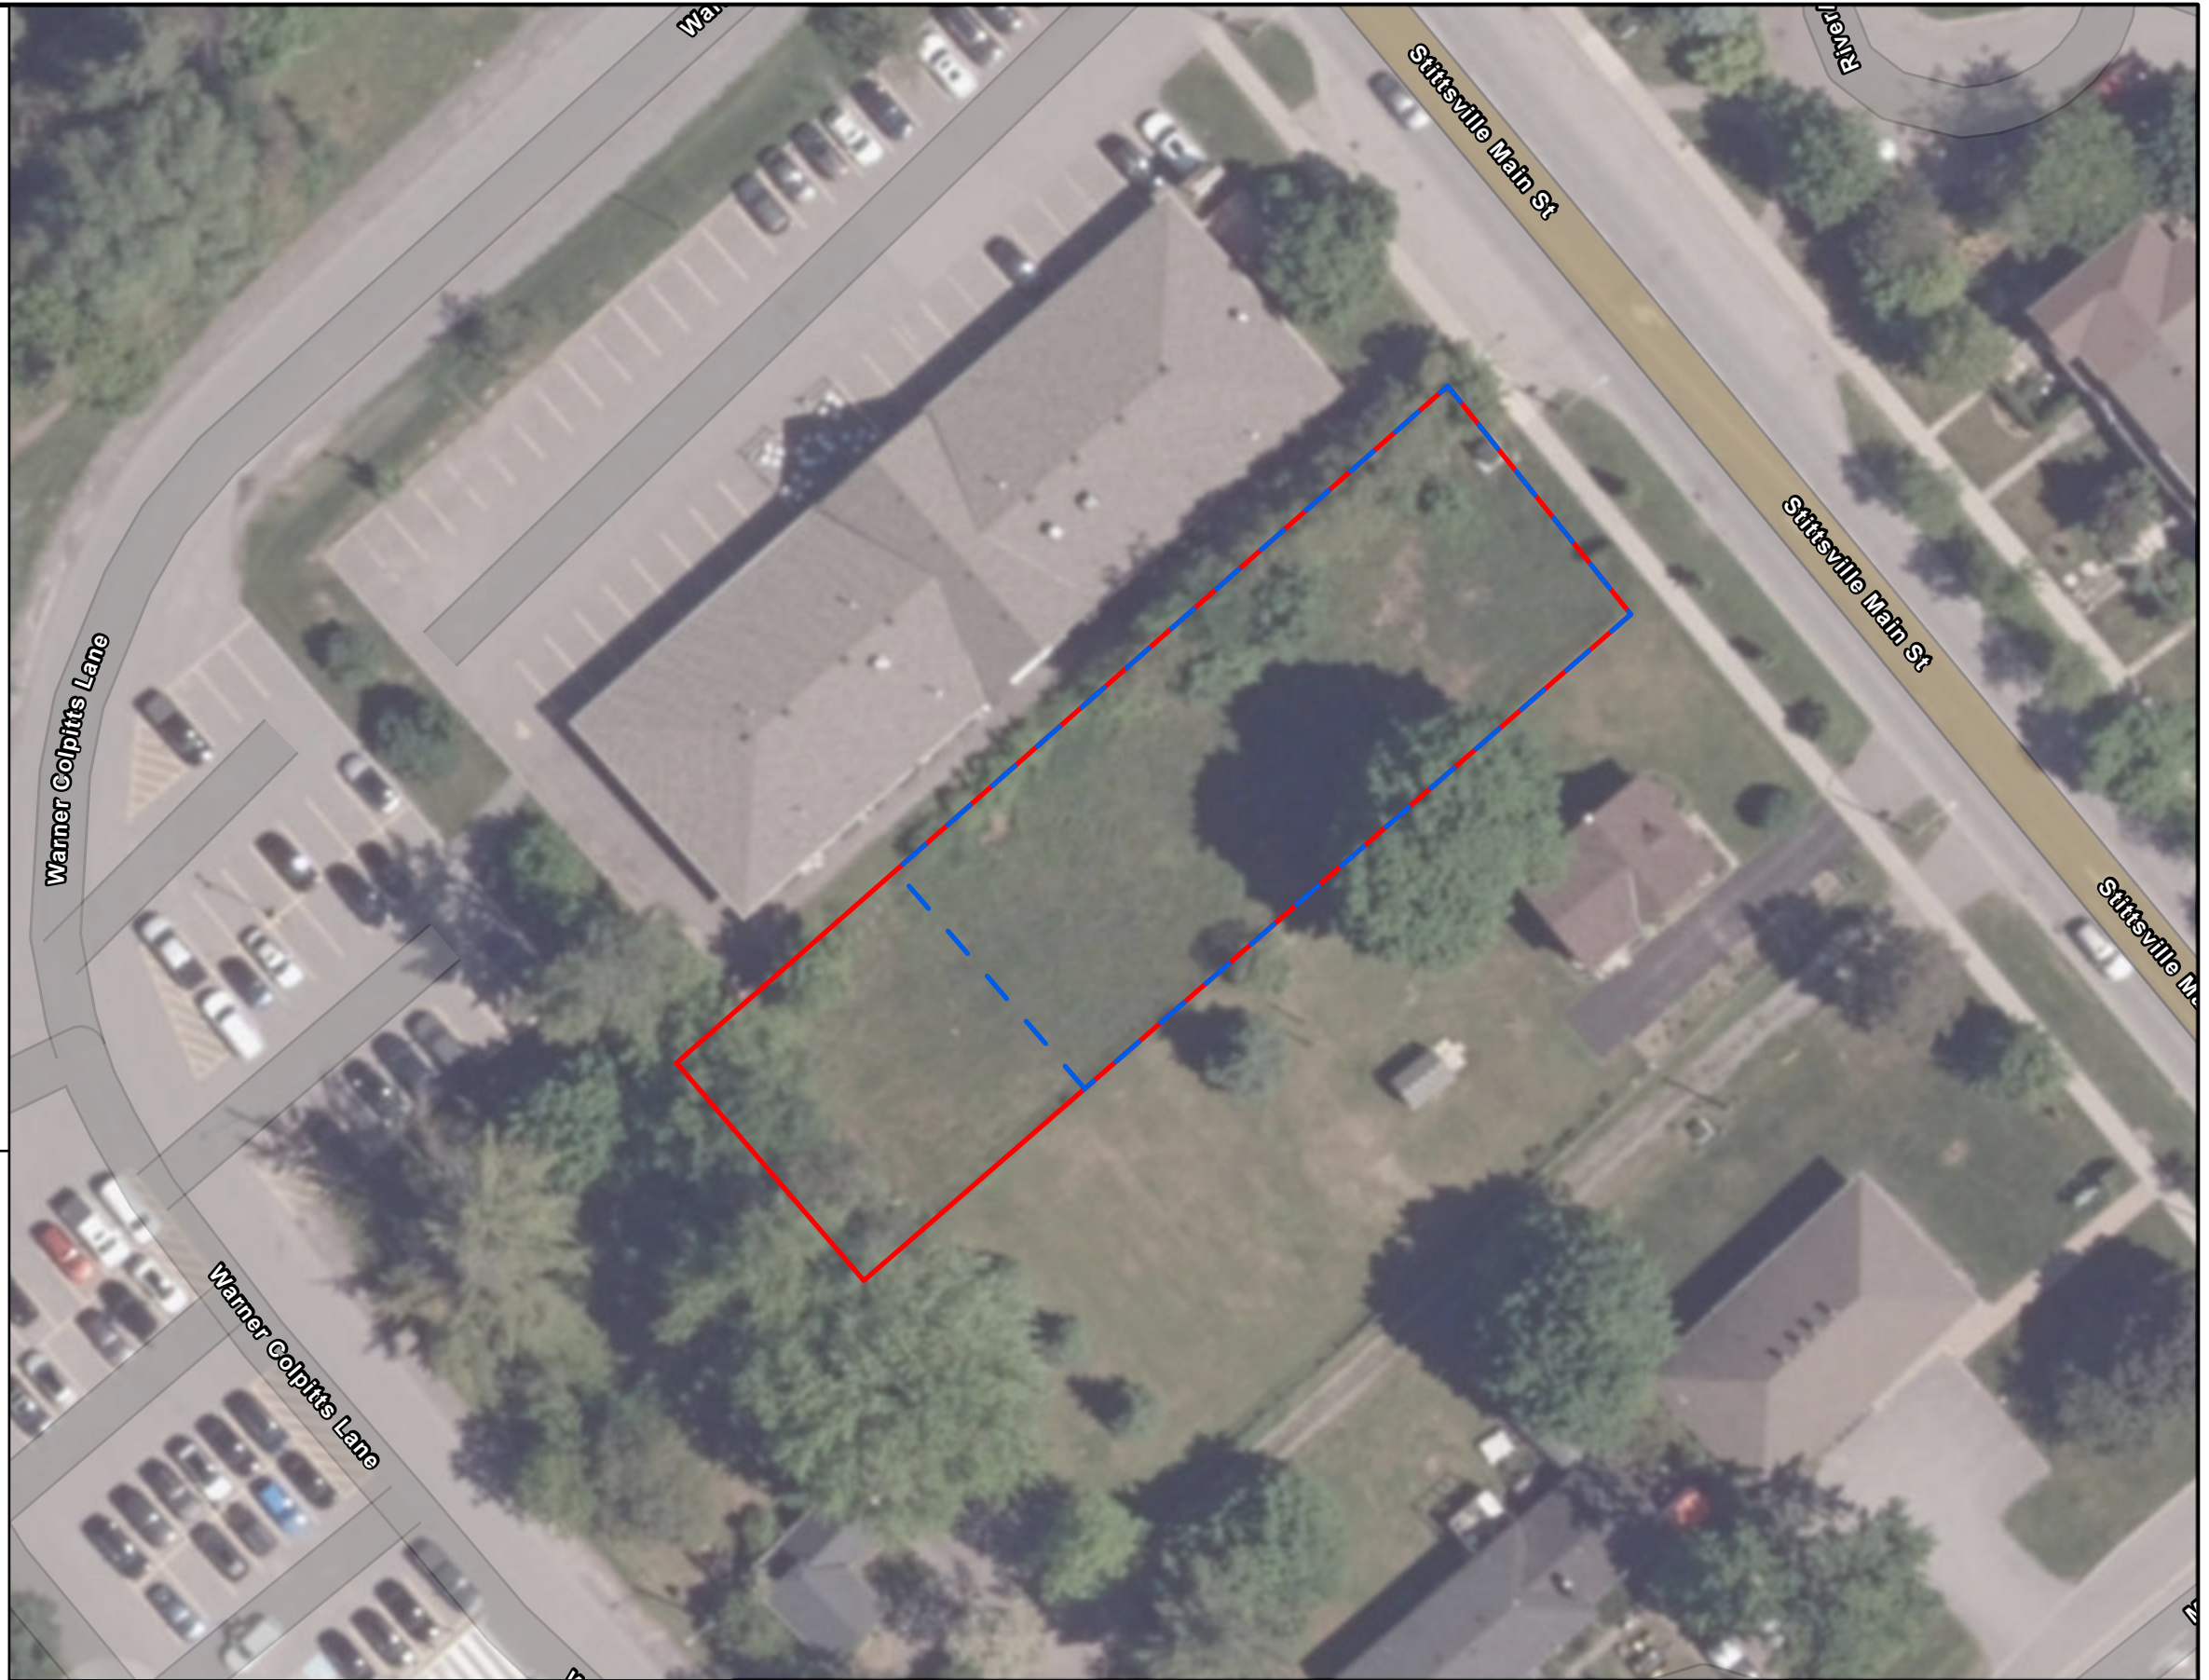
1412 STITTSVILLE MAIN STREET, OTTAWA
PHASE TWO ENVIRONMENTAL ASSESSMENT
AREAS OF POTENTIAL ENVIRONMENTAL CONCERN

- As such, one APEC was identified for the Site:
 - APEC 1: Importation of Fill Material of Unknown Quality across the entire Site impacting soil and groundwater media. The associated contaminants of potential concern (COPC) include Metals, Inorganics, Petroleum Hydrocarbons (PHCs), Volatile Organic Compounds (VOCs), Polycyclic Aromatic Hydrocarbons (PAHs).

-   SITE
-   APEC 1: PCA 30 - IMPORTATION OF FILL MATERIAL OF UNKNOWN QUALITY

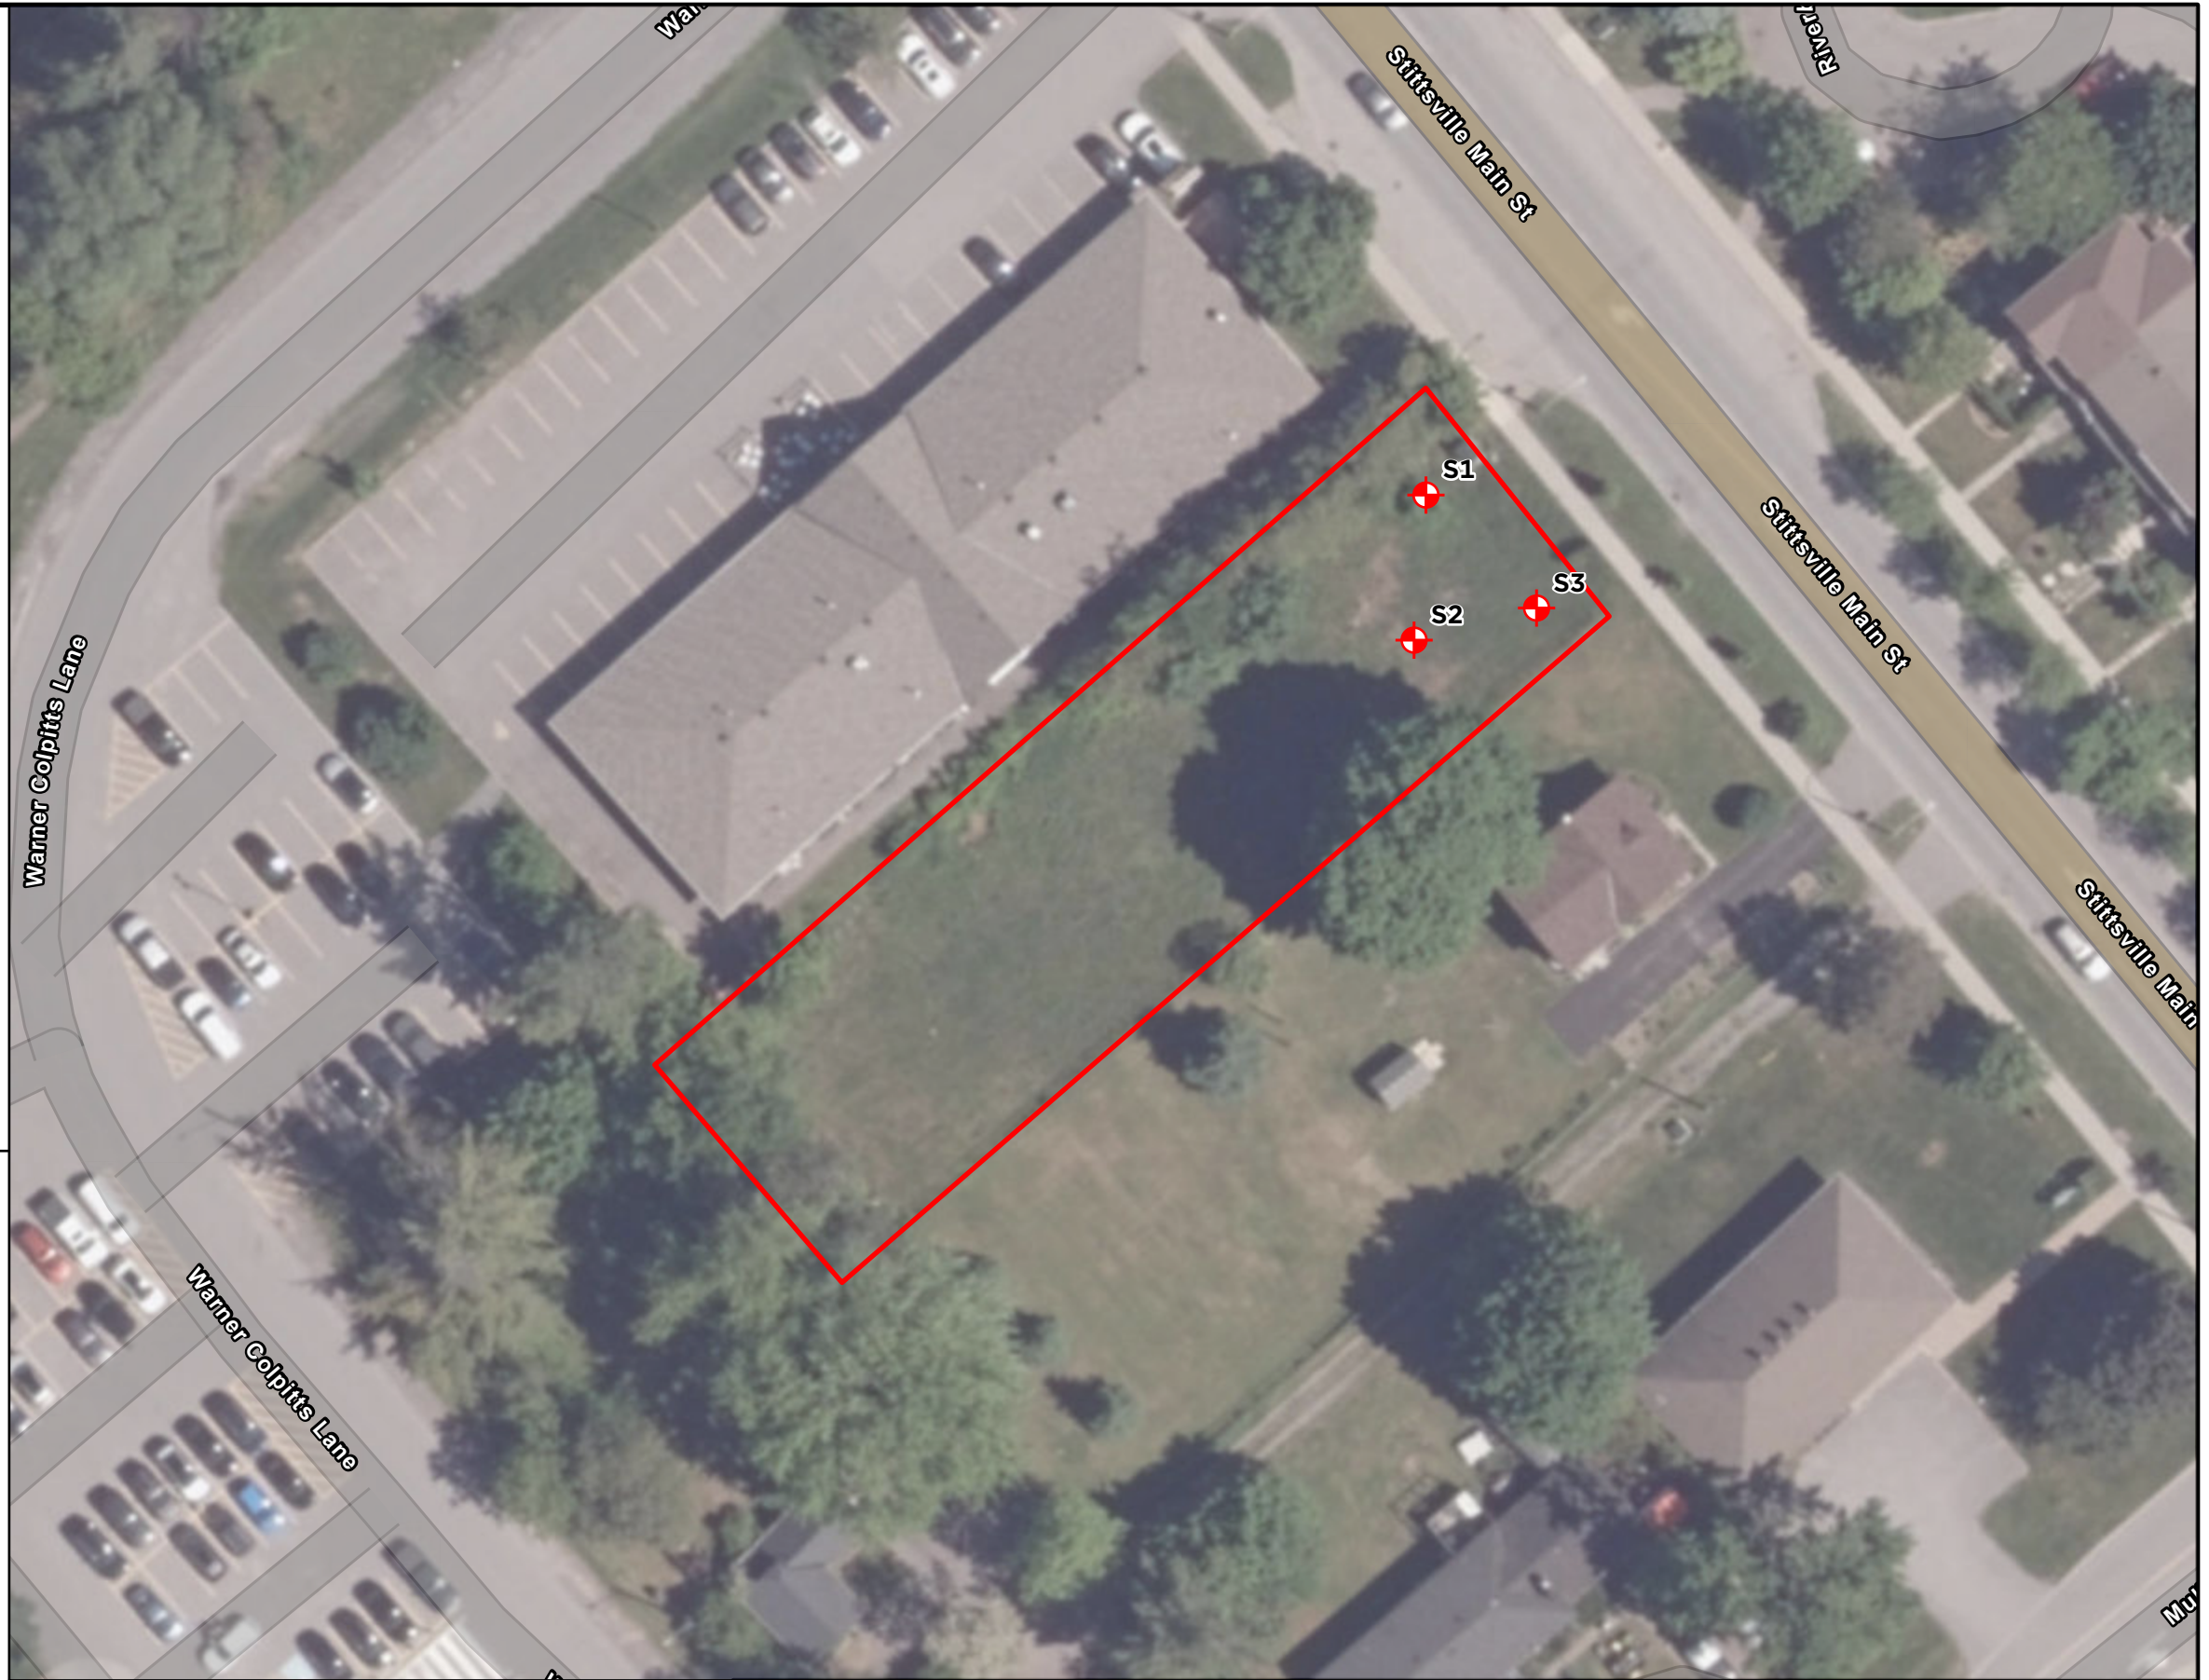
1412 STITTSVILLE MAIN STREET, OTTAWA
PHASE TWO ENVIRONMENTAL ASSESSMENT
TEST PIT LOCATION PLAN

- Three (3) hand dug test pits were advanced by Tatham on February 26, 2025. Soils samples were collected below the topsoil within the identified fill material. The soil samples were obtained at a depth of 0.3 – 0.6 m bgs.

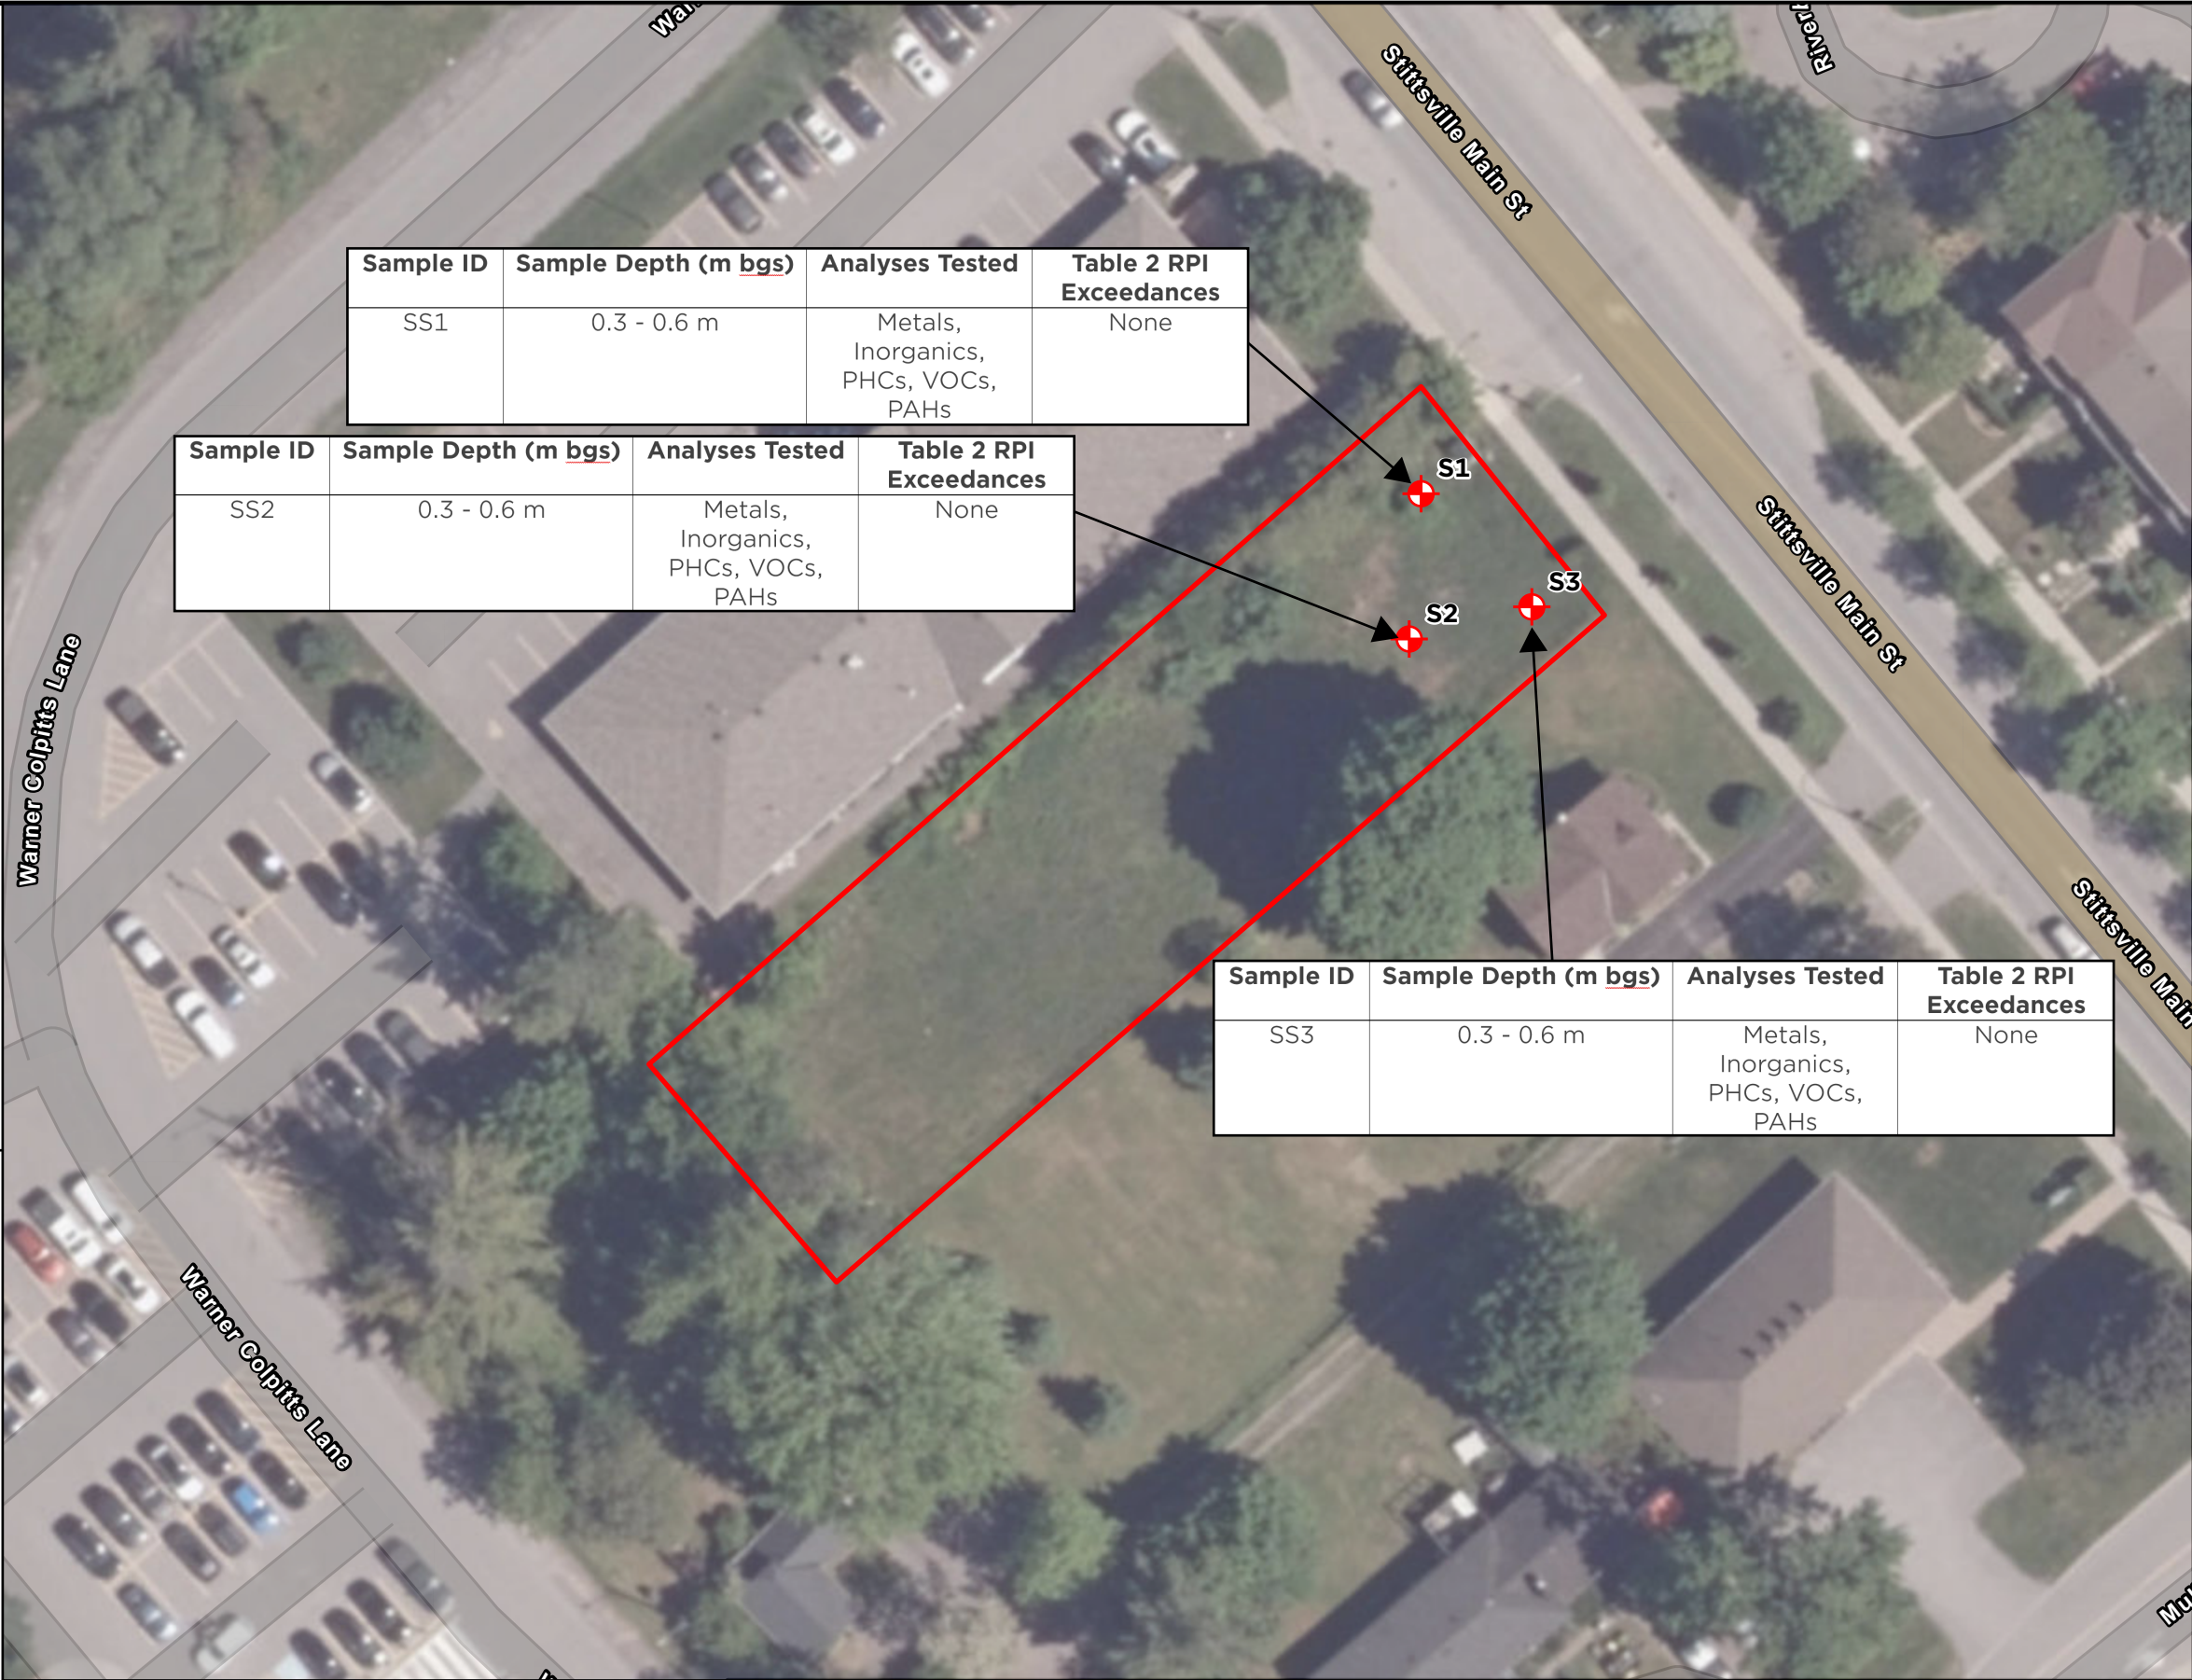
1412 STITTSVILLE MAIN STREET, OTTAWA
PHASE TWO ENVIRONMENTAL ASSESSMENT
SUMMARY OF SOIL CHEMISTRY RESULTS

- All three (3) soil samples met the applicable O.Reg. 153/04 Table 2 RPI Site Condition Standards (SCS) for coarse textured soils for Metals, Inorganics, PHCs, VOCs, and PAHs.

Sample ID	Sample Depth (m <u>bgs</u>)	Analyses Tested	Table 2 RPI Exceedances
SS2	0.3 - 0.6 m	Metals, Inorganics, PHCs, VOCs, PAHs	None

Sample ID	Sample Depth (m <u>bgs</u>)	Analyses Tested	Table 2 RPI Exceedances
SS3	0.3 - 0.6 m	Metals, Inorganics, PHCs, VOCs, PAHs	None

Based on the results of the sampling program outlined in this Phase Two Environmental Site Assessment, the soil meets the Table 2 RPI/ICC SCS for coarse textured soils. As such, it is of the QPs opinion no further investigations are required.
