Phase II Environmental Site Assessment

91 and 93 Holland Avenue
Ottawa, Ontario

April 21, 2021

Report: PE5171-2

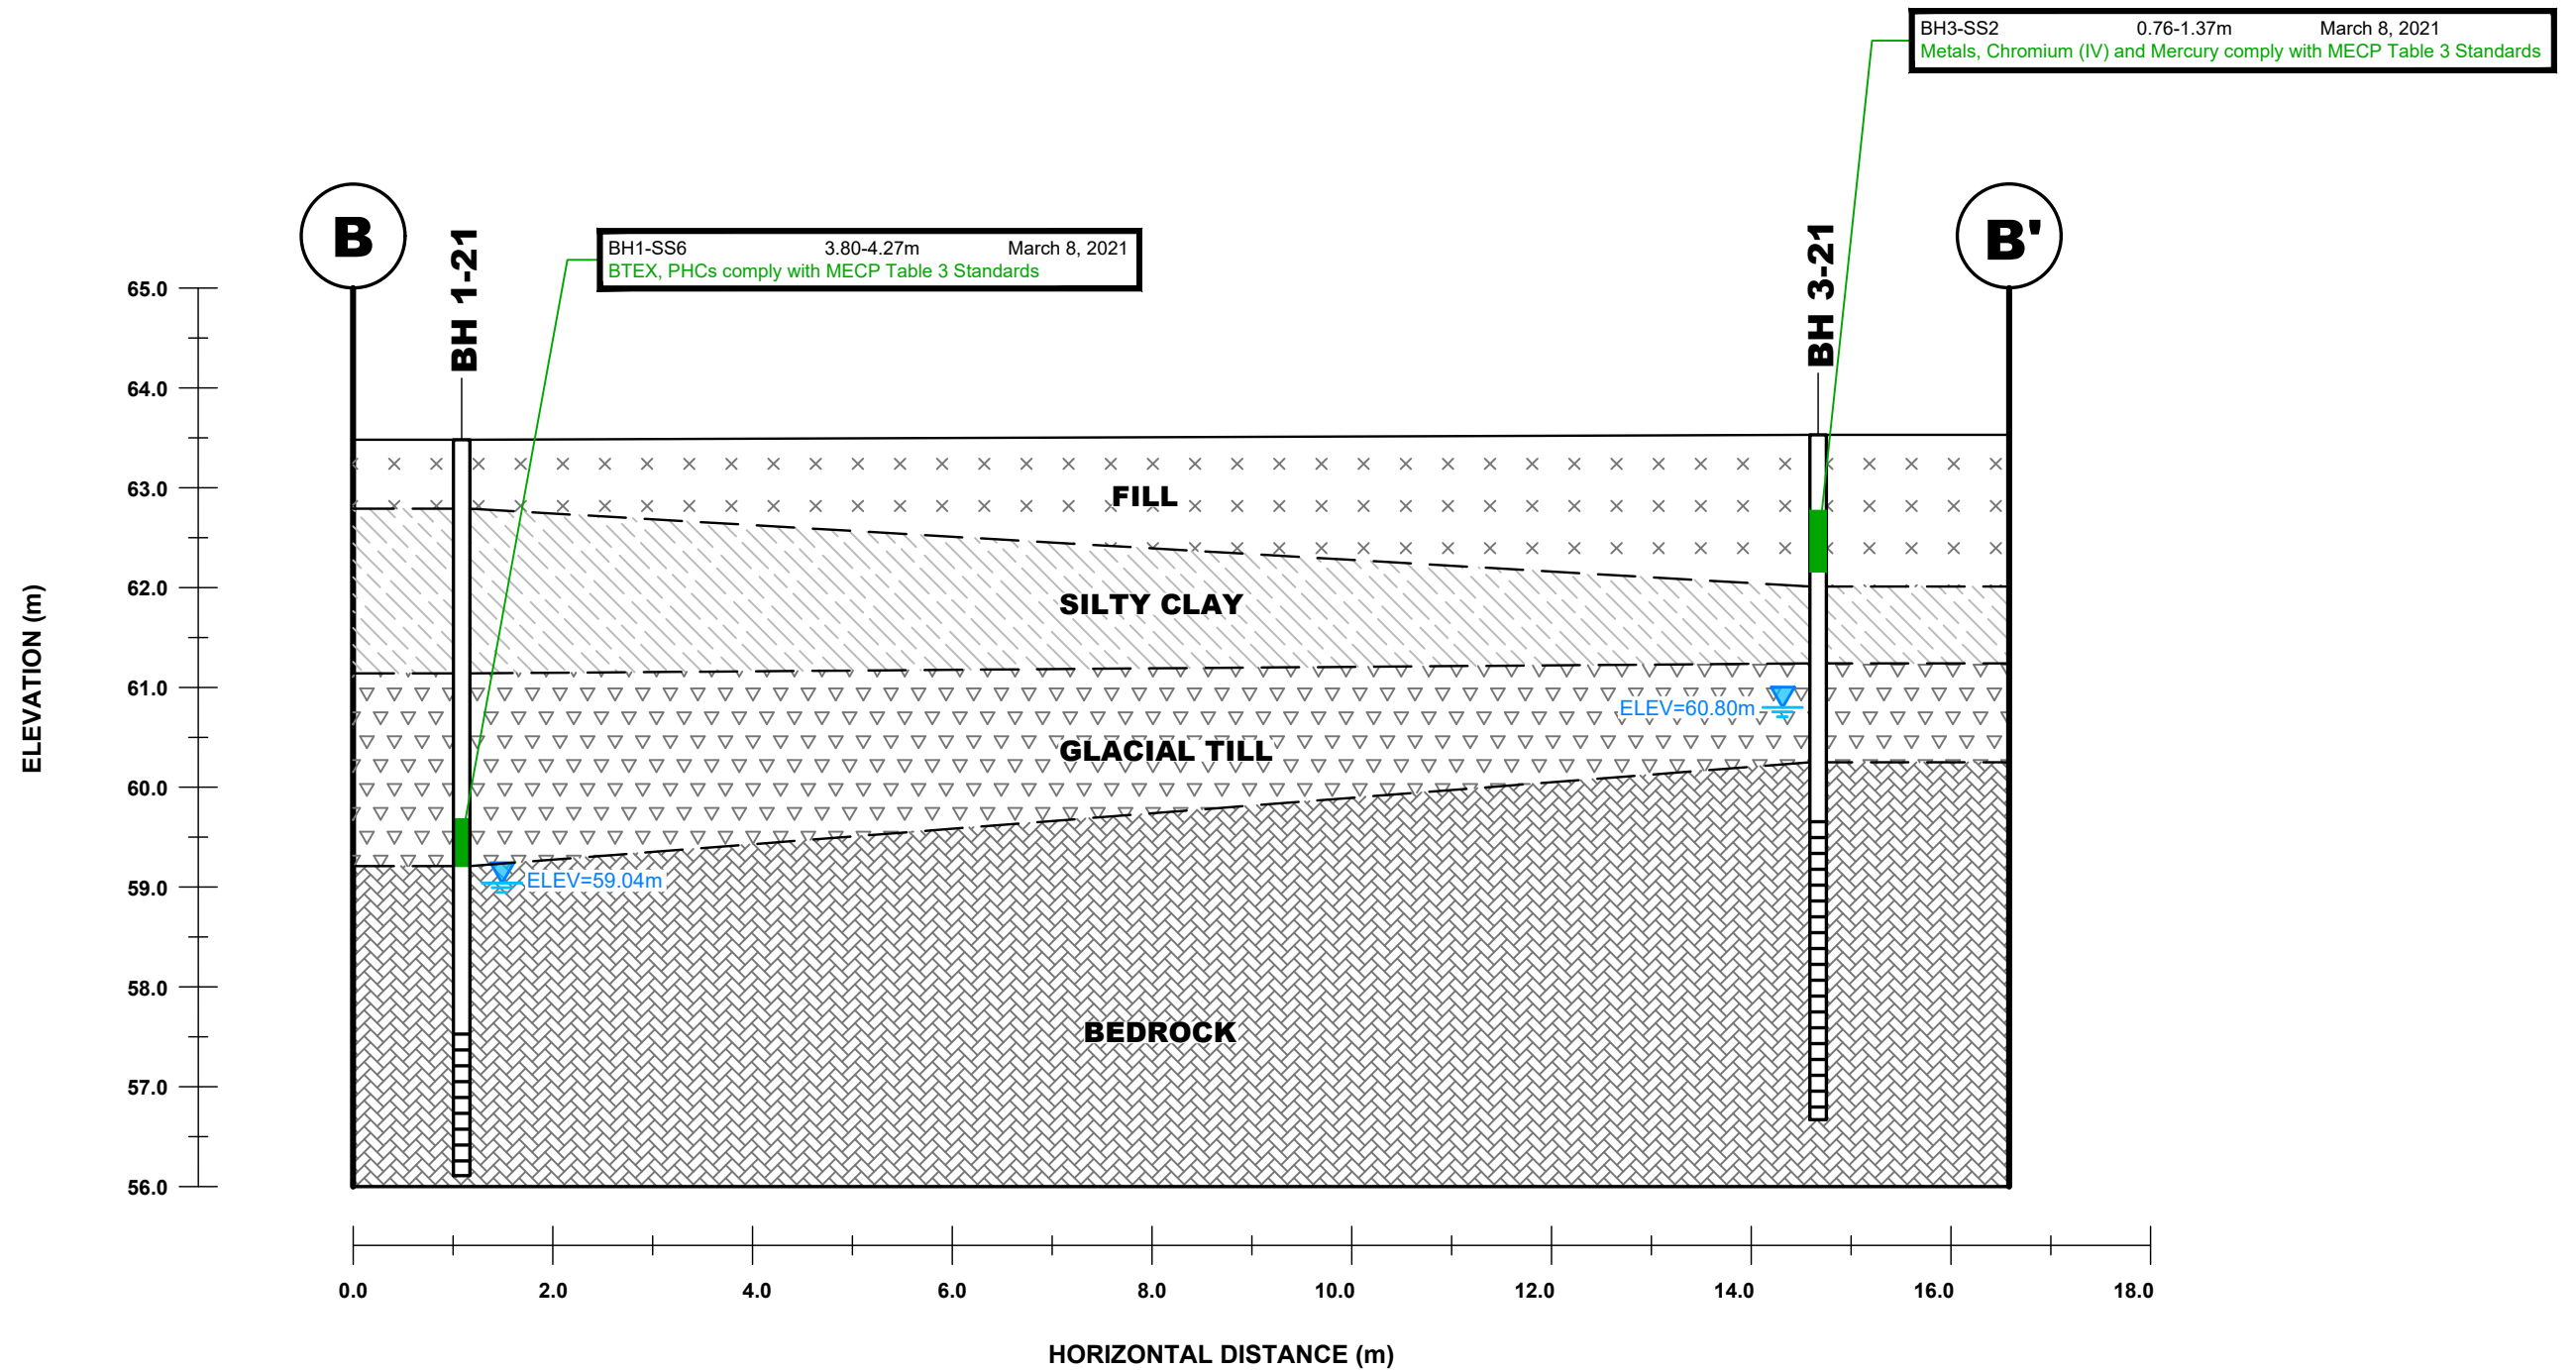
Scale:	AS SHOWN	Date:	04/2021
Drawn by:	YA	Report No.:	PE5171-2
Checked by:	MSP	Dwg No.:	PE5171-4B
Approved by:	KM	Revision No.:

SOIL RESULTS COMPLY WITH MECP TABLE 3 STANDARDS

SOIL RESULTS EXCEED MECP TABLE 3 STANDARDS

NICHOLSON GLUCKSTEIN
PHASE II - ENVIRONMENTAL SITE ASSESSMENT
91 & 93 HOLLAND AVENUE
OTTAWA, ONTARIO
Title:
CROSS SECTION B-B' - SOIL (BTEX, PHCs, METALS, CHROMIUM (IV) AND MERCURY)

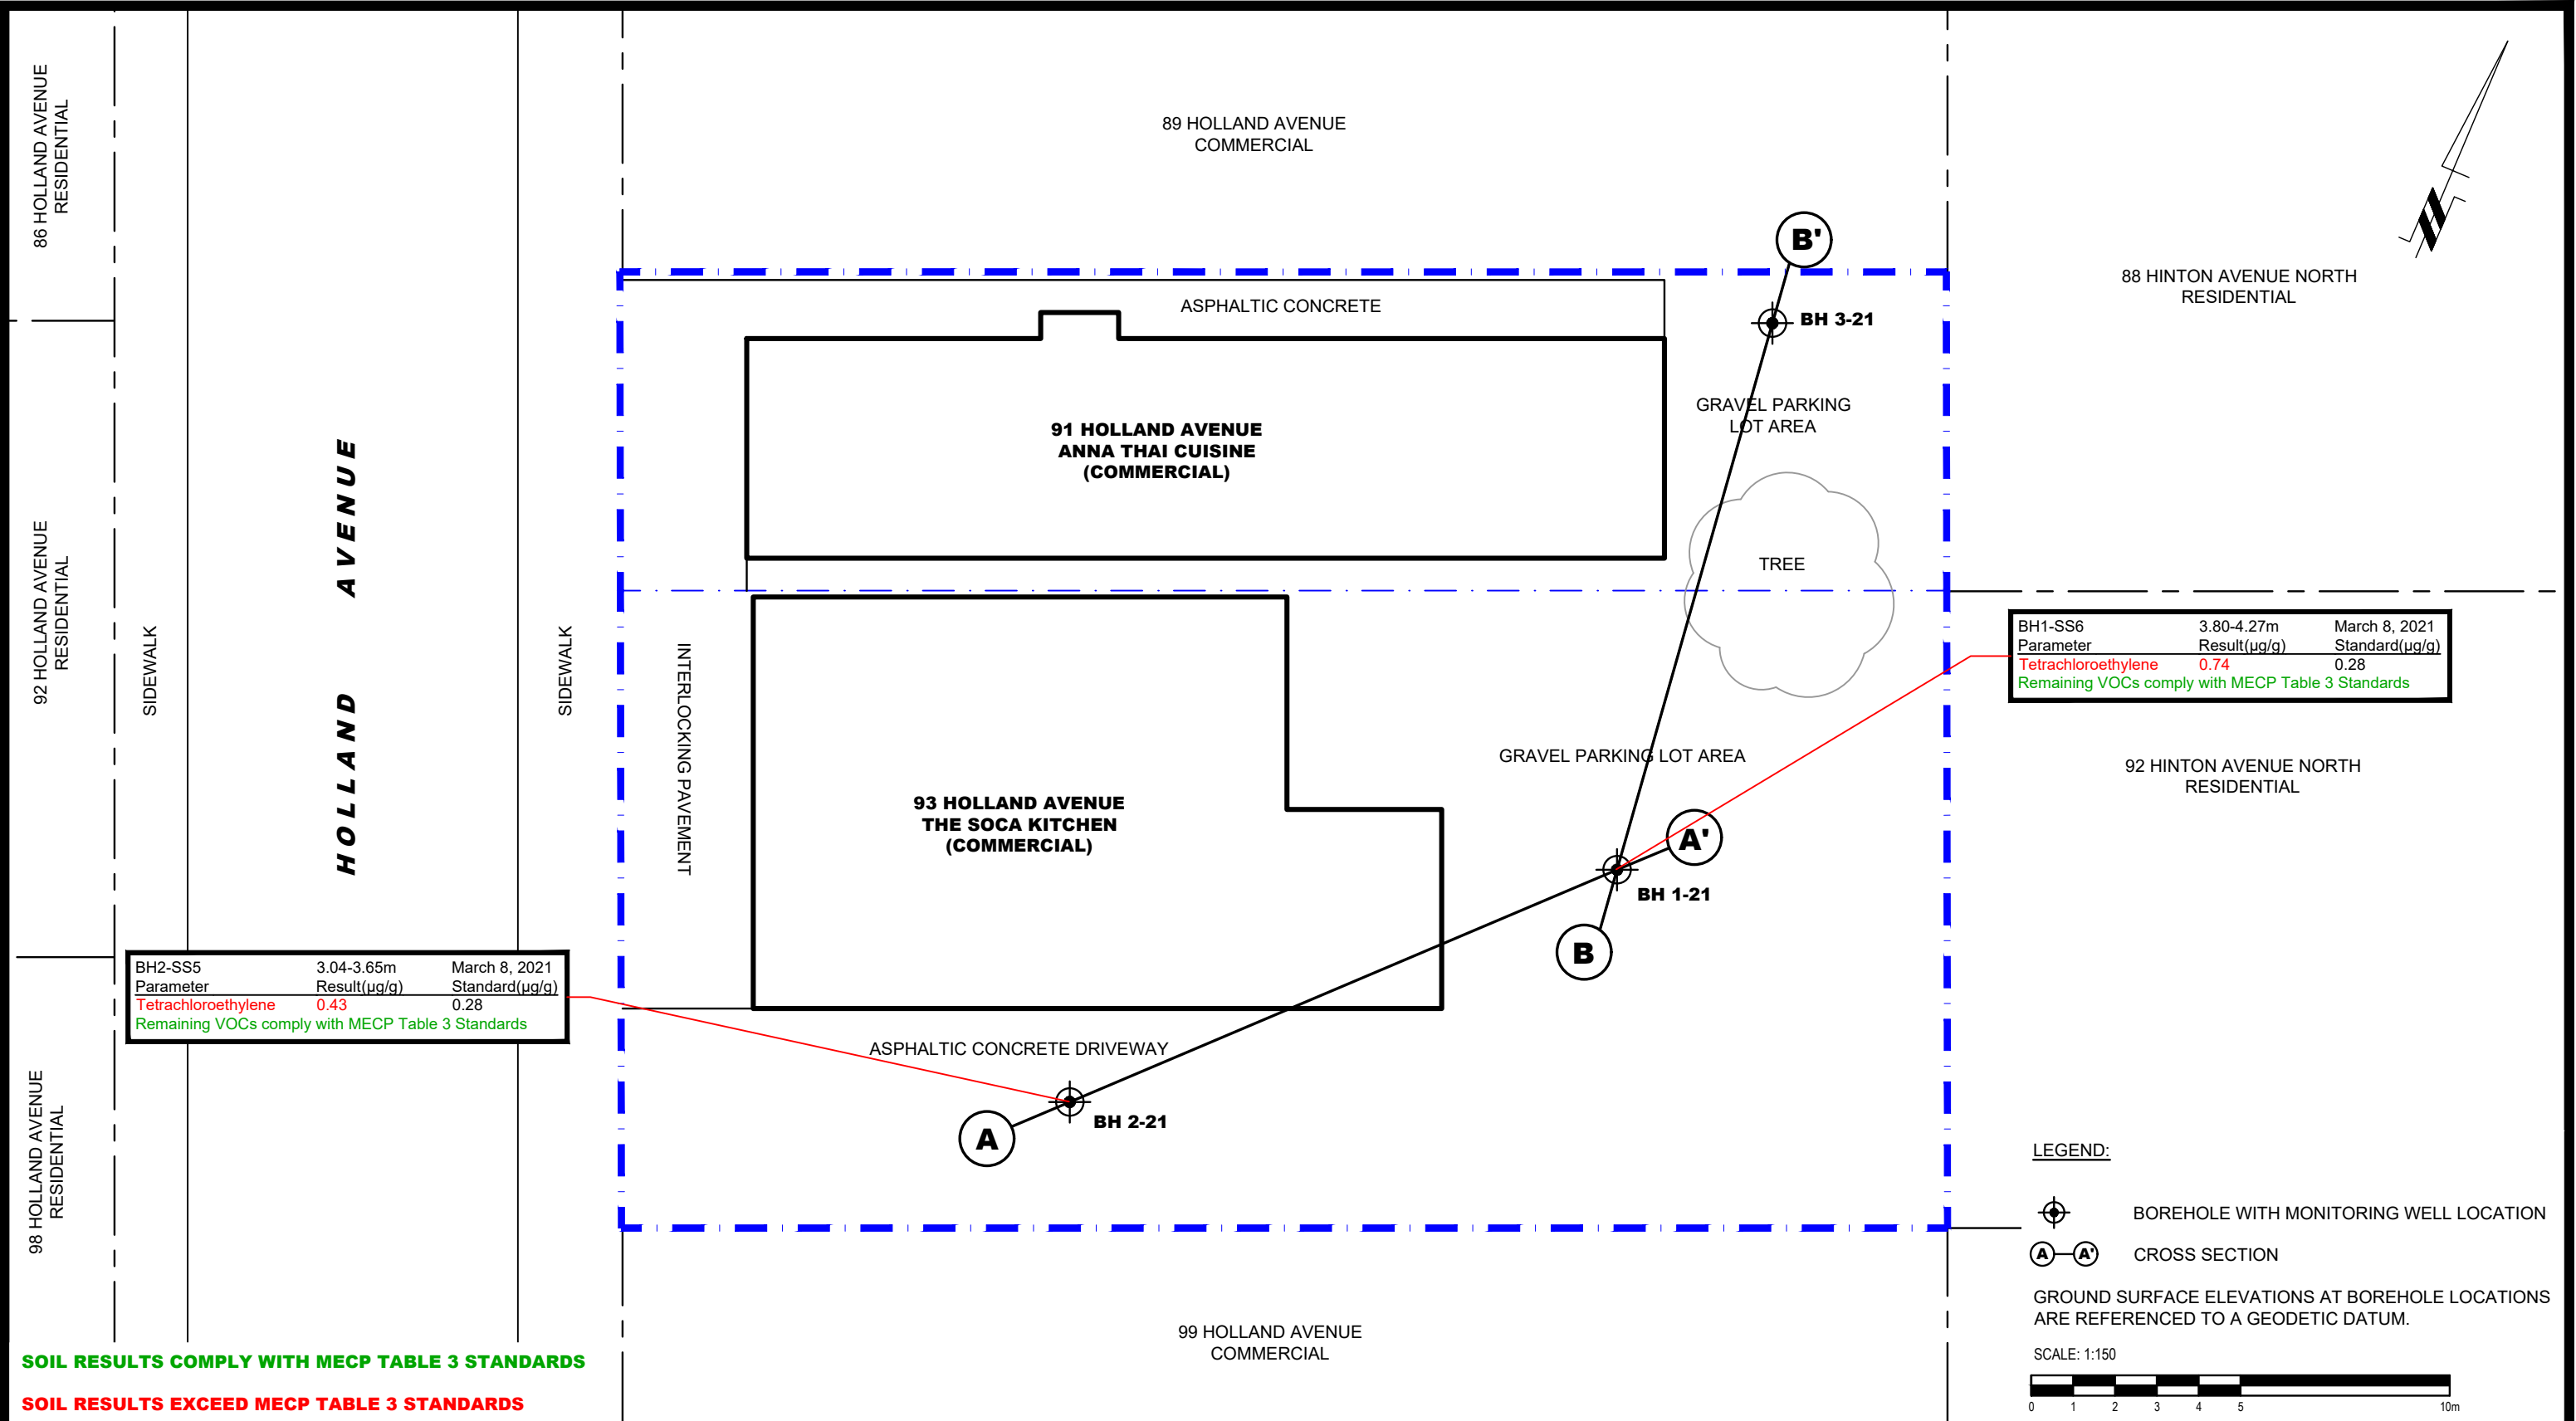
Scale:	1:150	Date:	04/2021
Drawn by:	JM	Report No.:	PE5171-2
Checked by:	MSP	Dwg No.:	PE5171-5
Approved by:	KM	Revision No.:

All VOC concentrations were found to comply with the selected MECP Table 3 Residential Standards with the exception of two parameters. Tetrachloroethylene concentrations in both samples from BH1 and BH2 exceeded the MECP Table 3 Residential Standards.

Parameter	Result (µg/g)	Standard (µg/g)
Tetrachloroethylene	0.74	0.28
Remaining VOCs comply with MECP Table 3 Standards

Parameter	Result (µg/g)	Standard (µg/g)
Tetrachloroethylene	0.43	0.28
Remaining VOCs comply with MECP Table 3 Standards

Based on the findings of the Phase II ESA it is recommended that a soil remediation be carried out to support the filing of an RSC. Given the depth of tetrachloroethylene-impacted soil, it is recommended that the soil remediation be carried out in conjunction with the construction excavation. A representative sample of impacted soil must be submitted for a leachate analysis in accordance with O.Reg. 347/558 prior to disposal at an approved landfill site.

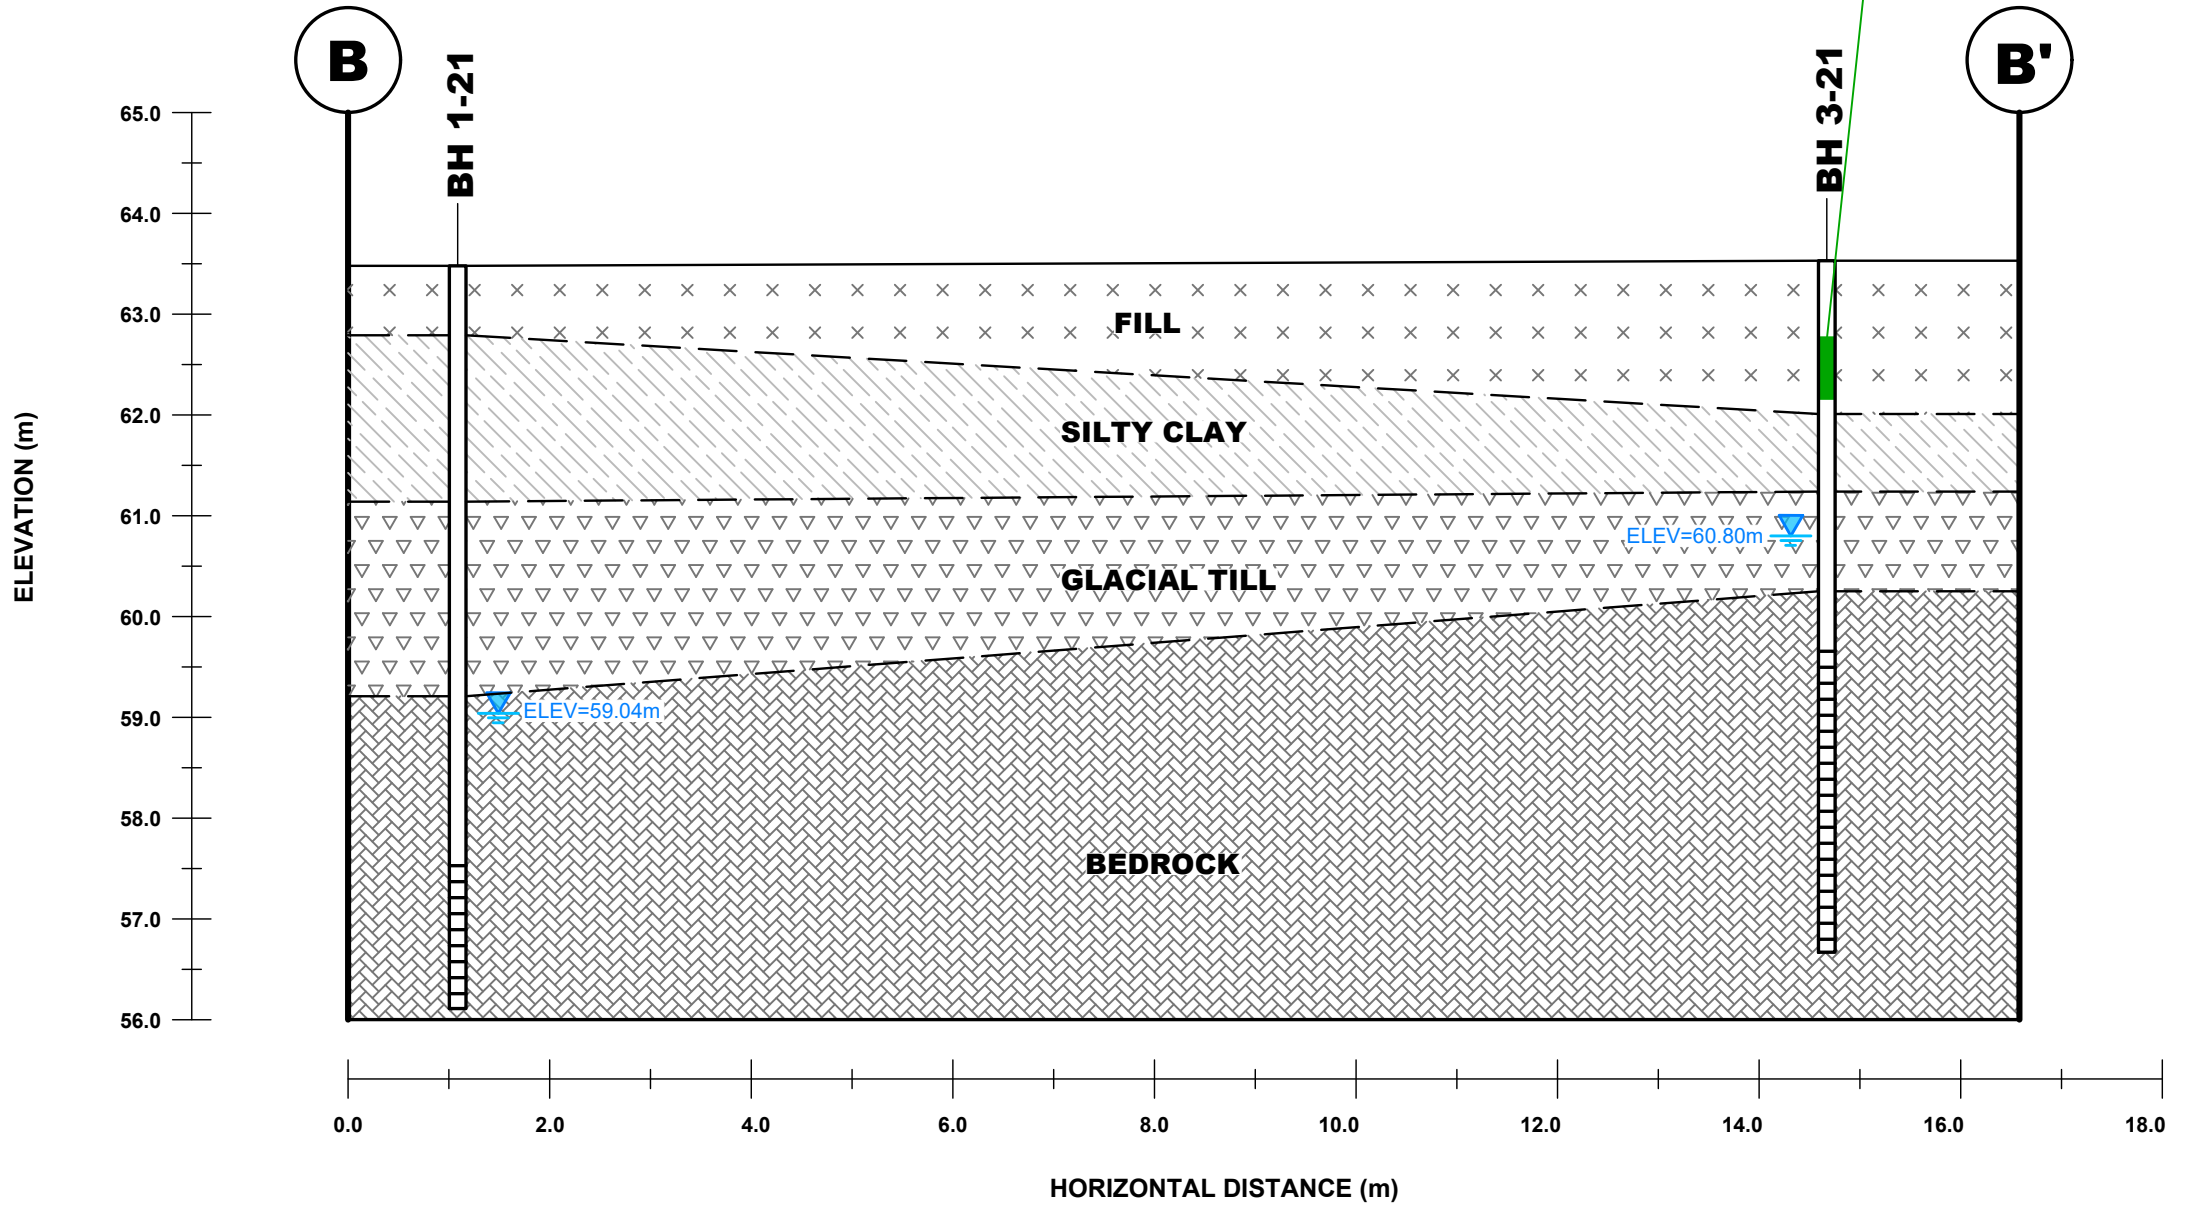
Scale:	AS SHOWN	Date:	04/2021
Drawn by:	YA	Report No.:	PE5171-2
Checked by:	MSP	Dwg No.:	PE5171-6B
Approved by:	KM	Revision No.:

NICHOLSON GLUCKSTEIN
 PHASE II - ENVIRONMENTAL SITE ASSESSMENT
 91 & 93 HOLLAND AVENUE
 OTTAWA, ONTARIO
 Title: **CROSS SECTION B-B' - SOIL (PAHs)**

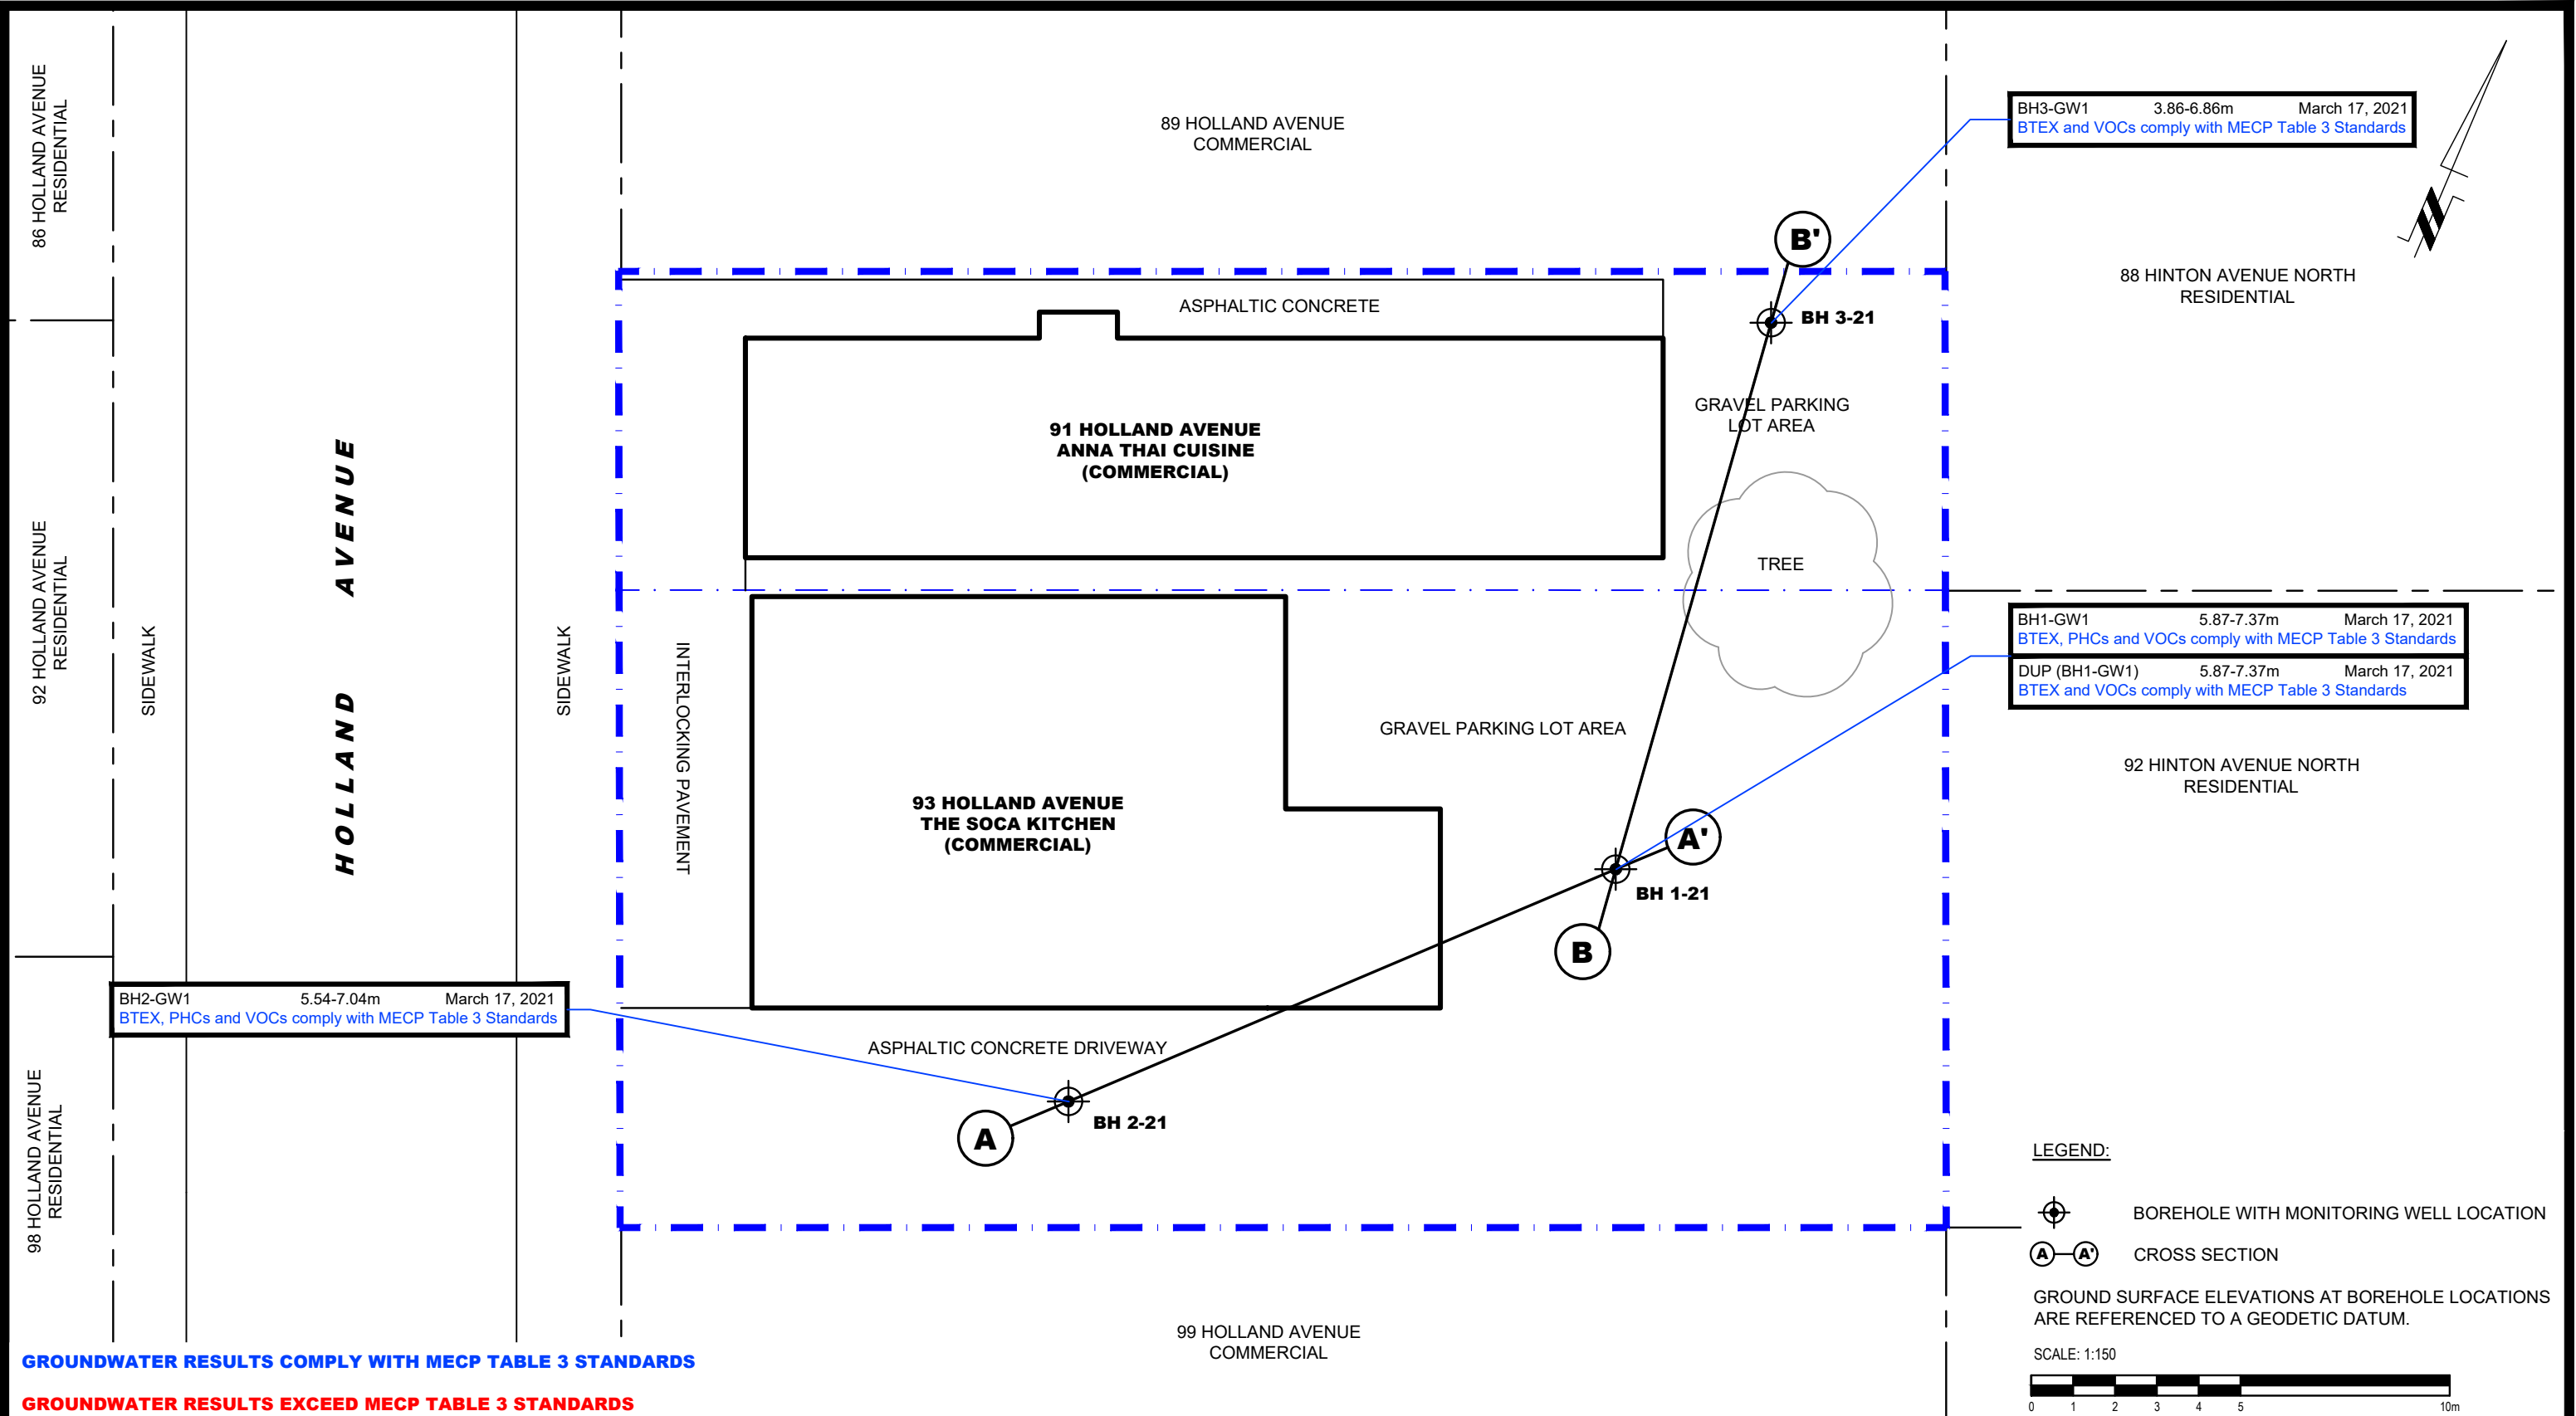
Scale:	1:150	Date:	04/2021
Drawn by:	JM	Report No.:	PE5171-2
Checked by:	MSP	Dwg No.:	PE5171-7
Approved by:	KM	Revision No.:

Groundwater samples from each of the boreholes were submitted for laboratory analysis of BTEX, PHC (F₁-F₄), and VOCs. The groundwater samples were obtained from the screened intervals noted in Table 2.

BH2-GW1 5.54-7.04m March 17, 2021
 BTEX, PHCs and VOCs comply with MECP Table 3 Standards

BH3-GW1 3.86-6.86m March 17, 2021
 BTEX and VOCs comply with MECP Table 3 Standards

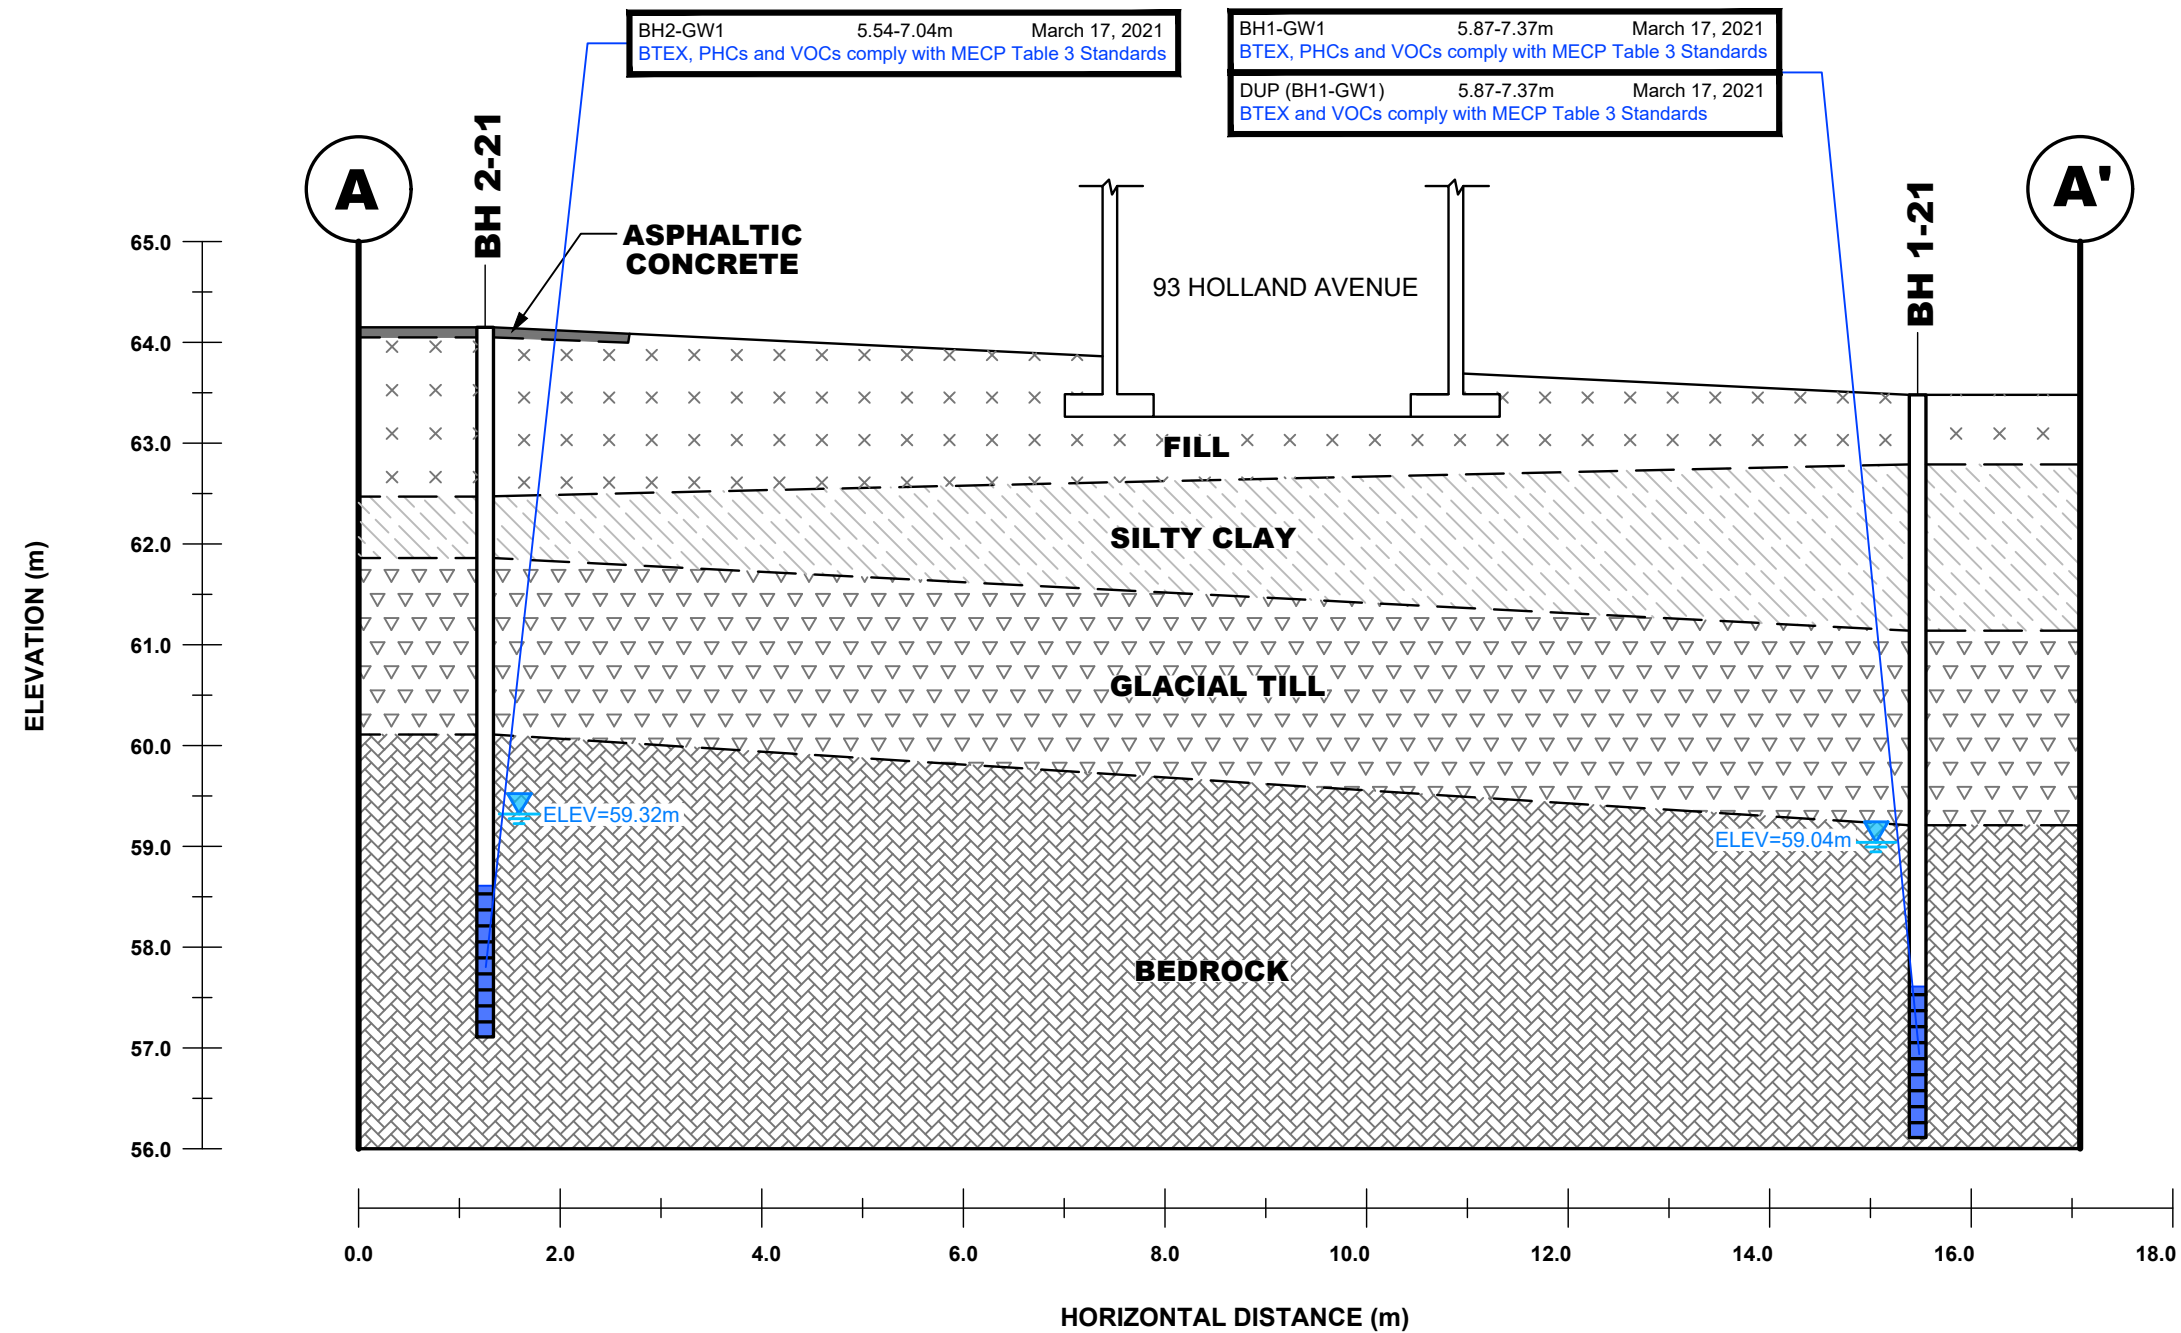
Scale:	AS SHOWN	Date:	04/2021
Drawn by:	YA	Report No.:	PE5171-2
Checked by:	MSP	Dwg No.:	PE5171-7A
Approved by:	KM	Revision No.:

GROUNDWATER RESULTS COMPLY WITH MECP TABLE 3 STANDARDS

GROUNDWATER RESULTS EXCEED MECP TABLE 3 STANDARDS

Title:
CROSS SECTION A-A' - GROUNDWATER (BTEX, PHCs, VOCs)
