## **Phase One Environmental Assessment**

*Proposed Development at Riverside Drive and Hunt Club Road, Ottawa Ontario*

**Golder Associates Ltd.**

December 2022

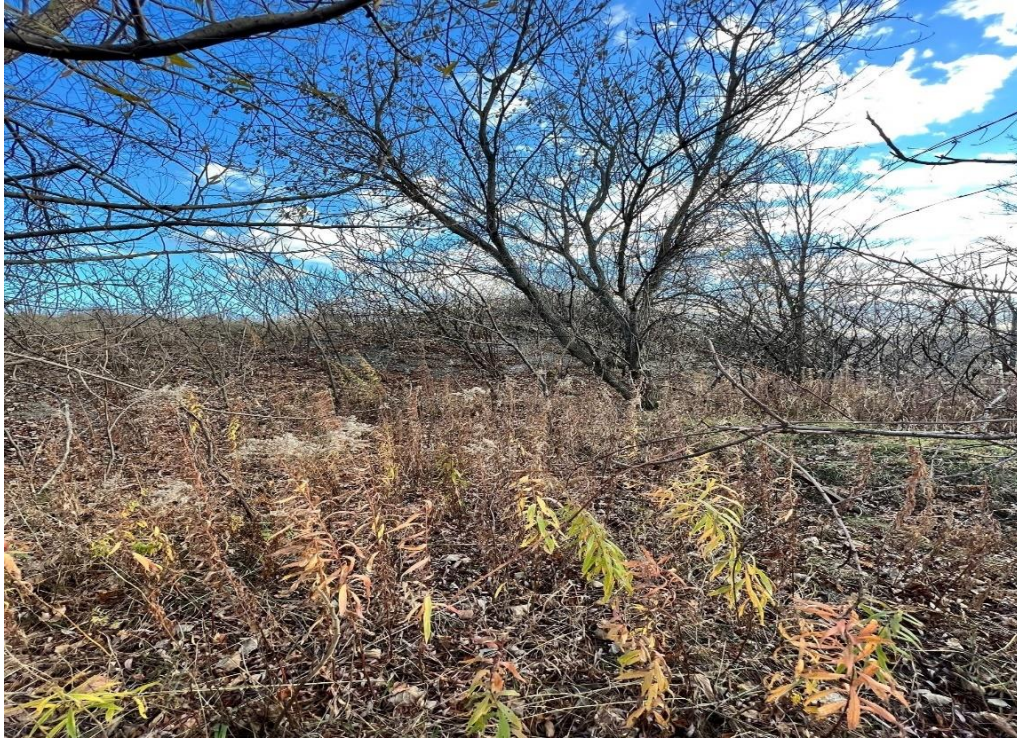
*Photo 1: Looking west at the Site from the central portion of the eastern Site boundary. A higher elevation hill is present, with lifeless foliage.*

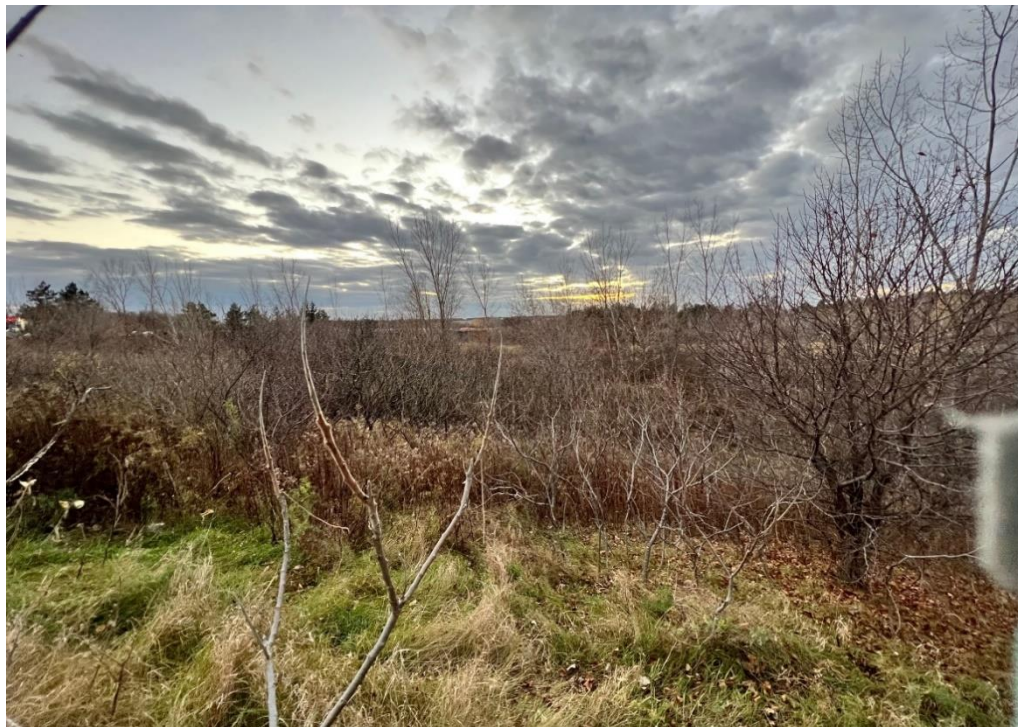
Photo 3: View of the eastern portion of the Site looking northwest.

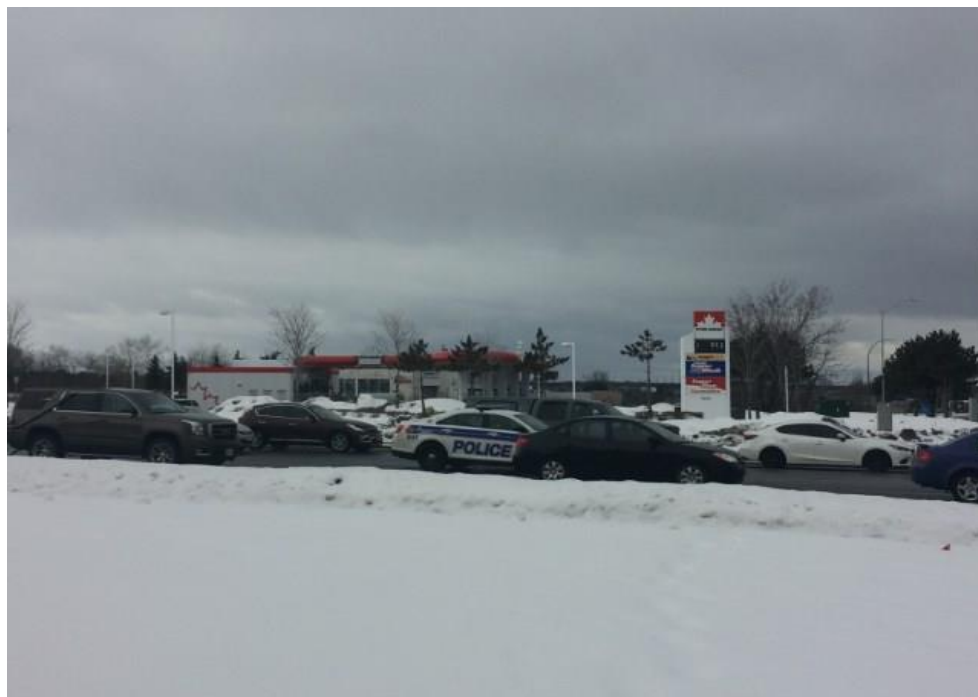
*Photo 8: Looking west at the retail fuel outlet located on the surrounding lands south of the Site at the southeast corner of Hunt Club Road and Riverside Drive.*

It was noted during the site visit that a retail fuel outlet was located on the surrounding lands south of the Site at 4000 Riverside Drive; approximately 70 m south of the Site. The presence of this retail fuel outlet is considered to be an off-Site PCA. As previously discussed, construction debris is present in the fill material located on the Site and fill material of unknown original and quality has been placed on the Site since the most recent Phase Two ESA investigation in 2001. As such, the current presence of this fill material on the Site is an on-Site PCA.
