Report

Trail Road Battery Energy Storage System (BESS)  
Fluvial Geomorphology Assessment

H375035-0000-2B0-066-0001

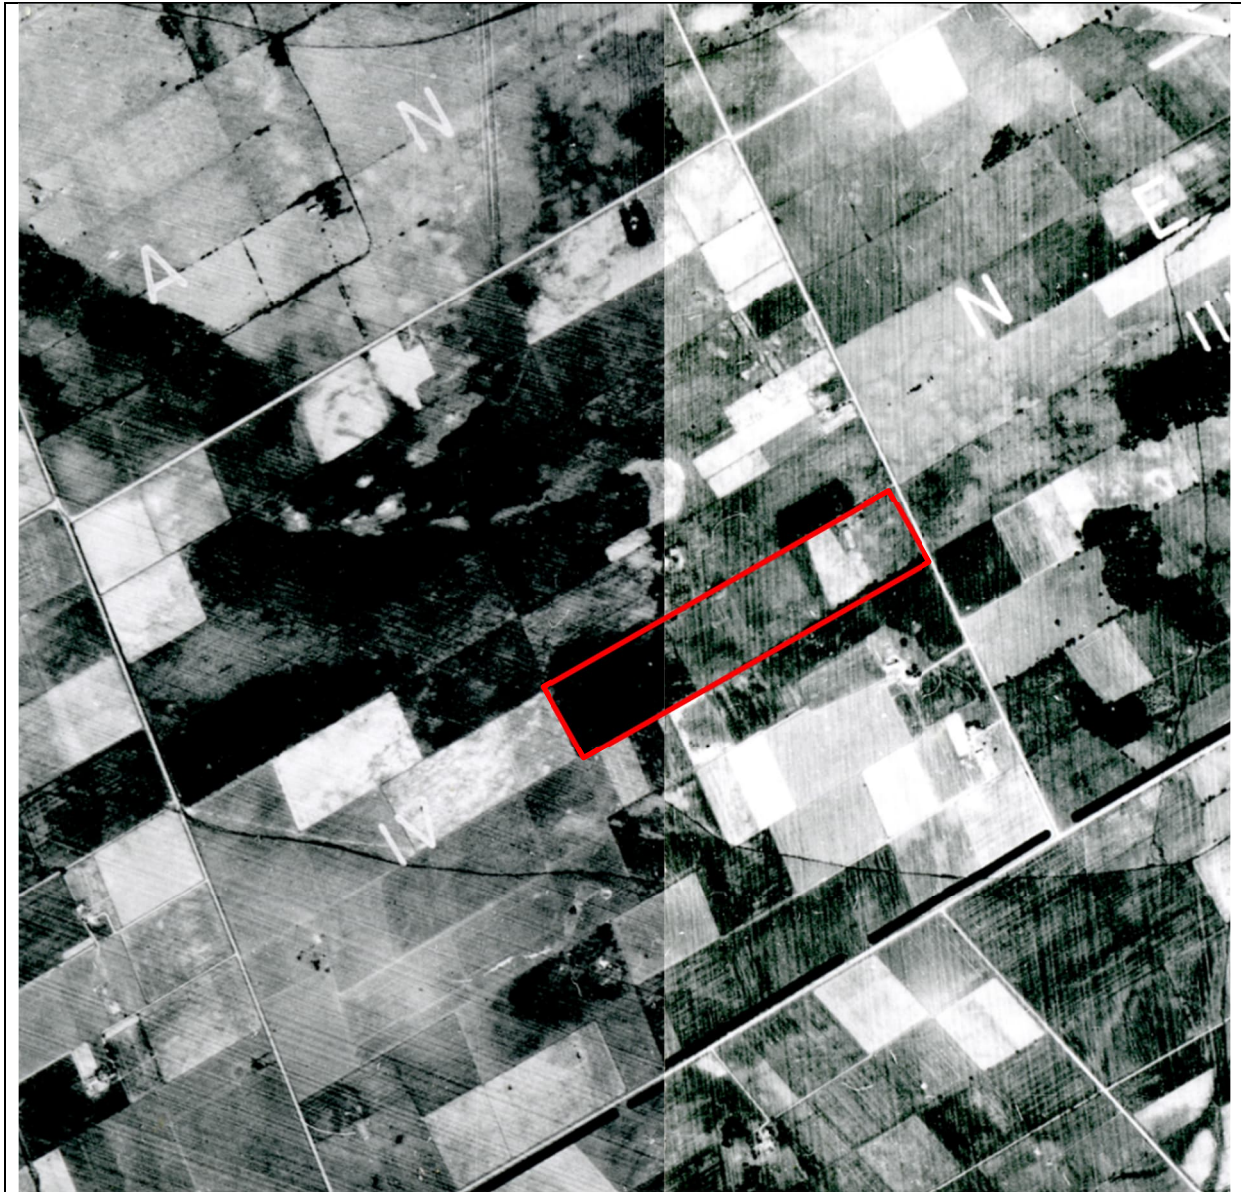
Between 2002 and 2004, the watercourse is present in good condition, with no observable changes compared to the 1954 aerial photography. The surrounding land use appears unchanged.

**Year:** 1954

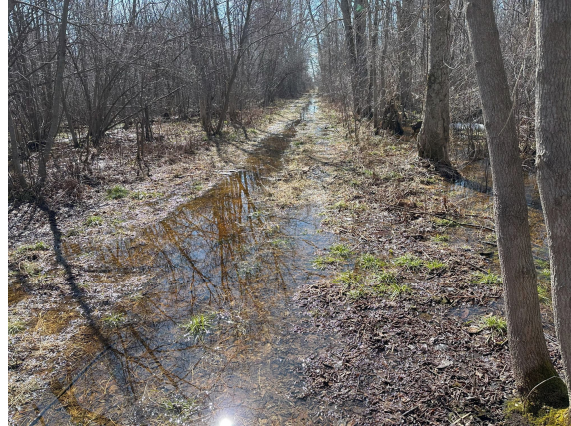
At the north boundary of the Project site, along the property line shared with the adjacent parcel, stagnant water was observed accumulating in a depressed corridor perpendicular to the main Creek alignment as shown in Photo 2 (Appendix B) from location S1. The presence of standing water outside the defined channel zone may also suggest the existence of secondary flow paths or backwater effects during wet periods, although no defined channel is visible in this area.

**Photo 2:** View looking northeast at the north site boundary (perpendicular to the creek), showing stagnant water on April 7, 2025.

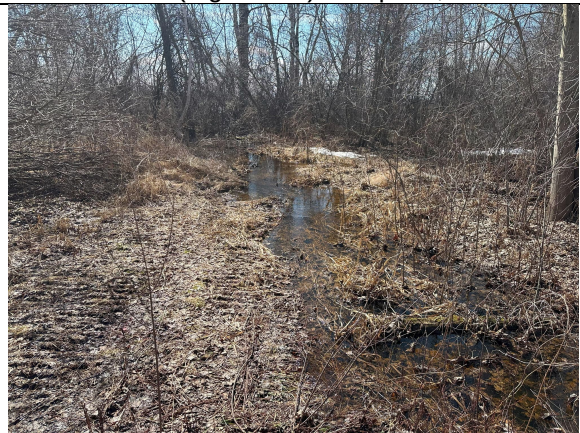
In several locations, including the area shown at location S8 (Photo 16 in Appendix B), evidence of localized channel adjustment and planform variability was observed. The Creek exhibits minor sinuosity, with lateral deflections of the low-flow channel that suggest active, albeit limited, fluvial processes. These deviations in flow alignment are likely the result of small-scale bank erosion and scour occurring along the outer margins of emerging meander features. While the degree of meandering is minimal due to the confined nature of the corridor and limited stream power, these features may represent the early development of a meander belt within the system.

**Photo 16:** View looking southeast (downstream) at location S8 (Figure 3-1) (minor sinuosity) on April 7, 2025.
