September 9, 2025  
File: PE6934-LET.02

Subject: **Phase I Environmental Site Assessment Update**  
**258 Durocher Street**  
**Ottawa, Ontario**

## Supplemental Phase II Environmental Site Assessment 258 Durocher Street, Ottawa, Ontario

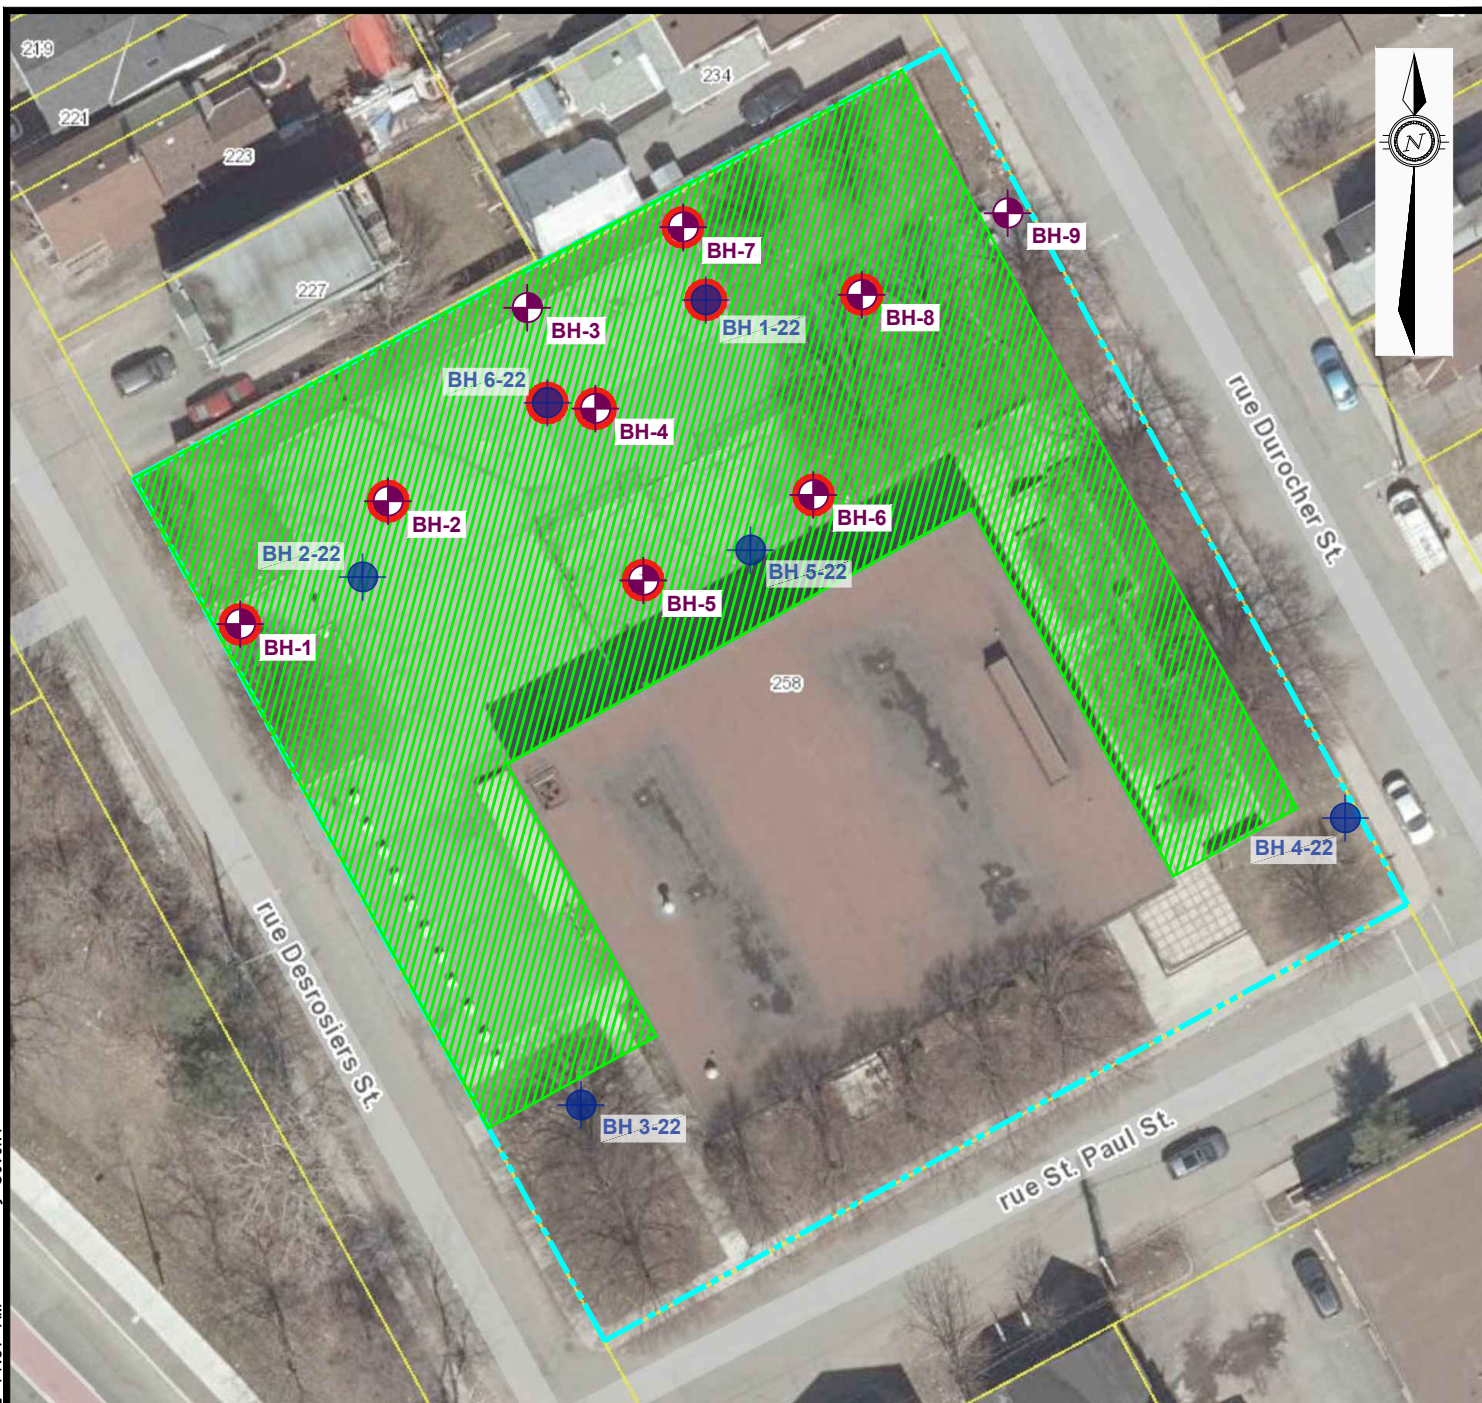
| | | | <b>FIG 2</b> |

On September 7, 2022, nine (9) boreholes (BH-1 to BH-9) were advanced at the Site by a licensed well contractor, under the full-time supervision of EXP staff. The boreholes were drilled to a maximum depth of 2.2 m bsg or refusal due to the presence of bedrock. The locations of the boreholes are presented on Figure 2 in Appendix A.

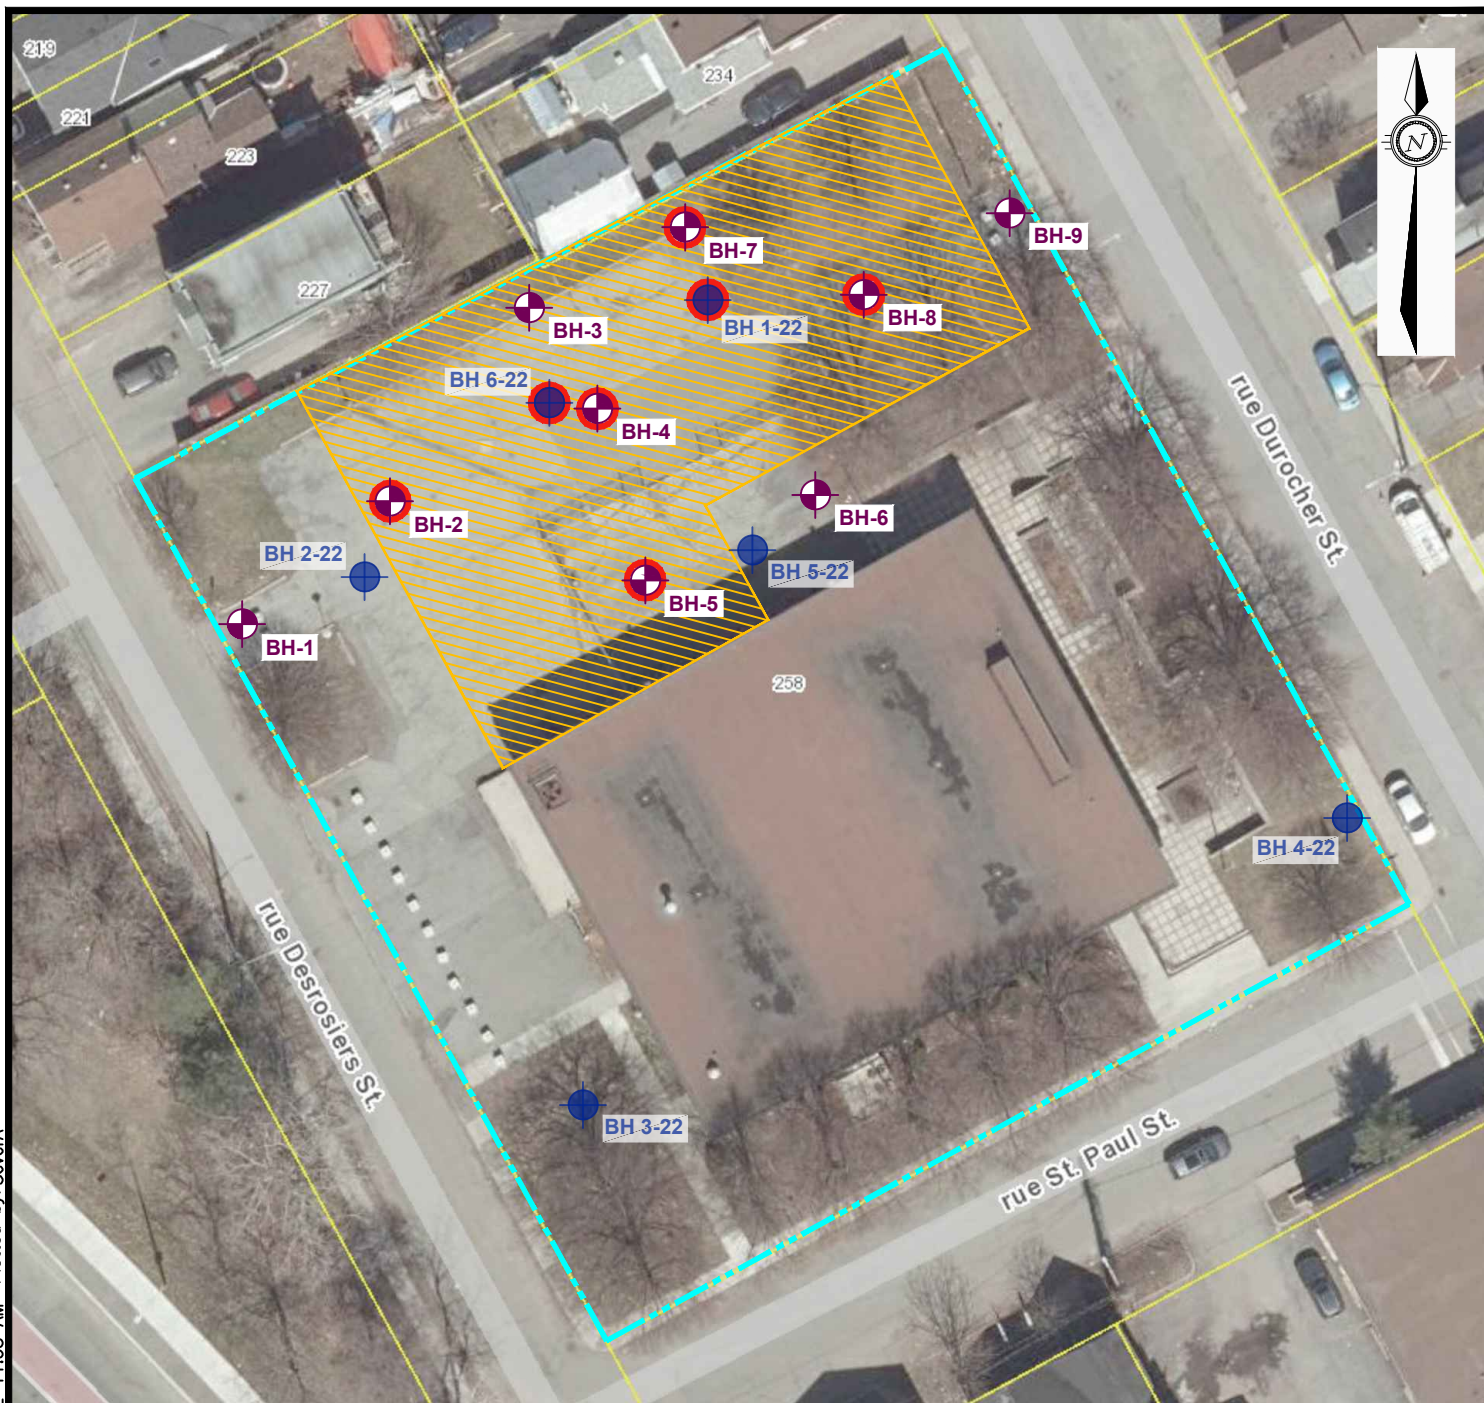
FIG 3

The area of Table 3 SCS impacted soil is shown on Figure 3. Using the clean hole approach, an estimated area of 2,245 m<sup>2</sup> and an estimated thickness of impact of 2 m, the resulting volume of MECP Table 3 impacted soil is approximately 4,490 m<sup>3</sup>.
