August 12, 2025

**Re: Phase One Environmental Site Assessment Update**  
2966 and 2978 Carp Road, Ottawa, Ontario  
Pinchin File: 361665

Pinchin Ltd. (Pinchin) is pleased to provide the findings of our Phase One Environmental Site Assessment (ESA) Update to York-Hop Corp. (Client) for the property described as 2966 and 2978 Carp Road, Ottawa, Ontario (Phase One Property or Site).

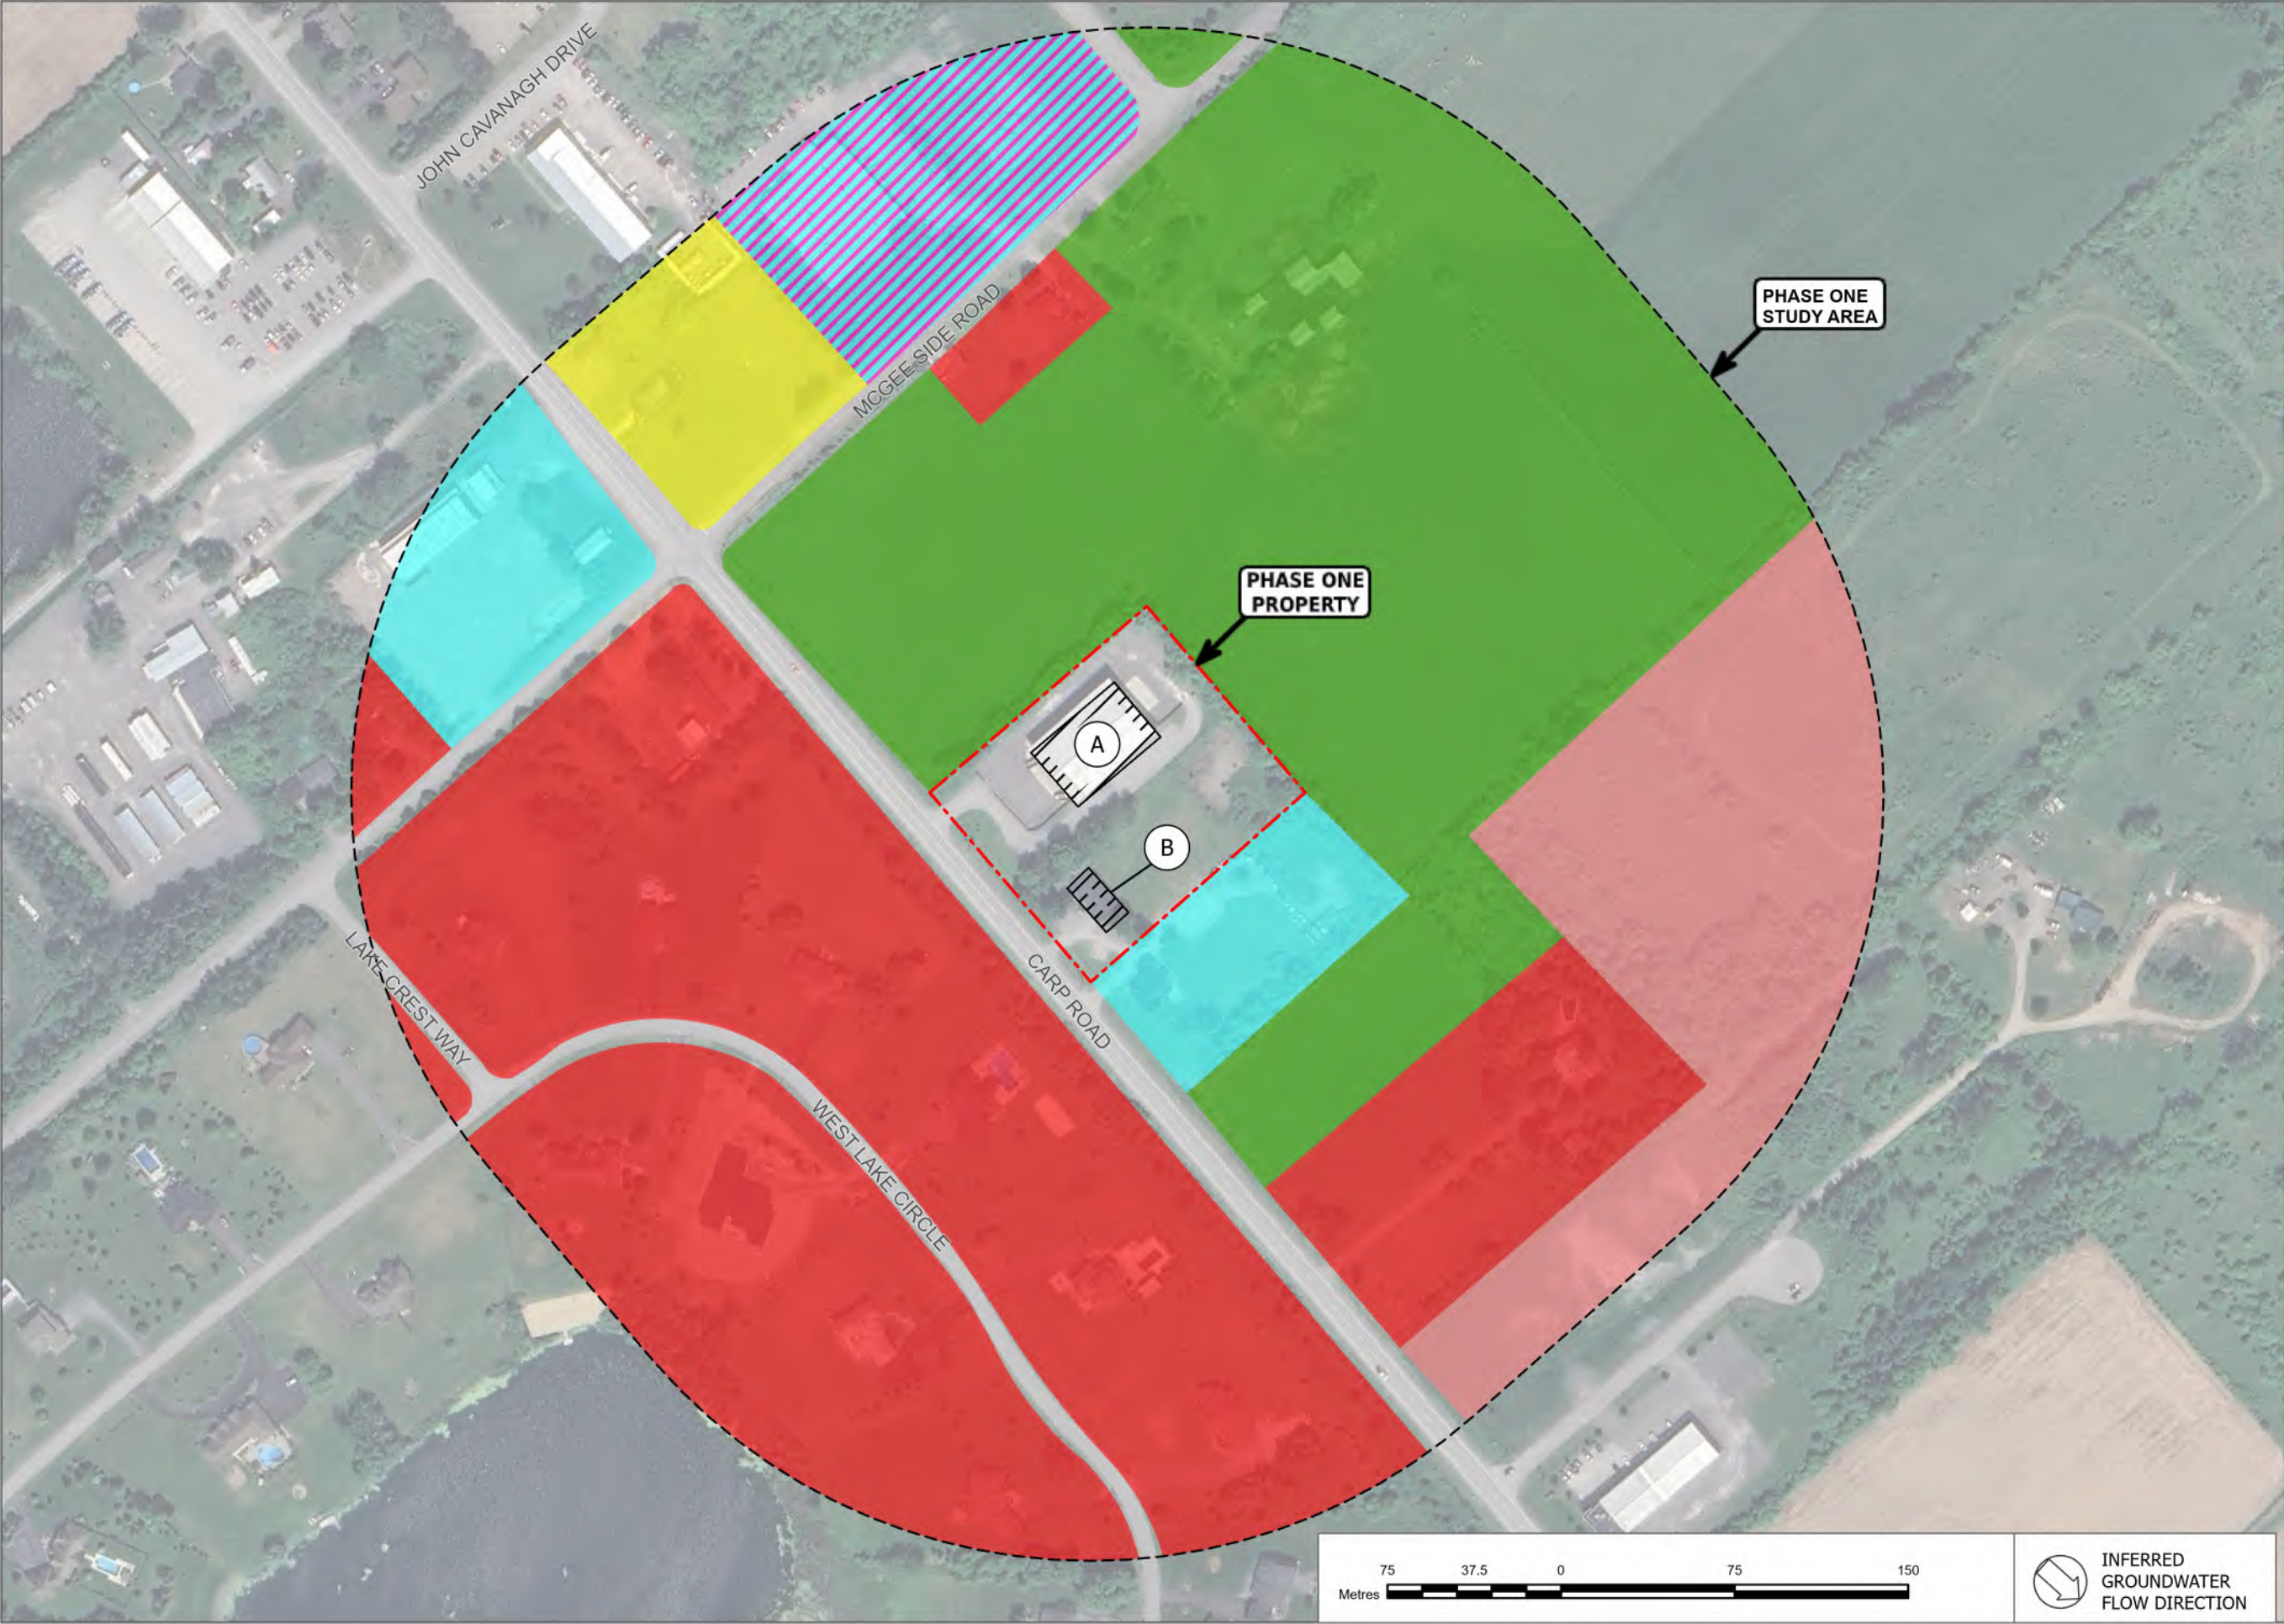
| DATE<br><b>AUGUST 2025</b> | FIGURE NUMBER<br><b>2</b> |

**PHASE ONE STUDY AREA**

INFERRED  
GROUNDWATER  
FLOW DIRECTION

This Phase One ESA Update has been prepared by Pinchin for Client as an update to a Phase One ESA dated March 1, 2022 completed for the 2966 and 2978 Carp Road, Ottawa, Ontario. The Phase One Property and Phase One Study Area are shown on Figures 2 and 3 (all figures are provided in Appendix I).

A conceptual site model (CSM) was created to provide a summary of the findings of the Update Phase One ESA. The Phase One CSM is summarized in Figures 1 through 3, which illustrate the following features within the Phase One Study Area, where present:

- Existing buildings and structures;
- Water bodies located in whole or in part within the Phase One Study Area;
- Areas of natural significance located in whole or in part within the Phase One Study Area;
- Drinking water wells located at the Phase One Property;
- Land use of adjacent properties;
- Roads within the Phase One Study Area; and
- PCAs within the Phase One Study Area, including the locations of tanks.

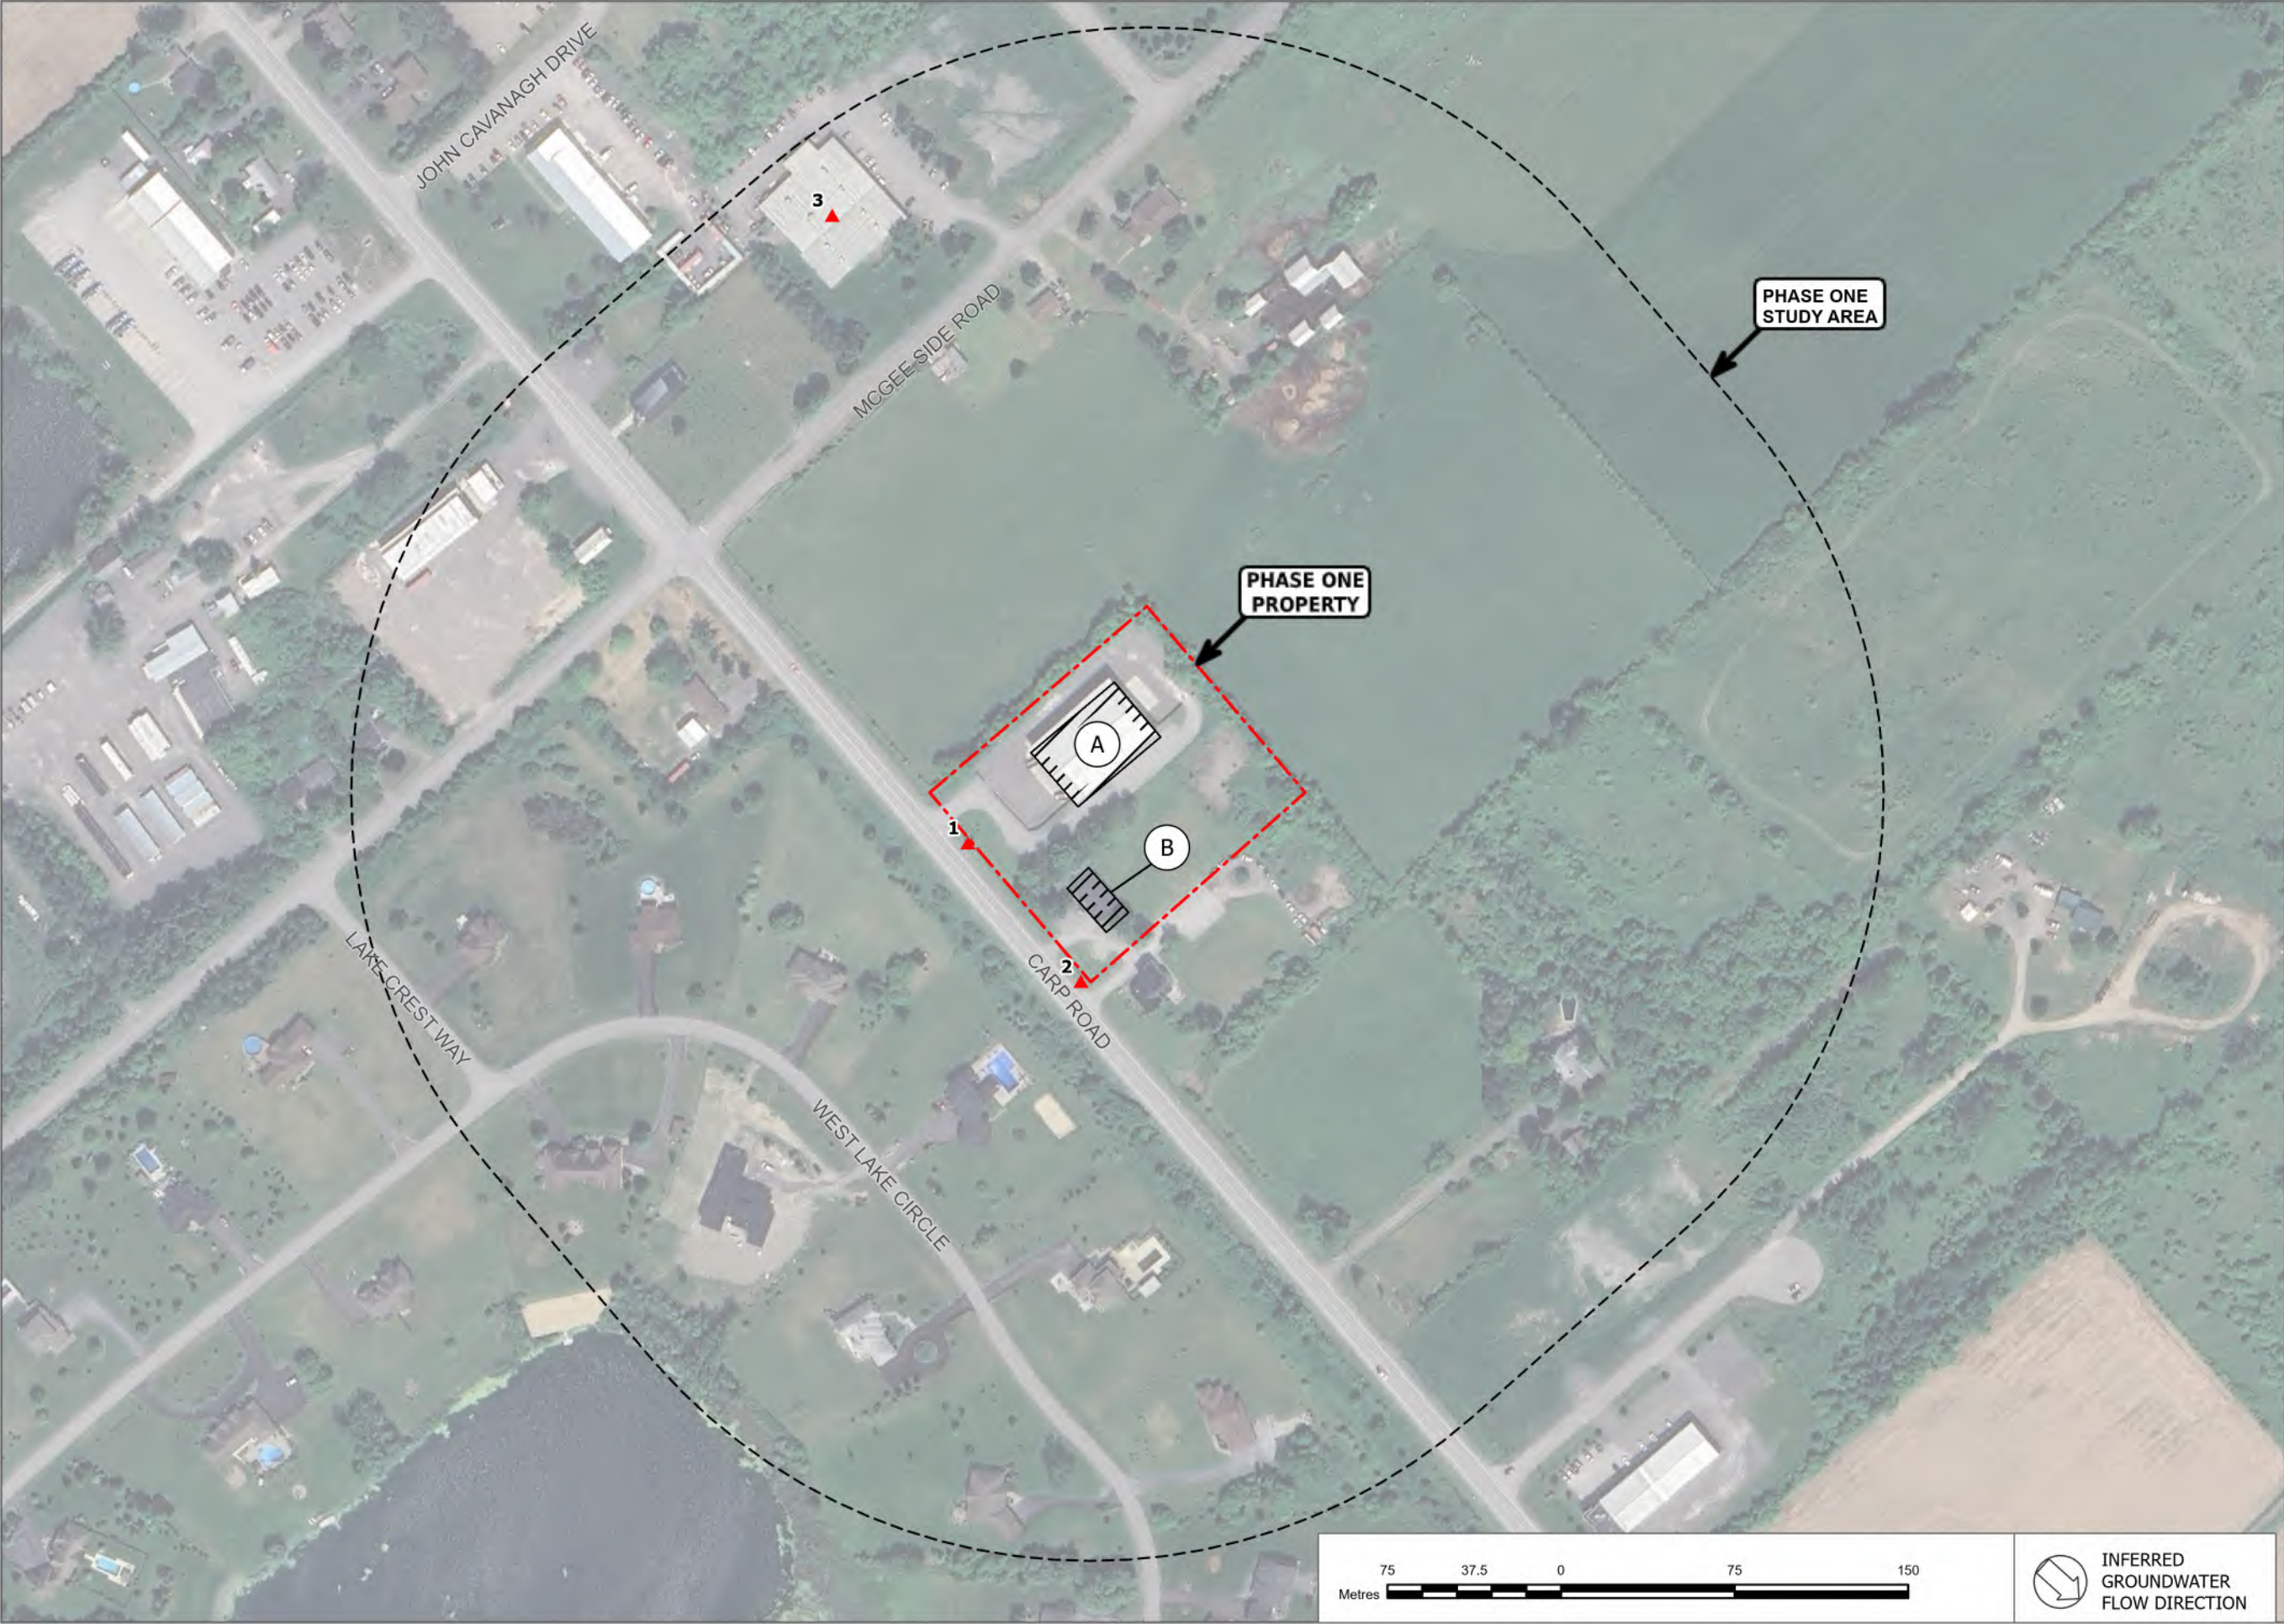
| DATE<br><b>AUGUST 2025</b> | FIGURE NUMBER<br><b>3</b> |

POTENTIALLY CONTAMINATING ACTIVITIES
-

**PHASE ONE STUDY AREA**

**INFERRED  
GROUNDWATER  
FLOW DIRECTION**

Pinchin formerly completed a Site inspection and a review of surrounding properties within the Phase One Study Area from publicly accessible locations on February 17, 2022 as part of the original Phase One ESA. The initial Site reconnaissance was completed by Pinchin personnel, under the supervision of Pinchin's Qualified Person (QP) overseeing this project. The Phase One Study Area is outlined on Figure 3.

- PCA #1 (Item 55: Transformer Manufacturing, Processing and Use – Three pole-mounted oil-cooled transformers are located adjacent to the northwest corner of the Phase One Property). However, no evidence of spills or historical spills (i.e., staining) was observed in the vicinity of these transformers and no issues of potential environmental concern (i.e., spills) were noted for these transformers within the Environmental Risk Information Service Ltd. (ERIS) report. In addition, any maintenance/environmental issues associated with the transformers would be the responsibility of Hydro Ottawa. As such, it is Pinchin's opinion that this PCA does not represent an APEC at the Phase One Property;

- PCA #2 (Item 55: Transformer Manufacturing, Processing and Use – One pole-mounted oil-cooled transformer is located adjacent to the southwest corner of the Phase One Property). However, no evidence of spills or historical spills (i.e., staining) was observed in the vicinity of these transformer and no issues of potential environmental concern (i.e., spills) were noted for this transformer within the ERIS report. In addition, any maintenance/environmental issues associated with the transformer would be the responsibility of Hydro Ottawa. As such, it is Pinchin's opinion that this PCA does not represent an APEC at the Phase One Property; and

- PCA #3 (Item 32: Iron and Steel Manufacturing and Processing – a commercial/light industrial operation, which generated approximately 141,986 kilograms (kg) of various hazardous wastes from 1997 to 2020, is located approximately 150 metres (m) northwest of the Phase One Property). Based on the distance between this property and the Phase One Property, it is Pinchin's opinion that this PCA does not represent an APEC at the Phase One Property.

- The Phase One Property is relatively flat with little relief. The area surrounding the Phase One Property slopes gradually towards the southeast. Local groundwater flow is inferred to be to the southeast, based on the topography of the area surrounding the Phase One Property and the location of the Carp River.
