Hydrogeological Study Report

2095 Dilworth Road

Kars, Ontario

Englobe Ref No: 02101208.000

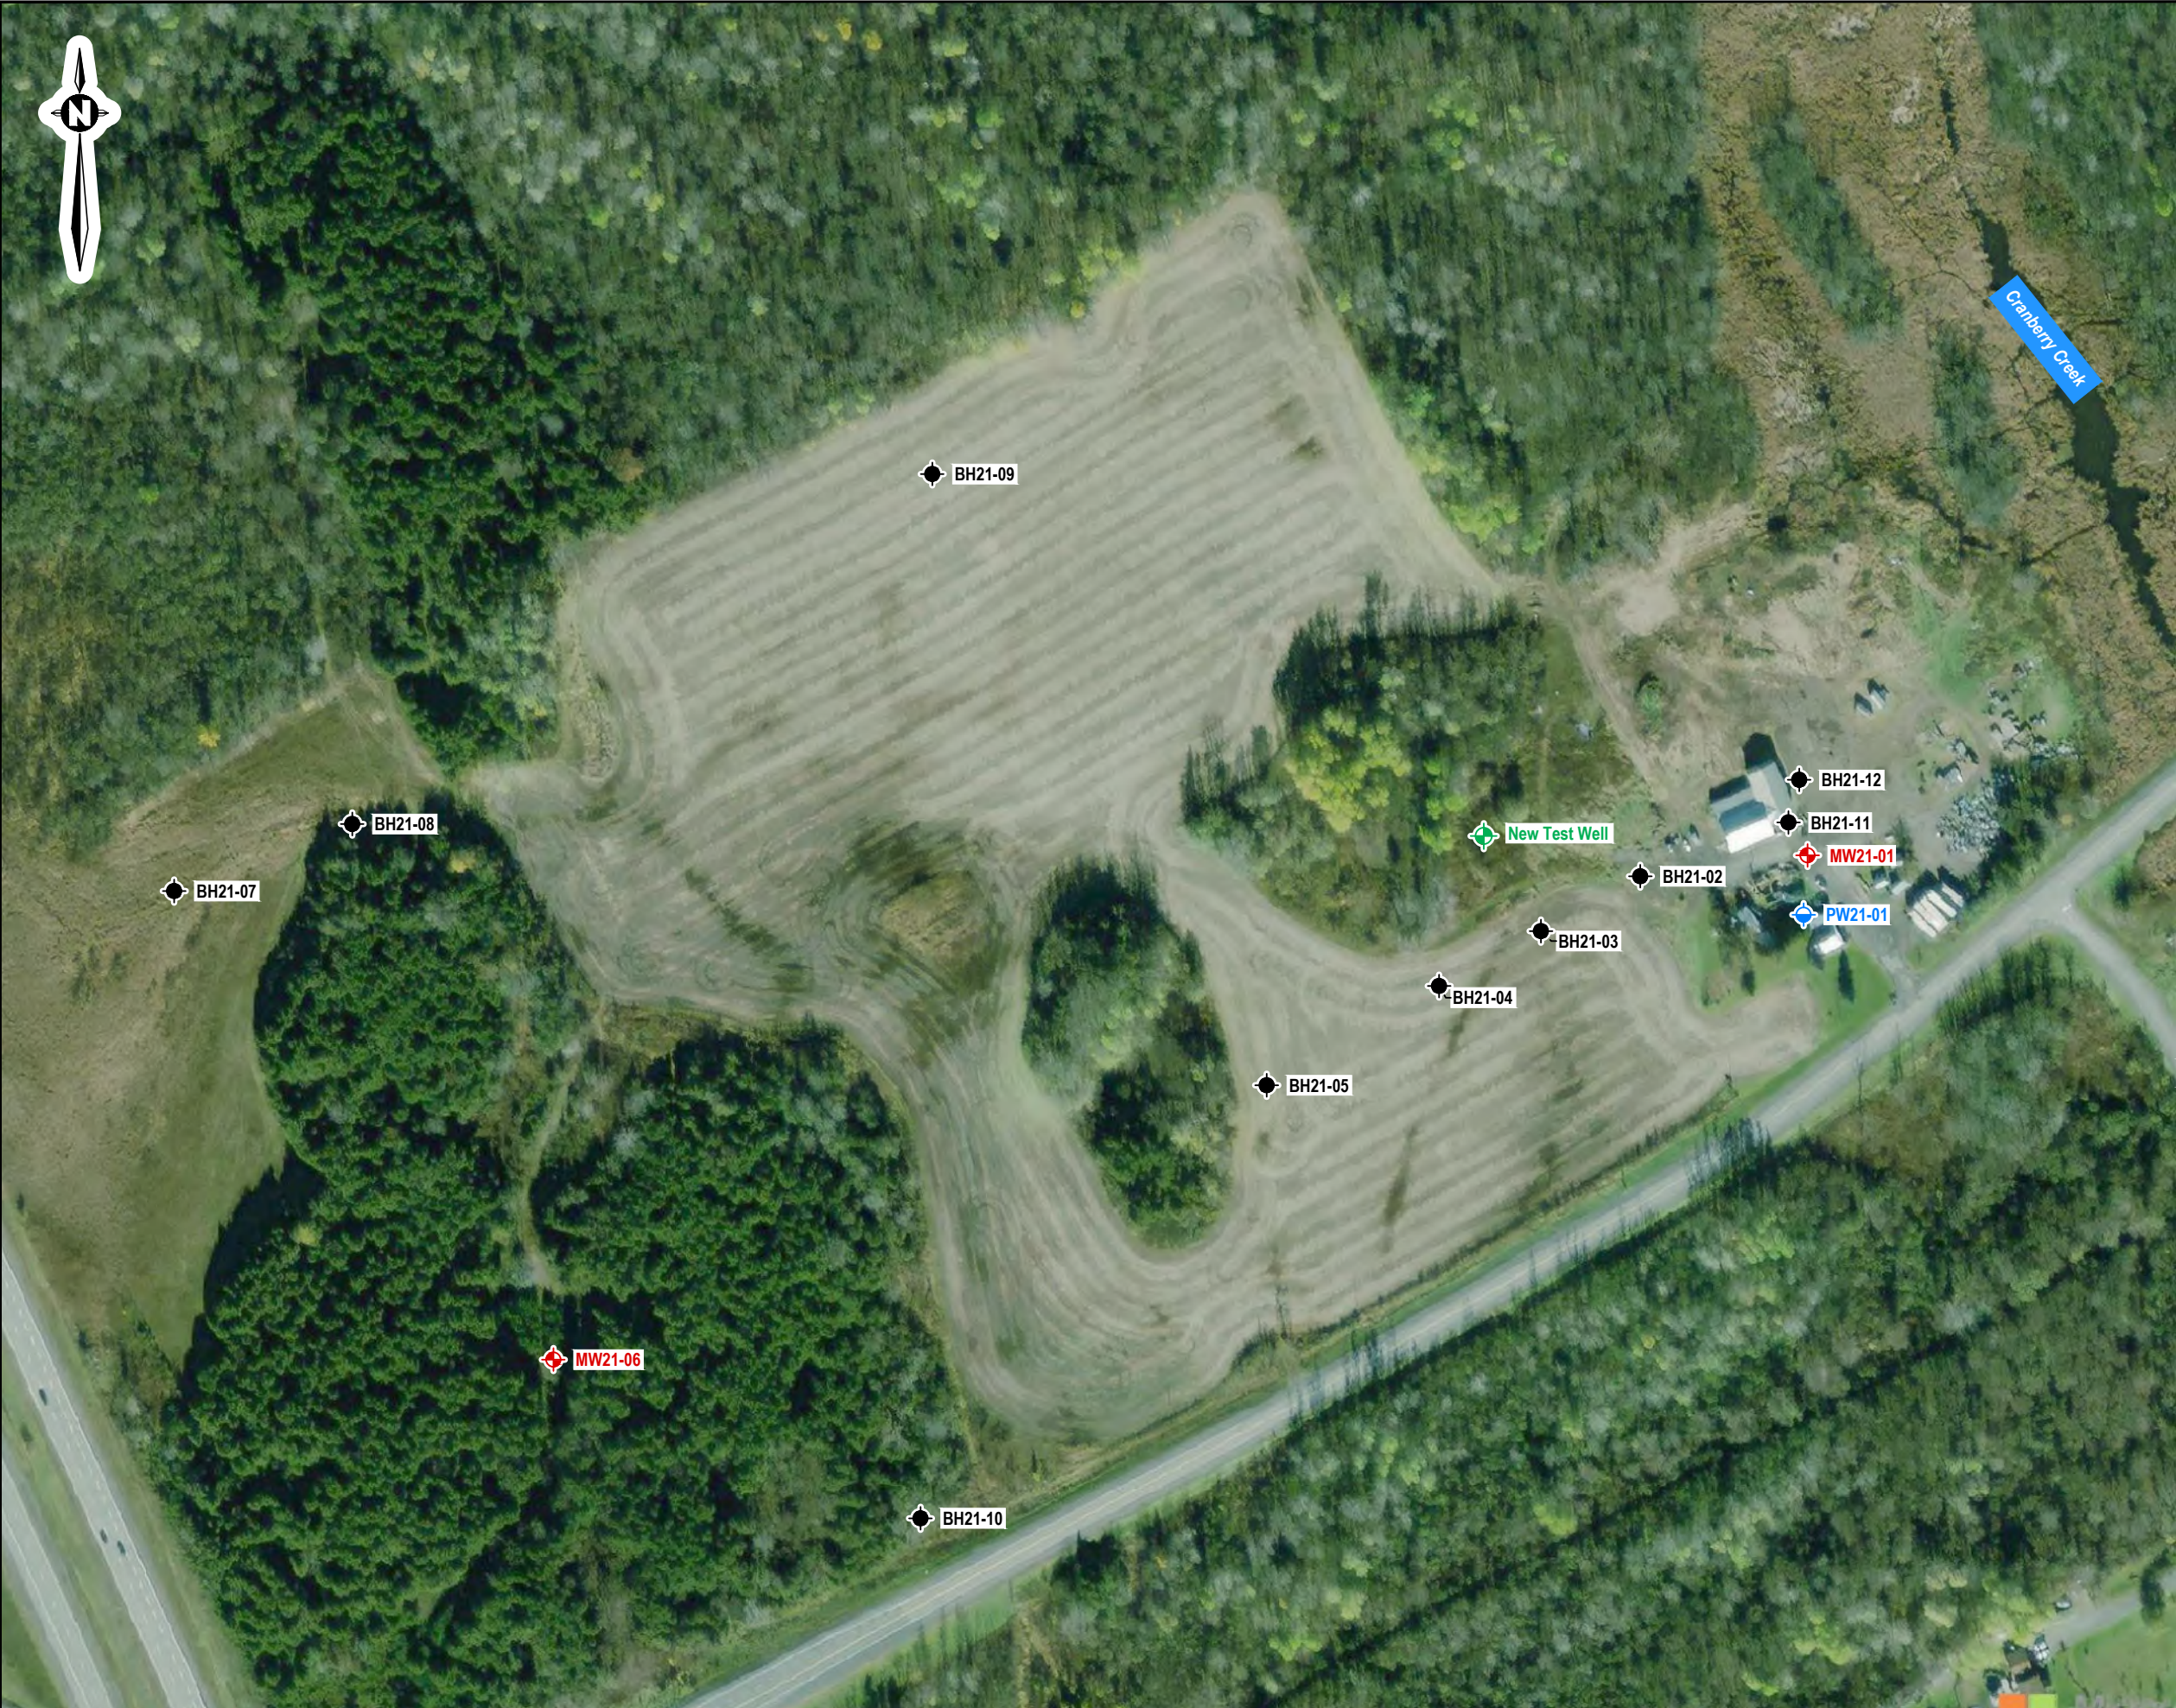
- Legend**
- Approximate location of borehole
 - Approximate location of monitoring well
 - New test well installed in 2024
 - Existing water well
