# **Phase I – Environmental Site Assessment**

4816 Bank Street  
Ottawa, Ontario

Prepared for DCR Phoenix Development Corporation Ltd.

Report: PE6552-1  
July 25, 2024

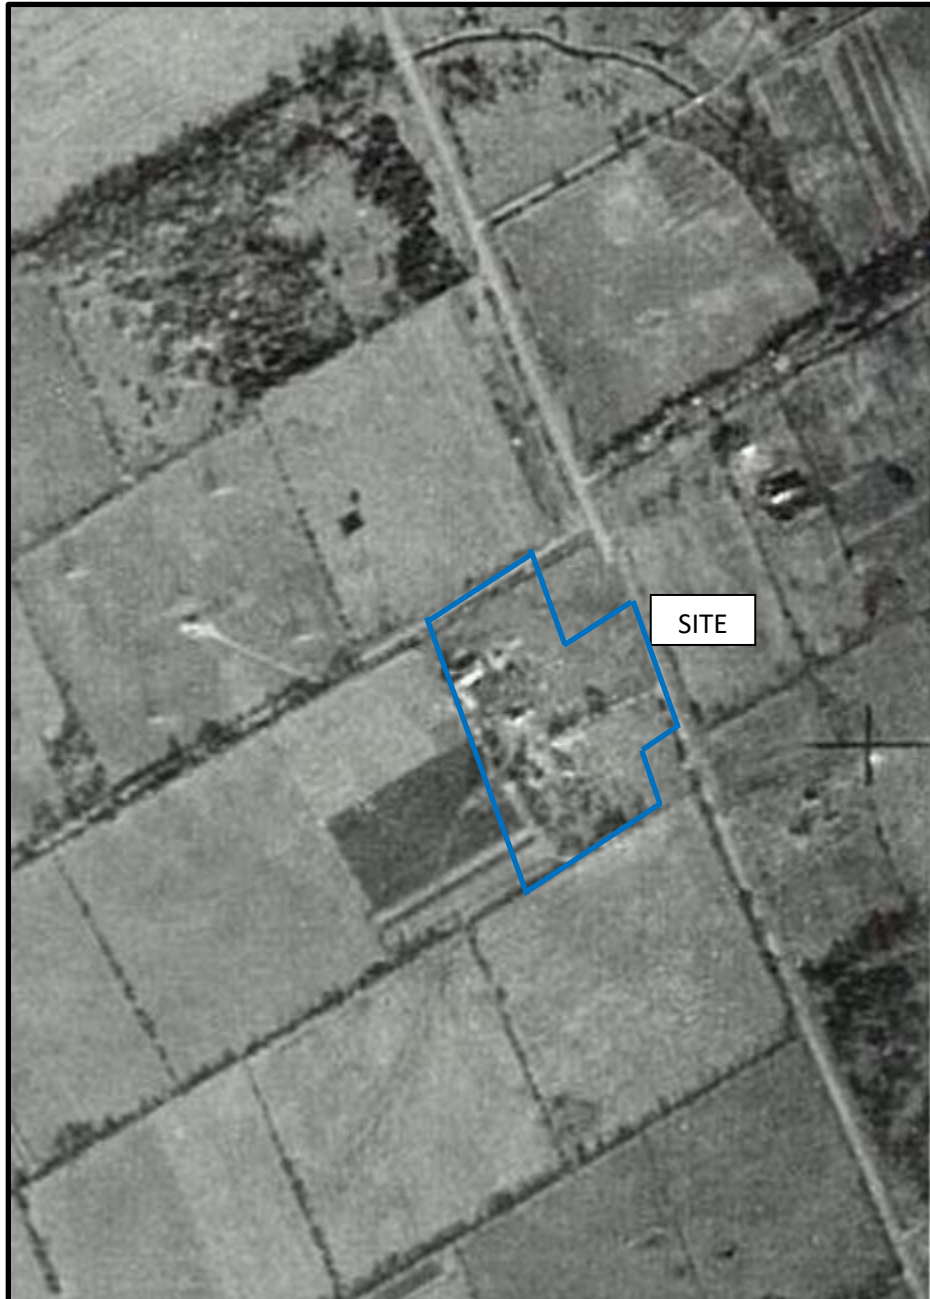
AERIAL PHOTOGRAPH  
1945

1945 (Poor Quality, National Air Photo Library) A farmstead consisting of multiple structures is observed on the Phase I Property. The surrounding properties are largely vacant or used for agricultural purposes. Structures can be seen to the northwest and northeast of the Phase I Property. A portion of Bank Street is observed east of the Phase I Property.

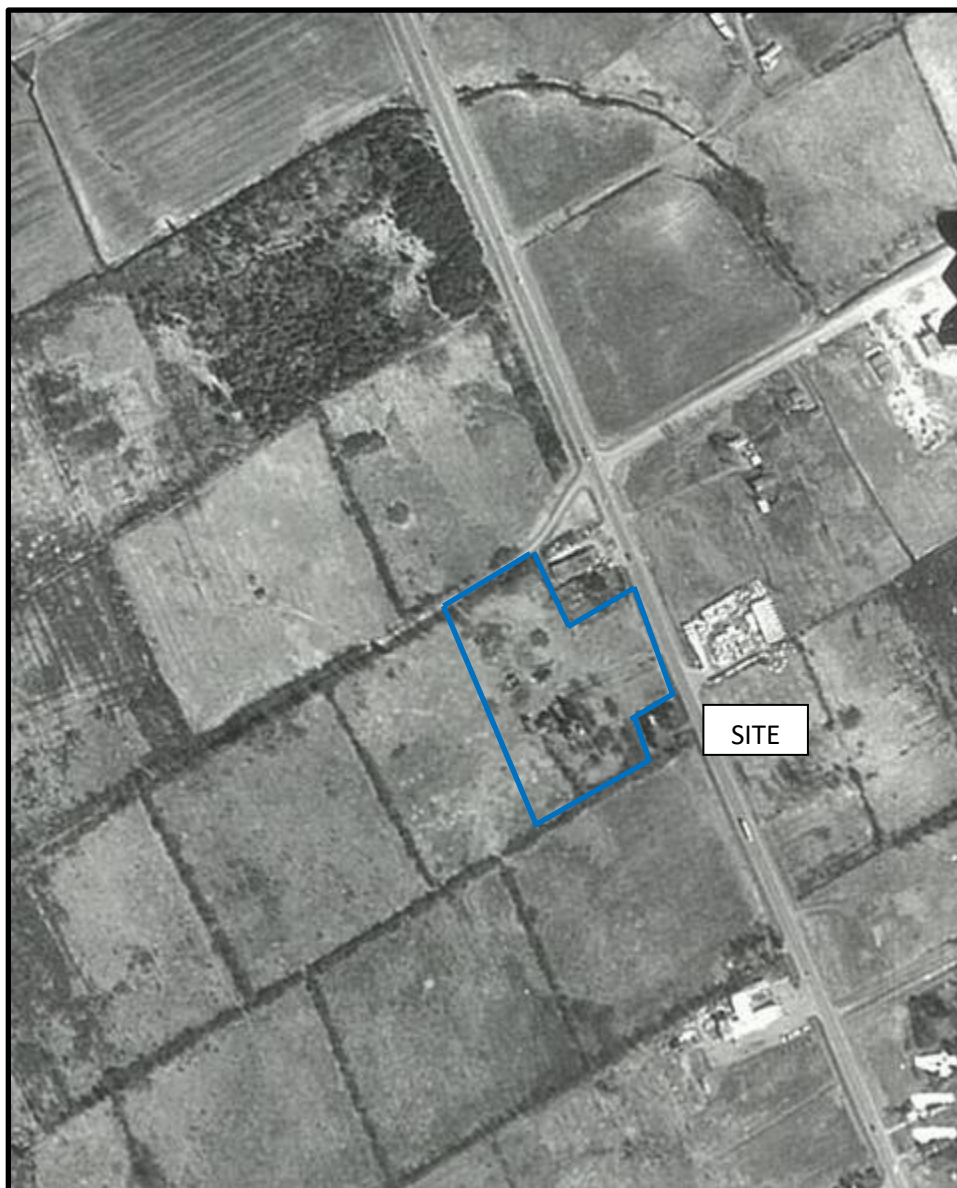
AERIAL PHOTOGRAPH  
1985

- 1985 (National Air Photo Library) The northern most building on the Phase I Property has been removed since the previous photo. The structures at 4815 Bank Street have been replaced with permanent structures. No other significant changes are apparent with respect to the surrounding lands.

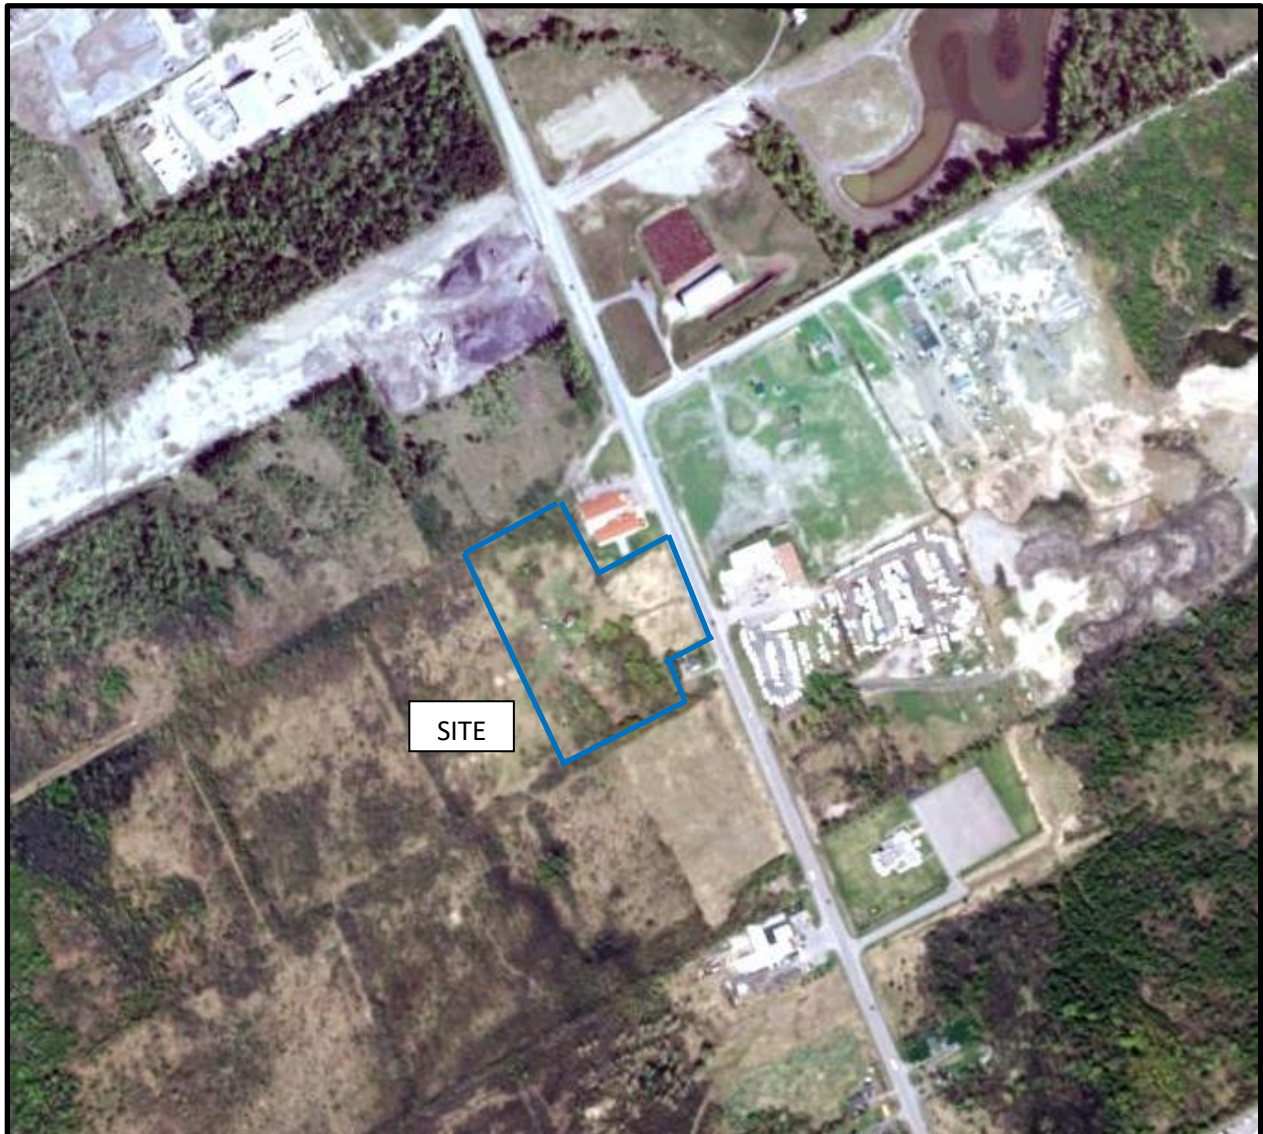
AERIAL PHOTOGRAPH  
2008

- 2008 (geoOttawa) A structure on the south side of the Phase I Property was removed and fenced gardens have been erected north and south of its former footprint since the previous photograph. The buildings directly north of the Phase I Property located at 4806 Bank Street have been demolished and replaced with two new commercial buildings. Tree clearing and earthworks are observed further North

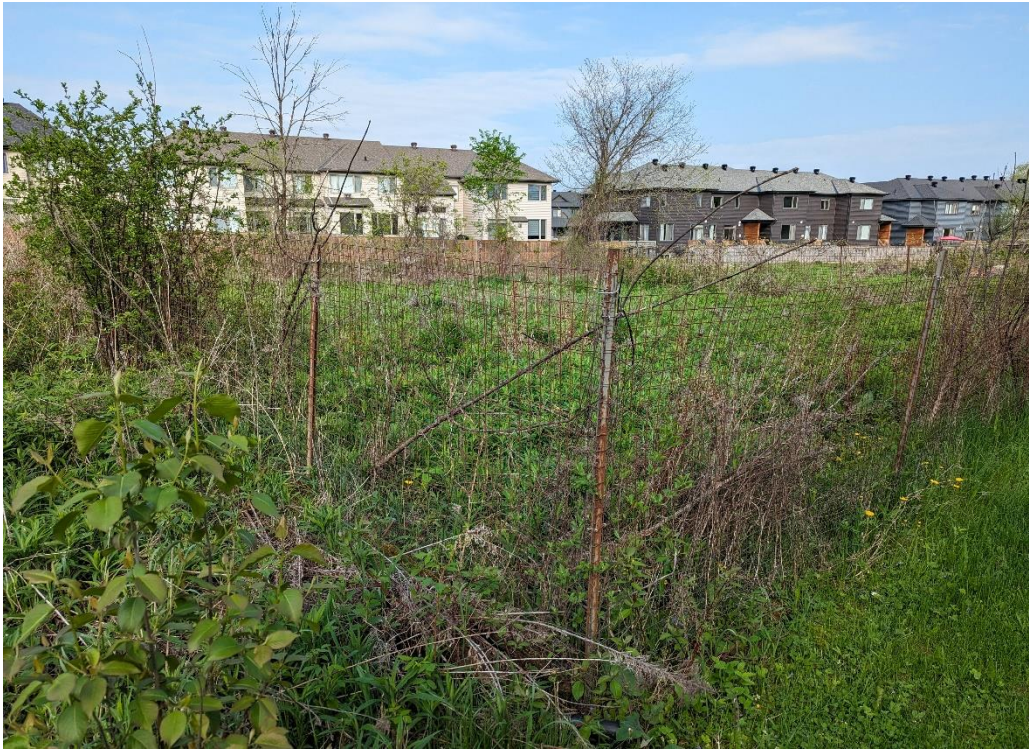
Photograph 5: View looking southwest from the center of the Phase I Property towards Cedar Creek Drive (fenced garden area).

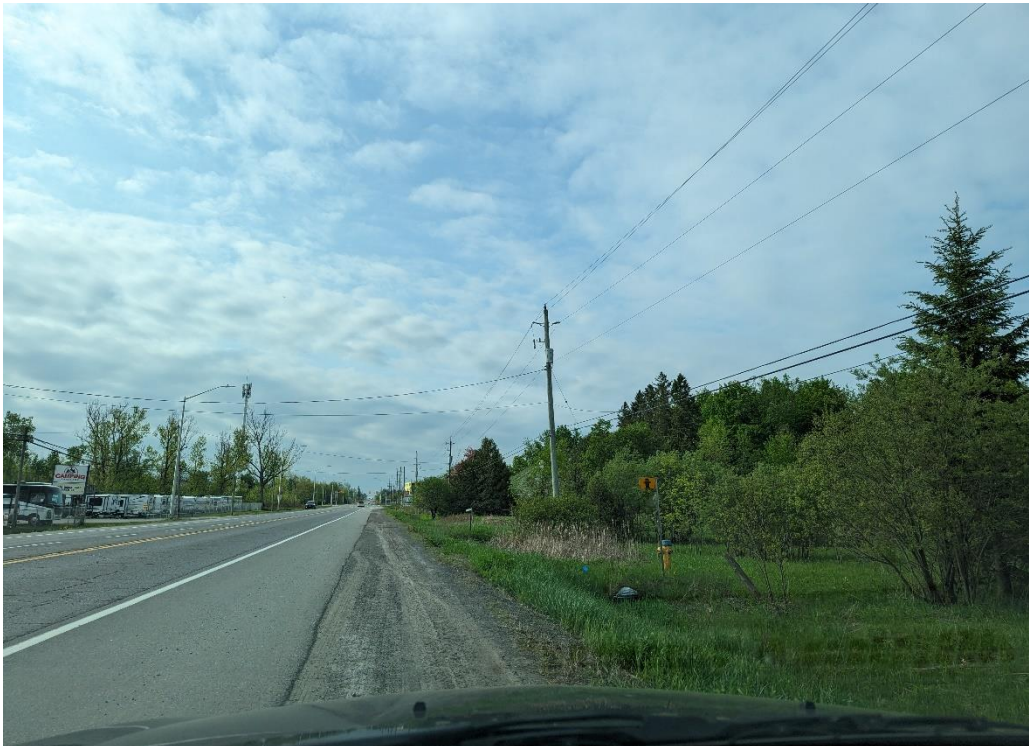
Photograph 8: View looking south, along the west side of Bank Street towards 4820 Bank Street – PCA 3 (pole mounted transformer).

- ❑ ID #2 – PCA 28: Gasoline and Associate Products Storage in Fixed Tanks Associated with an Aboveground Storage Tank Observed at 4810 Bank Street.
- ❑ ID #3 – PCA 55: Transformer Manufacturing, Processing and Use Associated with an Historical Transformer Oil Spill of Non-PCBs at 4820 Bank Street.
- ❑ ID #4 – PCA 12: Concrete, Cement and Lime Manufacturing Associated with a Ready-Mix Concrete Plant at RR#6, Highway 31 and Blais Road (3151 Blais Road).
- ❑ ID #5 – PCA 3: Airstrips and Hangars Operation Associated with a transport Canada Property located at 3151 Blais Road.
