Phase One Environmental Site Assessment

500 & 508 Edgeworth Avenue, Ottawa, Ontario

Project Number:
OTT-23002437-B0

Date Submitted:
2025-08-19

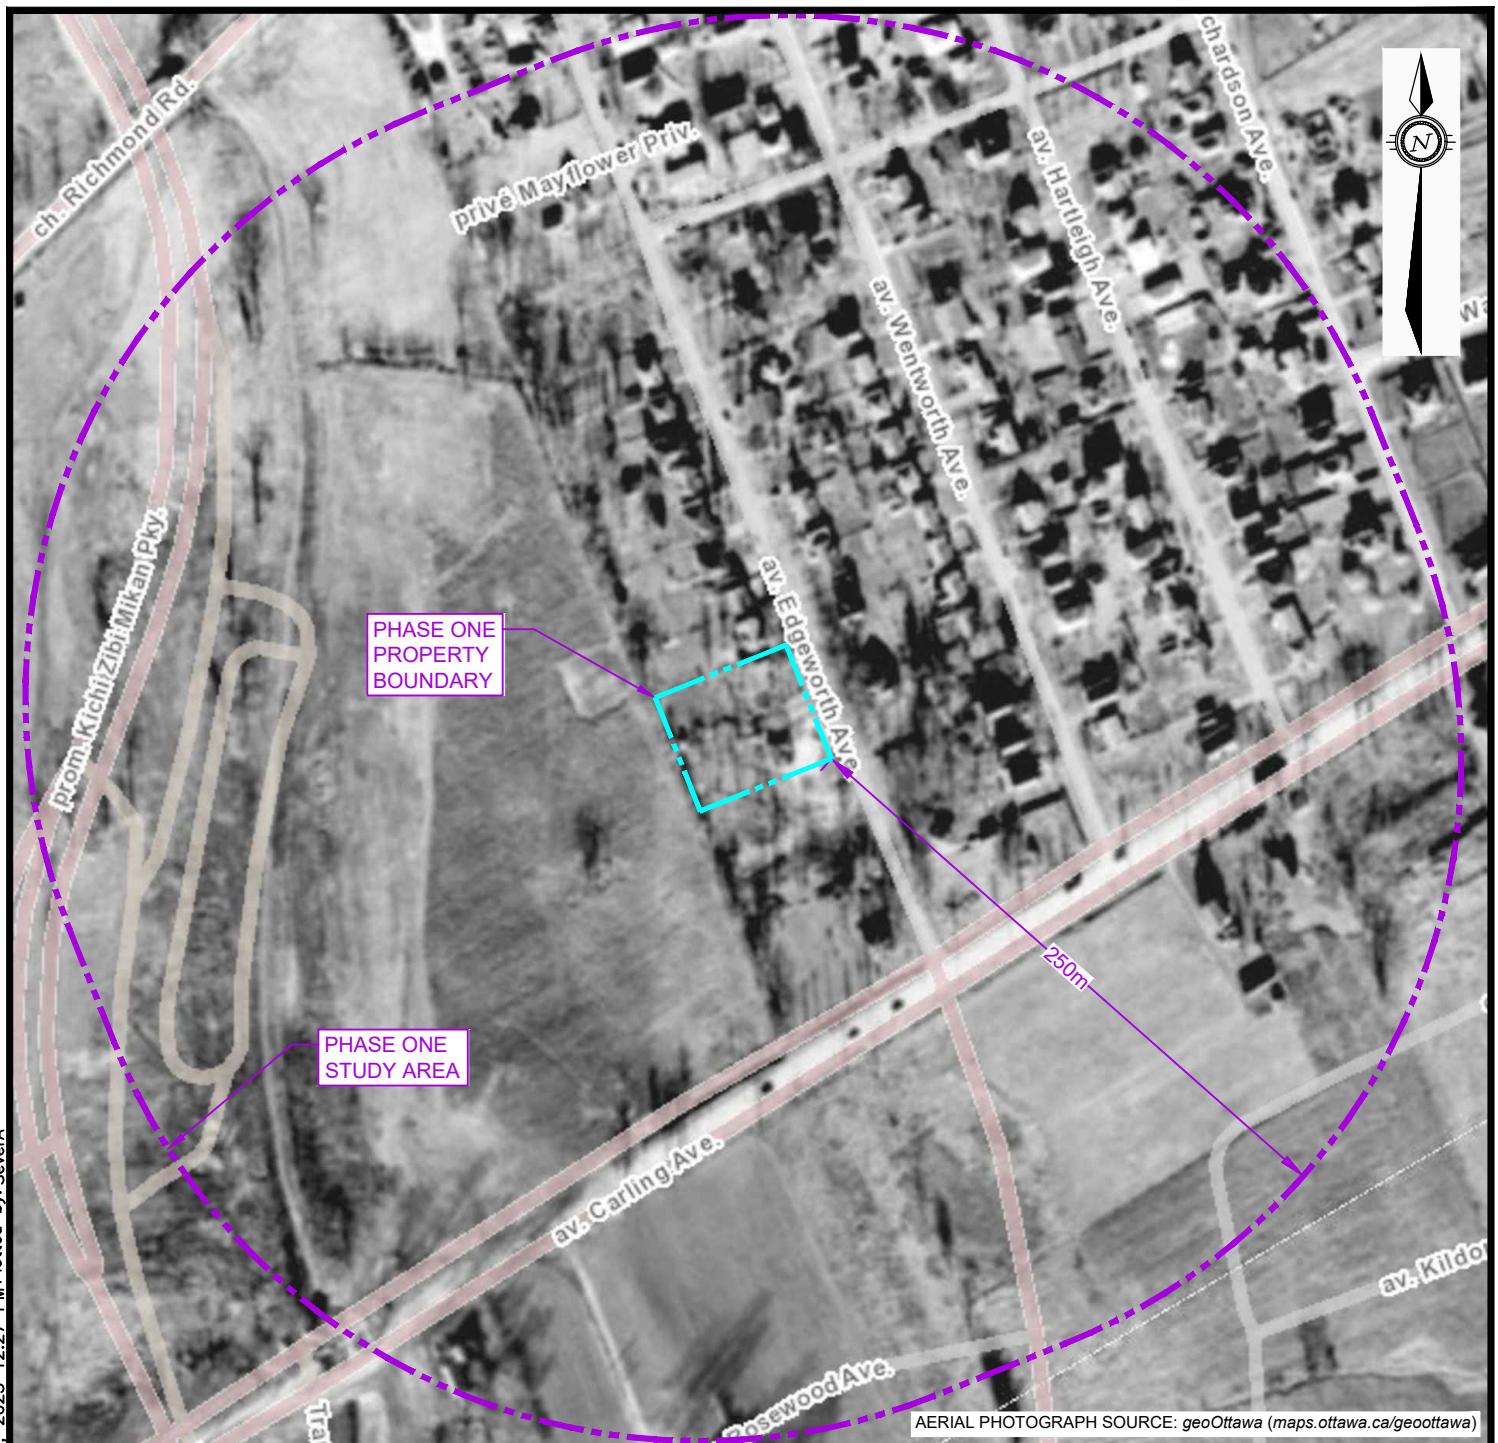
DATE MAY 2025	PROJECT: PHASE ONE ENVIRONMENTAL SITE ASSESSMENT 500 & 508 EDGEWORTH AVENUE, OTTAWA, ONTARIO	project no. OTT-23002437-A0
DESIGN LW	CHECKED CK	scale 1:3,000
DRAWN BY AS	TITLE: 1958 AERIAL PHOTOGRAPH	FIG E-1

Aerial Photograph (year)	Details
1958	Both of the existing residences are present on the Phase One property. Streets in the east part of the Phase One study area are present in the current configurations and are mainly residentially developed. Properties to the west of the Site, and properties to the south across Carling Avenue are undeveloped.
1965	The Phase One property appears similar to the 1958 aerial photograph. A repair garage is present on the northeast corner of the intersection of Carling Avenue and Edgeworth Avenue. An apartment building and detached residential development are now present to the south across Carling Avenue. Properties to the west of the Phase One property are undeveloped.
1976	The Phase One property appears similar to the 1965 aerial photograph. The residence south adjacent to the Phase One property has been demolished and replaced with a high-rise apartment building. The property at 2370 Carling Avenue has been partially developed with a retirement residence. Properties to the west of the Phase One property are undeveloped.

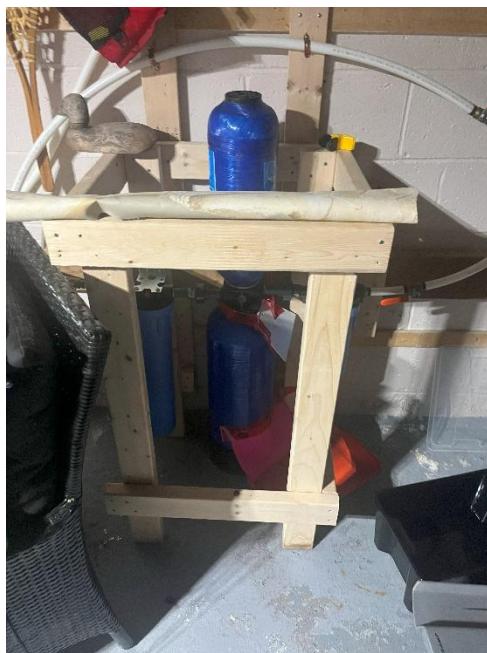
Photograph No. 2

Water treatment system in the basement at 508 Edgeworth Avenue.

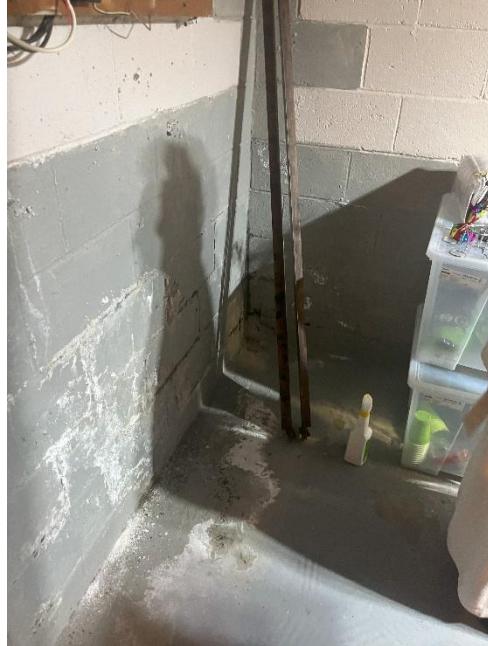
Photograph No. 3

No mould was observed at 500 Edgeworth Avenue. A small amount of mould was observed on the was in the northwest corner of the basement at 508 Edgeworth Avenue.

Small mould area on the wall in the basement.

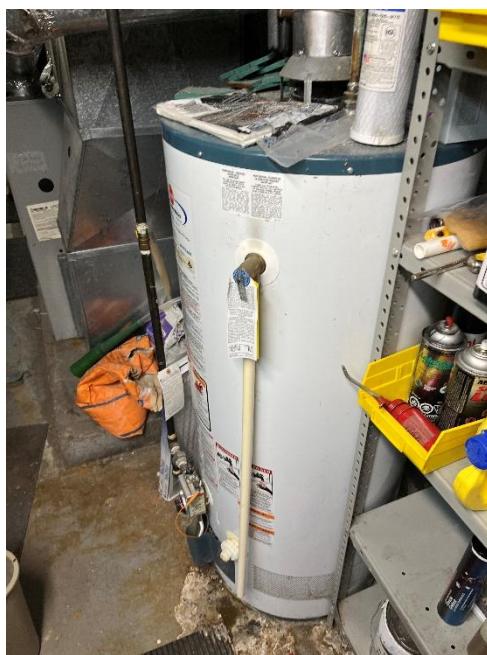
Photograph No. 6

Natural gas fired hot water tank and furnace in the basement of 500 Edgeworth Avenue.
