VUZE Construction

1015 Tweddle Road

TREE CONSERVATION REPORT

CIMA+ file number: Z0018492
18 November 2025 - Review 002

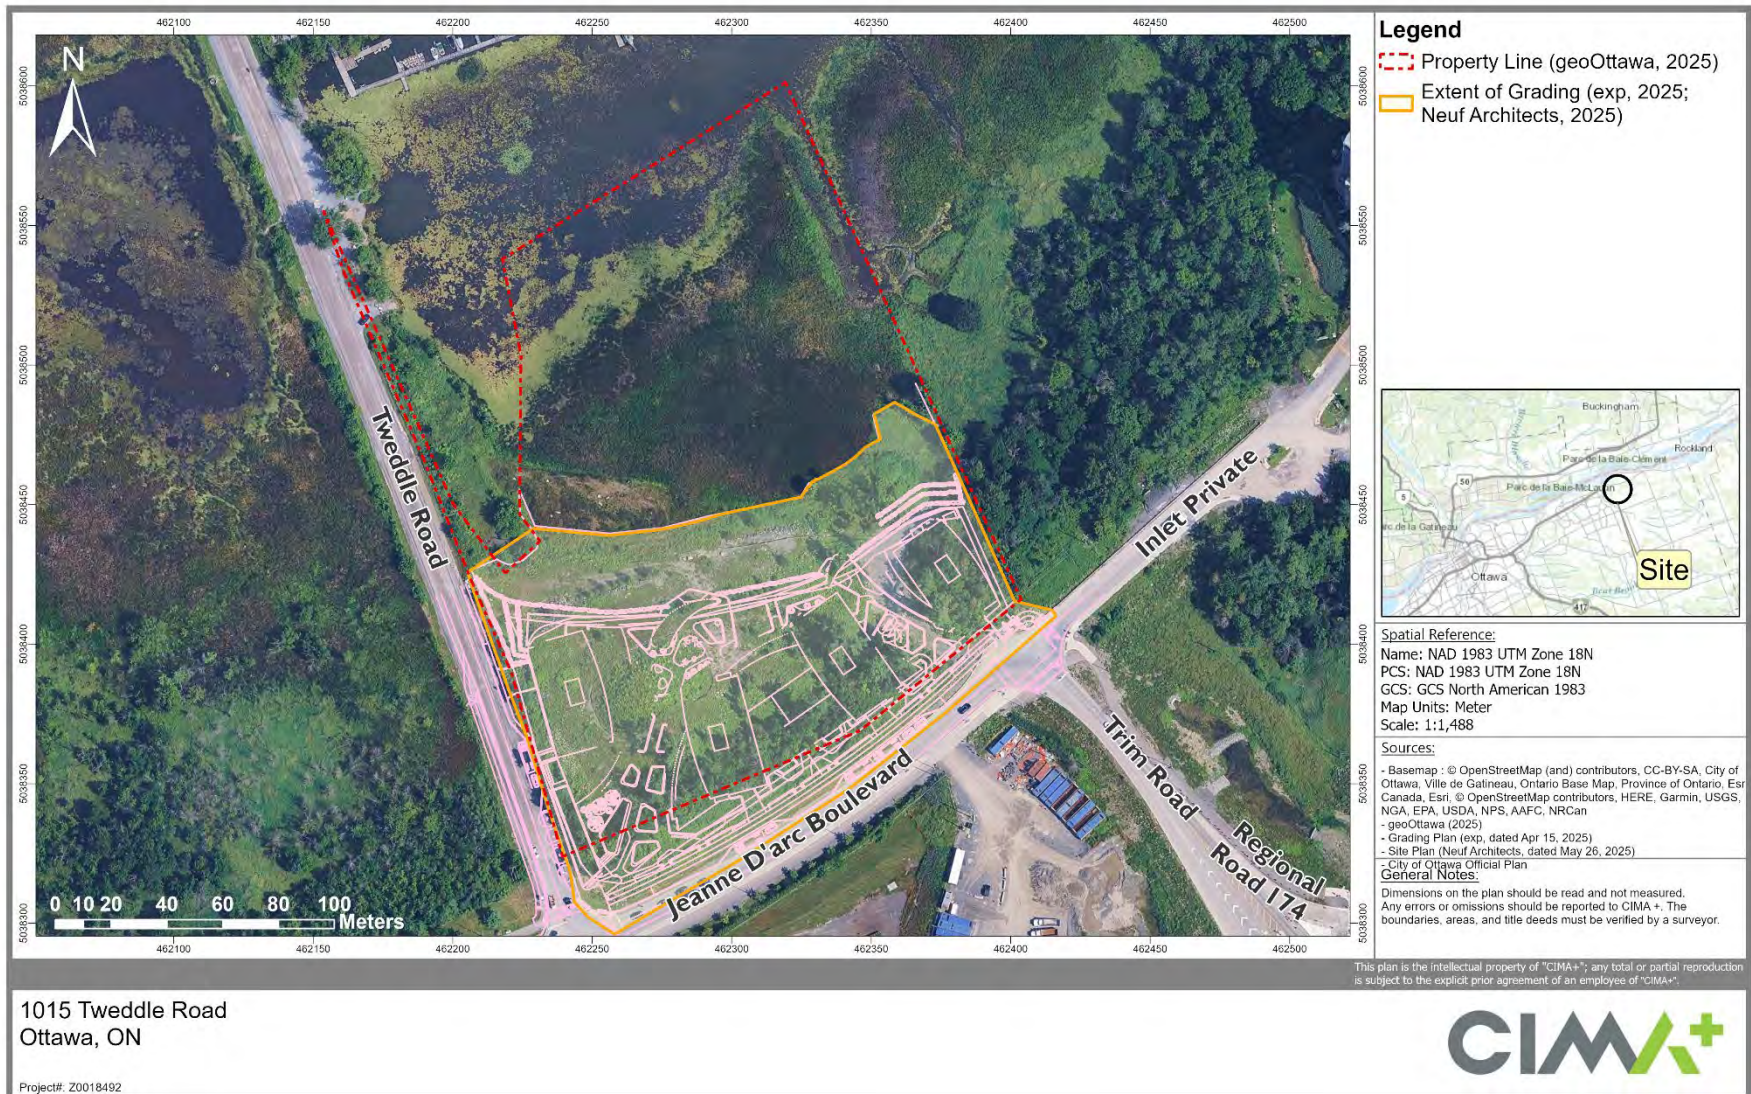
Figure 1: Property Location and Proposed Works

VUZE Construction, hereafter referred to as the proponent, intends to develop the property at 1015 Tweddle Road (the “Property”), situated at the northeast corner of the intersection at Tweddle Road and Jeanne d’Arc Boulevard North. As of 2022, Bowfin merged its services with CIMA+ who has taken over the mandate of updating this Tree Conservation Report (TCR) as per the City of Ottawa’s Tree Conservation Report Guidelines (2021).

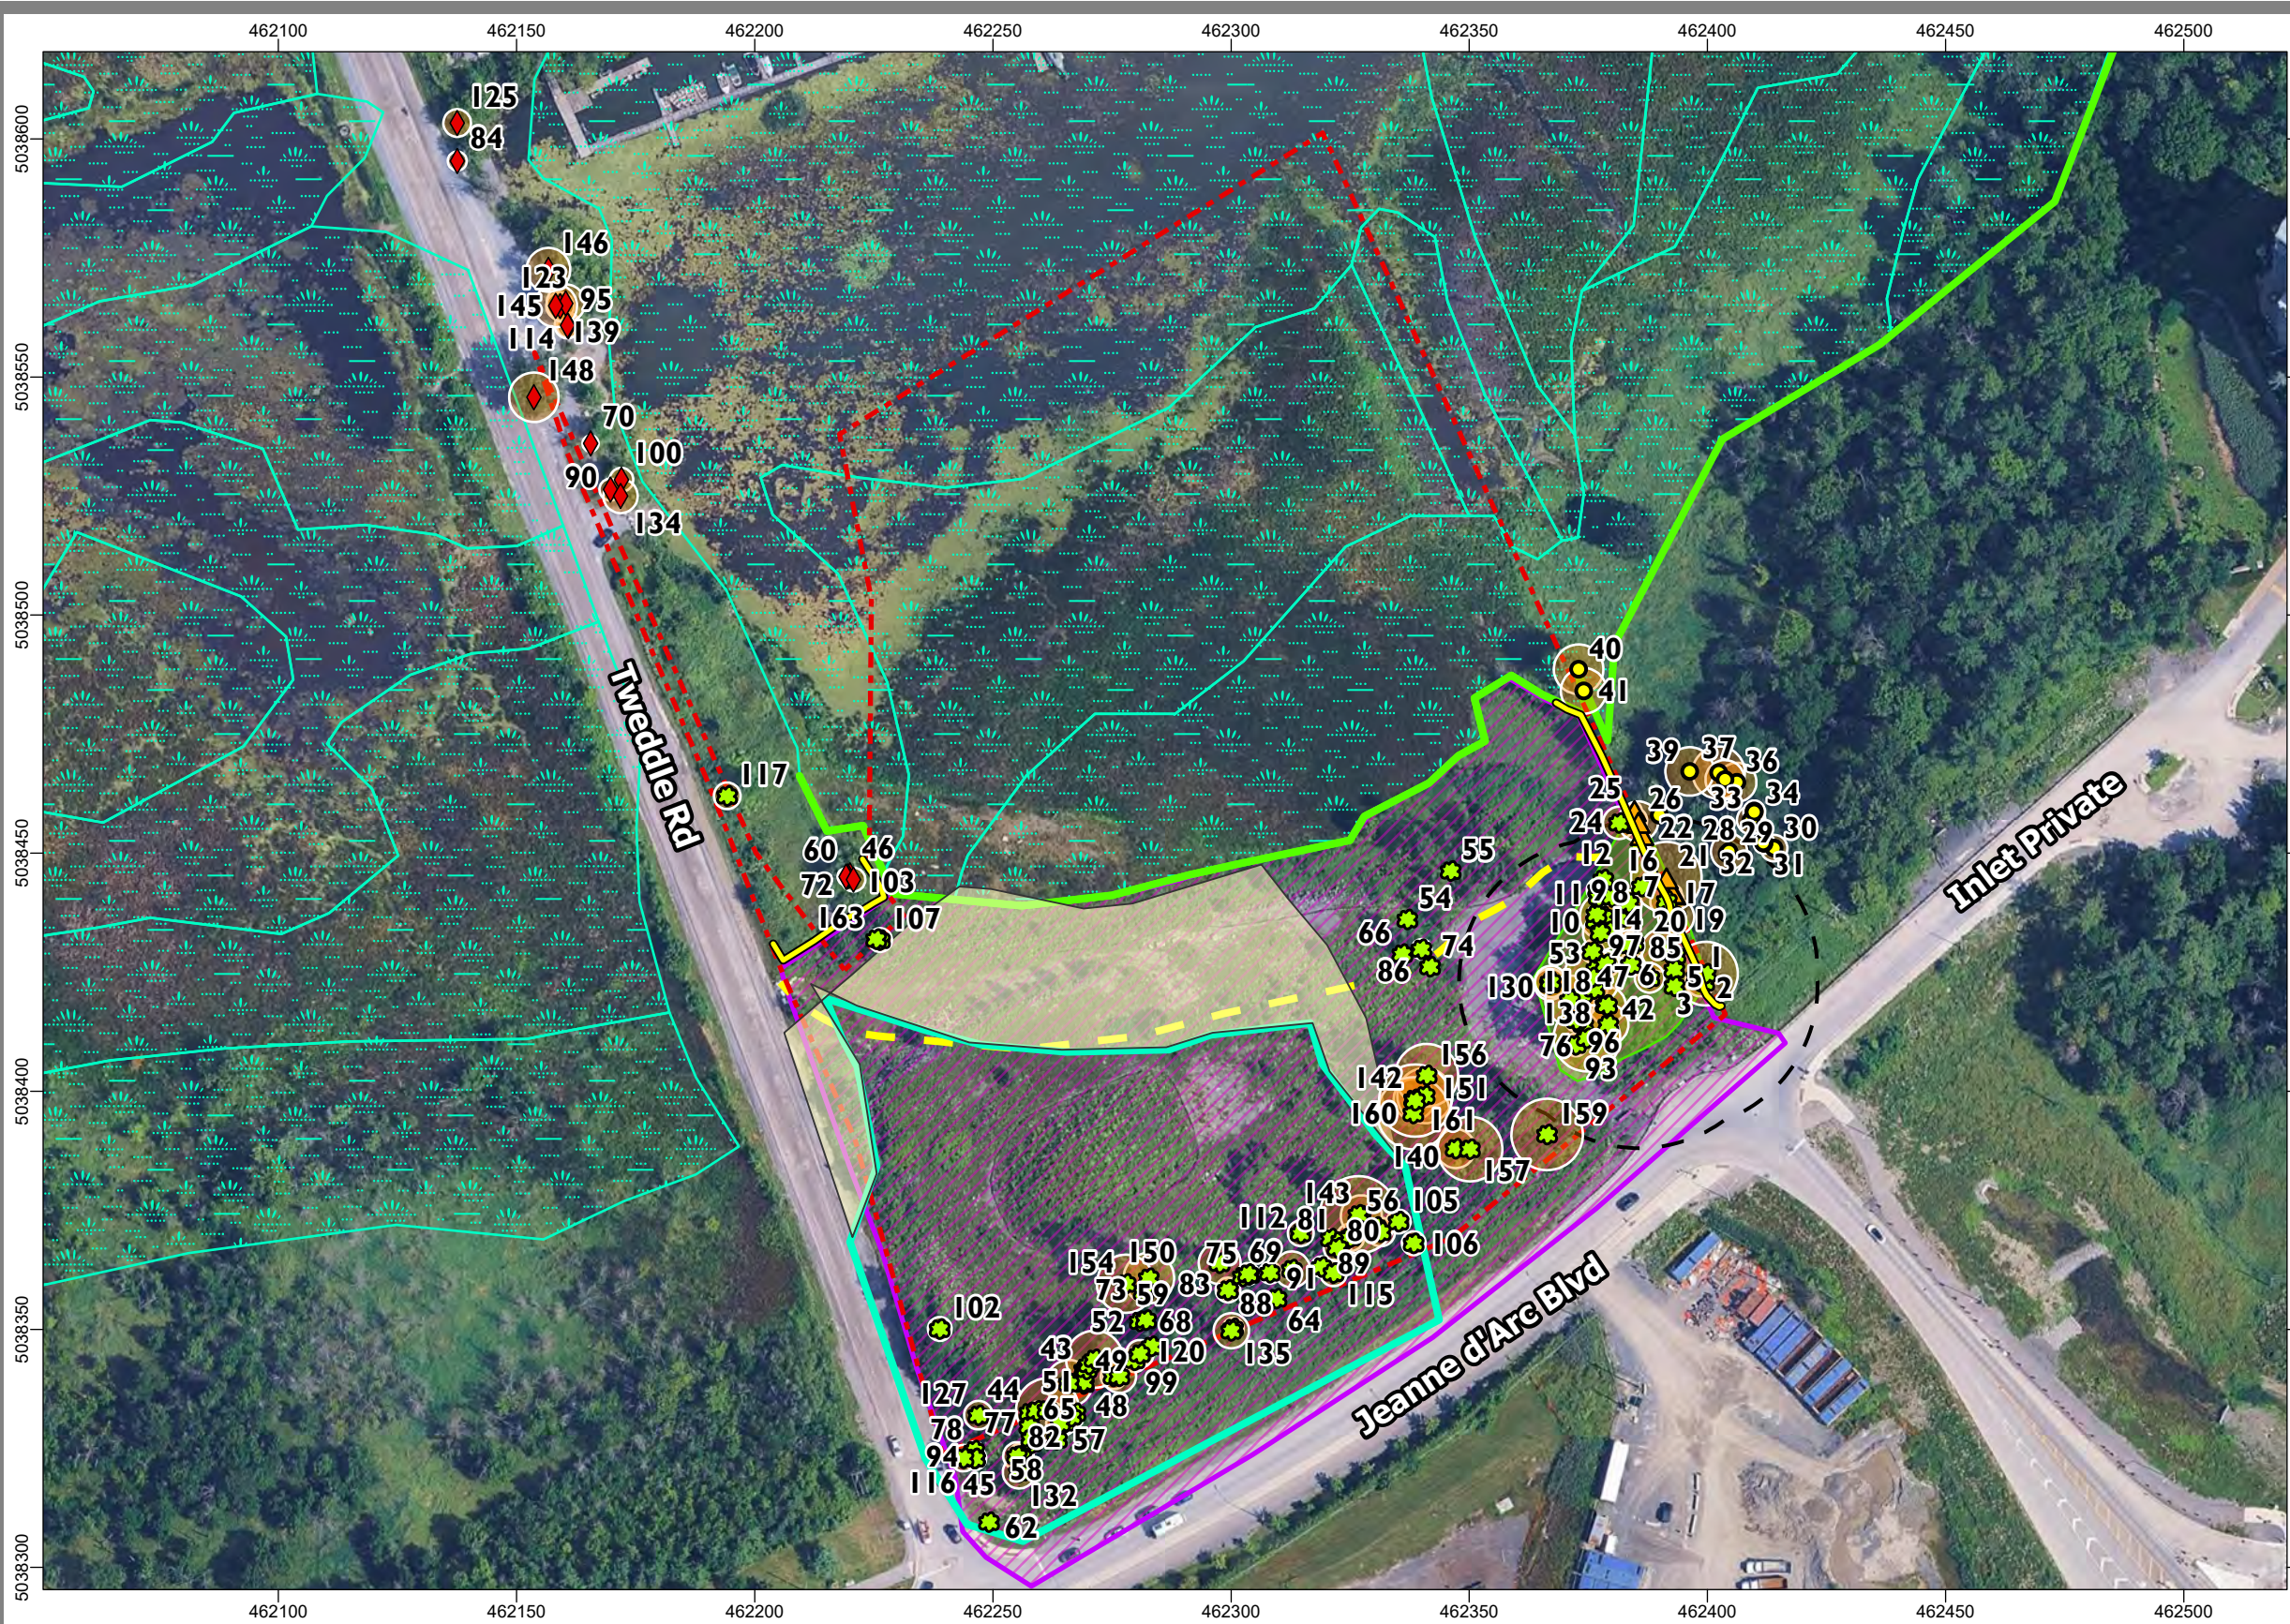
Appendix A Map 1

The location of individual trees are depicted on Map 1 and Map 2 (Appendix A, Appendix B).

- Provincially significant wetland on the north side of the Property
- Habitat of endangered and threatened species
 - Two (2) SAR Black Ash trees were found (Trees 164, 165) with dbh of 10 and 14 cm. These were located on the southeast corner of the Property.

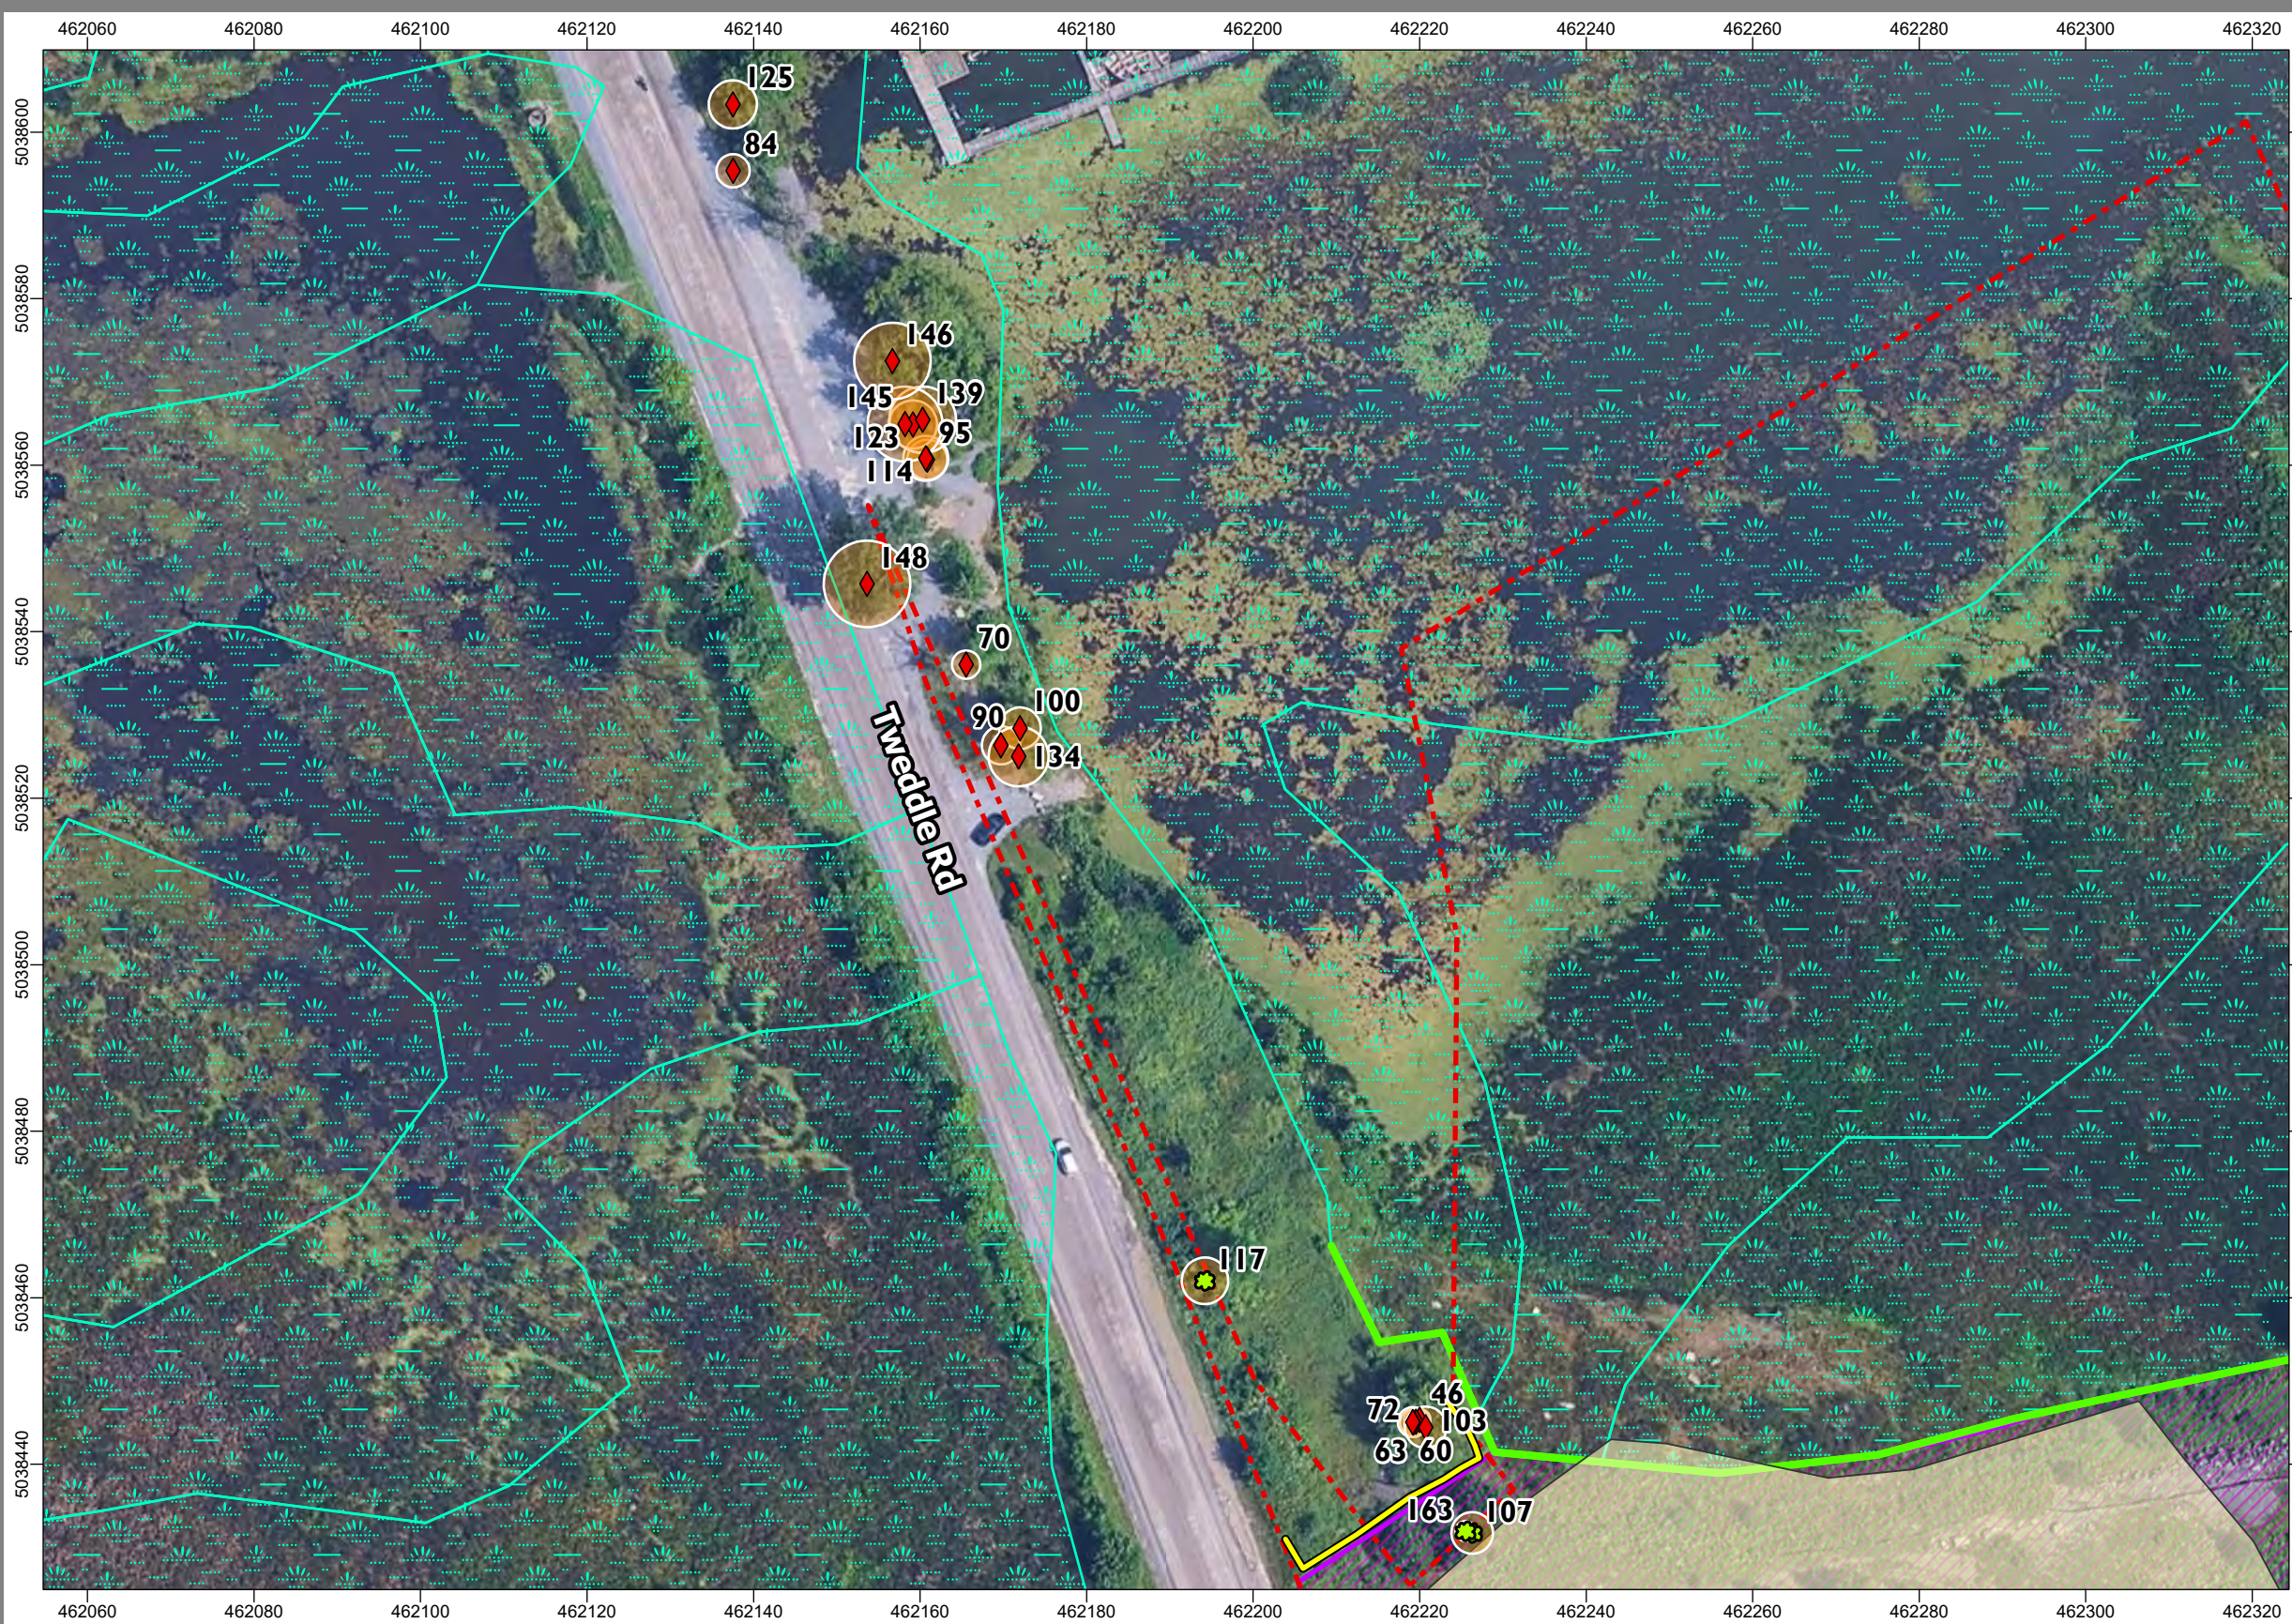
Map 1 - North

- Trees to be Retained:
 - 1 tree (Tree 117) to be retained is owned by VUZE Construction. This tree, and its CRZ, is situated along Tweddle Road, north of the area to be graded.

- 19 trees to be retained are City-owned trees situated north along Tweddle Road or Ottawa River. None of these individuals have their CRZs extending into the grading or construction limits.

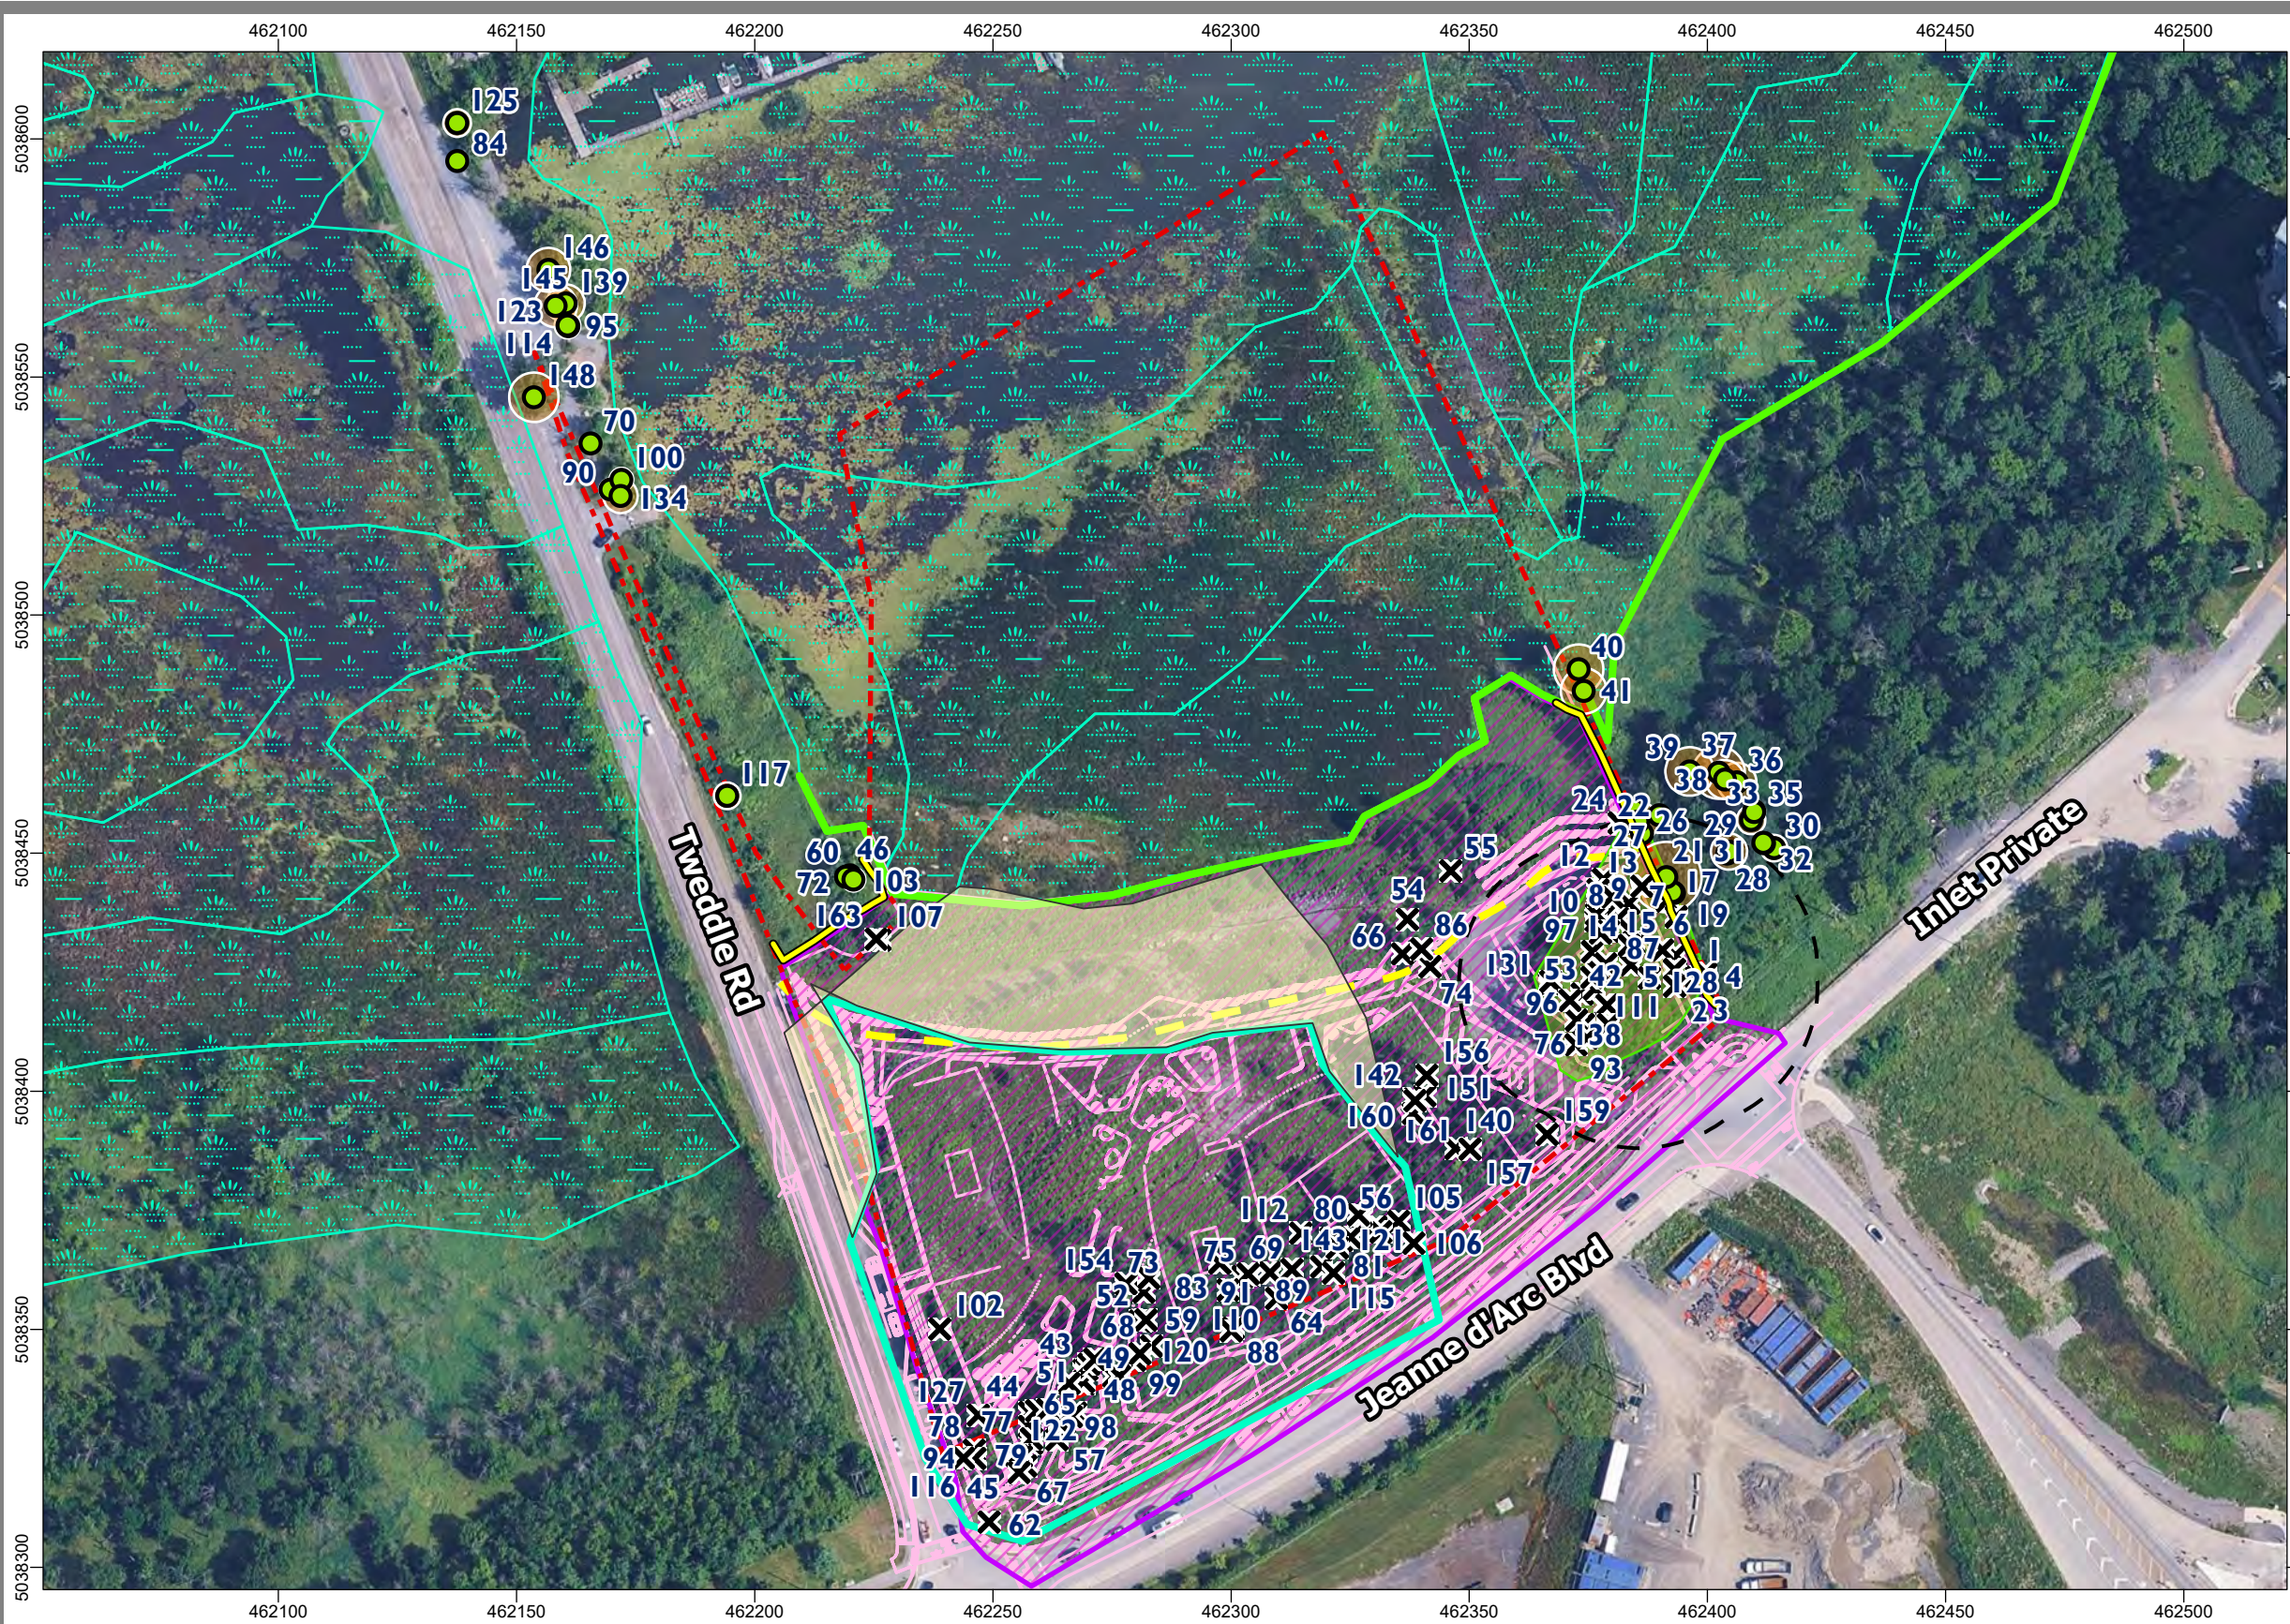
Appendix B Map 2

Of the 165 individuals inventoried, **124 trees** are anticipated to be removed, and **41 trees** are proposed for retention. These are summarized below.

- 3 of these trees have CRZs extending into the grading limits – Trees 21, 23, 26.

- Trees 21, 23 and 26 fall near the property line and are of shared ownership with the property owner to the east. These are recommended for retention and pruning, as grading will occur within their CRZs.
 - Tree 21 is a Bur Oak with dbh 74 cm
 - Tree 23 is an American Elm with dbh 23 cm.
 - Tree 26 is a Bur Oak with dbh 42 cm.

Three trees of shared ownership are proposed for retention and/or pruning as needed (Tree 21, 23, 26), as their minimum CRZ fall within the grading limits.
