# **Phase I – Environmental Site Assessment**

1296 and 1300 Carling Avenue,  
Ottawa, Ontario

Prepared for Ambassador Realty Inc.

**Report: PE3966-2**  
**October 10, 2025**

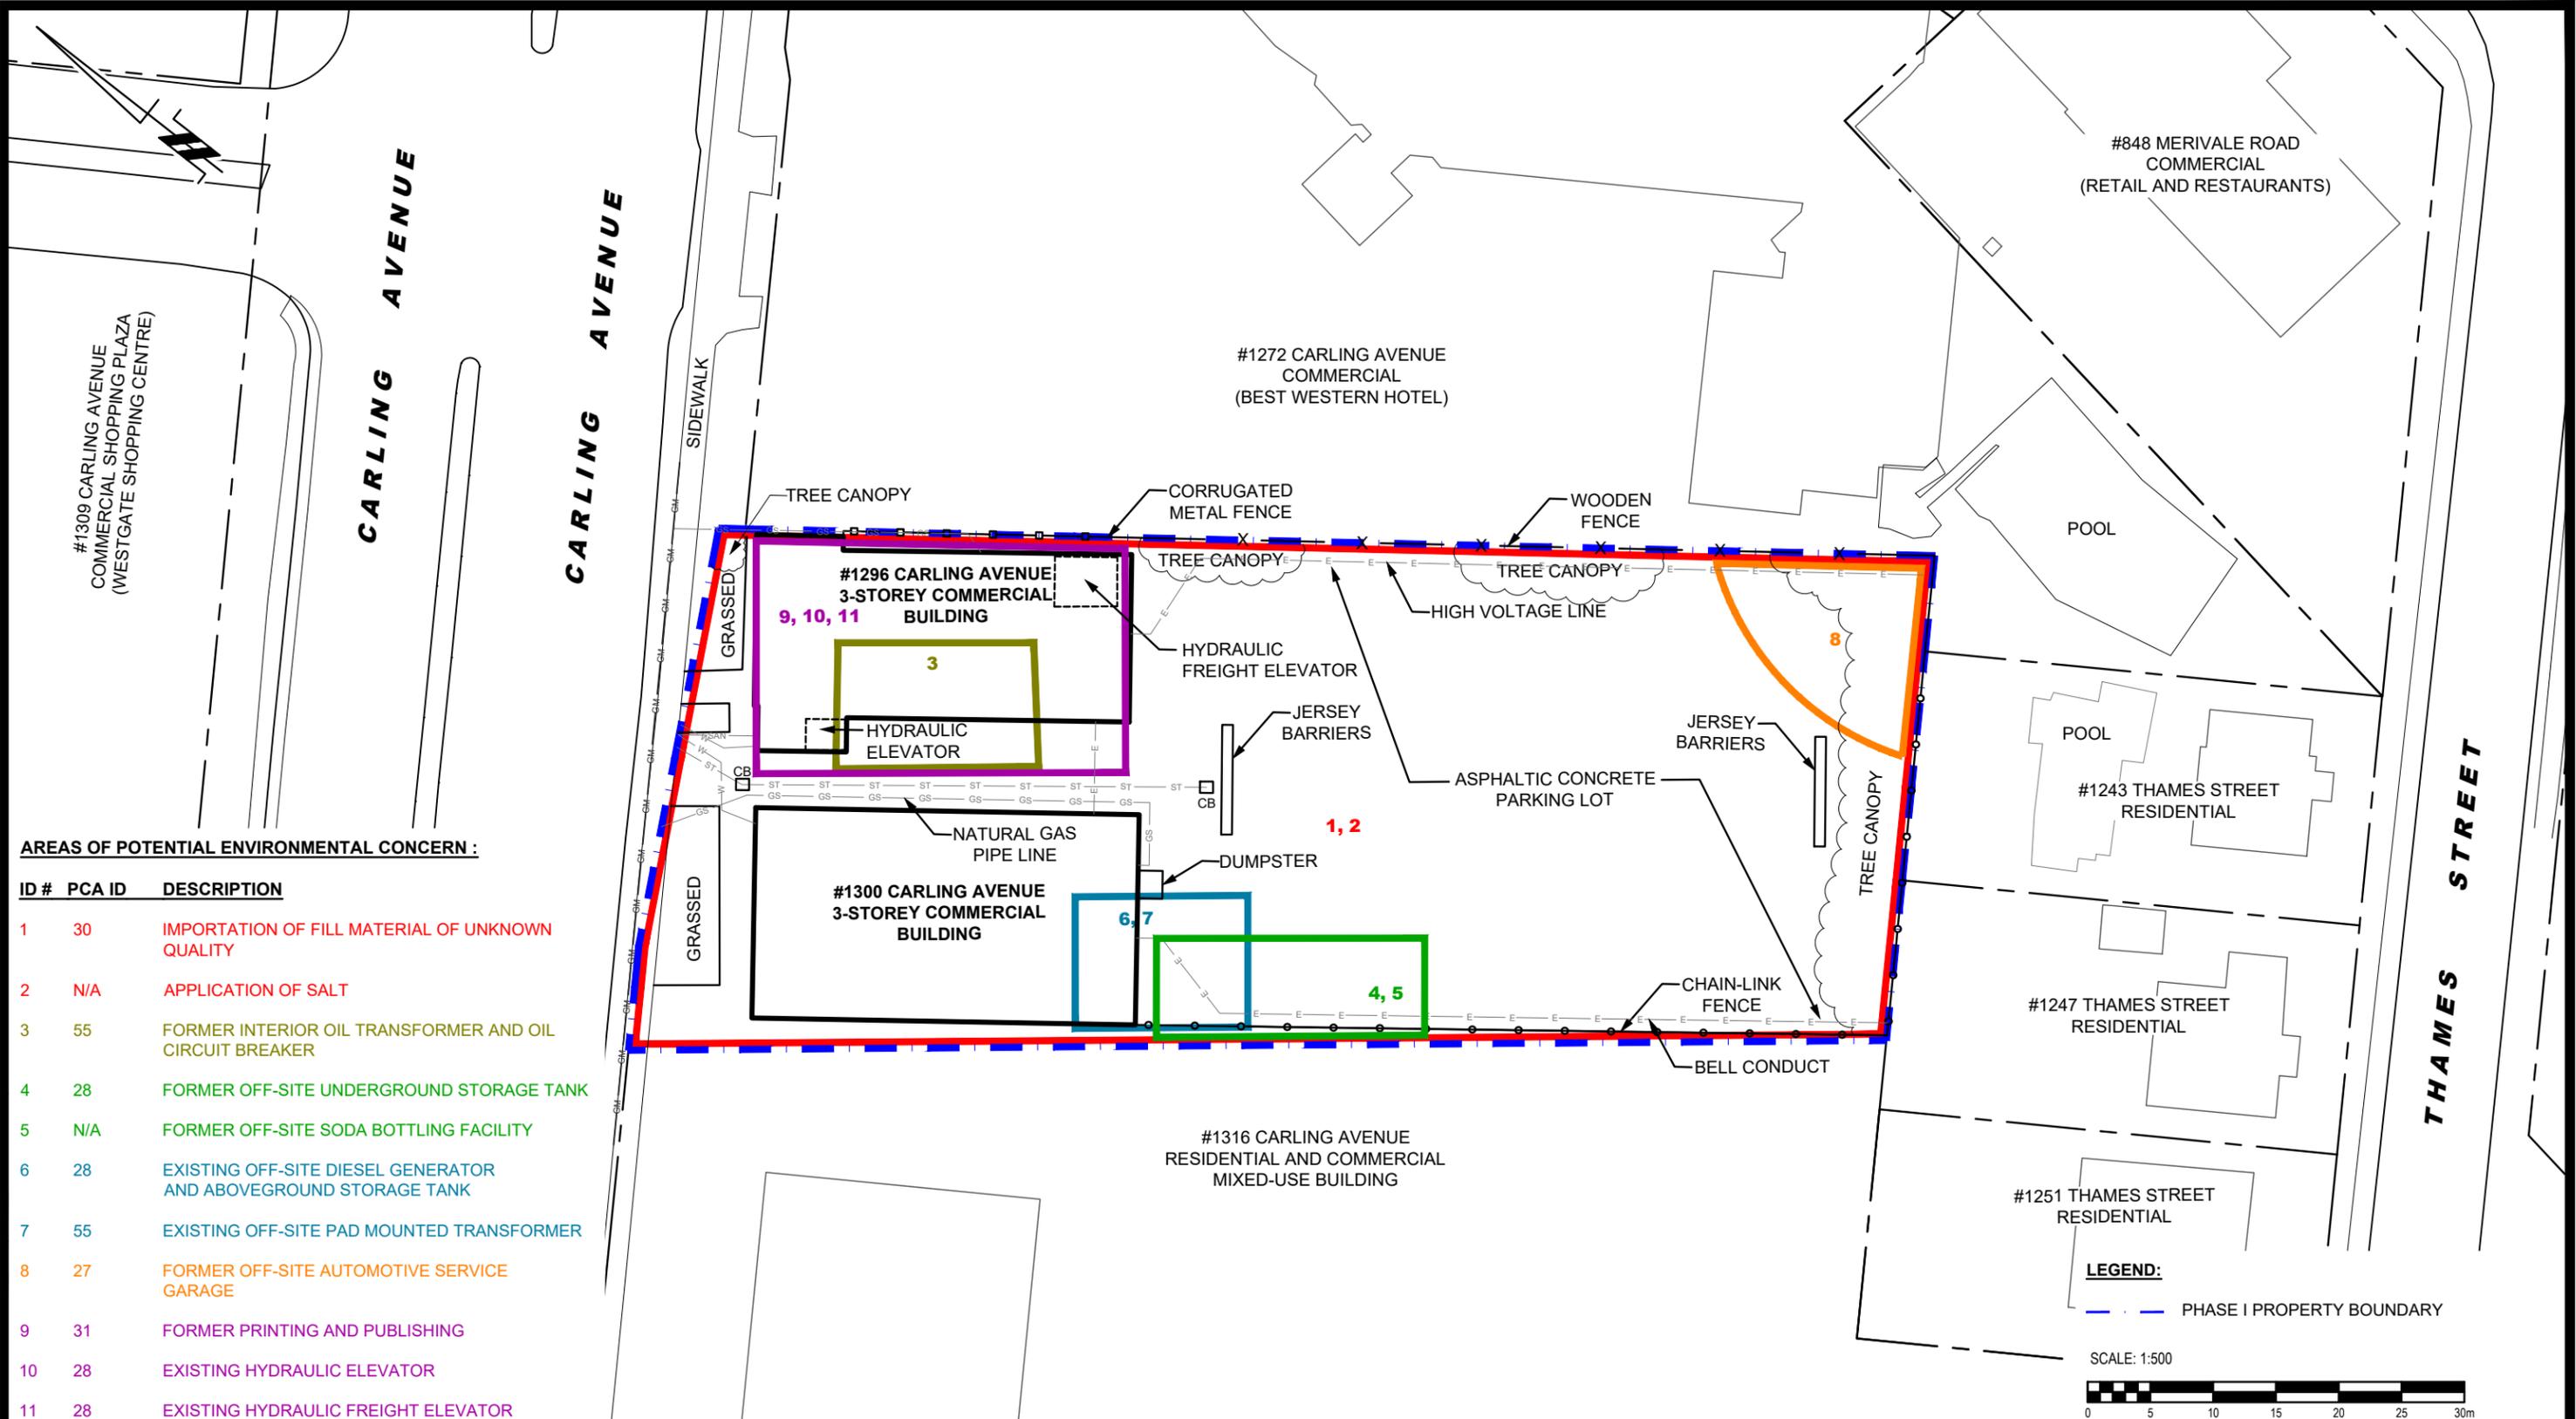
**SITE PLAN**

**AREAS OF POTENTIAL ENVIRONMENTAL CONCERN :**

ID #	PCA ID	DESCRIPTION
1	30	IMPORTATION OF FILL MATERIAL OF UNKNOWN QUALITY
2	N/A	APPLICATION OF SALT
3	55	FORMER INTERIOR OIL TRANSFORMER AND OIL CIRCUIT BREAKER
4	28	FORMER OFF-SITE UNDERGROUND STORAGE TANK
5	N/A	FORMER OFF-SITE SODA BOTTLING FACILITY
6	28	EXISTING OFF-SITE DIESEL GENERATOR AND ABOVEGROUND STORAGE TANK
7	55	EXISTING OFF-SITE PAD MOUNTED TRANSFORMER
8	27	FORMER OFF-SITE AUTOMOTIVE SERVICE GARAGE
9	31	FORMER PRINTING AND PUBLISHING
10	28	EXISTING HYDRAULIC ELEVATOR
11	28	EXISTING HYDRAULIC FREIGHT ELEVATOR

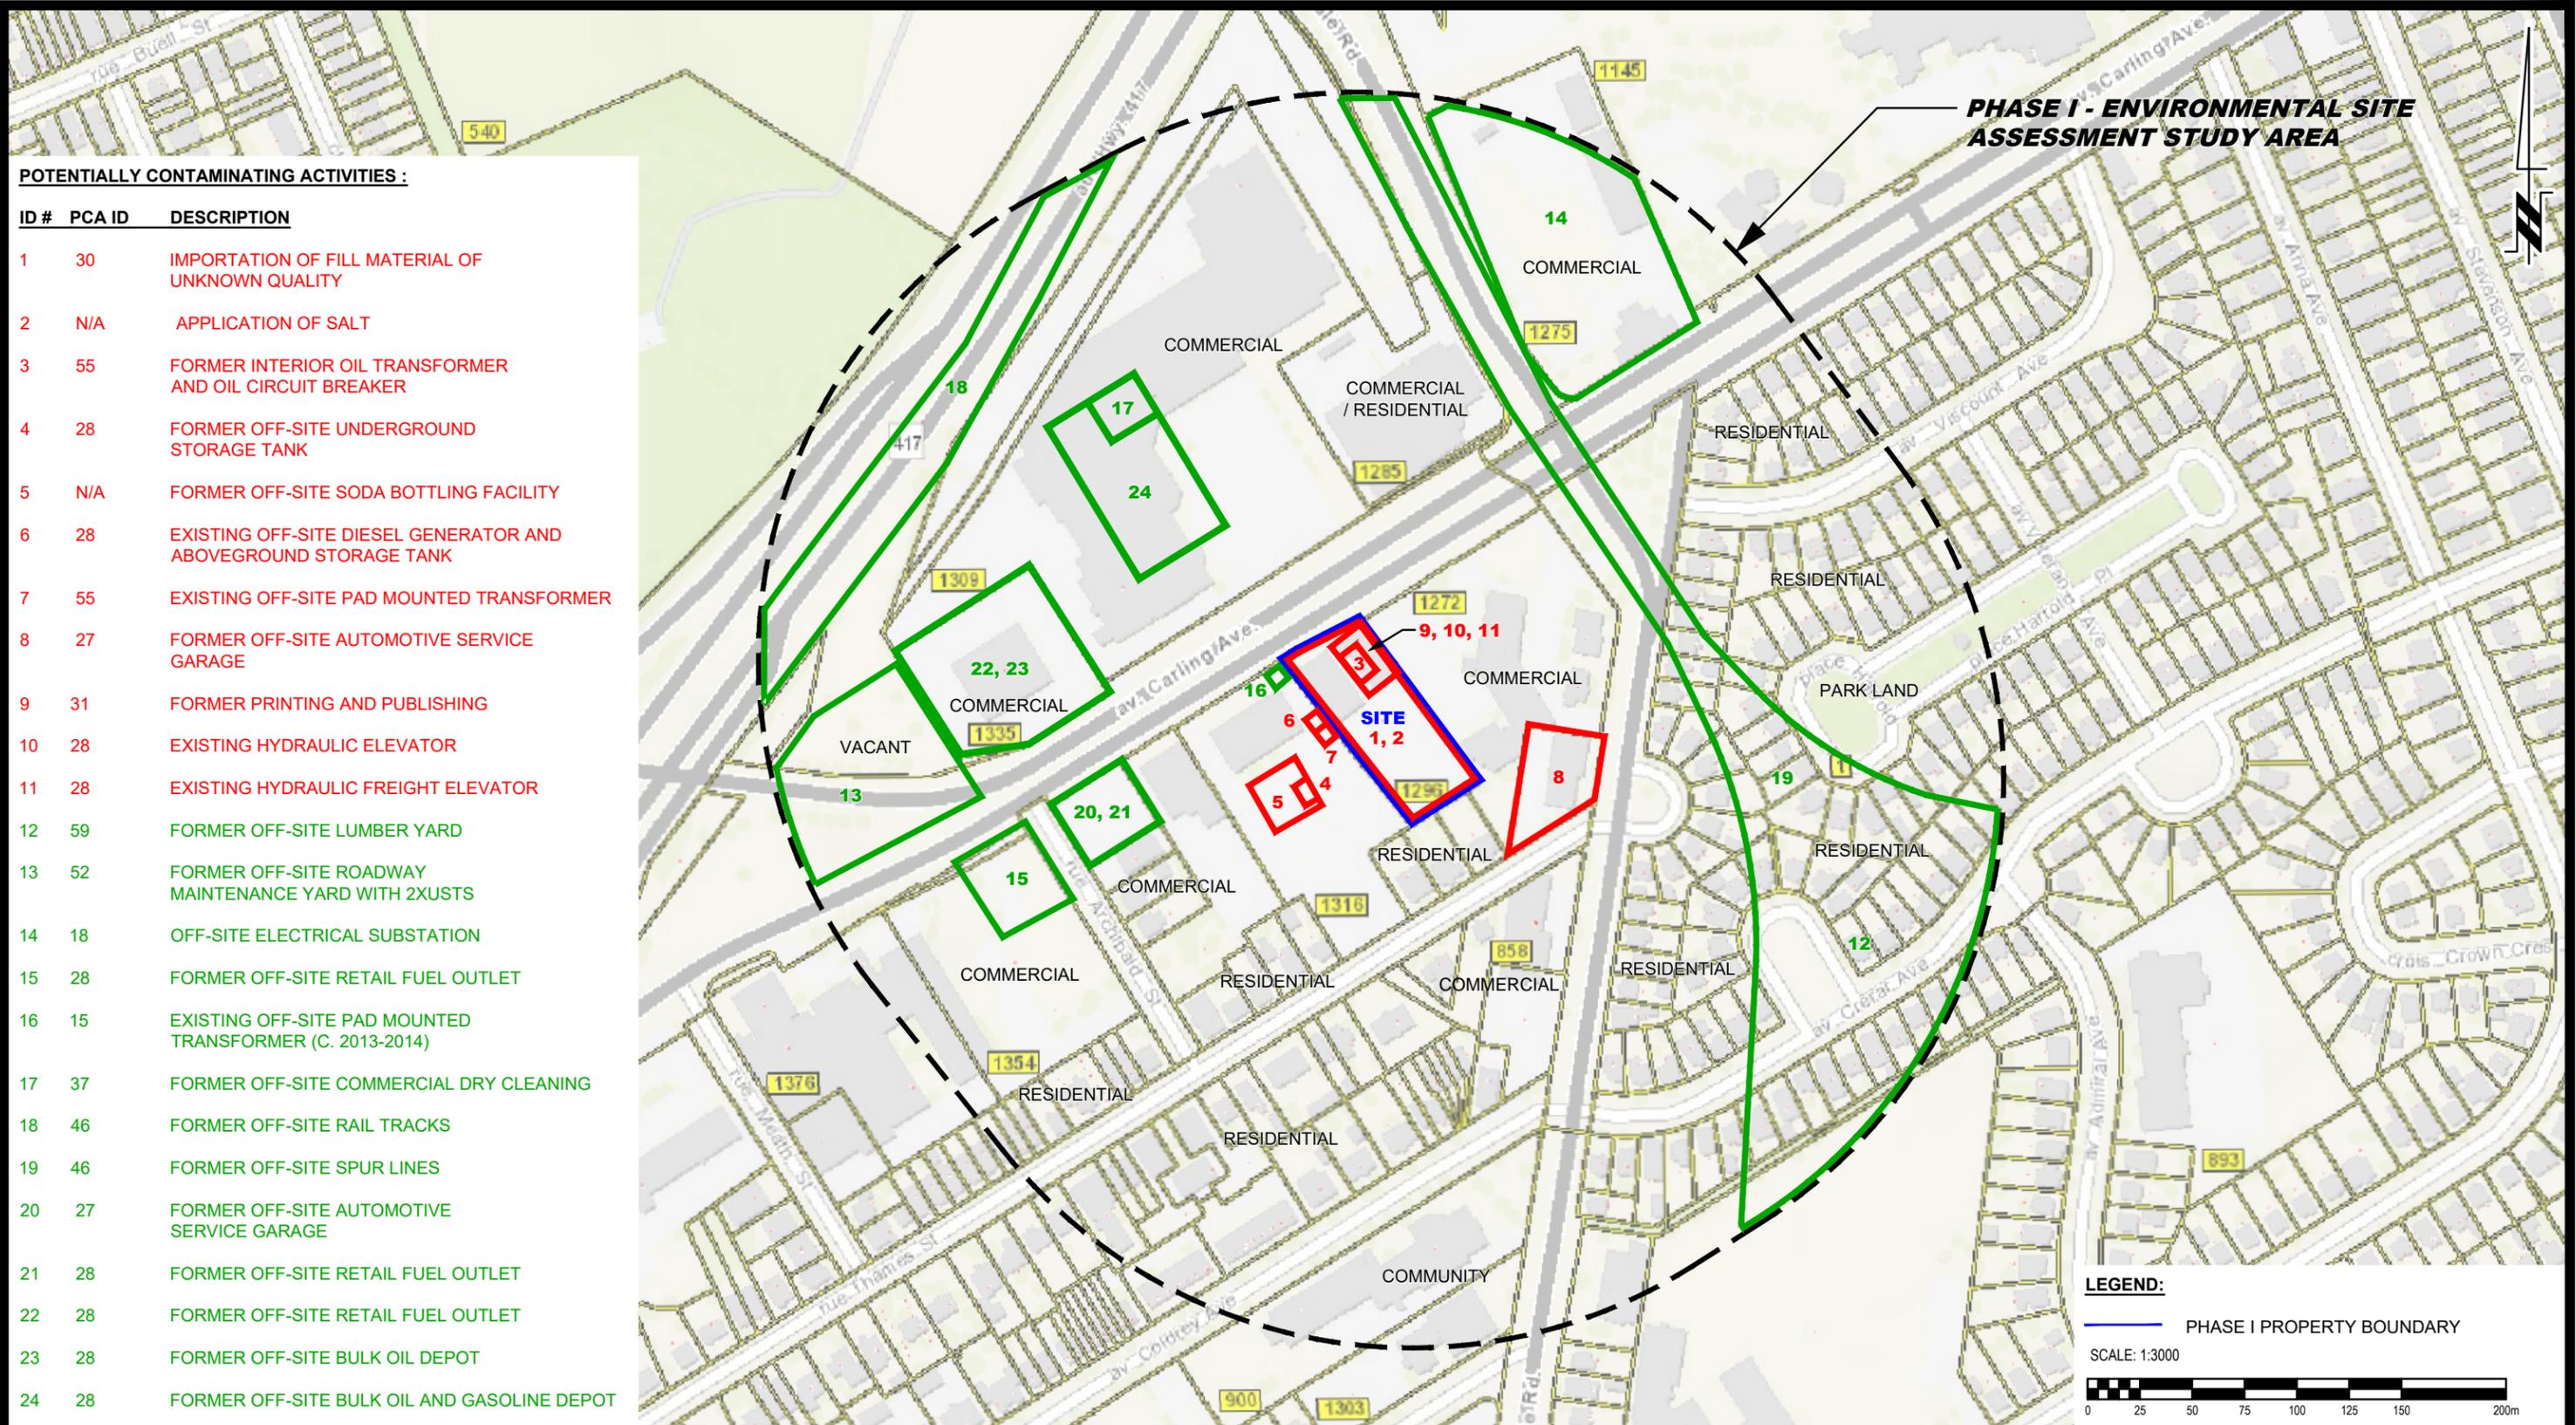
**DRAWING PE3966-3 – SURROUNDING LAND USE PLAN**

**POTENTIALLY CONTAMINATING ACTIVITIES :**

ID #	PCA ID	DESCRIPTION
1	30	IMPORTATION OF FILL MATERIAL OF UNKNOWN QUALITY
2	N/A	APPLICATION OF SALT
3	55	FORMER INTERIOR OIL TRANSFORMER AND OIL CIRCUIT BREAKER
4	28	FORMER OFF-SITE UNDERGROUND STORAGE TANK
5	N/A	FORMER OFF-SITE SODA BOTTLING FACILITY
6	28	EXISTING OFF-SITE DIESEL GENERATOR AND ABOVEGROUND STORAGE TANK
7	55	EXISTING OFF-SITE PAD MOUNTED TRANSFORMER
8	27	FORMER OFF-SITE AUTOMOTIVE SERVICE GARAGE
9	31	FORMER PRINTING AND PUBLISHING
10	28	EXISTING HYDRAULIC ELEVATOR
11	28	EXISTING HYDRAULIC FREIGHT ELEVATOR
12	59	FORMER OFF-SITE LUMBER YARD
13	52	FORMER OFF-SITE ROADWAY MAINTENANCE YARD WITH 2XUSTS
14	18	OFF-SITE ELECTRICAL SUBSTATION
15	28	FORMER OFF-SITE RETAIL FUEL OUTLET
16	15	EXISTING OFF-SITE PAD MOUNTED TRANSFORMER (C. 2013-2014)
17	37	FORMER OFF-SITE COMMERCIAL DRY CLEANING
18	46	FORMER OFF-SITE RAIL TRACKS
19	46	FORMER OFF-SITE SPUR LINES
20	27	FORMER OFF-SITE AUTOMOTIVE SERVICE GARAGE

Off-site PCAs were observed on the property adjacent to the west of the Phase I Property (1316 Carling Avenue), including a diesel AST associated with a backup generator, and two pad mounted transformers. The AST and centrally located pad mounted transformer are considered to represent off-site APECs on the Phase I Property. The pad mounted transformer in the northern portion of this property is an off-site PCA not considered to represent an APEC based on the noted condition

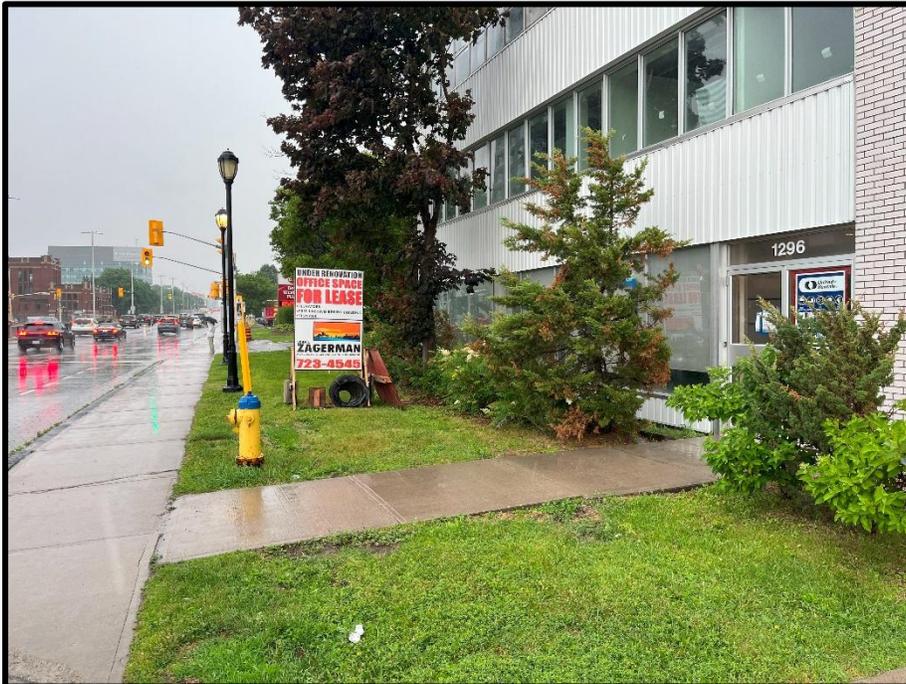
The building addressed 1296 Carling Avenue consists of a three-storey multi tenant commercial office building, with one basement level, constructed in approximately 1961. The building is finished on the exterior with brick and aluminum siding, and features a poured concrete foundation and a flat rolled roof. The building is municipally serviced, and heated via natural gas.

**Photograph 1:** View of the front (north) building face of 1296 Carling Avenue.

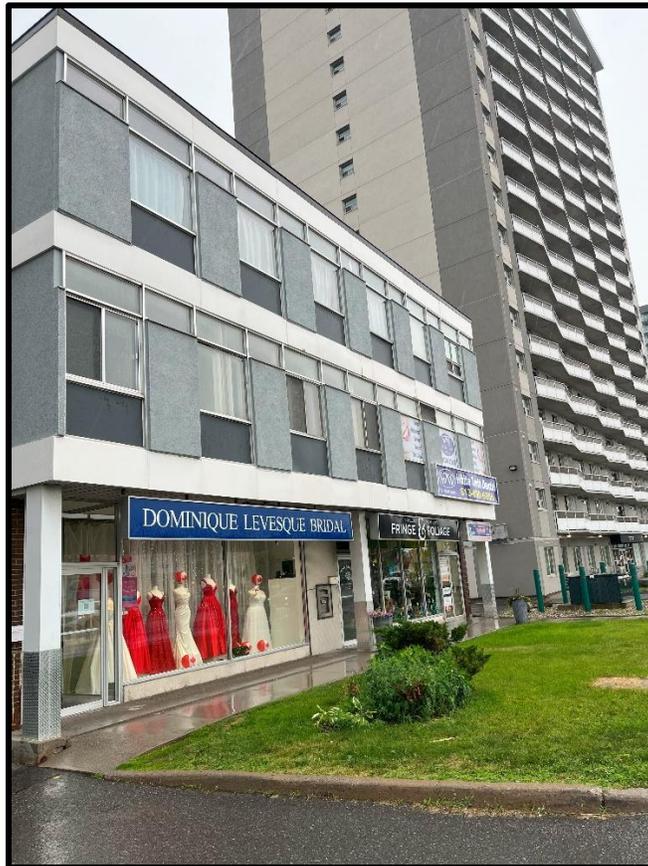
The building addressed 1300 Carling Avenue consists of a three-storey multi tenant commercial office building, with one basement level constructed in approximately 1960. The building is finished on the exterior with brick and cladding, and features a poured concrete foundation and a flat rolled roof. The building is municipally serviced, and heated via natural gas.

**Photograph 2:** View of the front (north) building face of 1300 Carling Avenue.

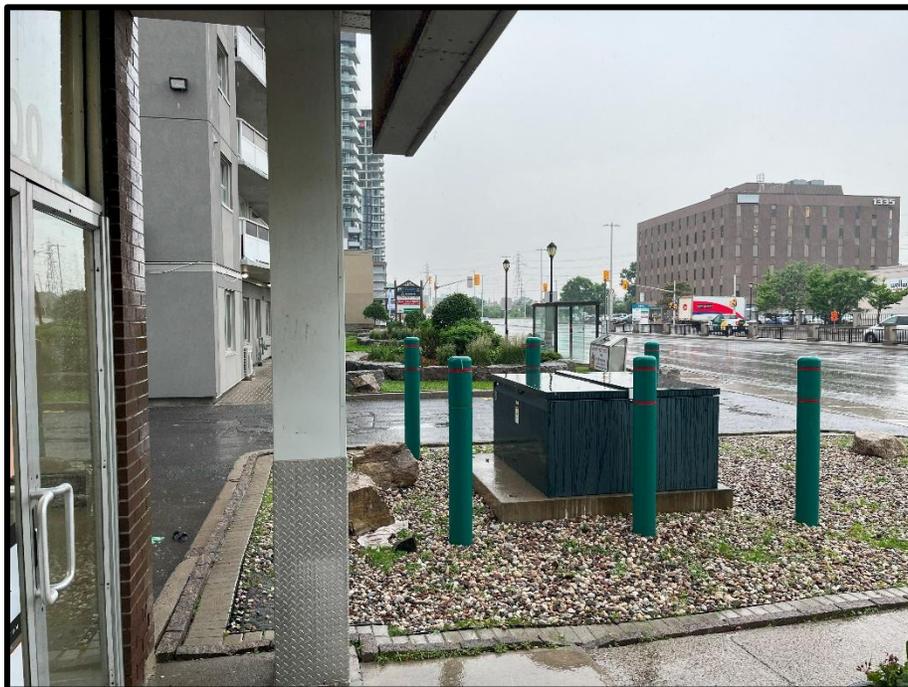
**Photograph 8:** View of the pad mounted transformer west of the subject site, in great condition.

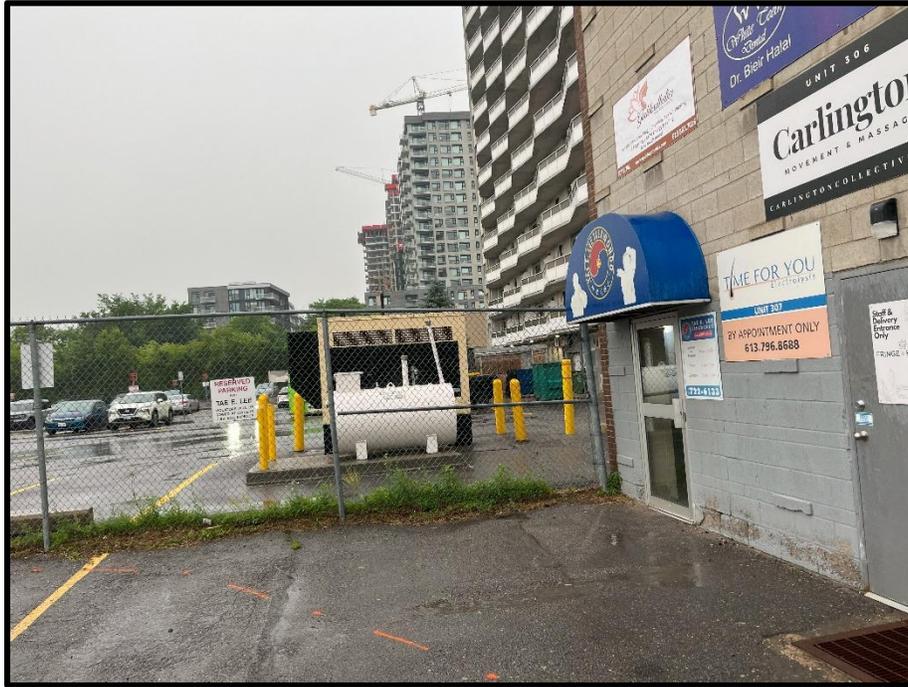
**Photograph 9:** View of the diesel AST and backup generator on the property adjacent to the west.

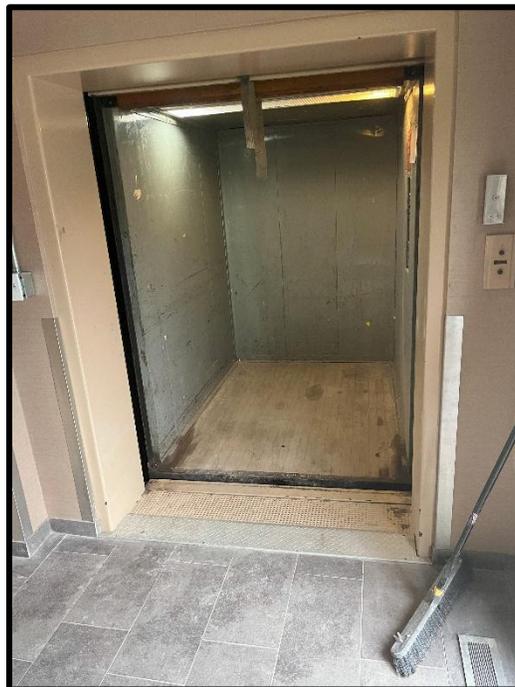
**Photograph 10:** View of the freight elevator in the interior of the 1296 Carling Avenue building.

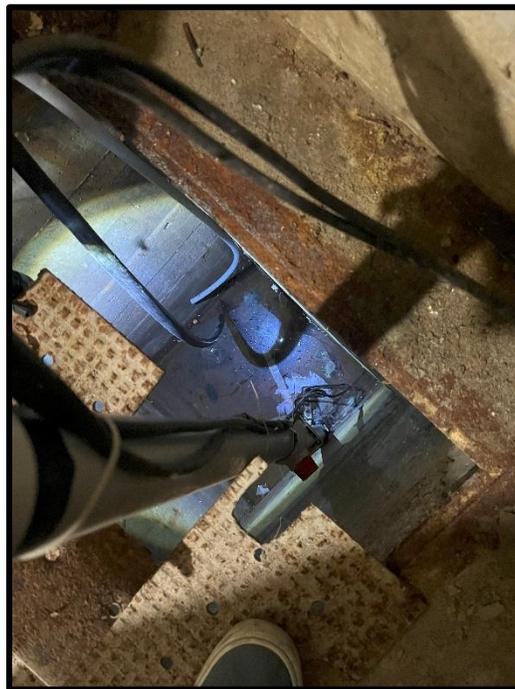
Wastewater generated from the subject building is discharged to the City of Ottawa sanitary sewer system. Roof drainage is discharged via surface run-off and infiltration. A sump pit was observed in the subject building, which appeared dry at the time of the site visit with no unusual visual or olfactory observations noted.

**Photograph 12:** View of the sump pit in a mechanical room of the 1296 Carling Avenue building.

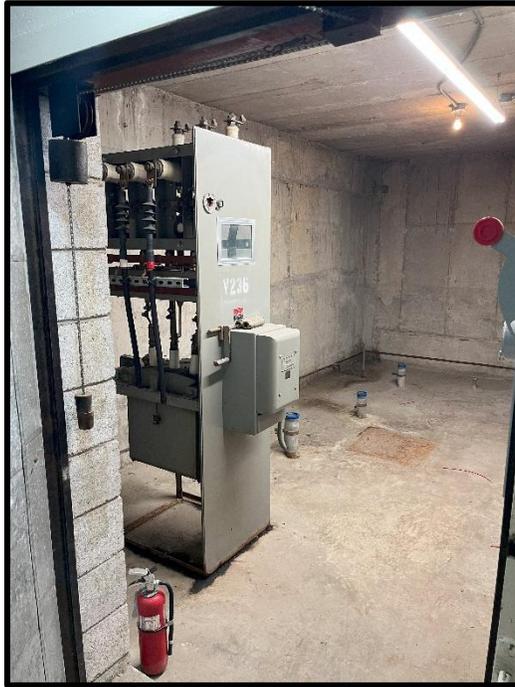
**Photograph 13:** View of the location of the former interior transformer and decommissioned oil circuit breaker room in the interior of the 1296 Carling Avenue building.

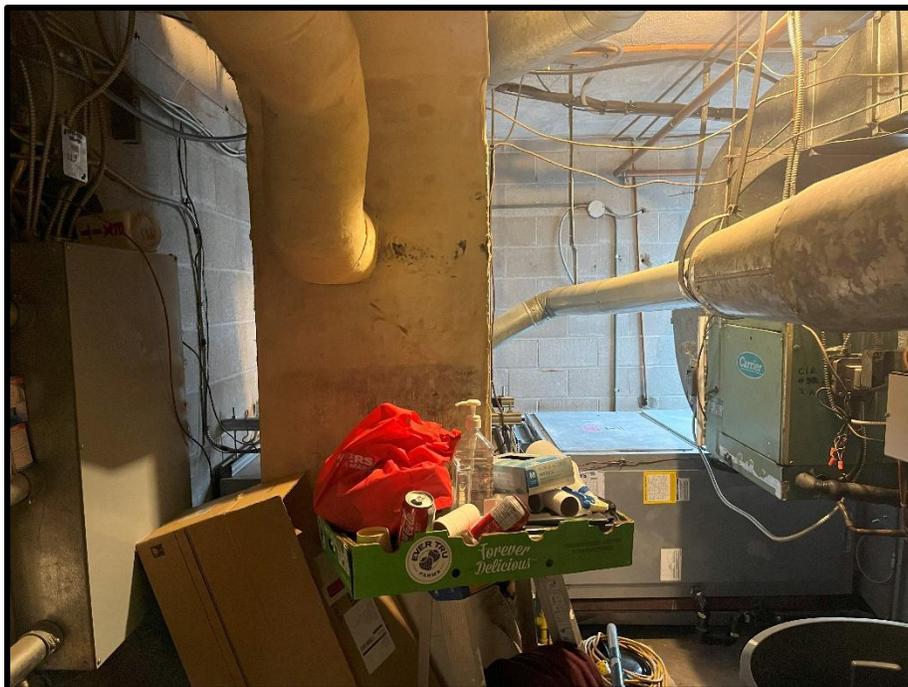
**Photograph 18:** View inside a mechanical room in the interior of the 1300 Carling Avenue building.
