# Phase I Environmental Site Assessment

2701 Pagé Road, Ottawa, Ontario

Prepared for 1001263920 ONTARIO INC.

Report: PE7228-1  
October 16, 2025

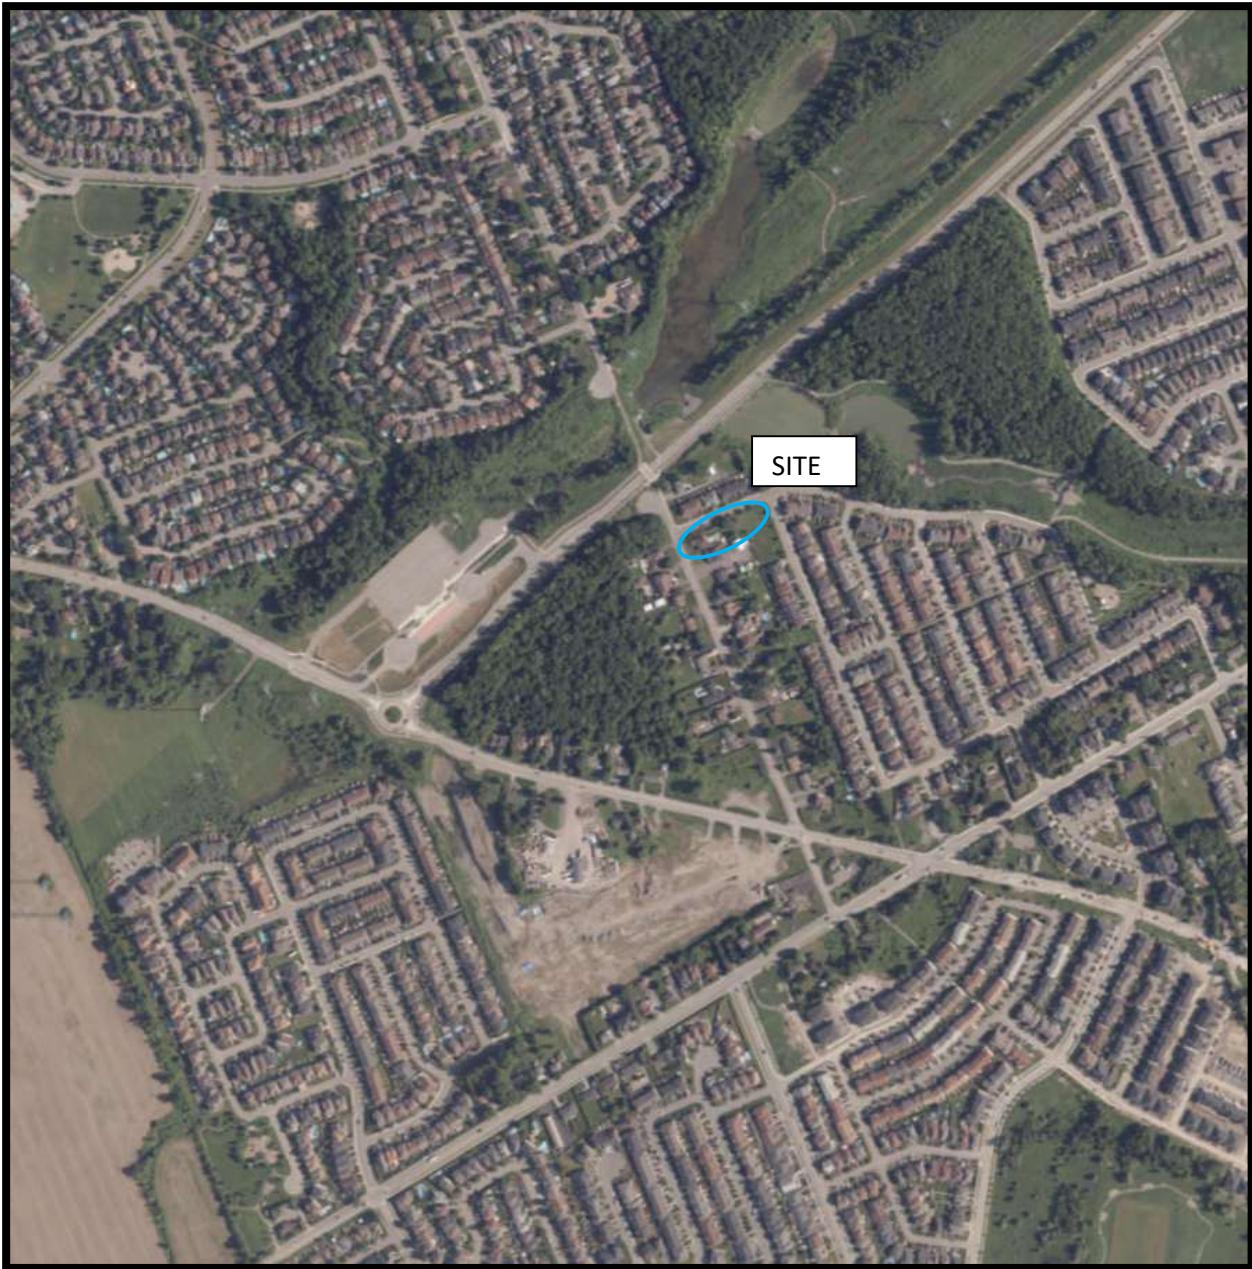
AERIAL PHOTOGRAPH  
2022

2022      There are no significant changes to the Phase I Property. The Phase I Study Area has undergone significant development. The area east of the site has been fully developed for residential use. Trailsedge Way is now visible running along the northern boundary of the Phase I Property. In addition, Pagé Road is now discontinued north and south of Brian Coburn Boulevard, which is visible north of the Phase I Property, forming 2 cul-de-sacs. The OC Transpo park and ride is now present west of the Phase I Property, across Brian Coburn Boulevard. No other changes were noted.

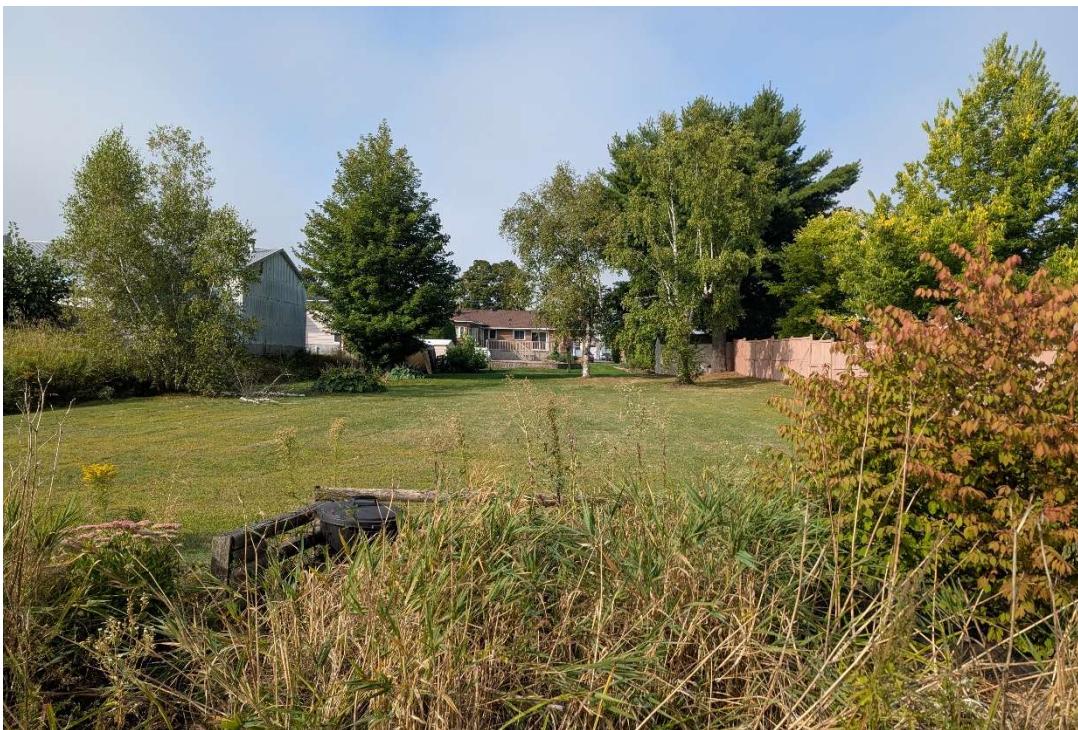
Photograph 1: View of Phase I Property from eastern property boundary.

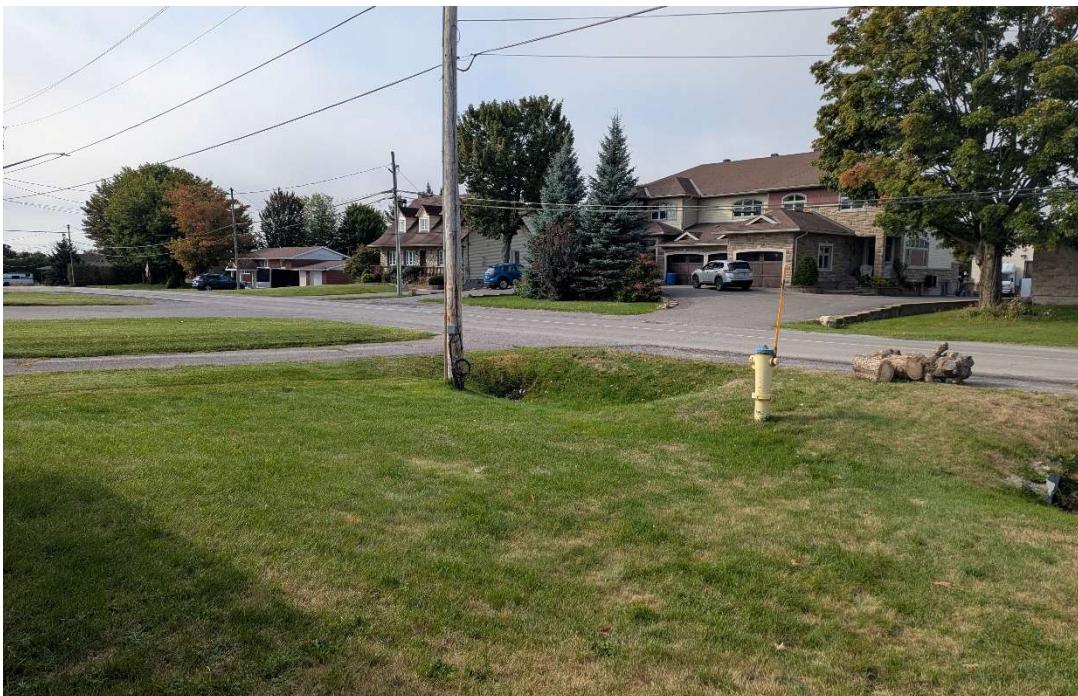
Photograph 2: View of southwest corner of Phase I Property.

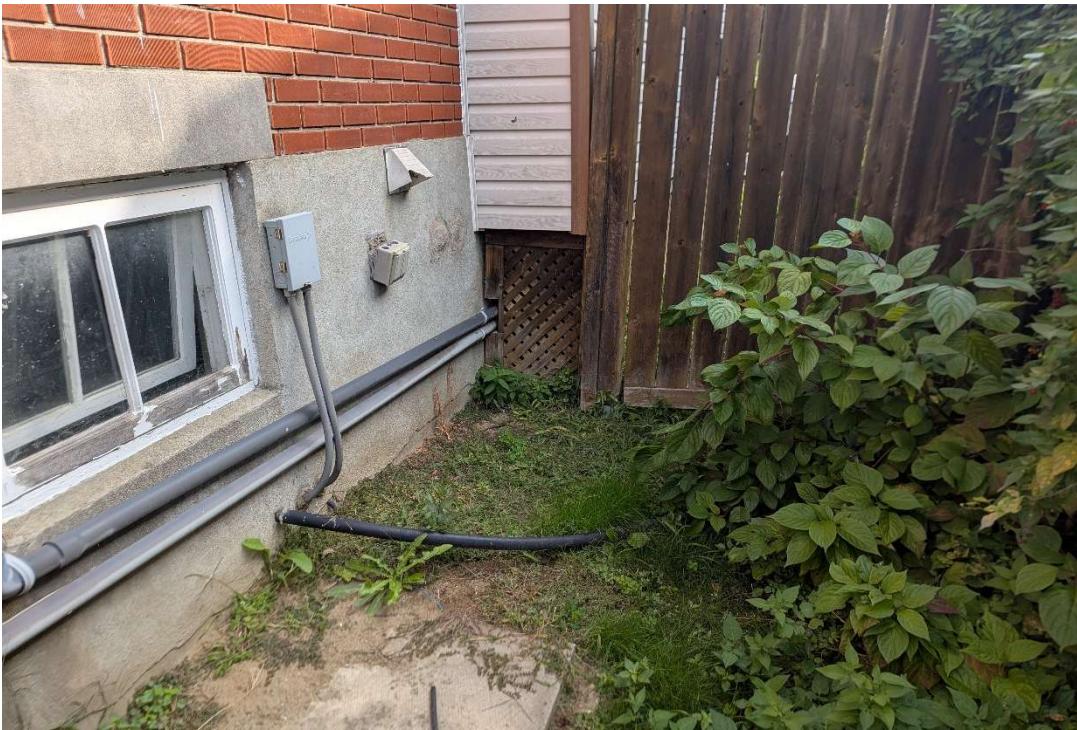
Two circular patches were observed on the south side of the building, indicating former fill and vent pipe locations, which are evidence of a former aboveground storage tank (AST) in the building. No staining or odours were observed in the vicinity of the former fill and vent pipes. No evidence or indications of current ASTs or underground storage tanks (USTs) were observed on the exterior of the building during the site visit. Various chemicals related to pool cleaning and maintenance were observed in one of the sheds in the yard. All chemicals appeared to be stored properly and there were no signs of spillage or staining. No concerns were identified with the presence of the chemicals currently stored on the Phase I Property. The former AST and associated piping is considered a PCA and is discussed in Section 7.1.

Photograph 3: Southern wall of residential dwelling; note former fill/vent pipe location.

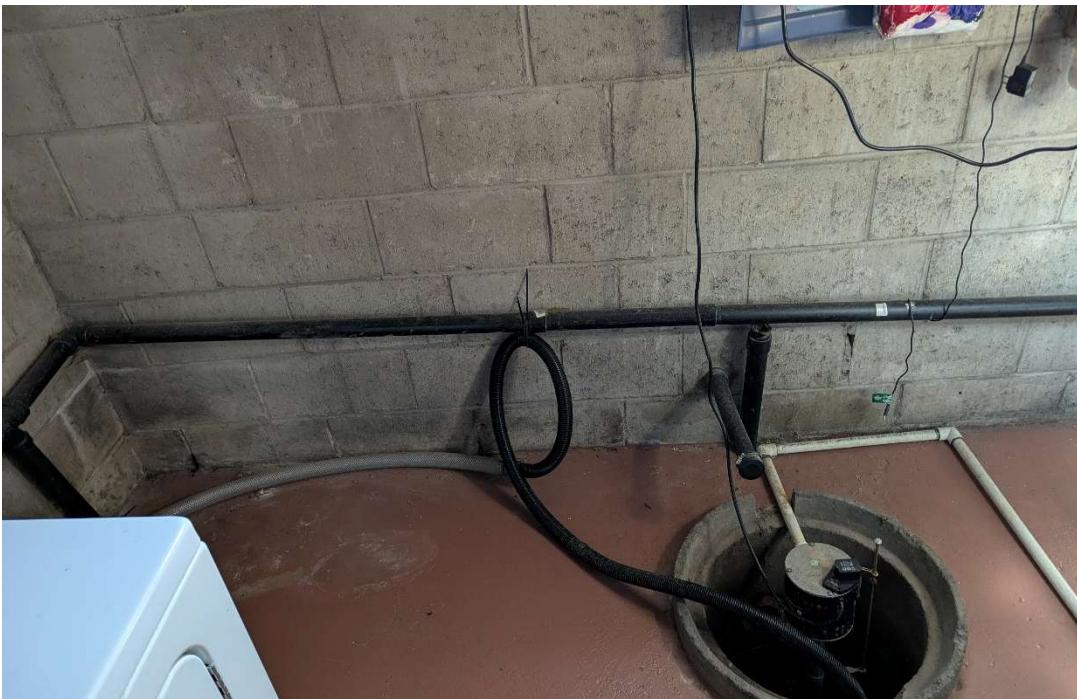
Wastewater is discharged into the municipal sewer system. Wastewater includes wash water, occasional pool and spa drain water, and sewage. One sump pit was observed in the basement. It did not appear to be operational. Stagnant water was observed in the sump. The water had no odour, but did have an organic sheen, not related to petroleum hydrocarbons. The property owner believes that this sump operated before the extensive residential development in the area (i.e., before the current municipal stormwater management system was constructed). No concerns have been identified with wastewater discharge.

Photograph 4: Out-of-use sump located in basement of residential dwelling.
