Geotechnical Investigation

Proposed Residential Development
2009-2013 Prince of Wales Drive
Ottawa, Ontario
Revision 4

LRL File No.: 220528

December 2022, Revised: January 2026

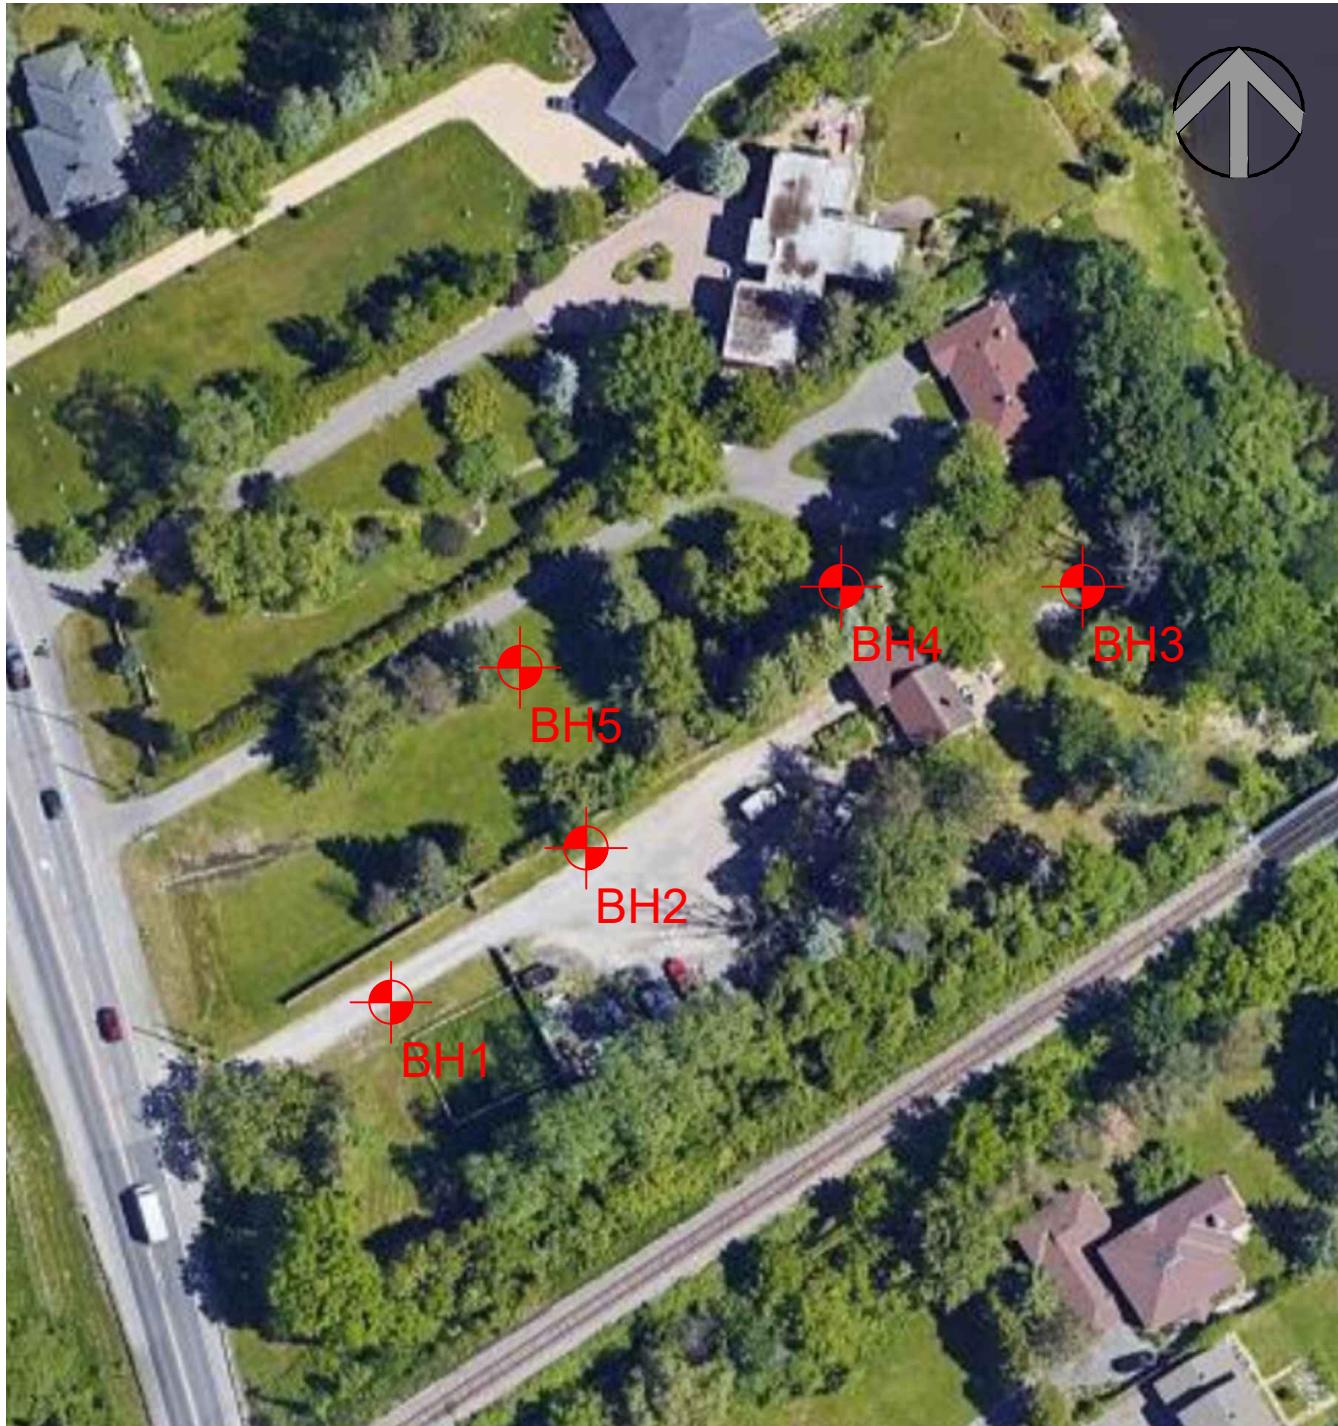
FIGURE 2

The fieldwork for this investigation was carried out on November 28, 2022. Prior to the fieldwork, the site was cleared for the presence of any underground services and utilities. A total of five (5) boreholes were drilled onsite to get a general representation of the site's underlying soil conditions, and labelled BH1 through BH5. The approximate locations of the boreholes are shown in Figure 2 included in **Appendix A**.

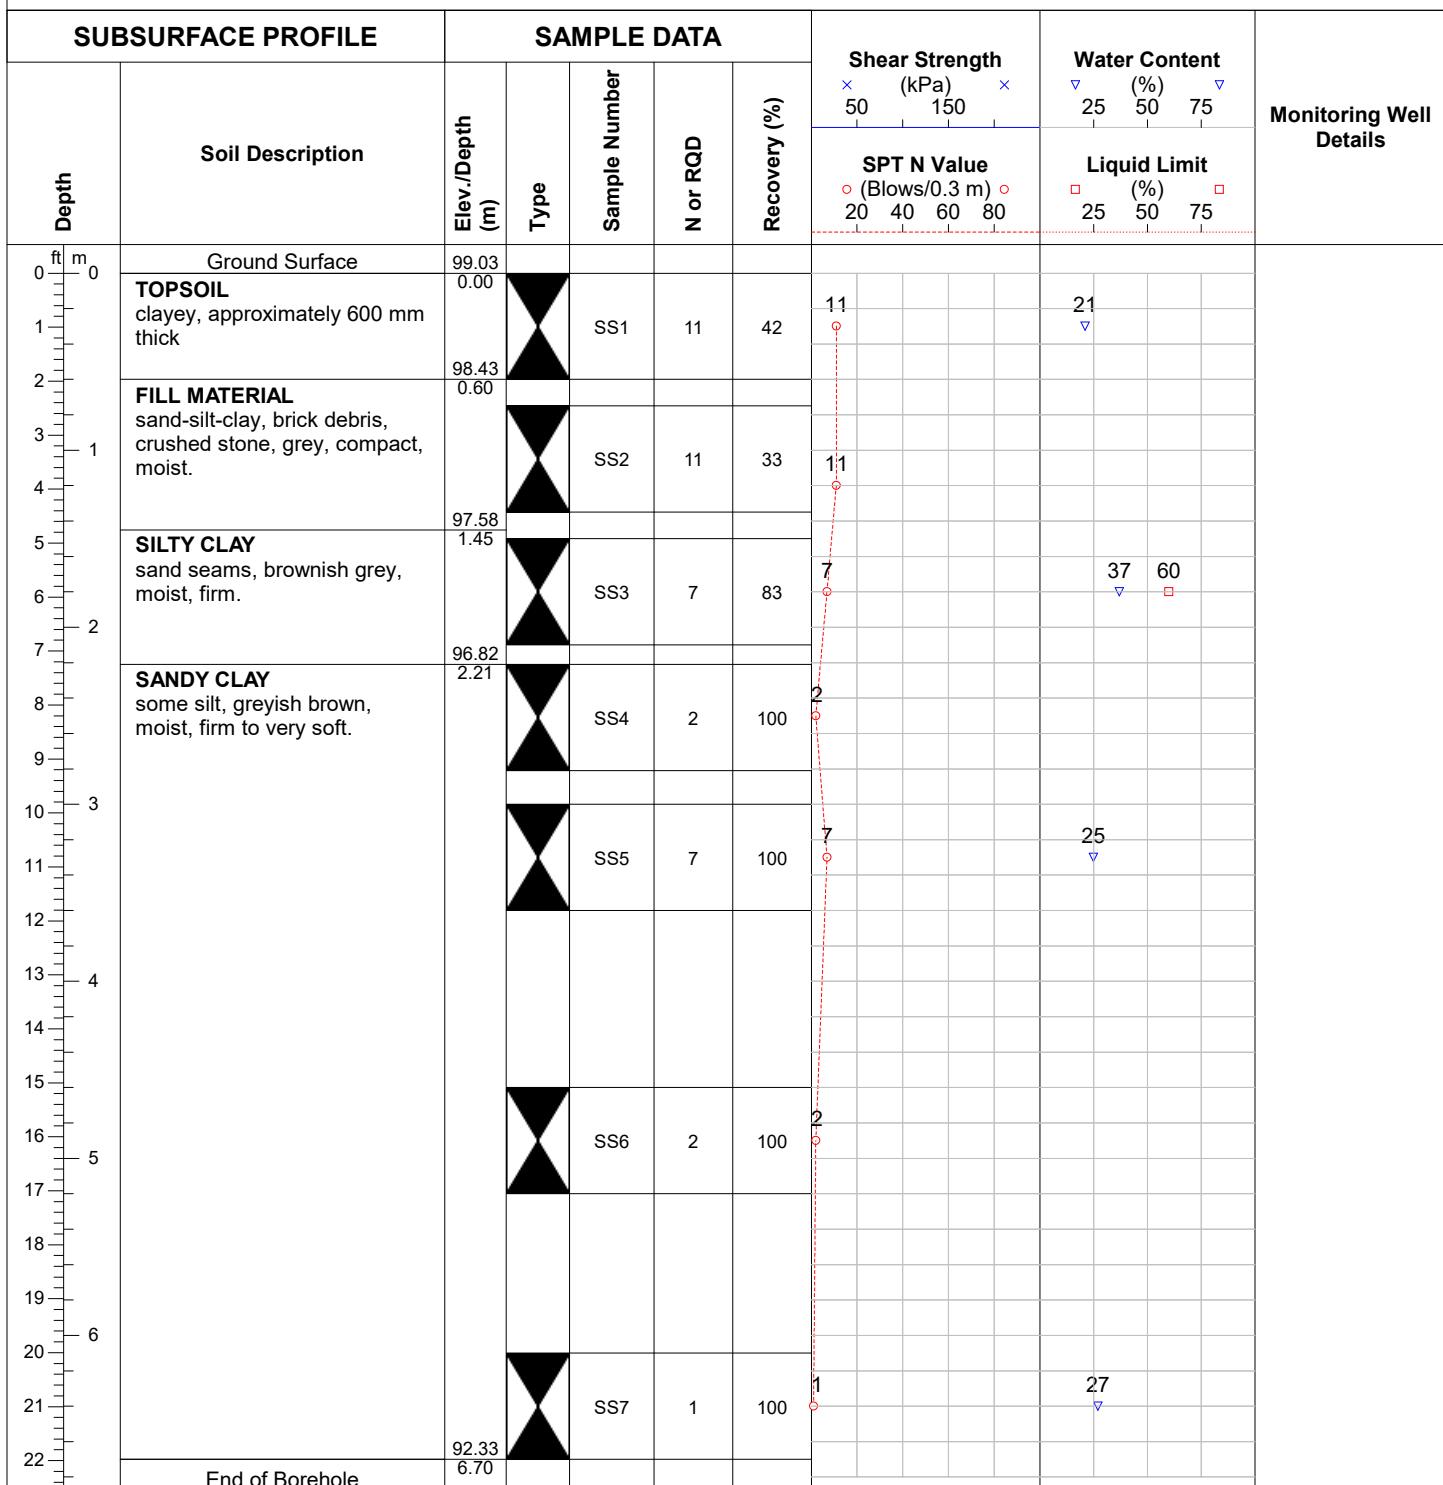
Drilling Equipment: Truck Mount CME 75

Drilling Method: Hollow Stem Auger

Easting: 445177 m

Northing: 5021522 m

Underlying the topsoil in BH1 and at the surface of BH2, a layer of fill material was encountered and extended to a depth of 1.45 m bgs. This material can generally be described as a mixture of sand-silt-clay, some crushed stone, grey, and moist. The SPT "N" values were found ranging between 11 and 27, indicating the material is compact. The natural moisture content was found to be 10%.

Underlying the fill material in BH1, a layer of silty clay was encountered and extended to a depth of 2.21 m bgs. This material had some sand seams, brownish grey in colour, and moist. The SPT "N" value was found to be 7, indicating the material is firm. The natural moisture content was found to be 37%.

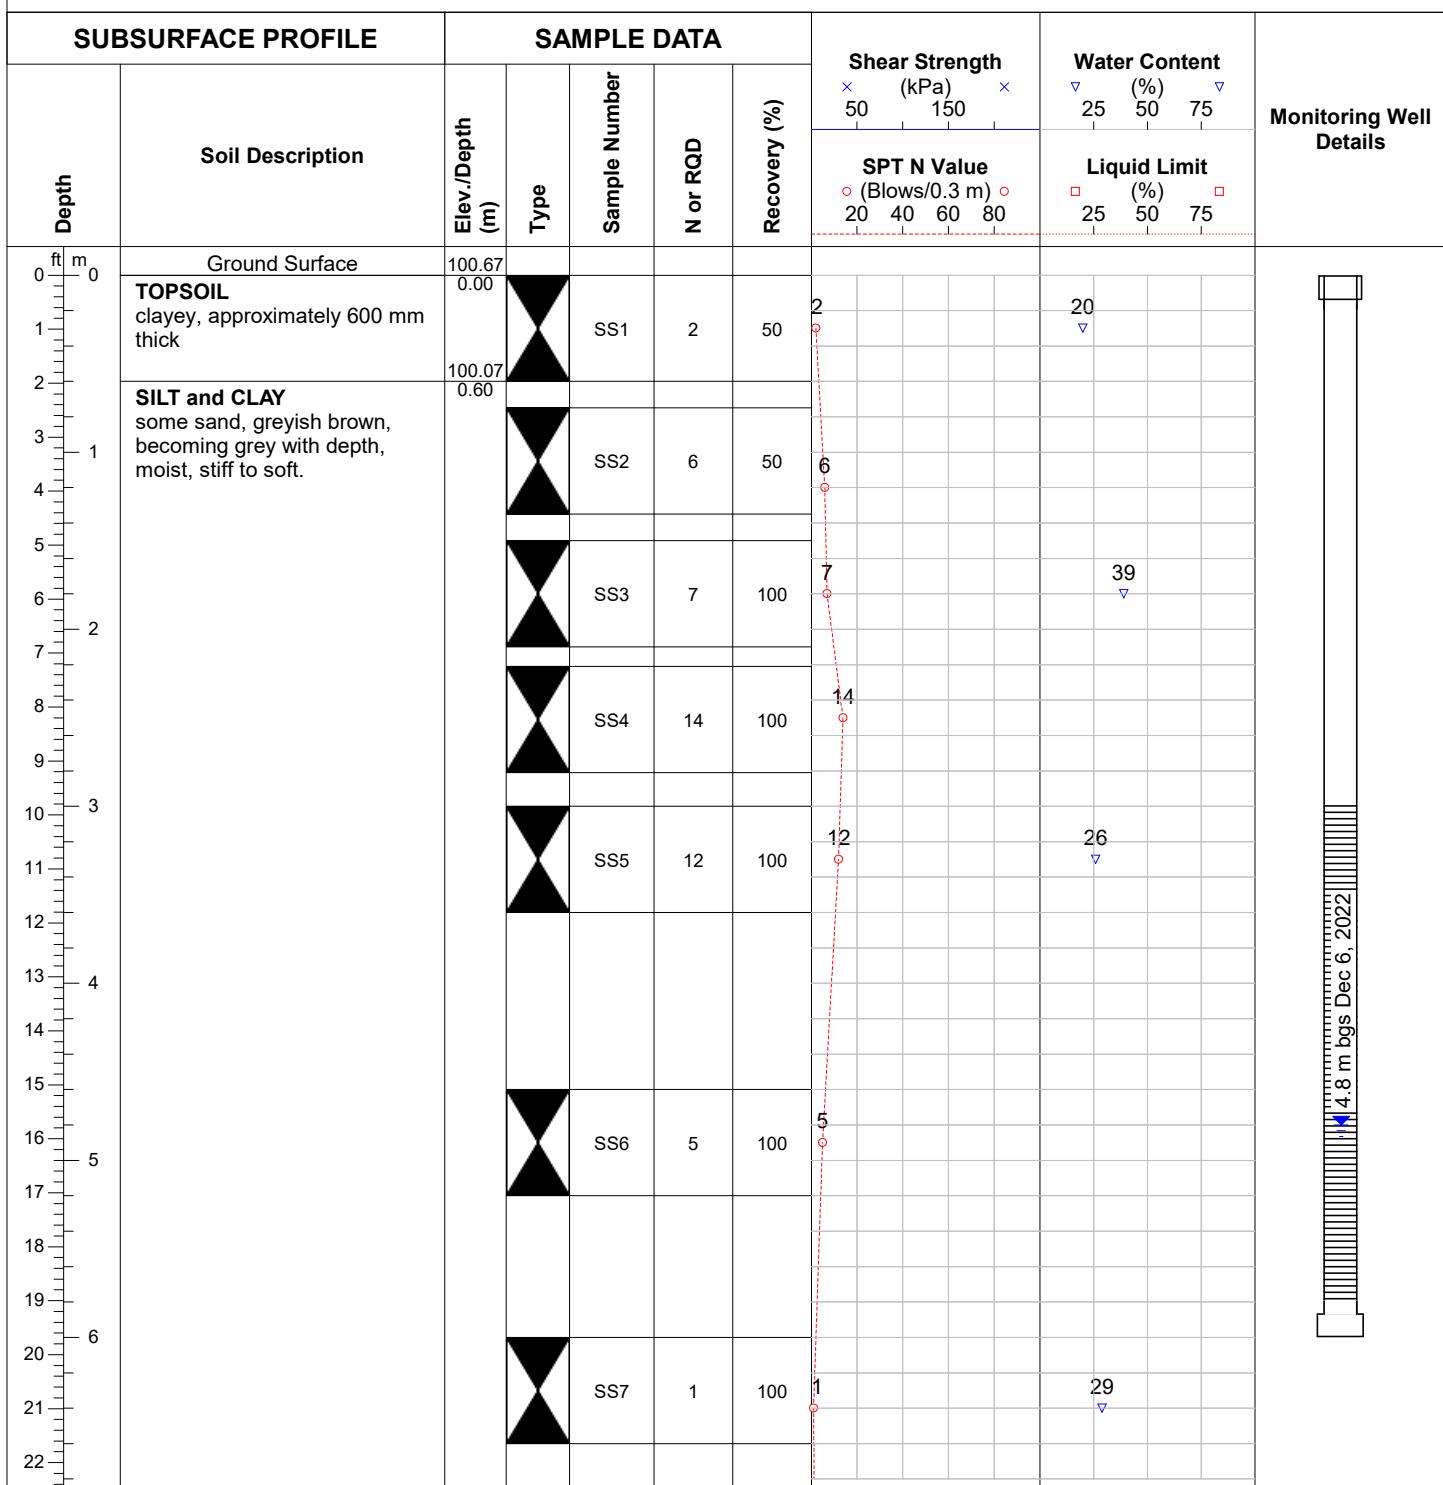
Drilling Equipment: Truck Mount CME 75

Drilling Method: Hollow Stem Auger

Easting: 445263 m

Northing: 5021584 m

Underlying the topsoil in BH3, a layer silt and clay was encountered, and extended to a depth of 8.23 m bgs. (end of exploration). The material had some sand, greyish brown to grey, and moist. The SPT "N" values were found ranging between 14 and 1, indicating the material is stiff to very soft with increased depth. The natural moisture contents were found to range between 26 and 39%.

The piezometer was measured on December 6, 2022. The water was found to be at 4.8 m bgs. The ground water level is shown on its respective borehole log.

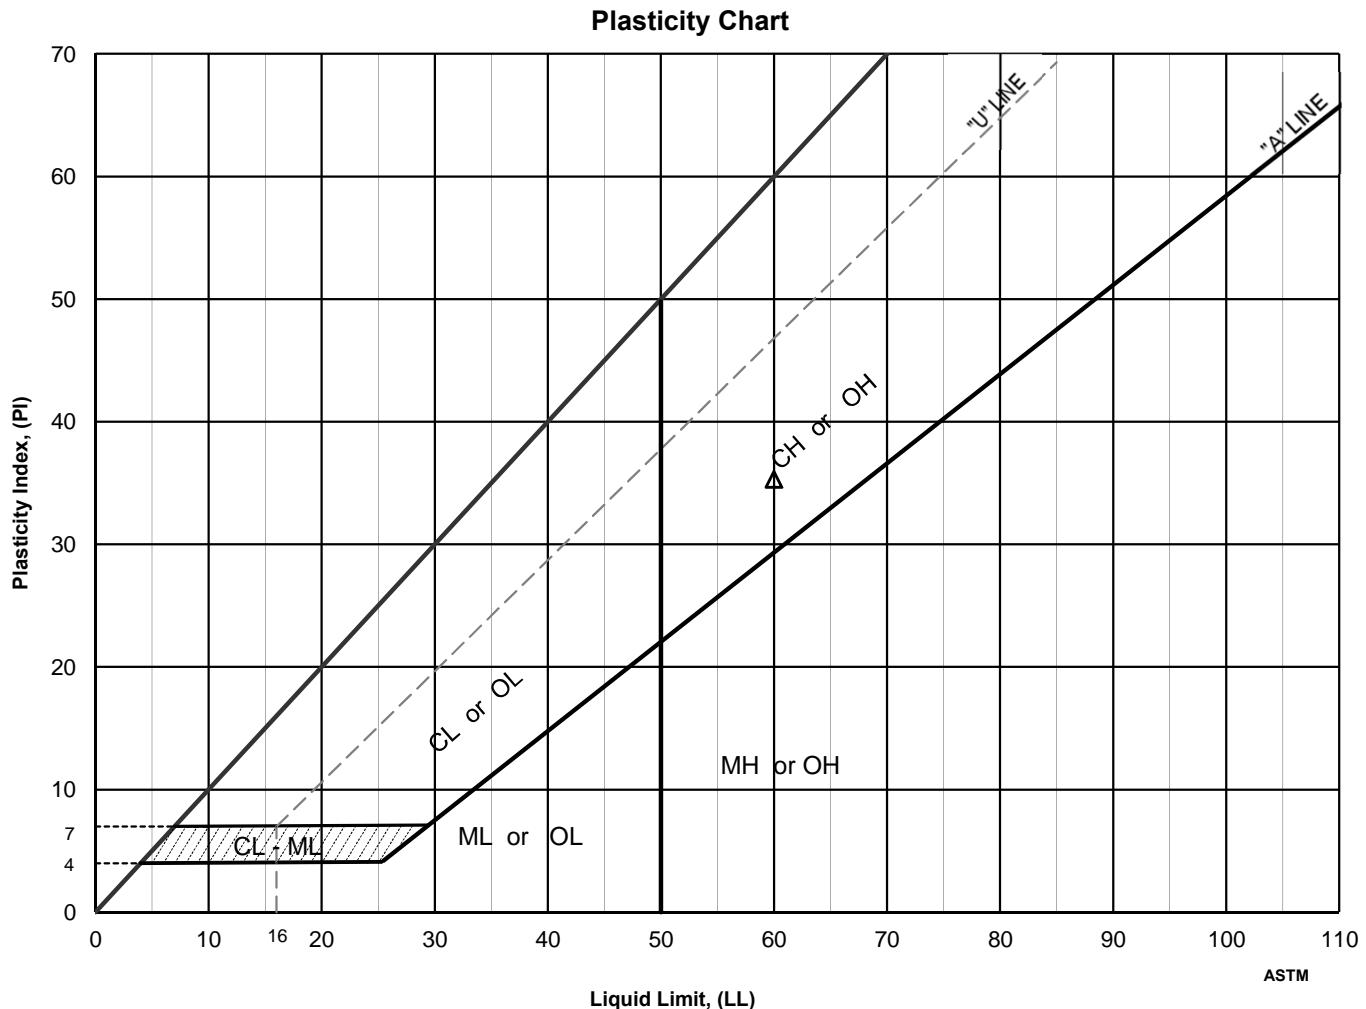
File No.: 220528
Report No.: 1
Date: November 28, 2022

Location	Sample	Depth, m	Moisture Content, %	Liquid Limit	Plastic Limit	Plasticity Index	Liquidity Index	Activity Number	USCS
BH 1	SS-3	1.52 - 2.13	37	60	25	35	0.36	n/d	CH

Atterberg limits and moisture contents were conducted on a split spoon soil sample. Based on the test result, the values indicate that the subsoils contain inorganic clays of high plasticity.

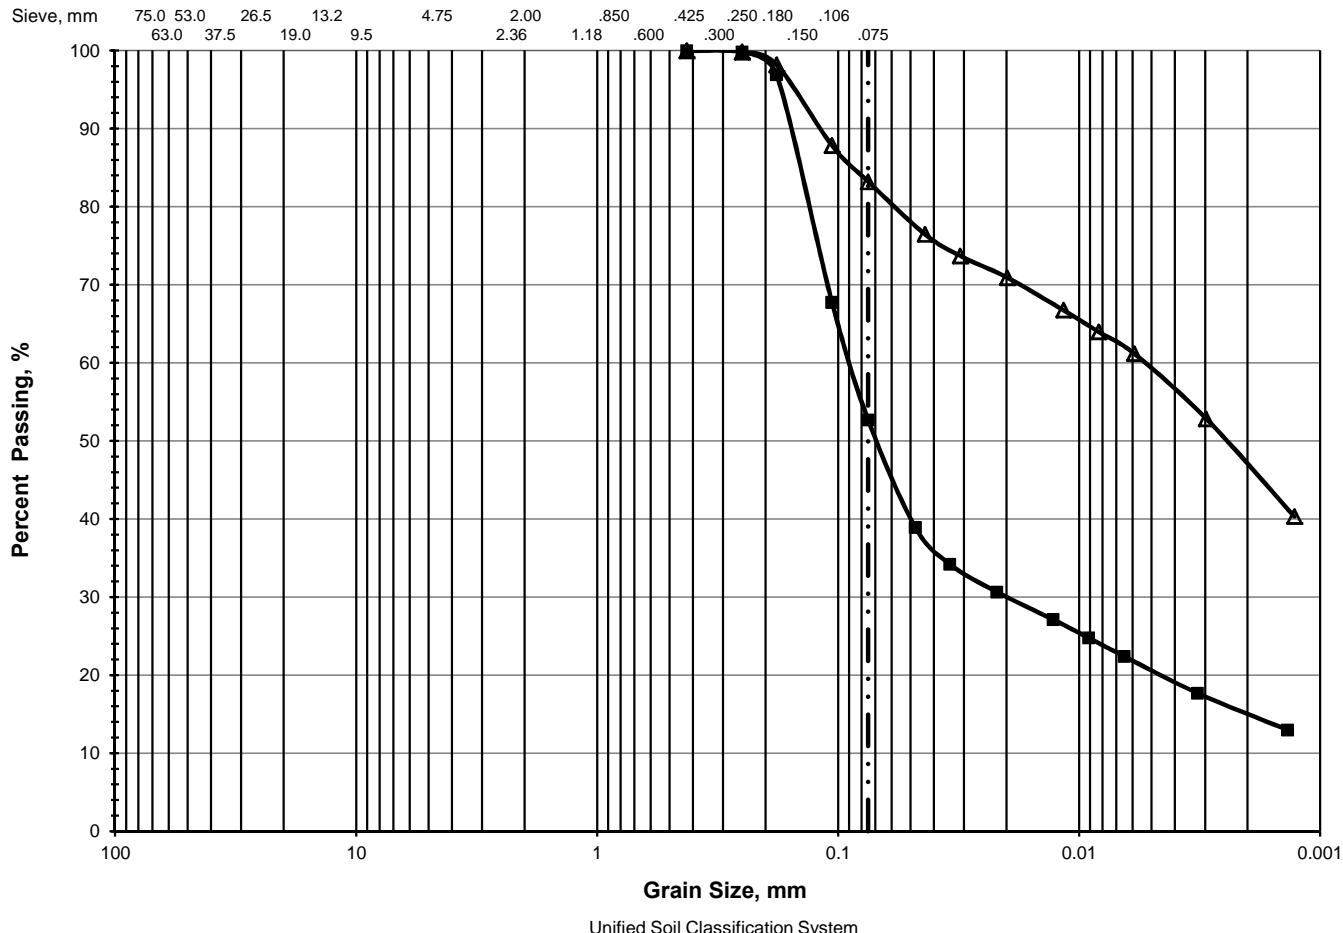
File No.: 220528
Report No.: 2
Date: November 28, 2022

> 75 mm	% GRAVEL		% SAND			% FINES	
	Coarse	Fine	Coarse	Medium	Fine	Silt	Clay
△	0.0	0.0	0.0	0.0	16.8	37.5	45.7
■	0.0	0.0	0.0	0.0	47.2	38.2	14.6

Location	Sample	Depth, m	D ₆₀	D ₅₀	D ₃₀	D ₁₅	D ₁₀	C _c	C _u
△	BH 3	SS-3	1.52 - 2.13	0.0055					
■	BH 5	SS-7	6.10 - 6.71	0.0900	0.0697	0.0203	0.0022

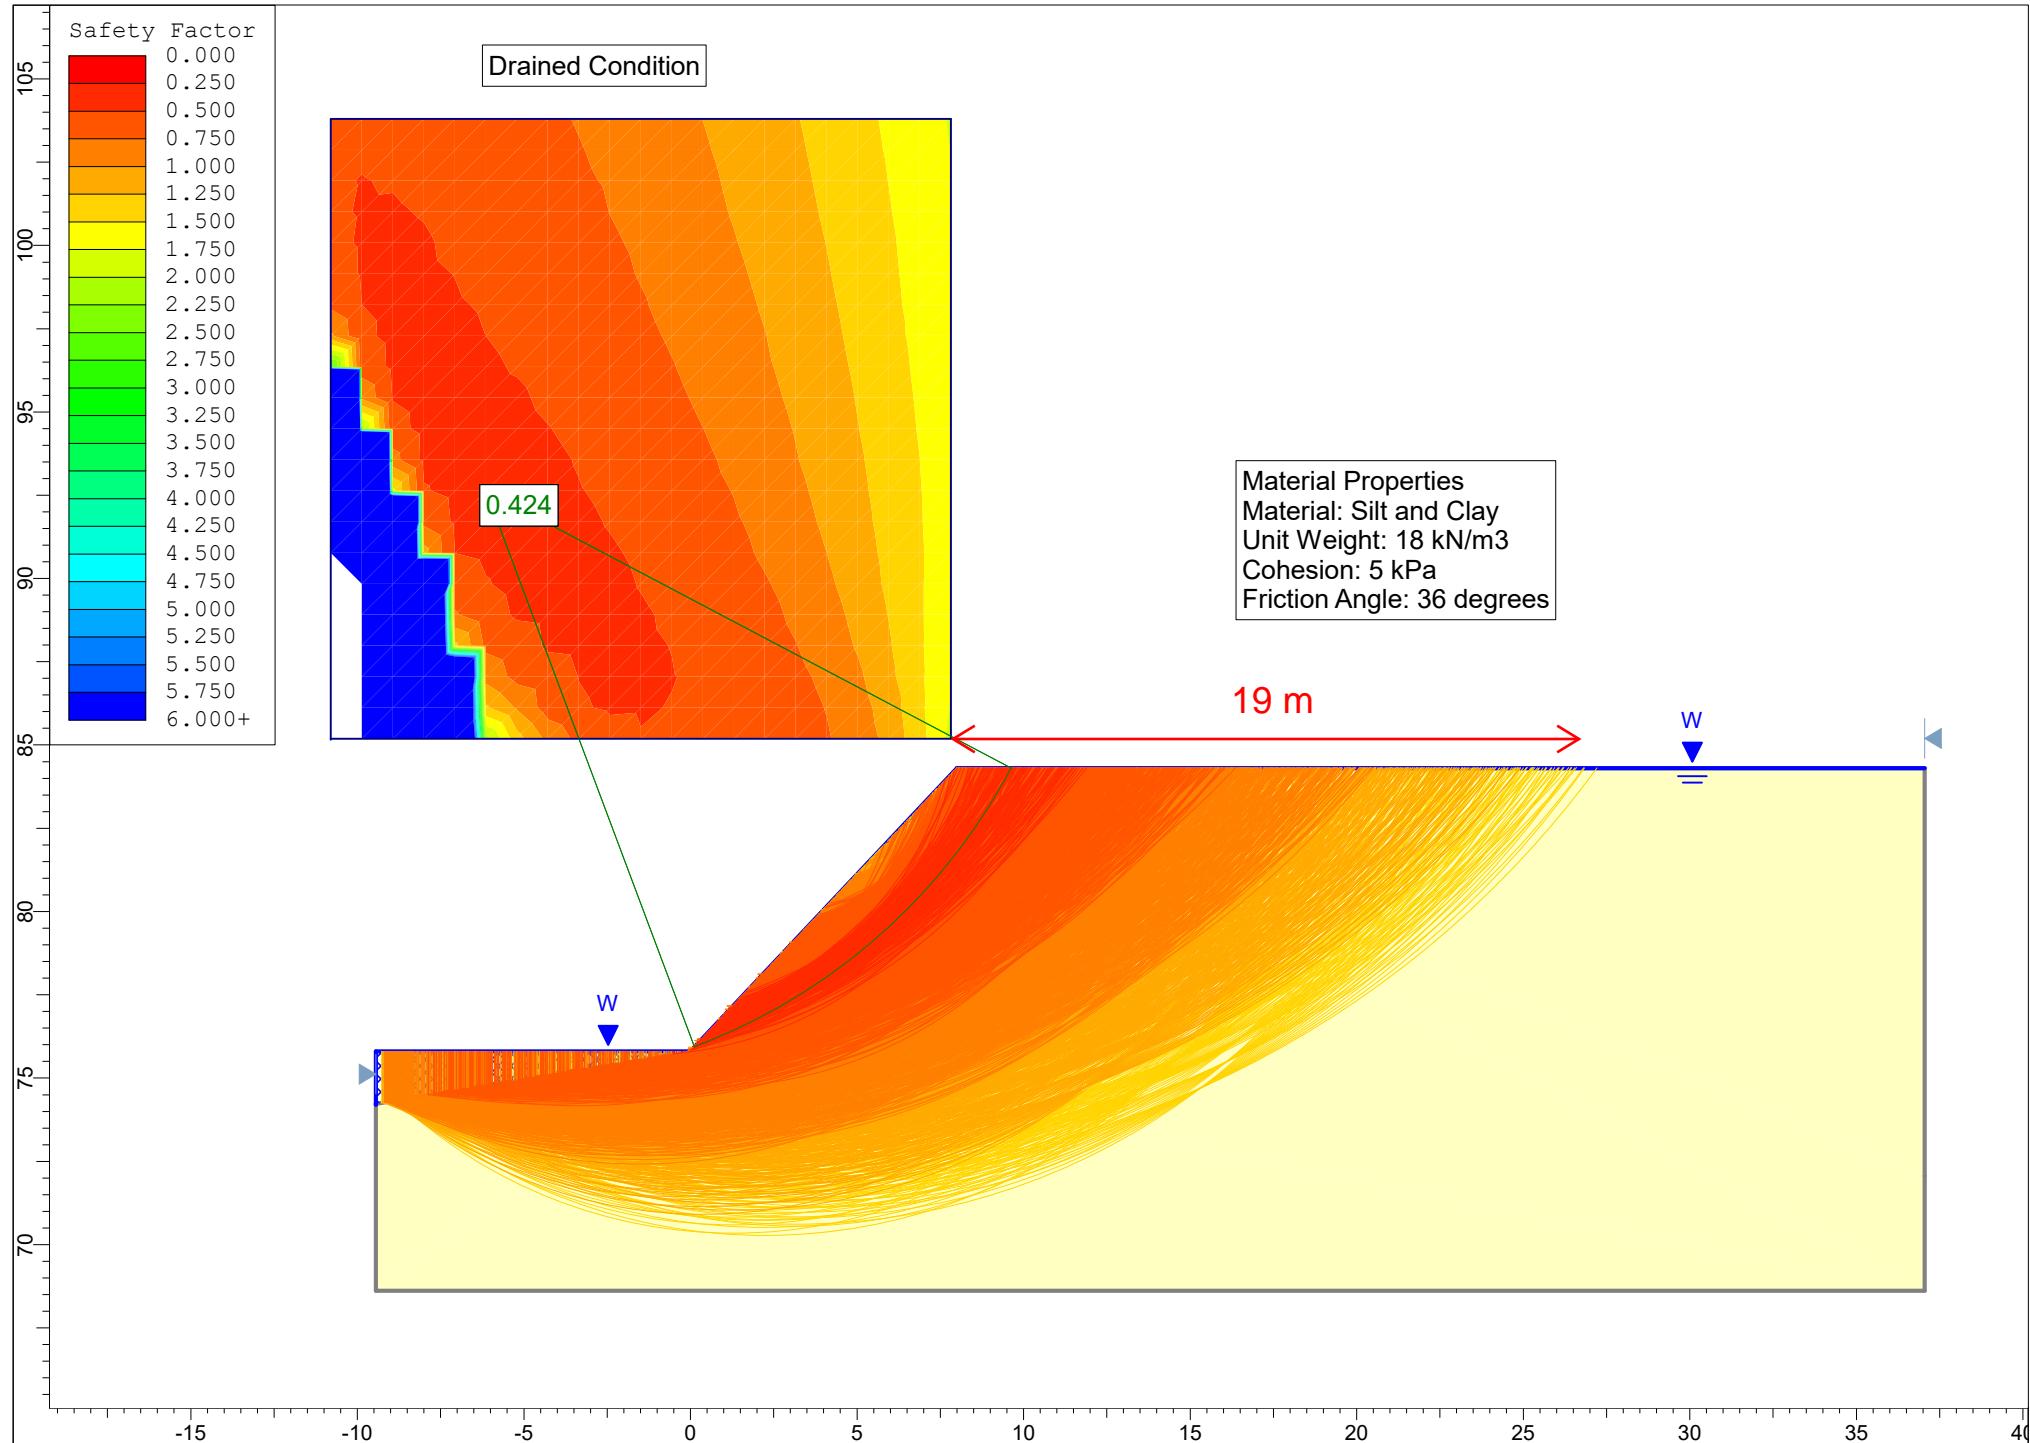
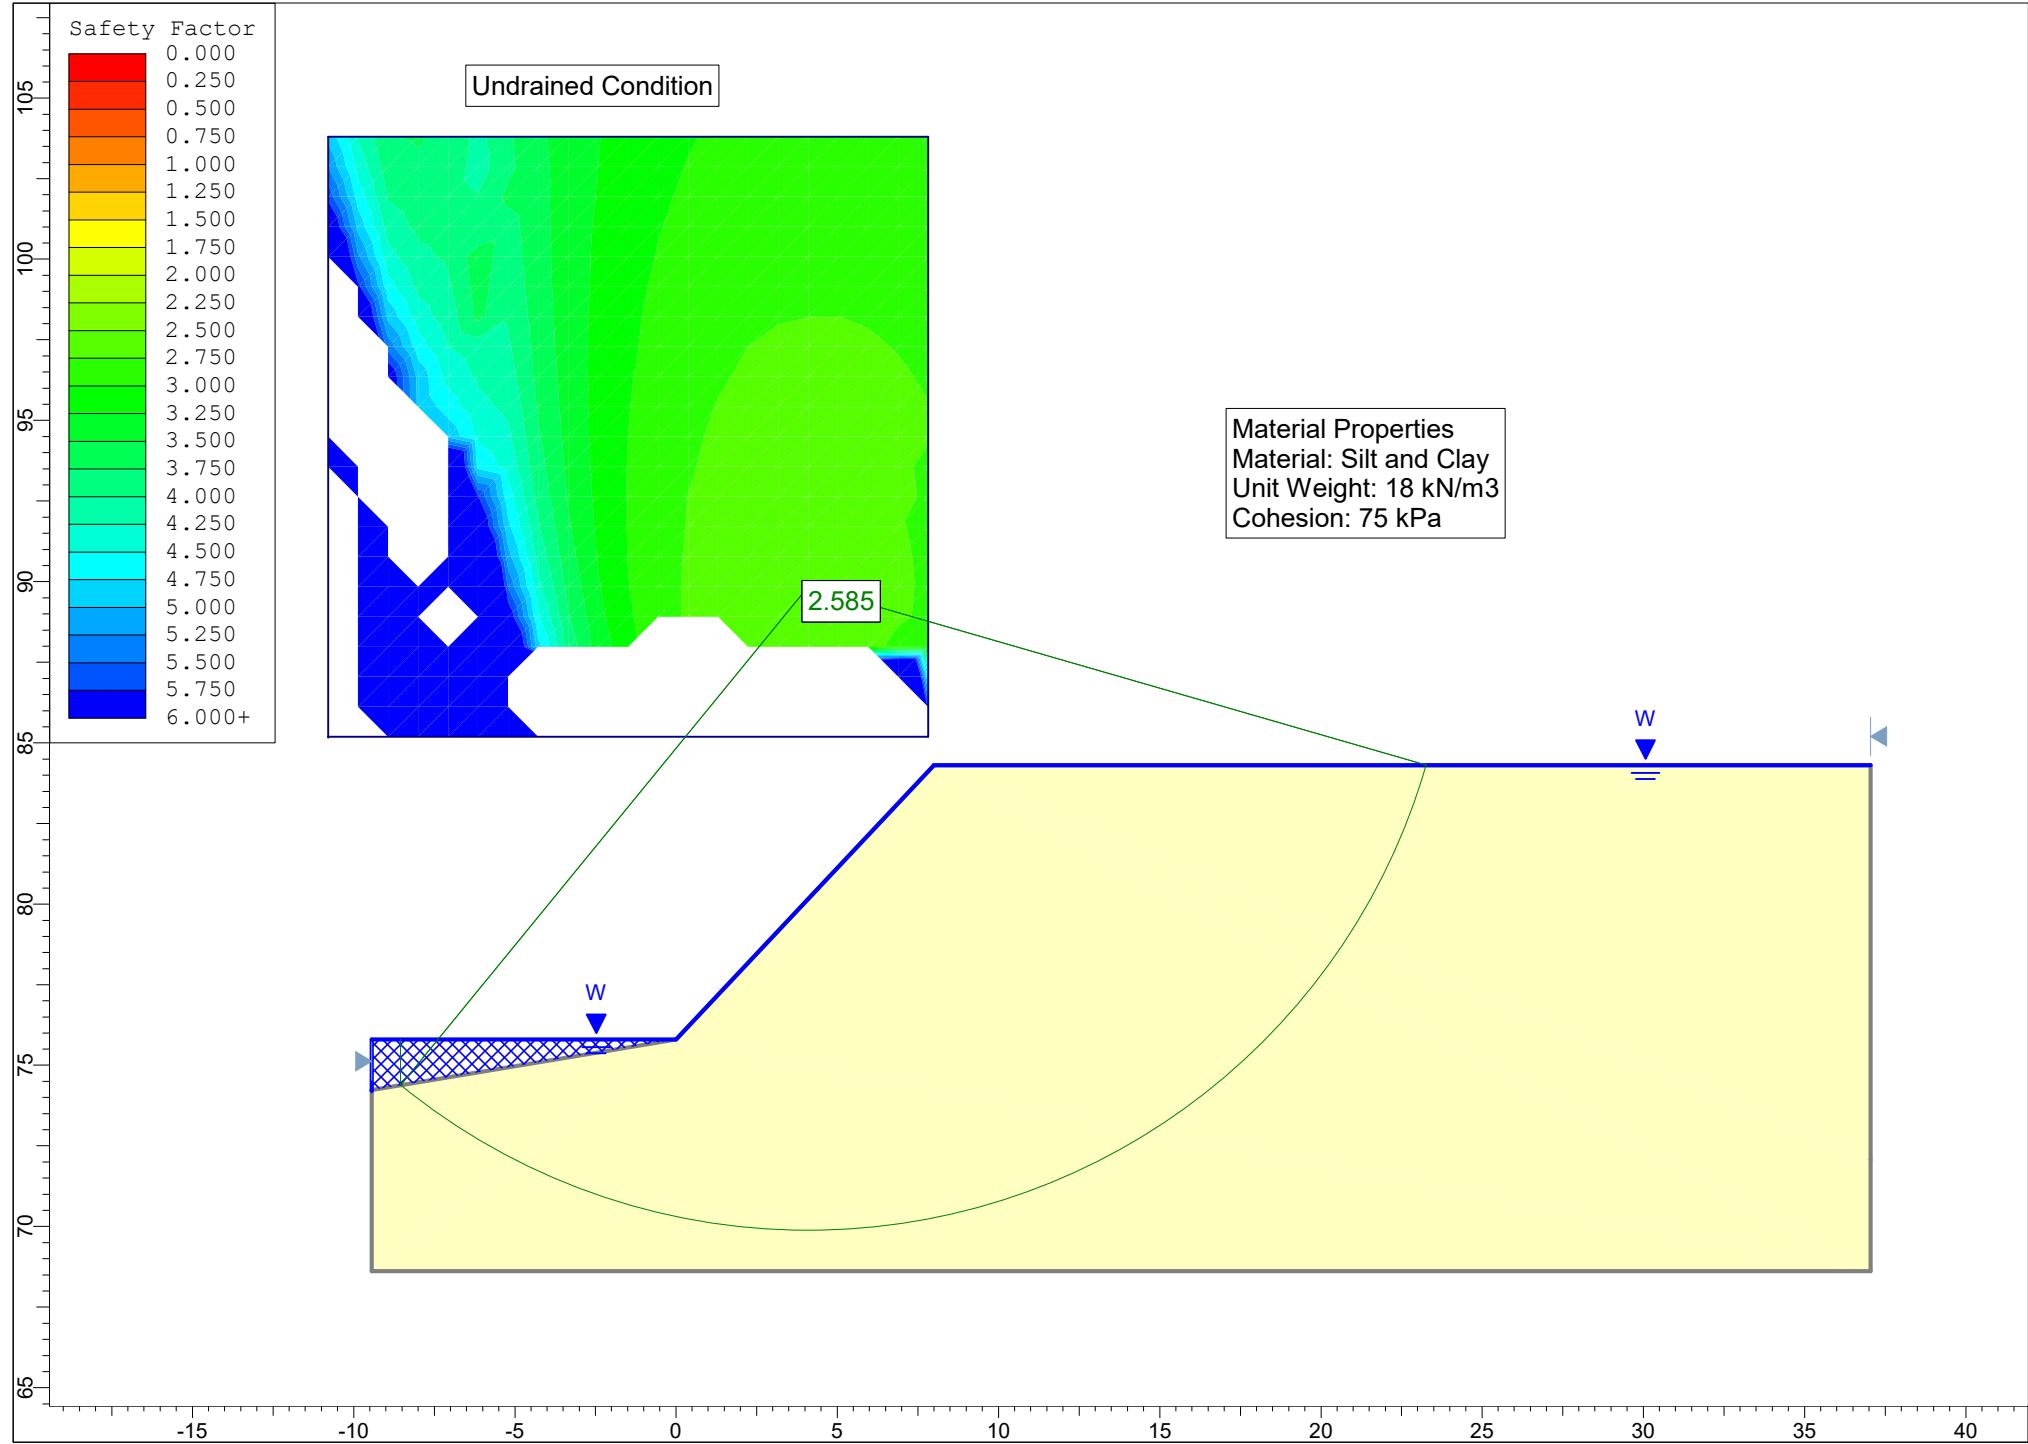
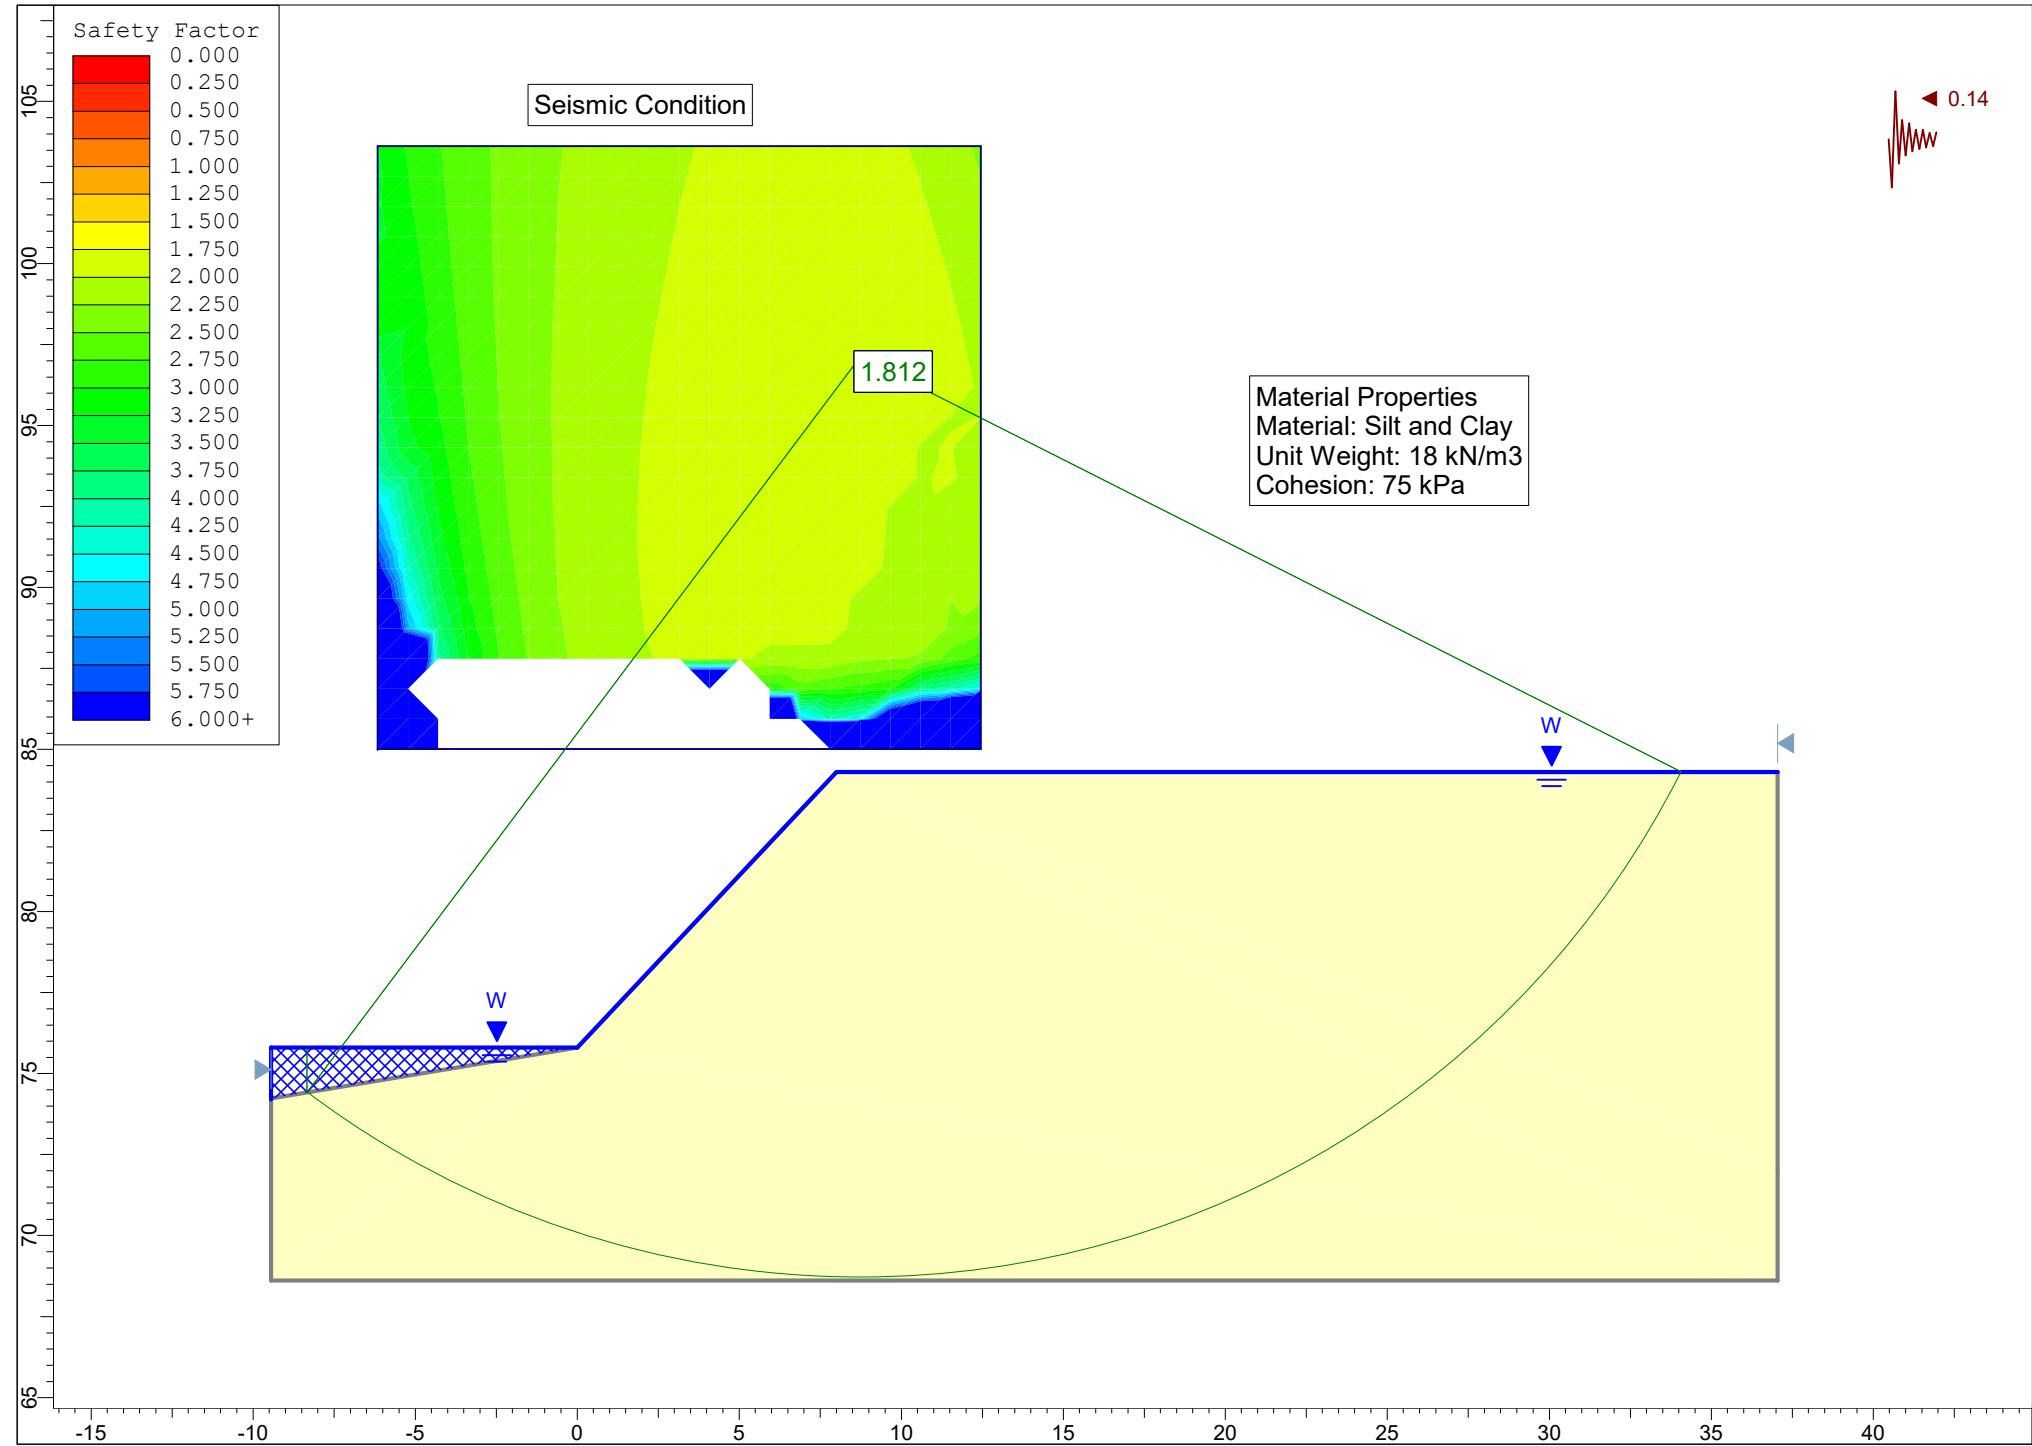
APPENDIX E
Slope Stability Modelling Results

The slope modelling program, Slide 5.0 (Rocscience), was used to implement the Bishop simplified method of slices. A slope profile, considered to be the steepest onsite (worst case scenario) was selected and modeled to check the conditions of the slope. The slope was analyzed under both the undrained (short term failure) and drained (long term failure) conditions.

Drained Condition	Undrained Condition	Seismic
Factor of Safety	0.42	2.59	1.81
Min. Required	1.50	1.50	1.10

These results indicate that the slope is unstable in the drained (long-term) condition. A setback for any permanent structure(s) (dwellings, decks, sheds, gazebos, pools, etc.) from the top of the slope is required to ensure that in the event of a slope failure, the structure(s) will be unharmed. The model was filtered to illustrate the failure surface with a FOS below 1.50.

The Stable Slope Allowance is the area where a factor of safety is less than 1.50 against overall rotational failure. As indicated in the attached model, **a 19.0 m setback is required for Stable Slope Allowance**.
