Phase One Environmental Site Assessment

1316 Carling Avenue
Ottawa, Ontario

**Homestead Land Holdings
Limited**

Pinchin File: 362140

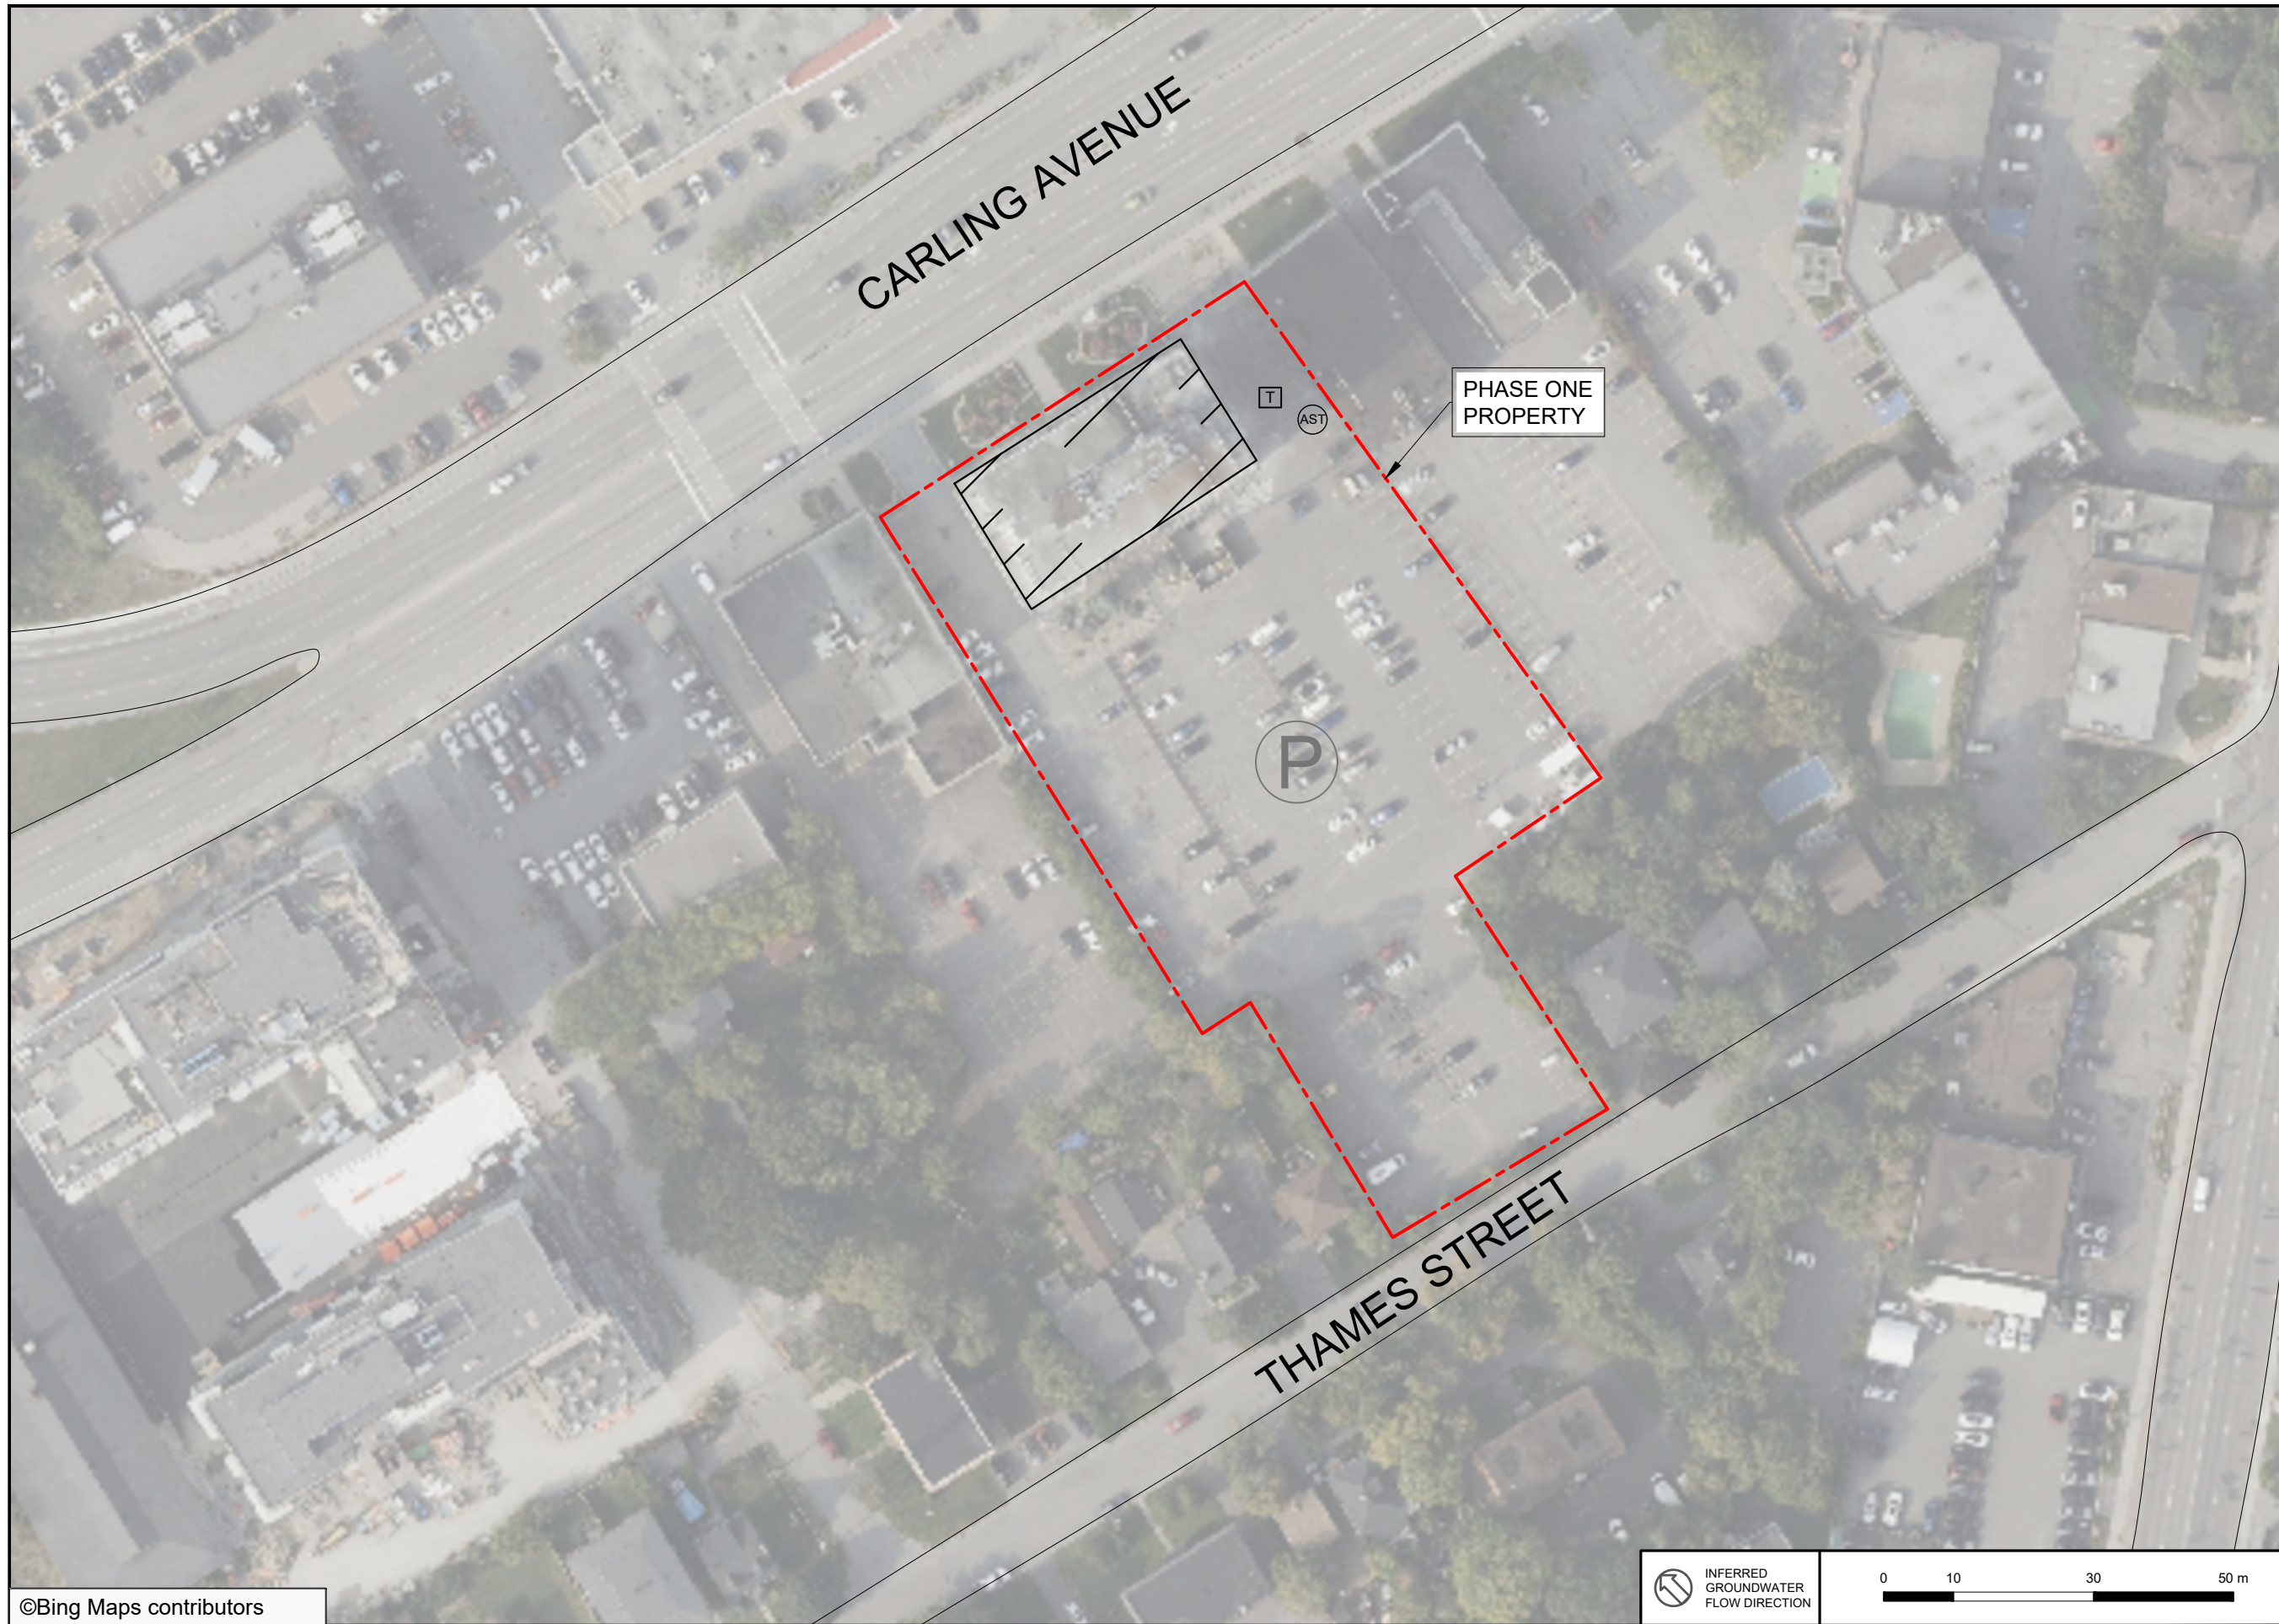
DATE: MARCH 2026	FIGURE NUMBER: 2
---------------------	---------------------

PHASE ONE PROPERTY

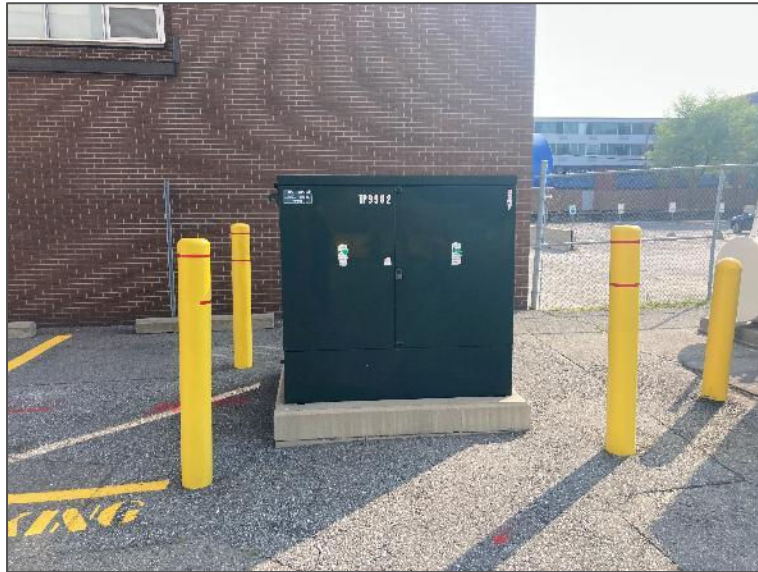
Photo 7 –Photo of transformer located on the northeast portion of the Phase One Property, looking east.

- A pad-mounted transformer located on the northeast portion of the Phase One Property (PCA-7). This PCA is not considered to result in an APEC, based on Pinchin's observation in the vicinity of the transformer (i.e., no staining), and the fact that any spillage from the transformer would be the responsibility of the transformer owner (Hydro Ottawa).

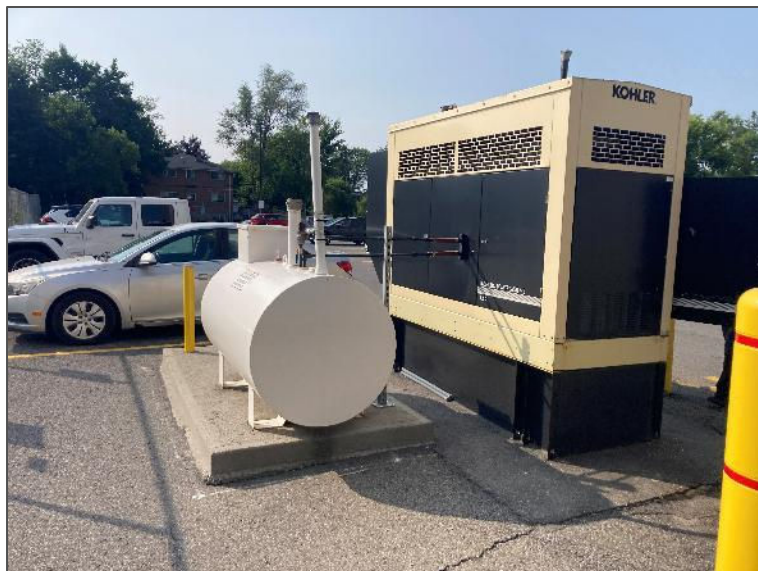
Photo 8 – Photo of generator and associated diesel AST located on the north east portion of the Phase One Property, looking south.

- A diesel generator and associated diesel AST located on the northeast portion of the Phase One Property (PCA-6). This PCA is not considered to result in an APEC, based on Pinchin's observation in the vicinity of the AST (i.e., no staining), the fact that the tank is double-walled and given that the underlying surface is asphalt.

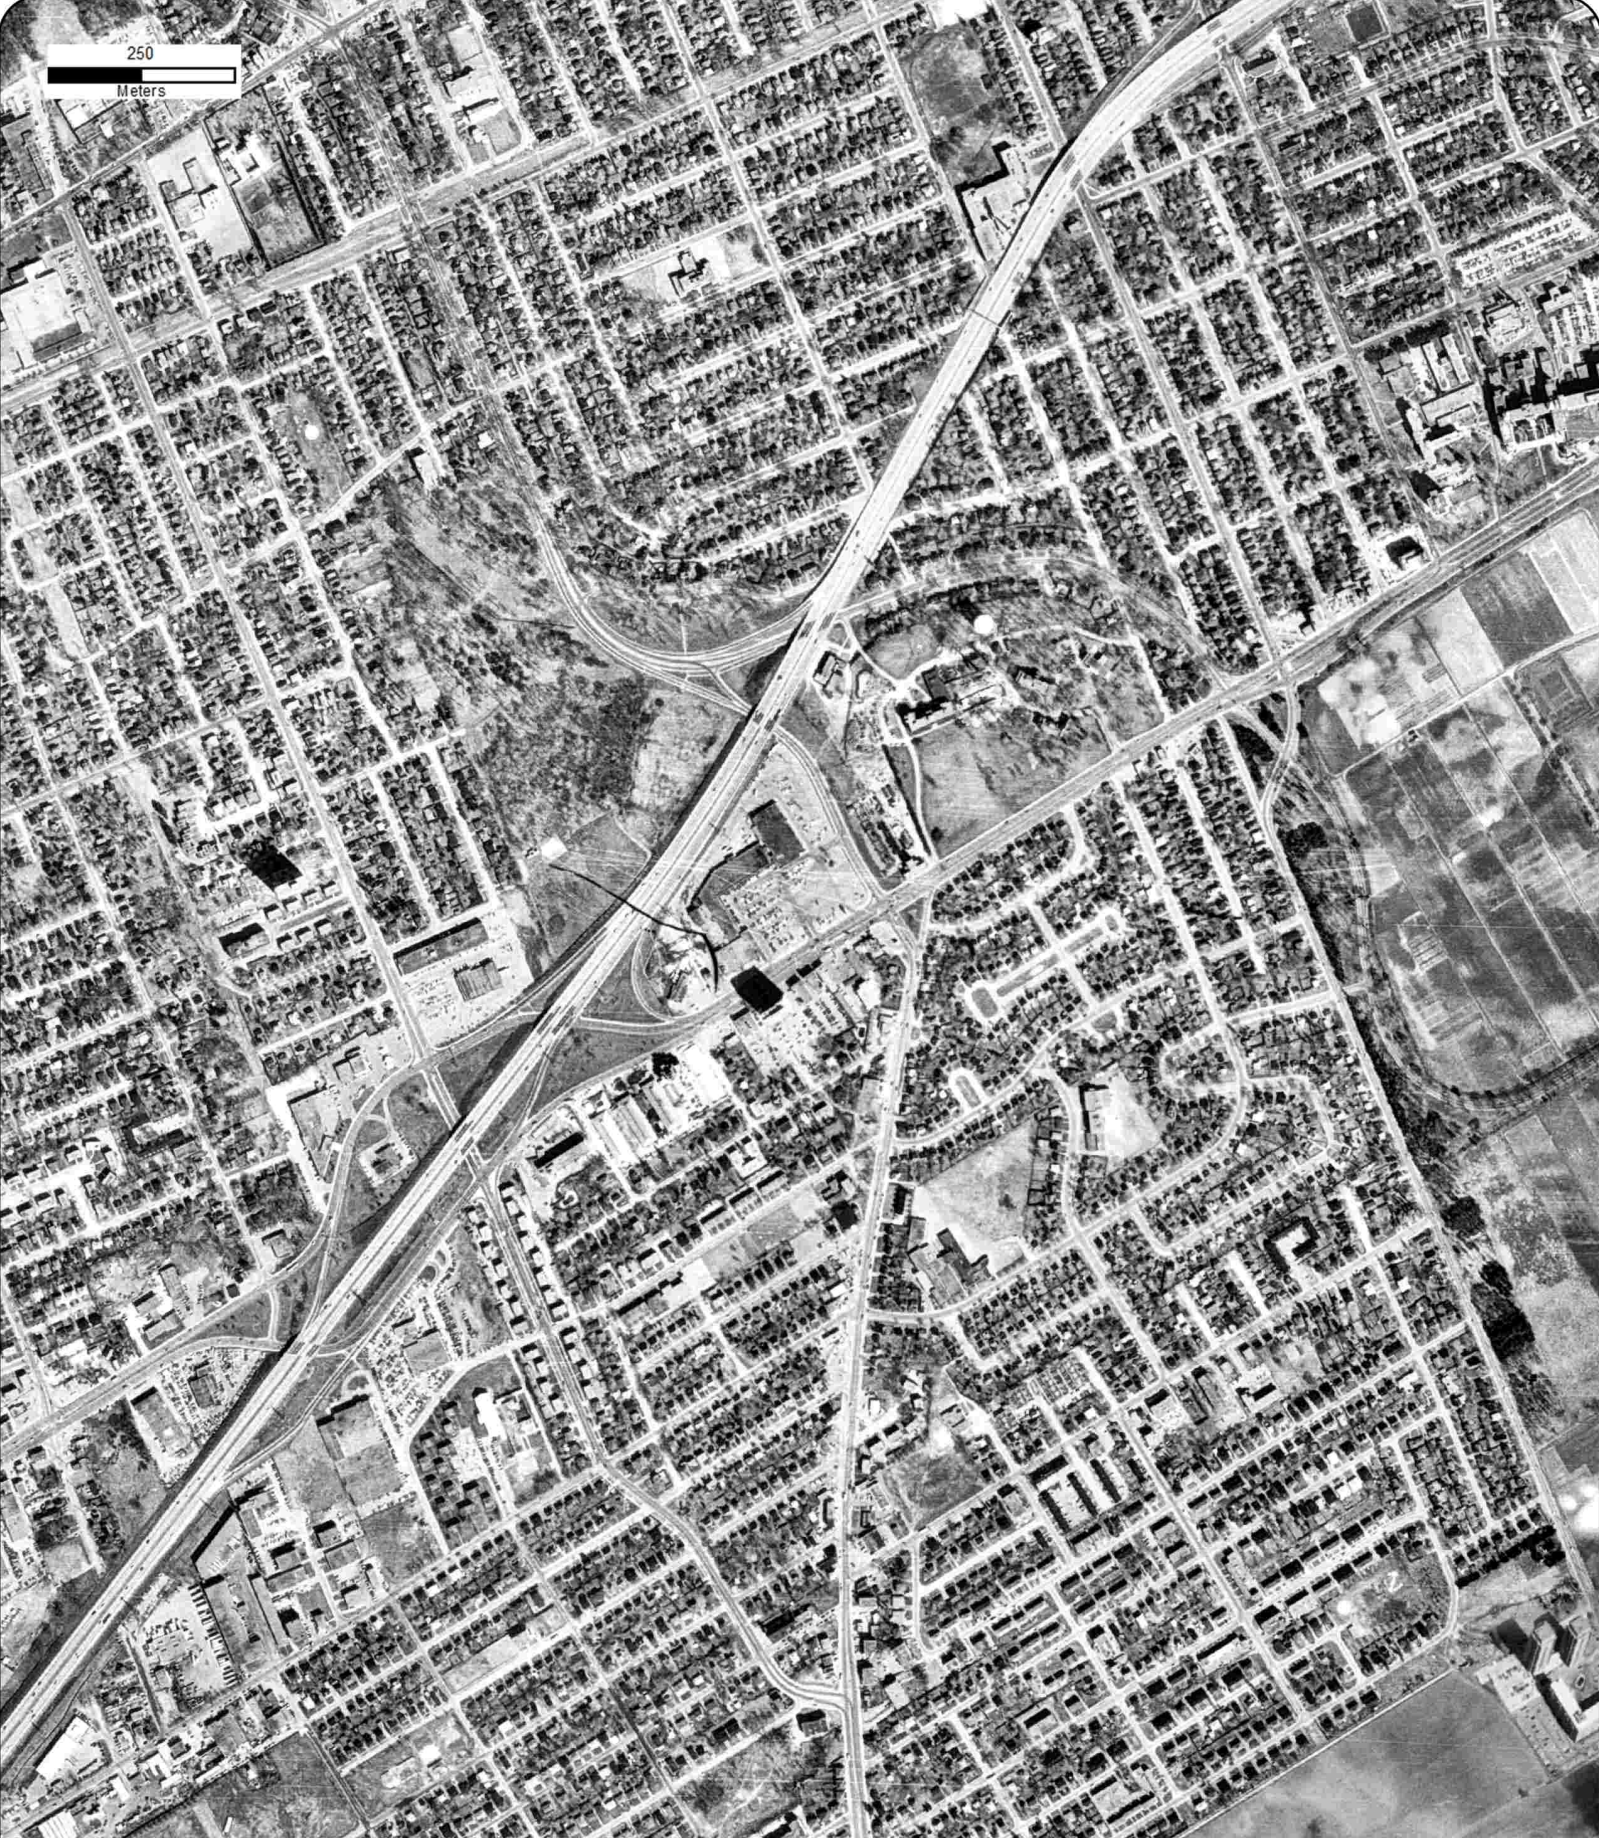
Year: 1973
Source: NAPL
Scale: 10,000
Comment:

Year of Photograph	Phase One Property
1973	The other two previously noted buildings appeared to be demolished and one building was visible on the Phase One Property which was similar in size, shape and orientation to the present-day Site Building.
1978	Same as above.
1981	Same as above.
1987	Same as above.
1996	Same as above.
2001	Same as above.
2004	Same as above.
2008	Same as above.
2014	Same as above.
2019	Same as above.
2025	Same as above.

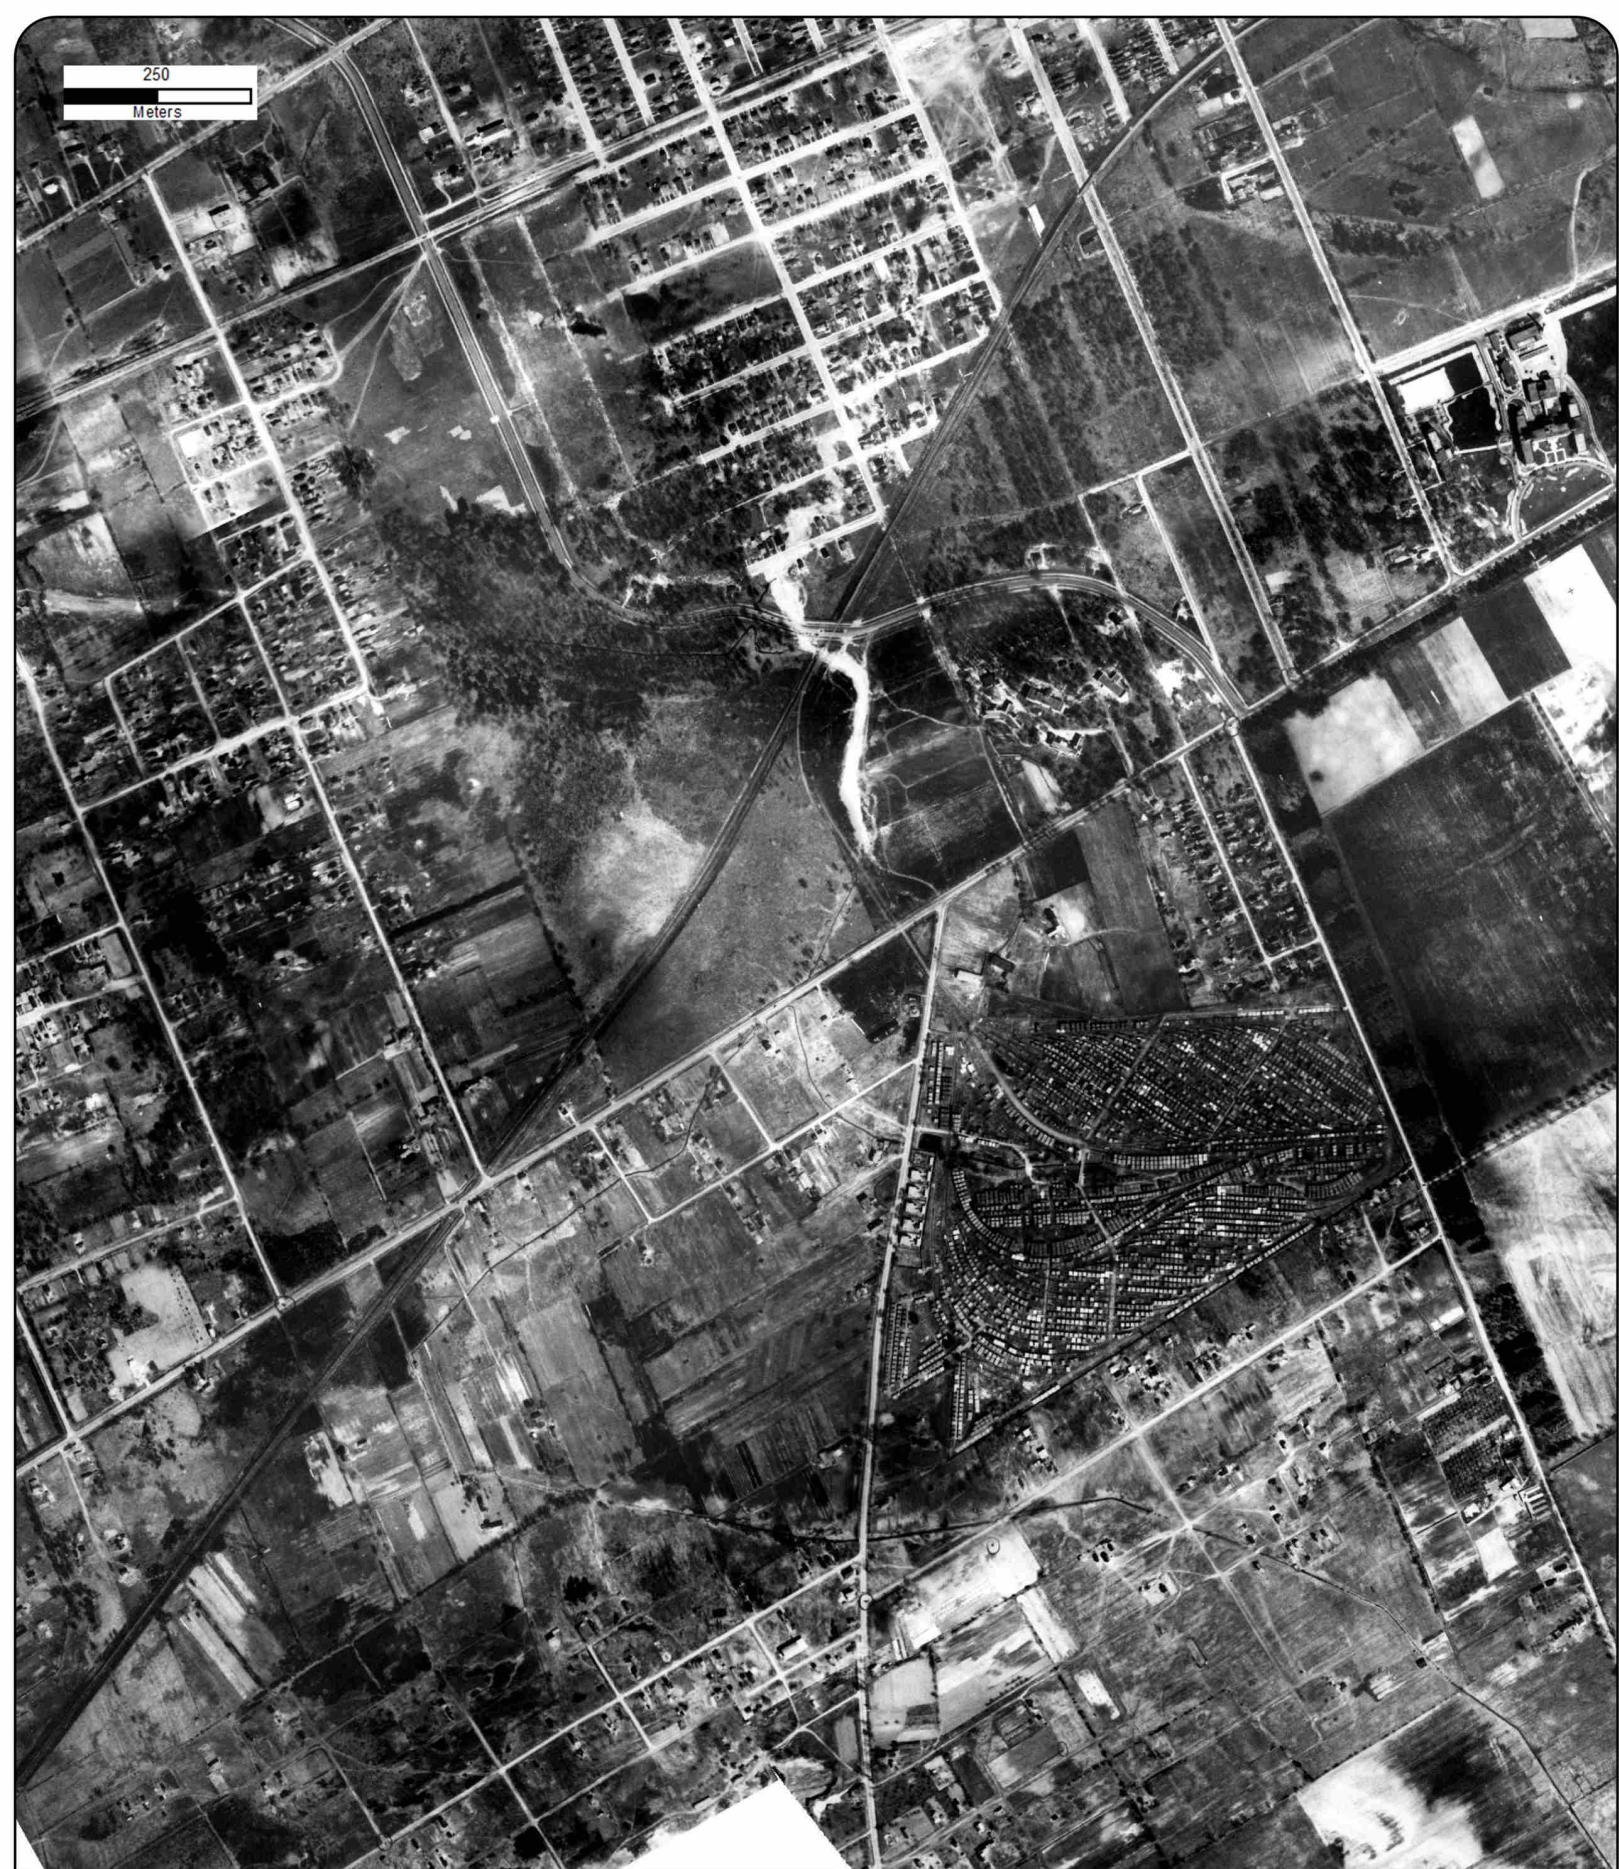
Year: 1928
Source: OTTAWA
Scale: 10,000
Comment:

To the best of Pinchin's knowledge, no major buildings or structures had been constructed on the Phase One Property prior to 1928, with the exception of a single residential dwelling as observed in the 1928 aerial photograph. The 1957 FIP and 1958 and 1965 aerial photographs showed the property was developed with two residential dwelling on the northwest and south portions of the Phase One Property and an industrial building was evident on the west-central portion of the Phase One Property. As per the FIP, the industrial building was occupied by Seven-Up Bottling Co. (Ottawa) Ltd. The present-day Site Building was first observed in the 1976 aerial photograph, and all other aforementioned buildings appeared to be demolished. Based on the above information, the first developed use of the Phase One Property is assumed to be 1928.
