TREE CONSERVATION REPORT

2180 Montreal Road

Tree Conservation Report submitted as Partial
Requirements for a Site Plan Control Application

Address: 2180 Montreal Road

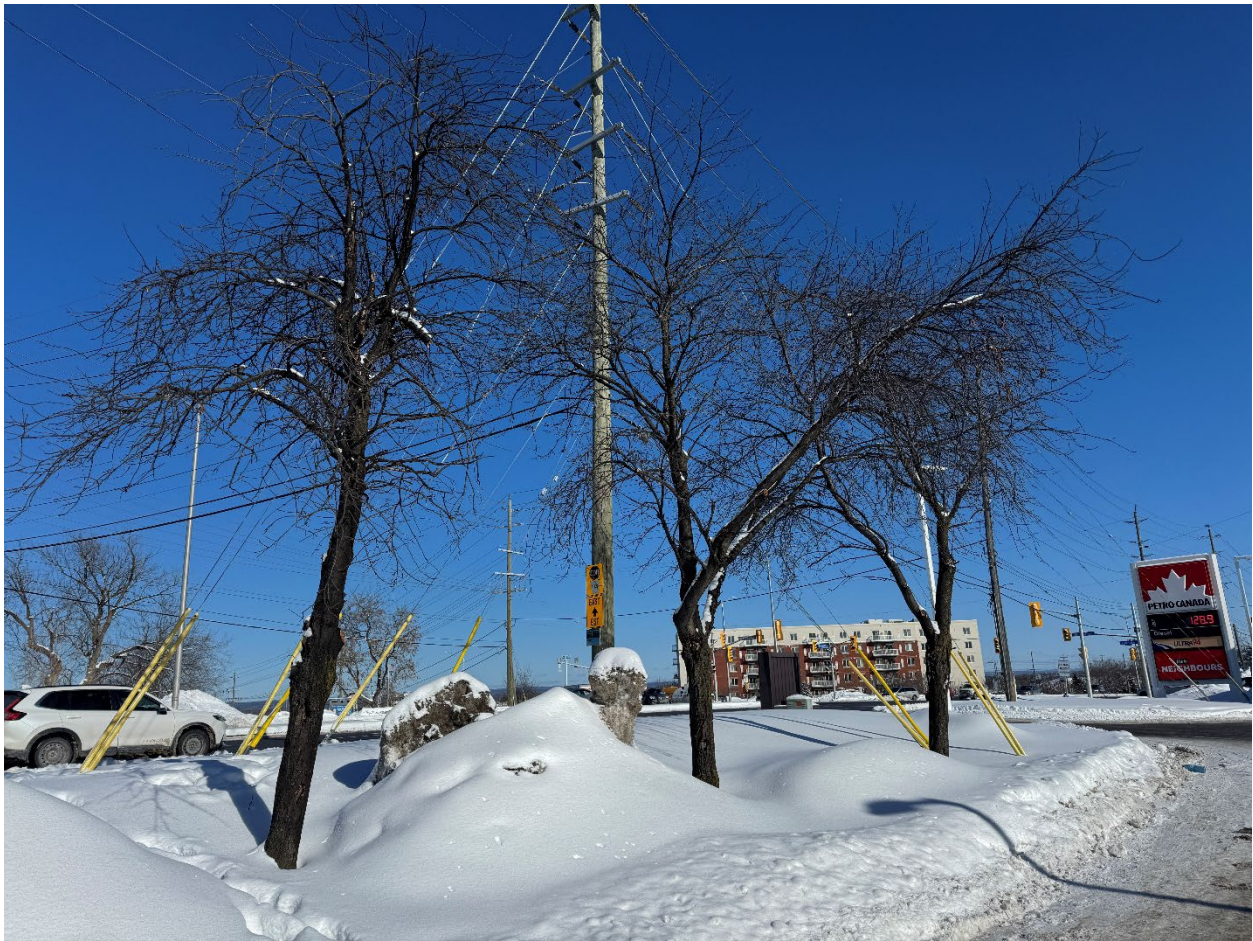
24	Shubert choke cherry (<i>Prunus virginiana</i> 'Schubert')	24	2180 Montreal Rd	Poor; blacknot present	Remove due poor to health
25	Shubert choke cherry (<i>Prunus virginiana</i> 'Schubert')	23	2180 Montreal Rd	Poor; blacknot present, poor pruning cuts	Remove due poor to health
26 ⁴	Black walnut (<i>Juglans nigra</i>)	12	Jointly owned with 976 Shefford Rd	Good	Retain and protect

Photo 3: Trees 23-25, Shubert choke cherries in poor condition, removal and replacement recommended

Additionally, **three (3) trees (Trees 23–25)** are recommended for removal and subsequent replacement due to poor health. These specimens are **Cherry trees** exhibiting advanced stages of **Black Knot** (*Apiosporina morbosa*), a progressive fungal disease common to the *Prunus* genus that compromises structural integrity and aesthetic value.
