# **Phase II – Environmental Site Assessment**

1209 Michael Street North  
Ottawa, Ontario

Prepared for Inside Edge Properties

Report: PE7253-2  
January 22, 2026

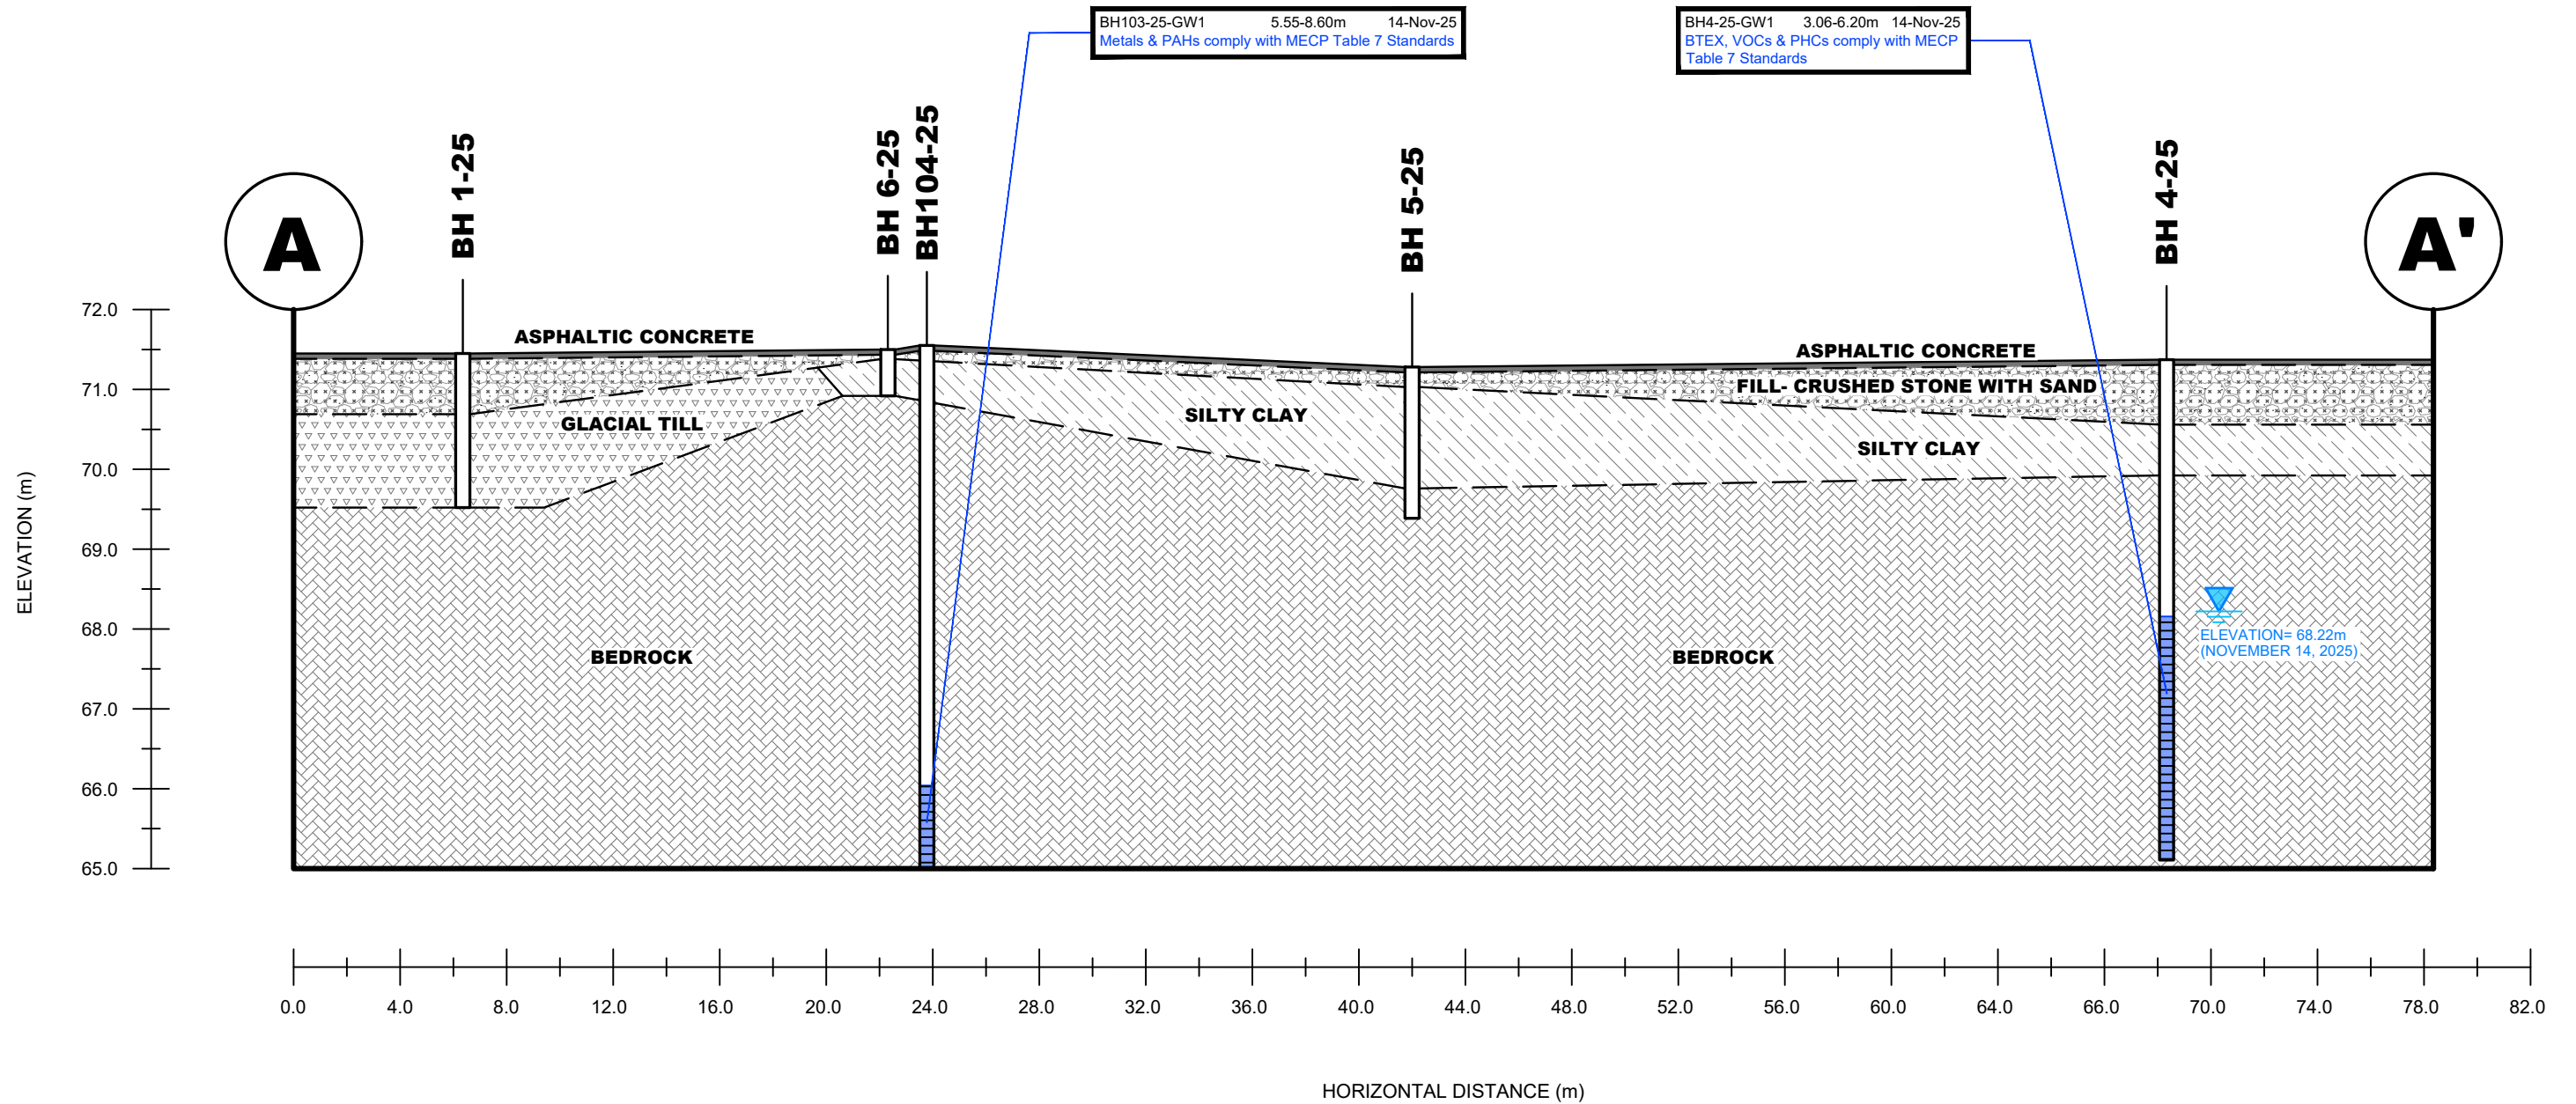
Scale:	AS SHOWN	Date:	01/2026
Drawn by:	YA	Report No.:	PE7253-2
Checked by:	NS	Dwg. No.:	<b>PE7253-8A</b>
Approved by:	MB	Revision No.:

The concentration of sodium in Sample BH103-25-GW1 is in excess of the selected MECP Table 7 Non-Potable Groundwater Standards. All remaining parameters detected in the groundwater sample analyzed comply with the standards. The elevated sodium level is suspected to be the result of the application of road salt on the Phase II Property during snow and ice conditions and thus, as per Section 49.1 of O. Reg 153/04, does not represent a contaminant issue.

**Title: CROSS SECTION A-A' - GROUNDWATER (BTEX, VOCs, PHCs, METALS, PAHs)**
