March 18, 2019
File: PE4577-LET.01

Subject: **Phase I - Environmental Site Assessment Update**
1068-1090 Cummings Avenue
Ottawa, Ontario

HUNTINGTON PROPERTY GROUP	
PHASE I - ENVIRONMENTAL SITE ASSESSMENT	
1090 CUMMINGS AVENUE	
OTTAWA,	ONTARIO
Title:	
SITE PLAN

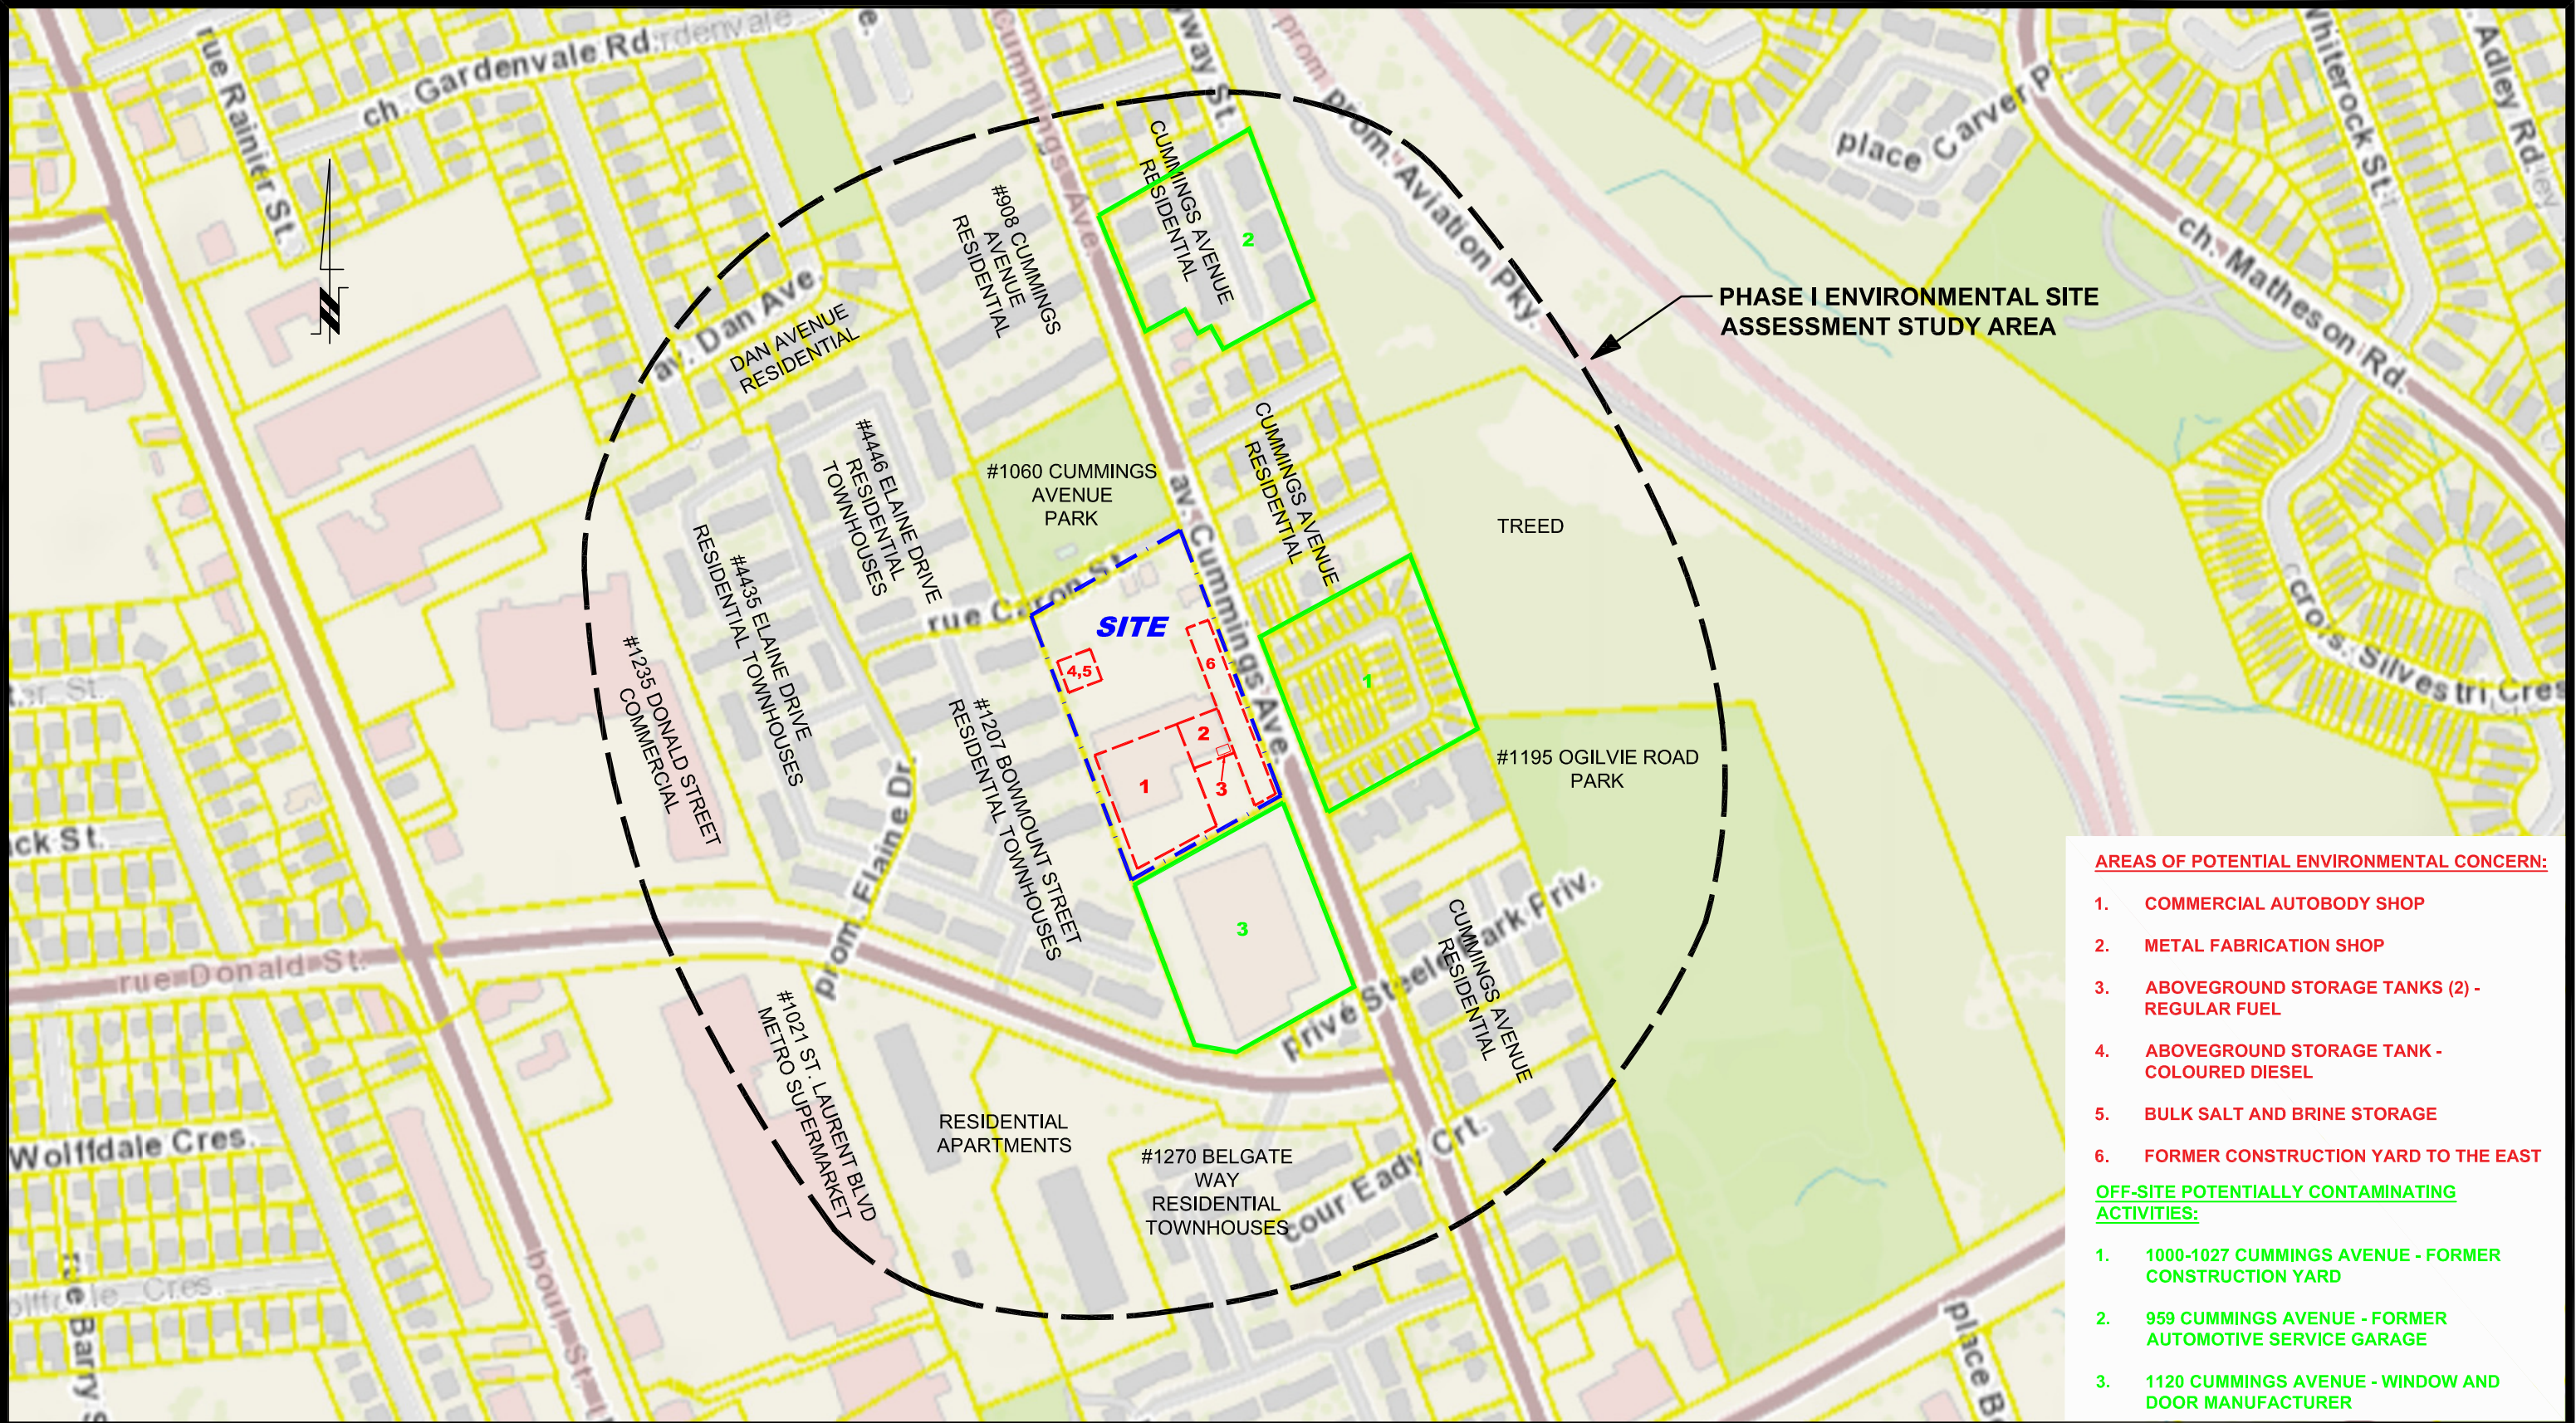
Neighbouring land use in the Phase I study area comprised of roadways, residential dwellings, an Ambico Steel windows and doors production business to the south, and a park to the north. Land use is shown on Drawing PE4577-2 - Surrounding Land Use Plan.

1. COMMERCIAL AUTOBODY SHOP
2. METAL FABRICATION SHOP
3. ABOVEGROUND STORAGE TANKS (2) - REGULAR FUEL
4. ABOVEGROUND STORAGE TANK - COLOURED DIESEL
5. BULK SALT AND BRINE STORAGE
6. FORMER CONSTRUCTION YARD TO THE EAST
