**Phase I Environmental Site Assessment**

Industrial Property  
564 Industrial Avenue  
Ottawa, Ontario

**May 14, 2013**

Report: PE2979-1

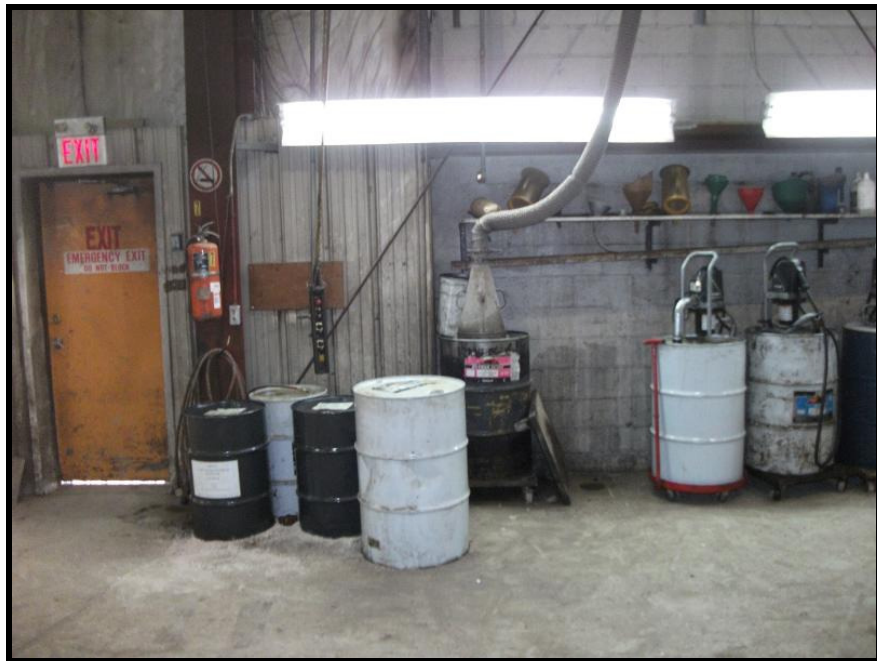
Photograph 2: Lubricant storage along north interior wall of addition portion of site building.

No fuel storage was observed on the interior of the subject site. Chemical storage on the interior of the subject site included several 208-litre drums of lubricants, several parts-washing stations containing varsol, and various cleaning solvents contained in their original commercial containers. All containers appeared to be in fair to good condition. No information was available concerning the disposal of waste oil or solvents.

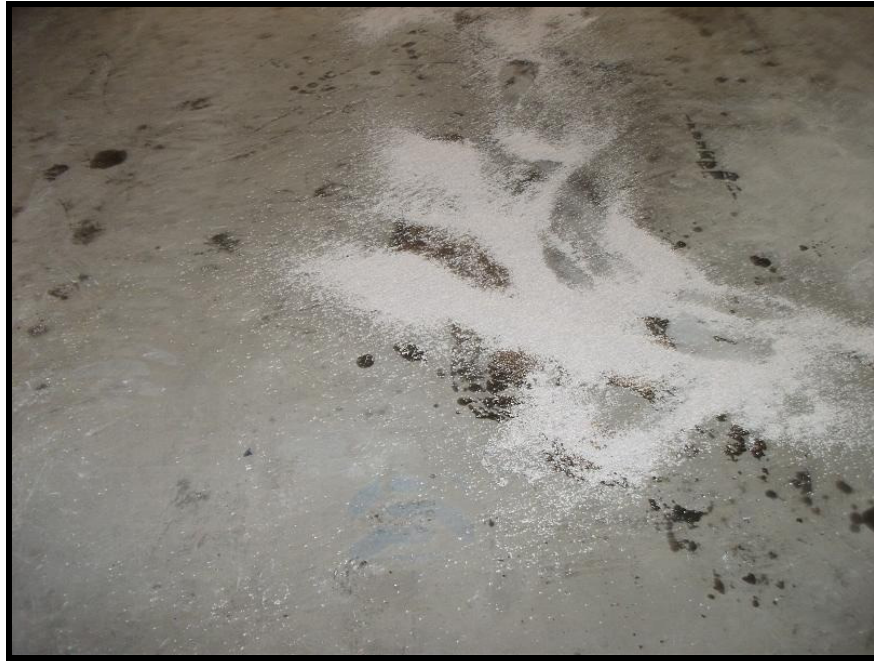
Photograph 3: Localized staining on shop floor.

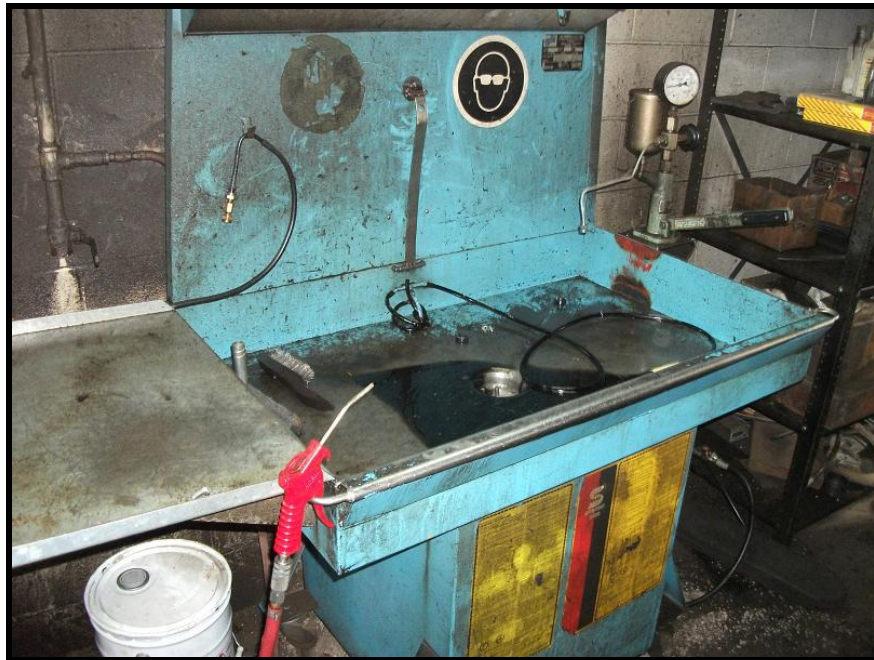
Photograph 4: Parts washing sink

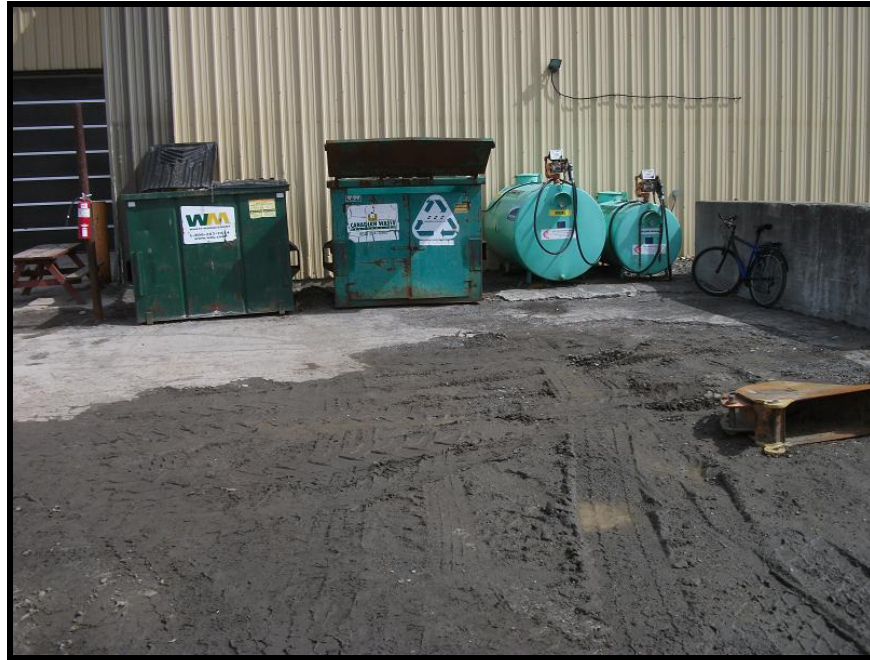
Two ASTs were observed on the exterior of the subject building - one 2,270 L double-walled steel AST containing diesel fuel, and one 1,345 double-walled steel AST containing gasoline. Both ASTs were manufactured in 2007. Both ASTs appeared to be in good condition, with no evidence of leakage or staining.

Photograph 7: ASTs on west exterior wall of addition portion of site building.

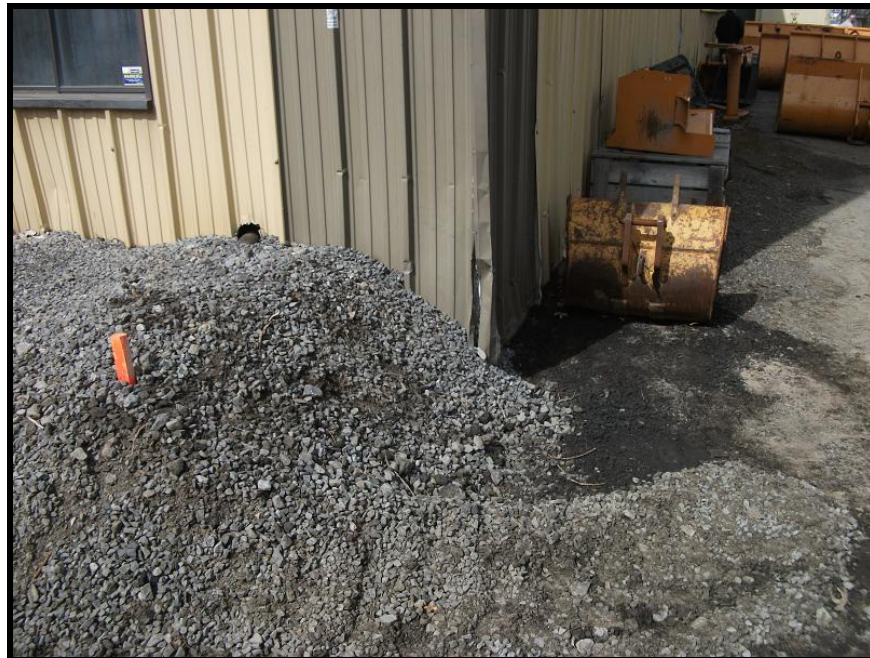
Localized staining was noted throughout the parking area. Significant staining was noted on the south side of the subject building, surrounding a concrete pad used for pressure-washing of equipment, and an area of mounded gravel at the southeast corner of the building. A pipe, running from the interior of the building, appeared to end in this gravel pile; upon further inspection, the pipe was found to be associated with a rack on the interior of the building on which parts were set to drip-dry after cleaning. This rack/pipe/gravel configuration represents an environmental concern, as it provides a pathway for hydrocarbons and solvents associated with parts lubrication and cleaning to enter the soil and groundwater at the subject site.

Photograph 8: Gravel pile and localized staining at southeast corner of subject building.
