Phase I-Environmental Site Assessment

Commercial and Residential Properties
320 McRae Avenue, 1976 Scott Street,
311 and 315 Tweedsmuir Avenue
Ottawa, Ontario

January 28, 2016
Report: PE3391-1R

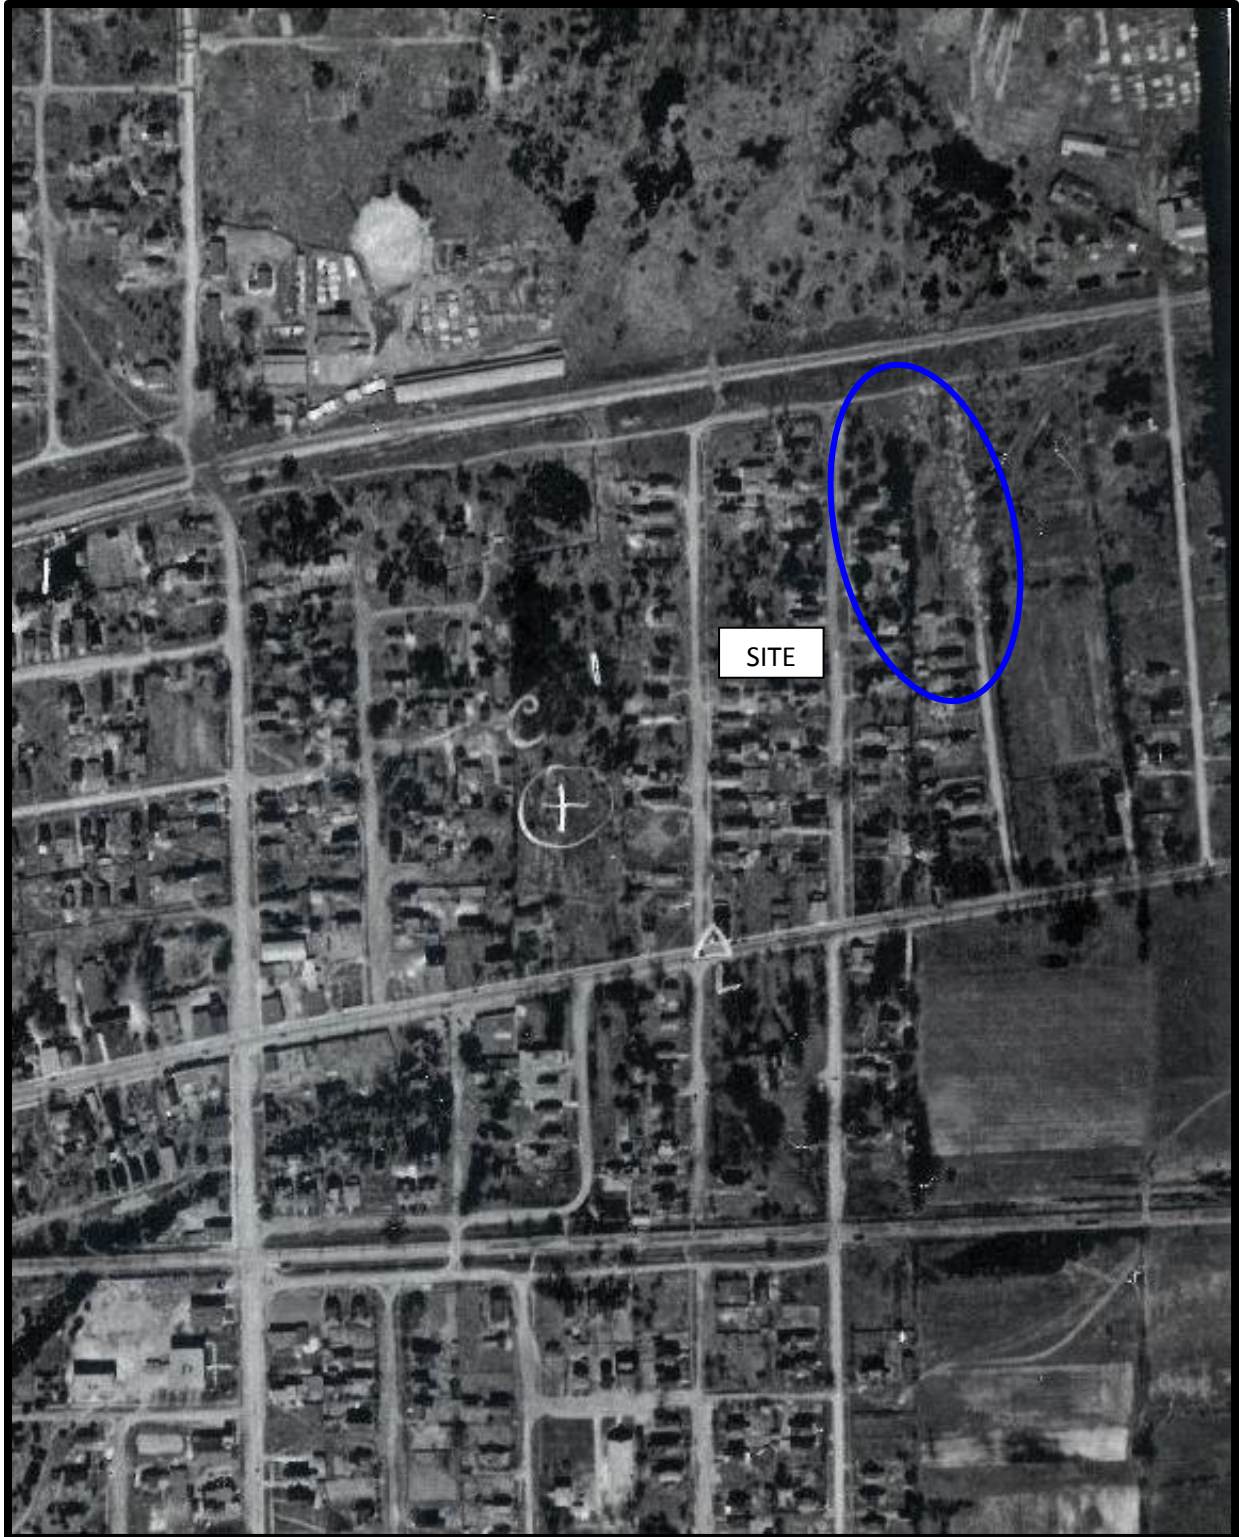
AERIAL PHOTOGRAPH
1928

The earliest aerial photograph, from 1928, shows the northeast side of the subject site as vacant with potential fill piles from the possible use of the subject site as a landfill. The residences at Tweedsmuir Avenue appear to be present in 1928. By 1958 the residences at 311 and 315 Tweedsmuir Avenue, a restaurant at 1976 Scott Street and an autobody repair shop at 320 McRae are present as observed in the air photo and identified in the city directories.

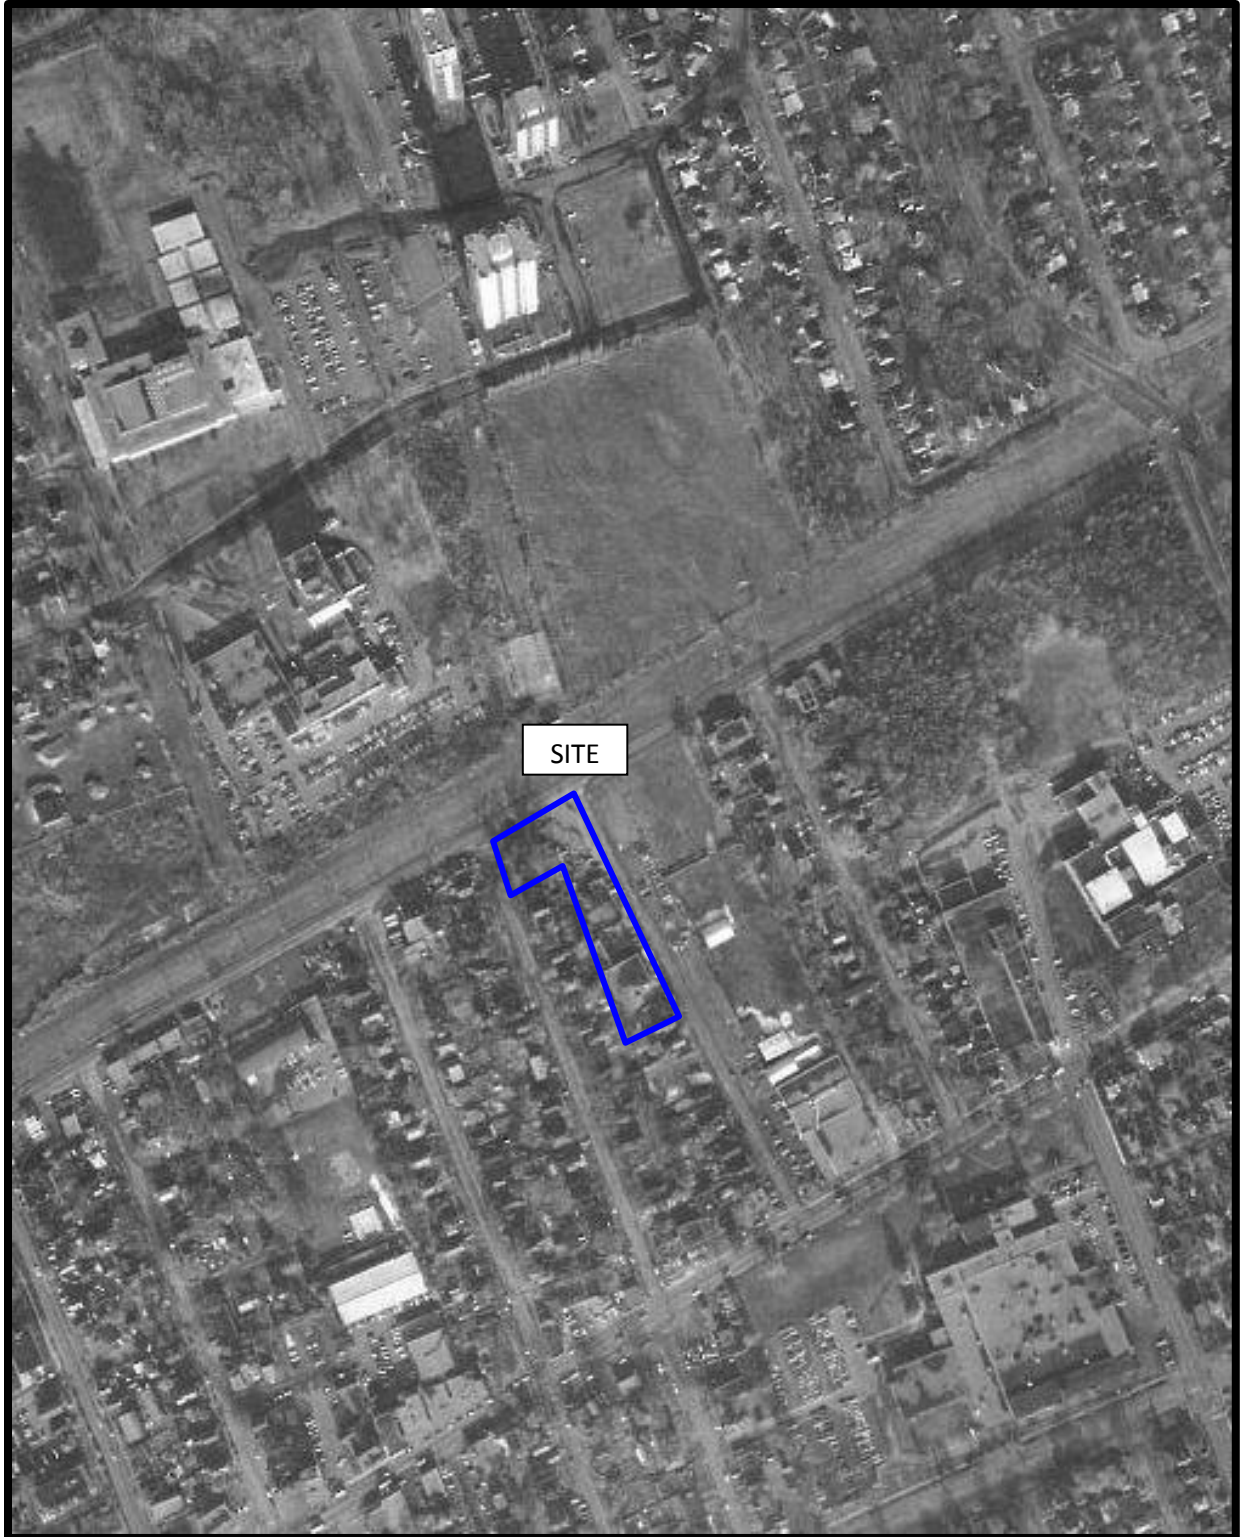
AERIAL PHOTOGRAPH
1976

- 1976 The subject site appears to be occupied by the present day commercial structure. The other structures on the property cannot be clearly observed in this photograph. The land to the east of McRae Avenue appears to be occupied by a single commercial structure. The properties along Scott Street appear to be increasingly commercial. The government buildings further to the north of the subject site have been completed. The former coal and lumber yard further to the northeast of the subject site is now vacant. Residential dwellings are present further to the northeast.

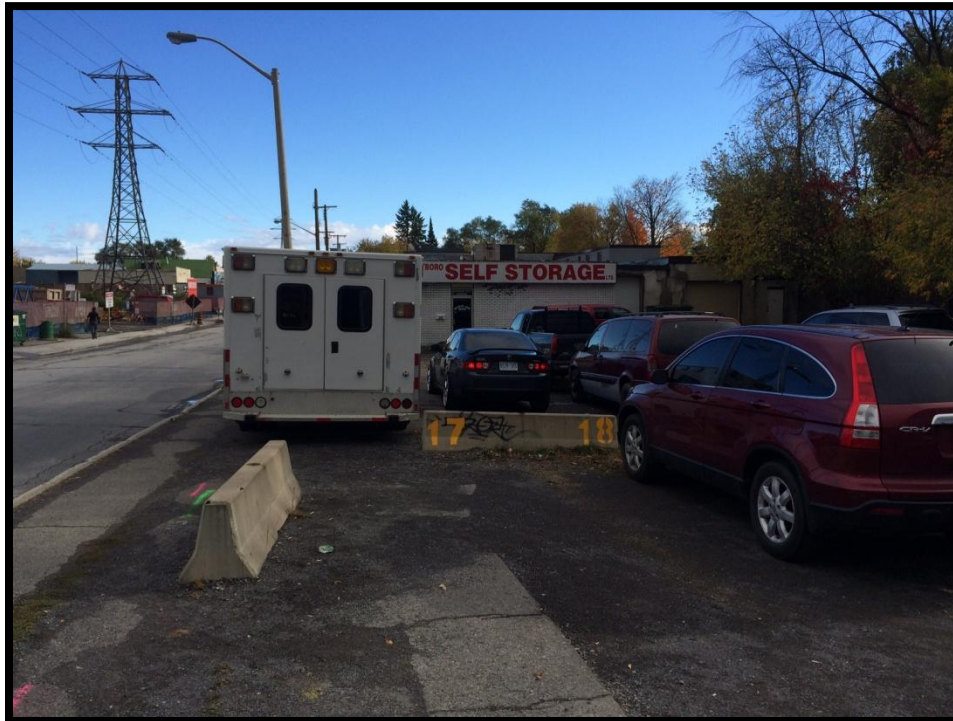
Photograph 1: View of subject site, looking south along east property boundary. Photograph includes the commercial building, the parking area and the gravel cover of the former UST nest excavation.

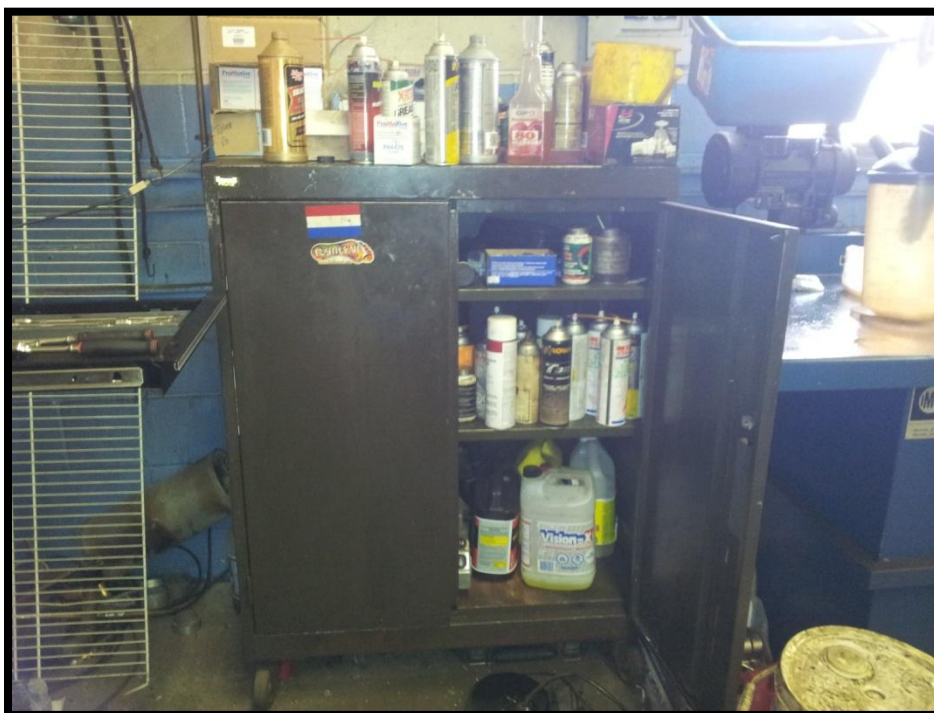
Photograph 2: View of a chemical cabinet in the Gifford Automotive garage. Photograph illustrates the variety of chemicals and lubricants utilized at the general automotive service garages.

It is recommended that the garage tenants be asked to improve their management of chemicals, fuels and oils on the property. Future spills should be addressed immediately and saturated absorbent material should be removed and replaced where necessary.

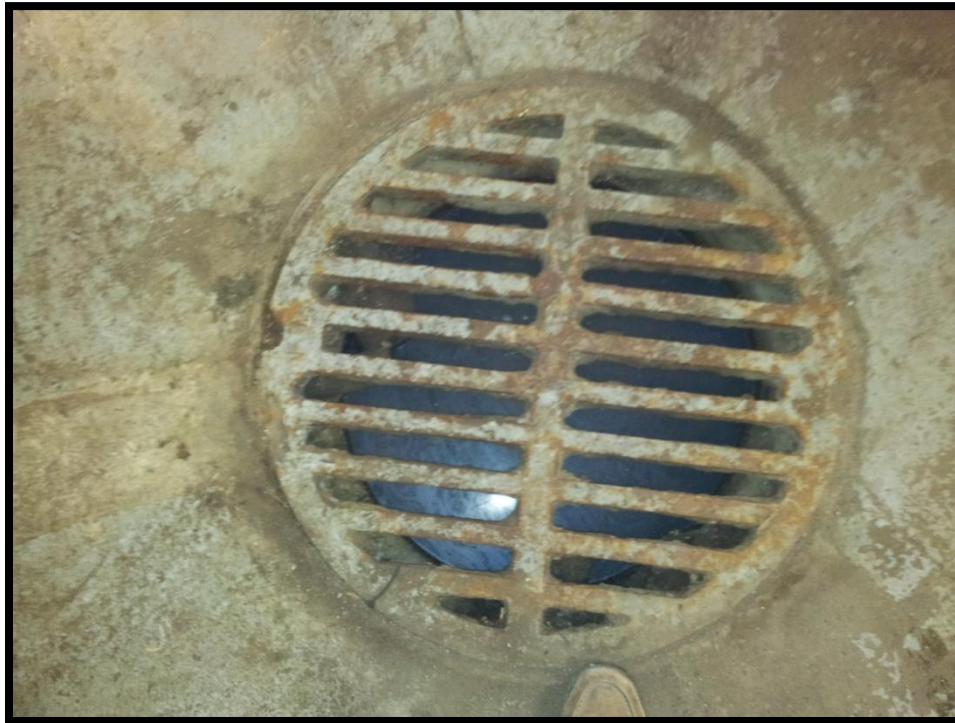
No sumps were observed in the buildings. Several drains and oil/water separators are present within the commercial property. An oily sheen or film was observed on the water in the two (2) oil/water separators and the interior drains observed in the garage units and the landscaper's unit.

Photograph 3: View of drain in the landscaper's garage bay. Photograph depicts oil water with a film in the drain system.

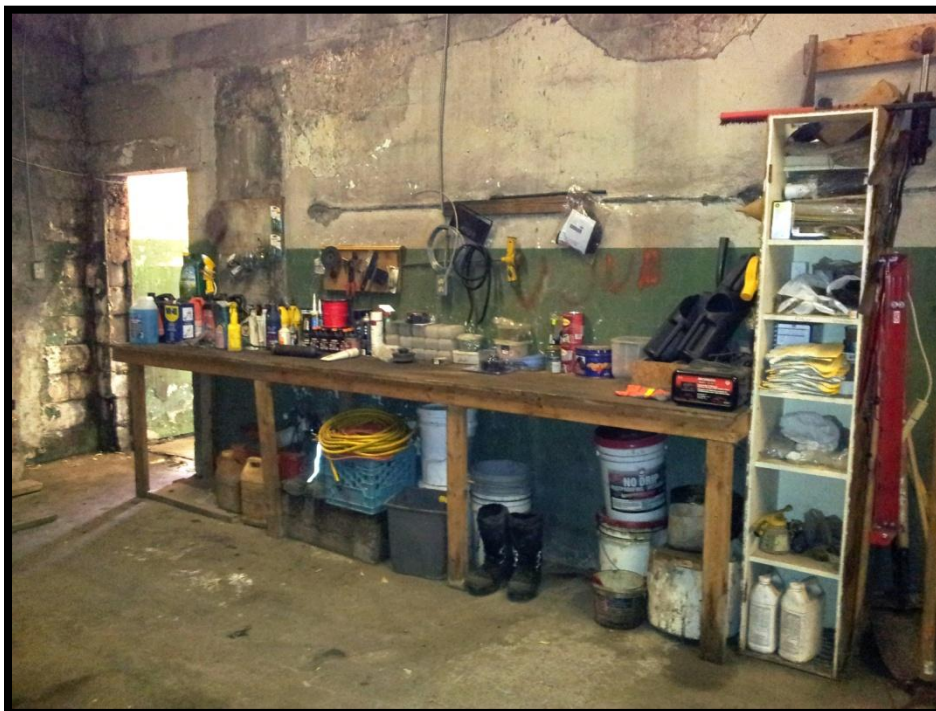
Photograph 4: View of interior wall of landscaper's garage bay. Photograph illustrates general chemicals (including waste oil buckets) and equipment in the garage bays which indicate the likelihood of continued mechanical servicing activities within the unit.

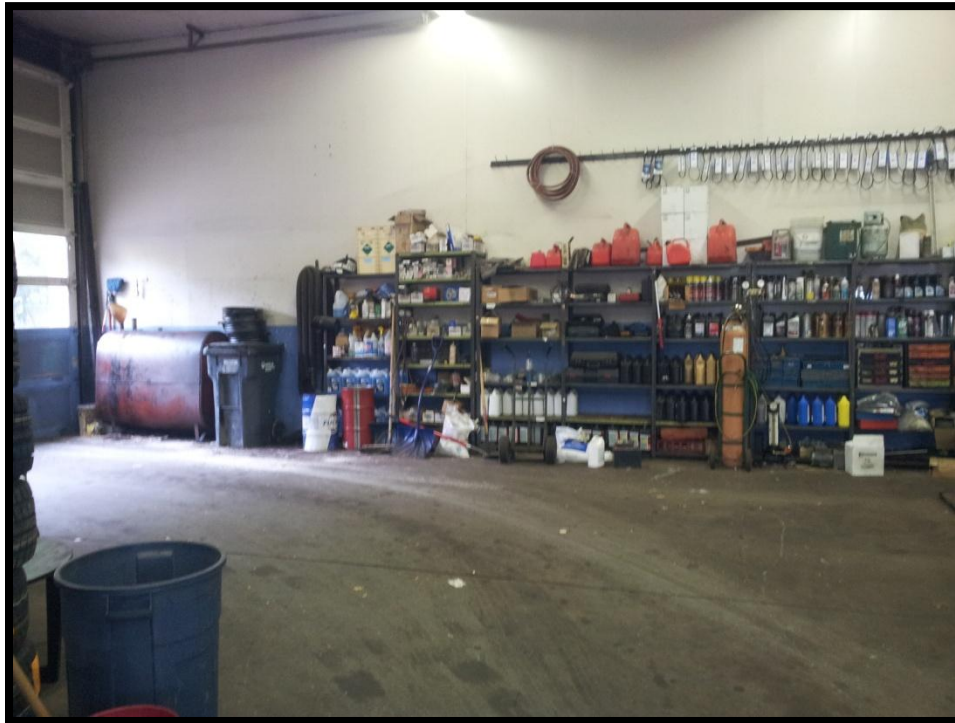
Photograph 5: View of west wall within the Gifford Automotive garage unit. Photograph depicts various chemicals and supplies, including solvents and aerosol containers used in various activities on-site. Waste oil tank present at south end of the wall.

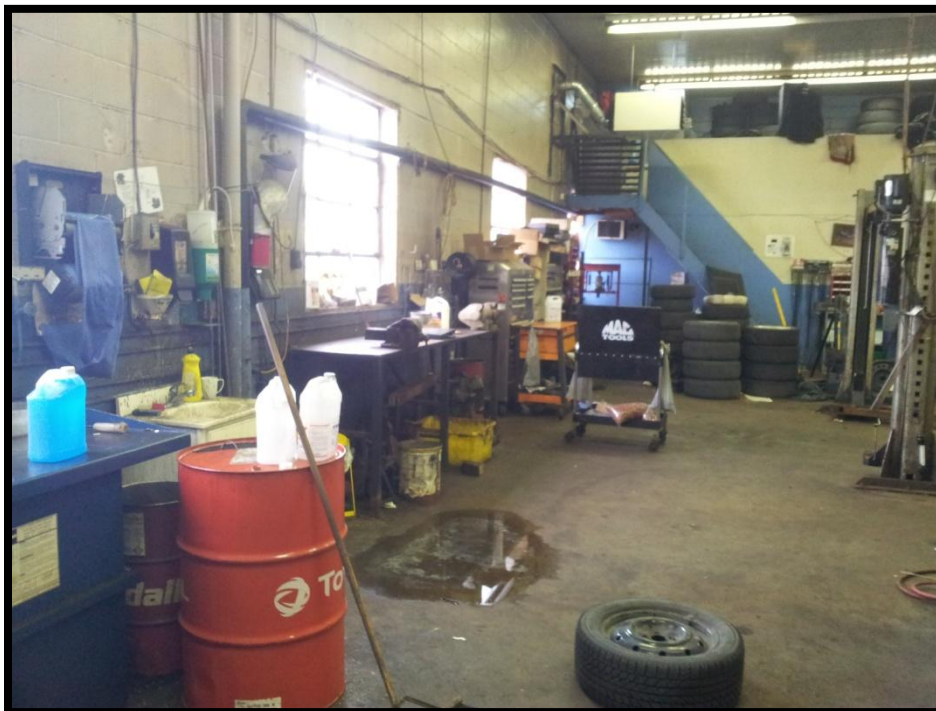
Photograph 6: View of east wall within Gifford Automotive garage unit. Photograph depicts general automotive mechanical garage, with new oil AST on far left and minor spill of miscellaneous fluid.

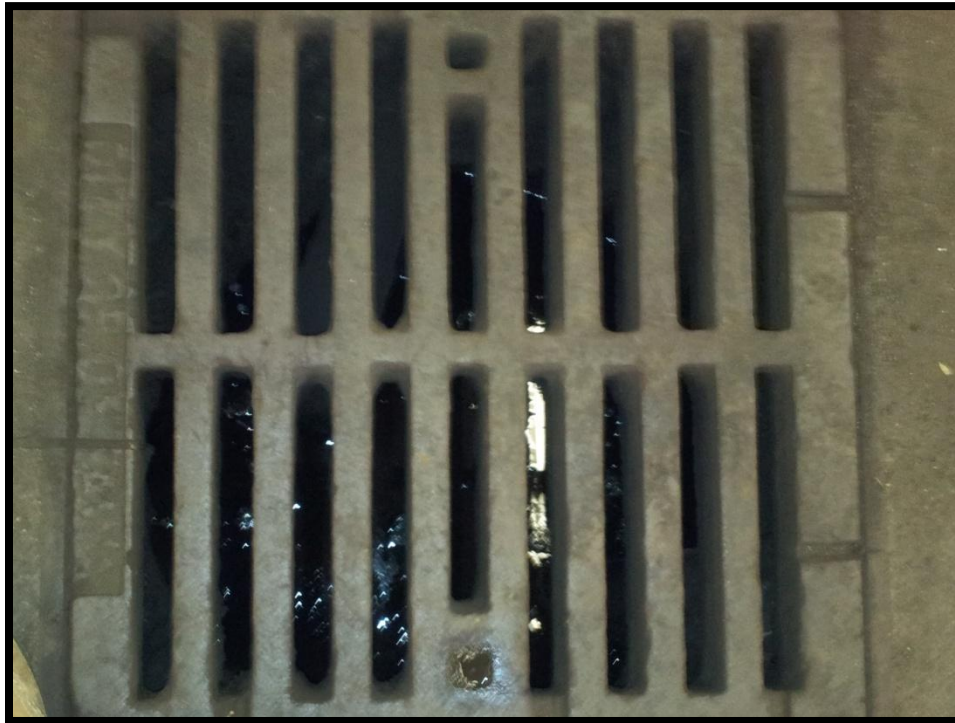
Photograph 7: View of oil/water separator drain within Gifford Automotive. Photograph depicts active oil water separator with oily water.

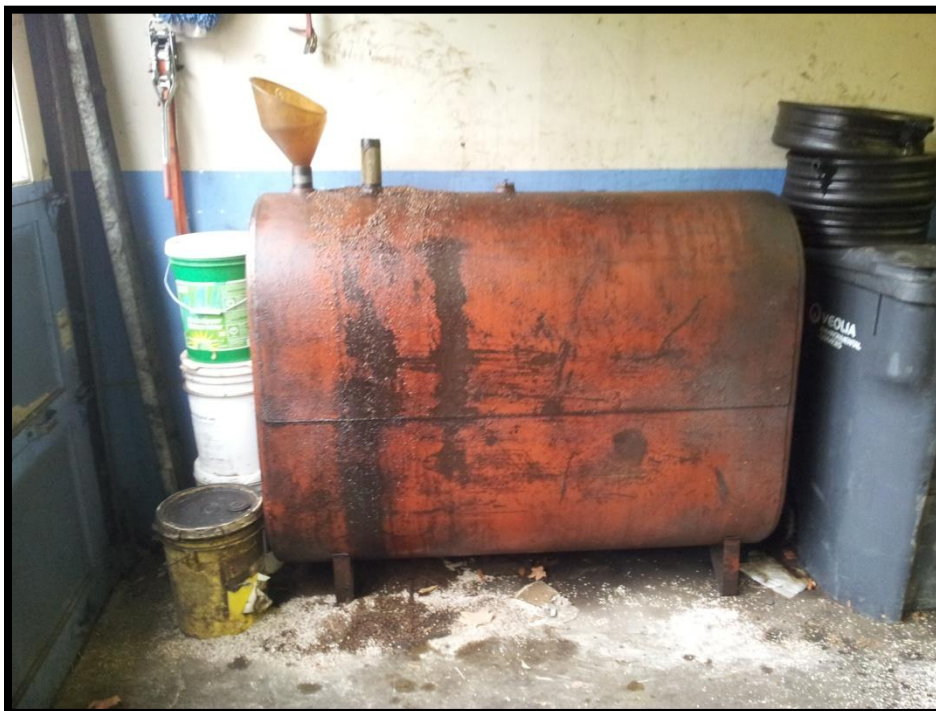
One (1) waste oil tank and one (1) new oil aboveground storage tank are present in both of the garage units. Staining was observed around all of the ASTs. Saturated absorbent material was observed beneath the waste oil AST in the Gifford Automotive garage and the floor was stained with spilt oil.

Photograph 8: View of the waste oil AST on east wall of Gifford Automotive garage unit. Photograph depicts staining around AST, absorbent material on and around the AST and recent oil releases to the floor.

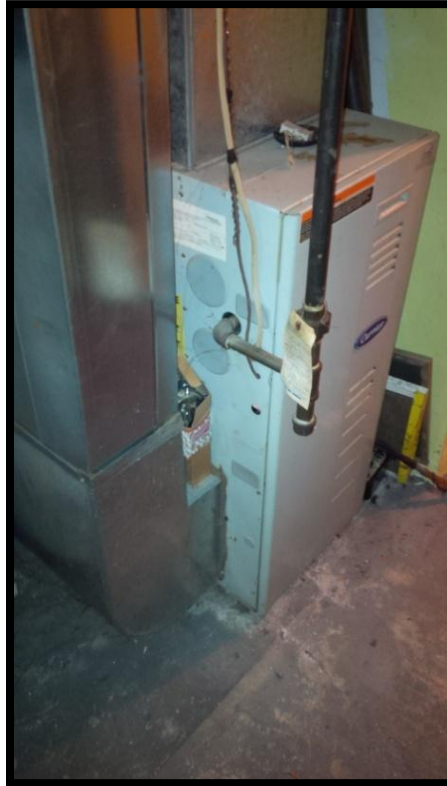
Photograph 11: Natural gas furnace in basement at 315 Tweedsmuir Avenue.
