Preliminary Hydrogeological Assessment for Private Services:

Proposed Residential Development
10 King Street
Richmond, Ontario

Report: PH1292-REP.01

UPDATED: APRIL 8, 2012

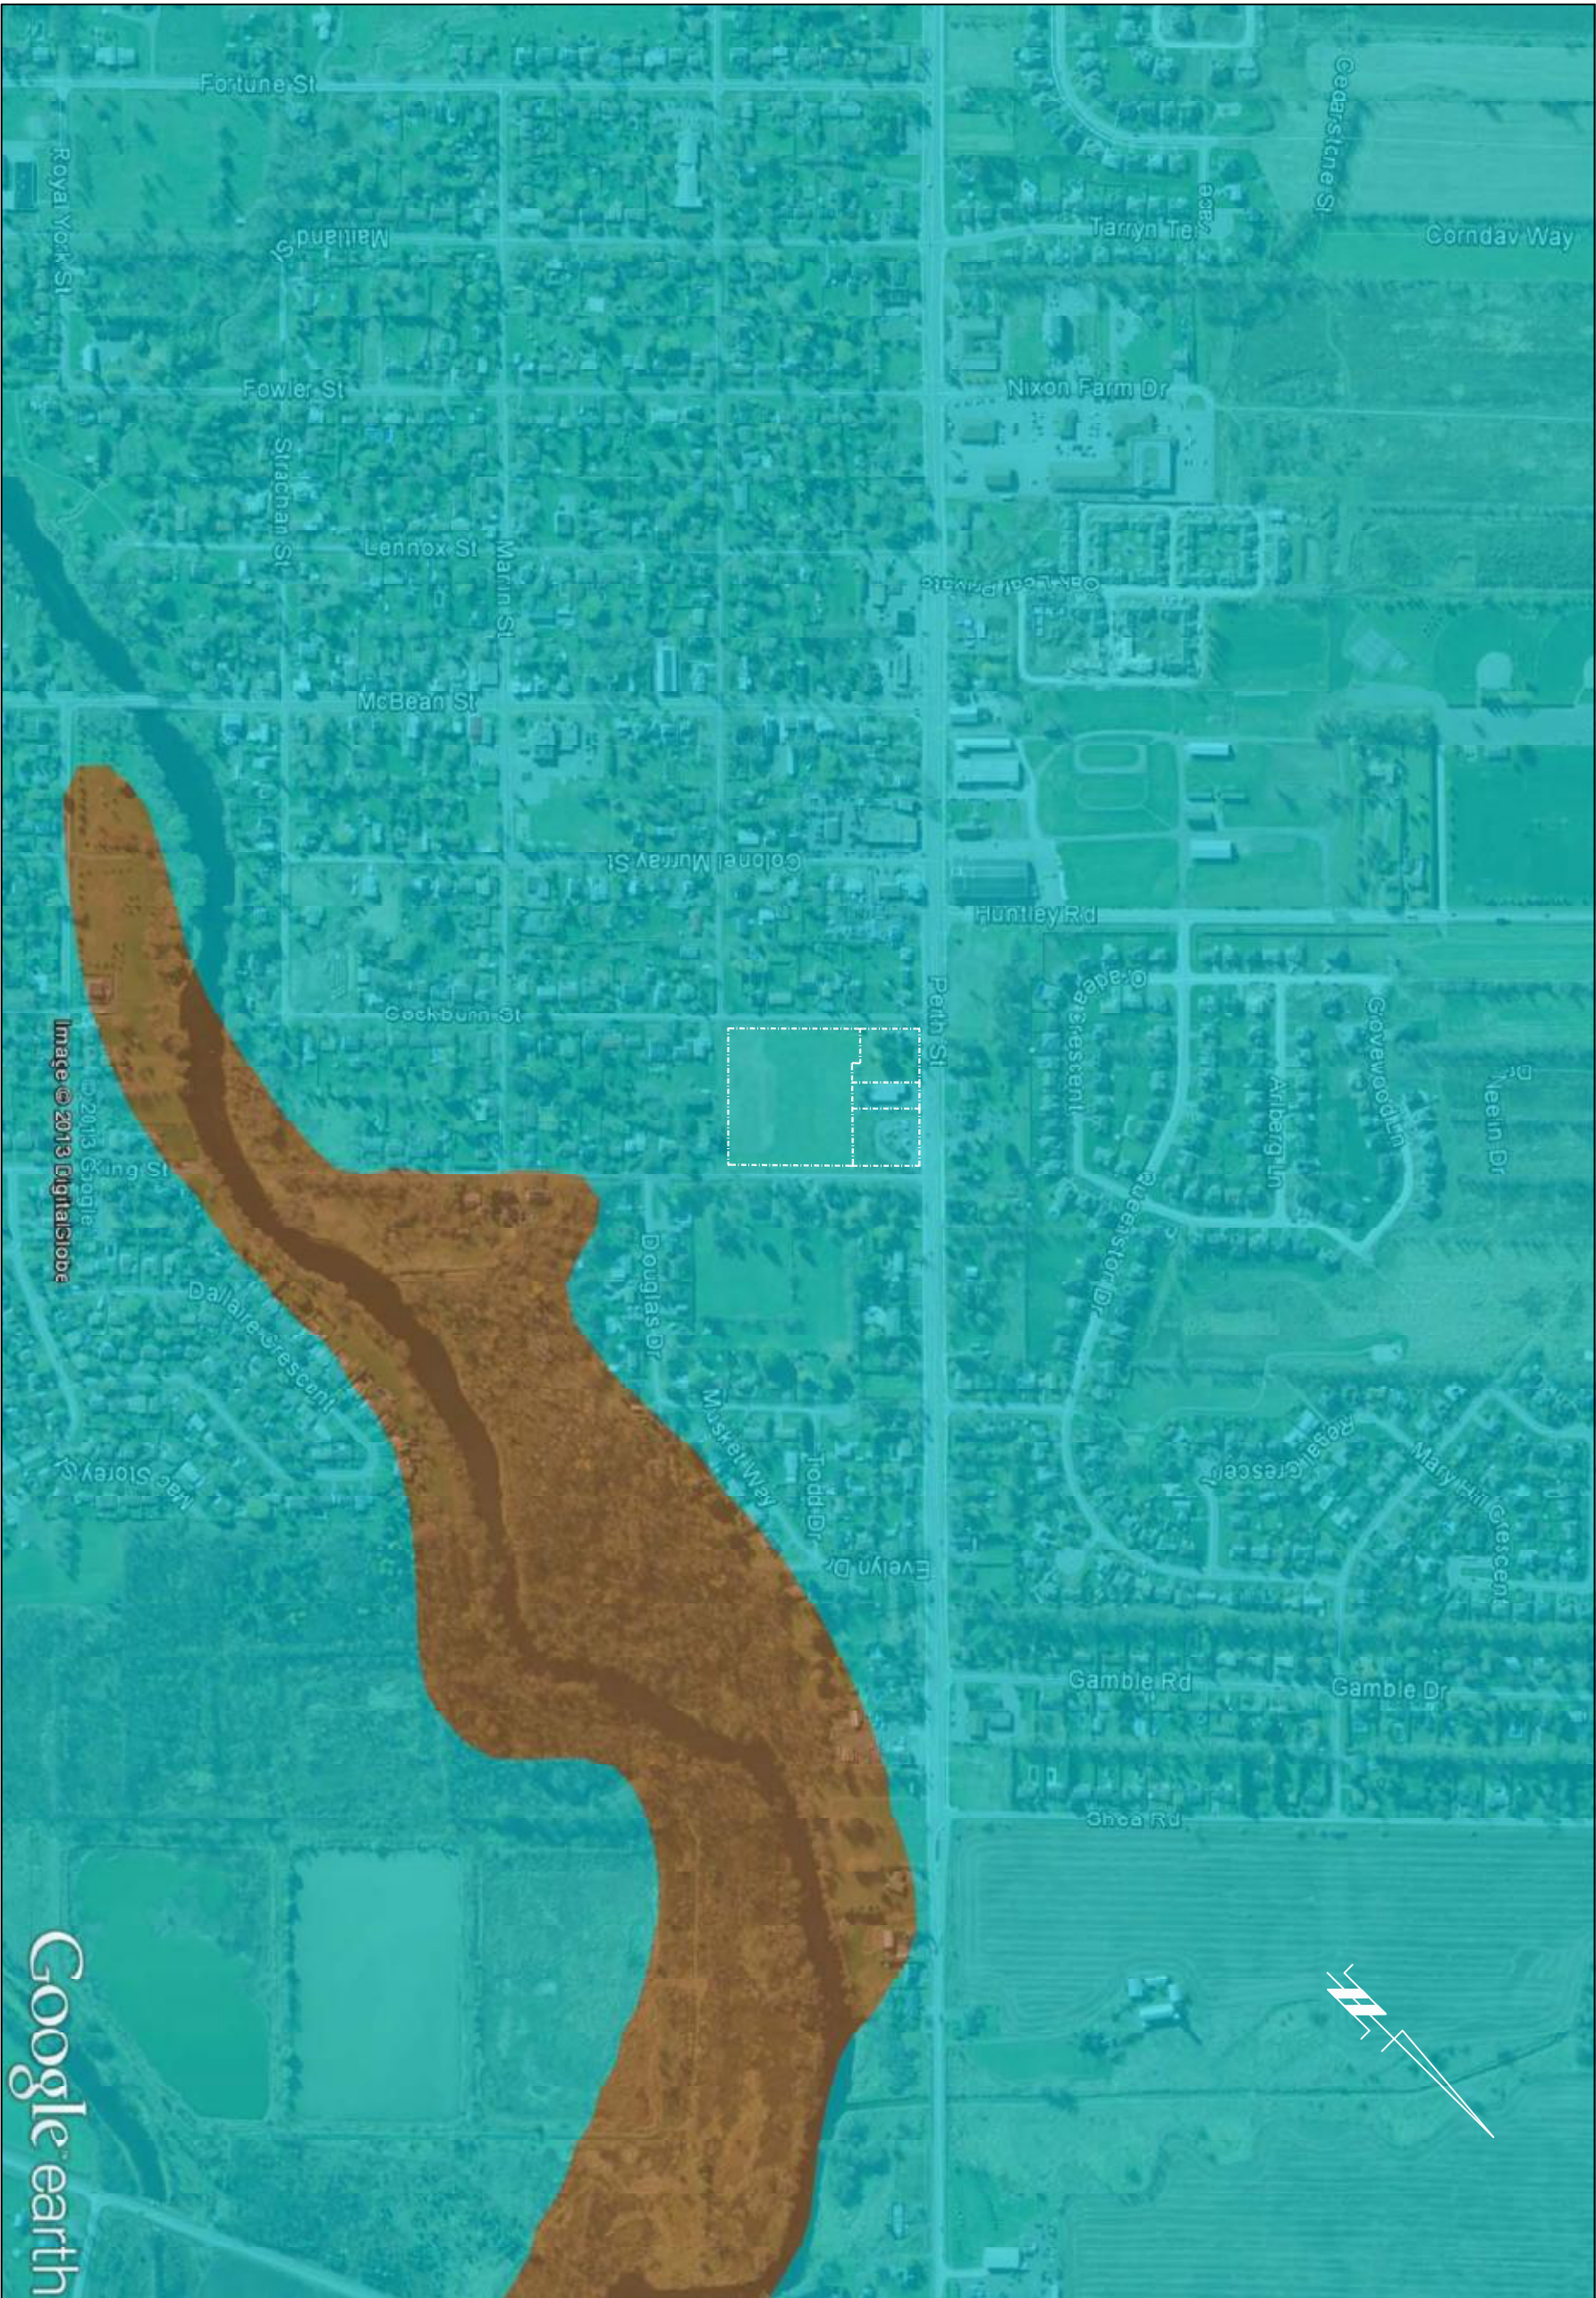
NOTE: INFORMATION REPRODUCED FROM ONTARIO GEOLOGICAL SURVEY G.I.S. OVERLAY FOR GOOGLE EARTH
REFERENCE SHOULD BE MADE TO SITE SPECIFIC GEOTECHNICAL INVESTIGATION FINDINGS BY PATERSON GROUP INC.

Cross Section Issues	The cross section, PH1292-FIG.2 has been updated to include domestic wells and TW4 and TW5 are better delineated. The Oxford/March Formation Transition is better delineated on this updated plan, also.
Well Record Mapping	Paterson has updated Drawing PH1292-Fig.2 to accurately reflect the existing water well information based on the MOE WWR's. The locations of 6 King Street and 13 Cockburn are included on both the updated Figure and on the Test Hole Location Plan - PH1292-1.
Missing Well Records/ Additional Well informatio required	The available MOE WWR's for the neighbouring lots have been included in Figure 2 and are included in Appendix 2. The Statistical Analysis has been included in Section 5.2.
Missing Pumping Test Data	All pumping test data carried out for TW4 and TW5 are included in Appendix 4. The pumping tests completed for TW1, TW2, TW3 and EW are appended to Appendix 4 for reference purposes only as the analysis and discussion appear in Paterson Report No. PH1292-REP.01
