Environmental Impact Statement &  
Tree Conservation Report  
3740 Jockvale Road, Ottawa, ON

March 2016  
Prepared for Uniform Urban Developments

McKinley Environmental Solutions (MES) was retained by Uniform Developments to prepare an Environmental Impact Statement (EIS) and Tree Conservation Report (TCR) for the proposed development of the property at 3740 Jockvale Road, Ottawa, Ontario (the Site). The EIS and TCR are presented as an integrated submission and should be read together.

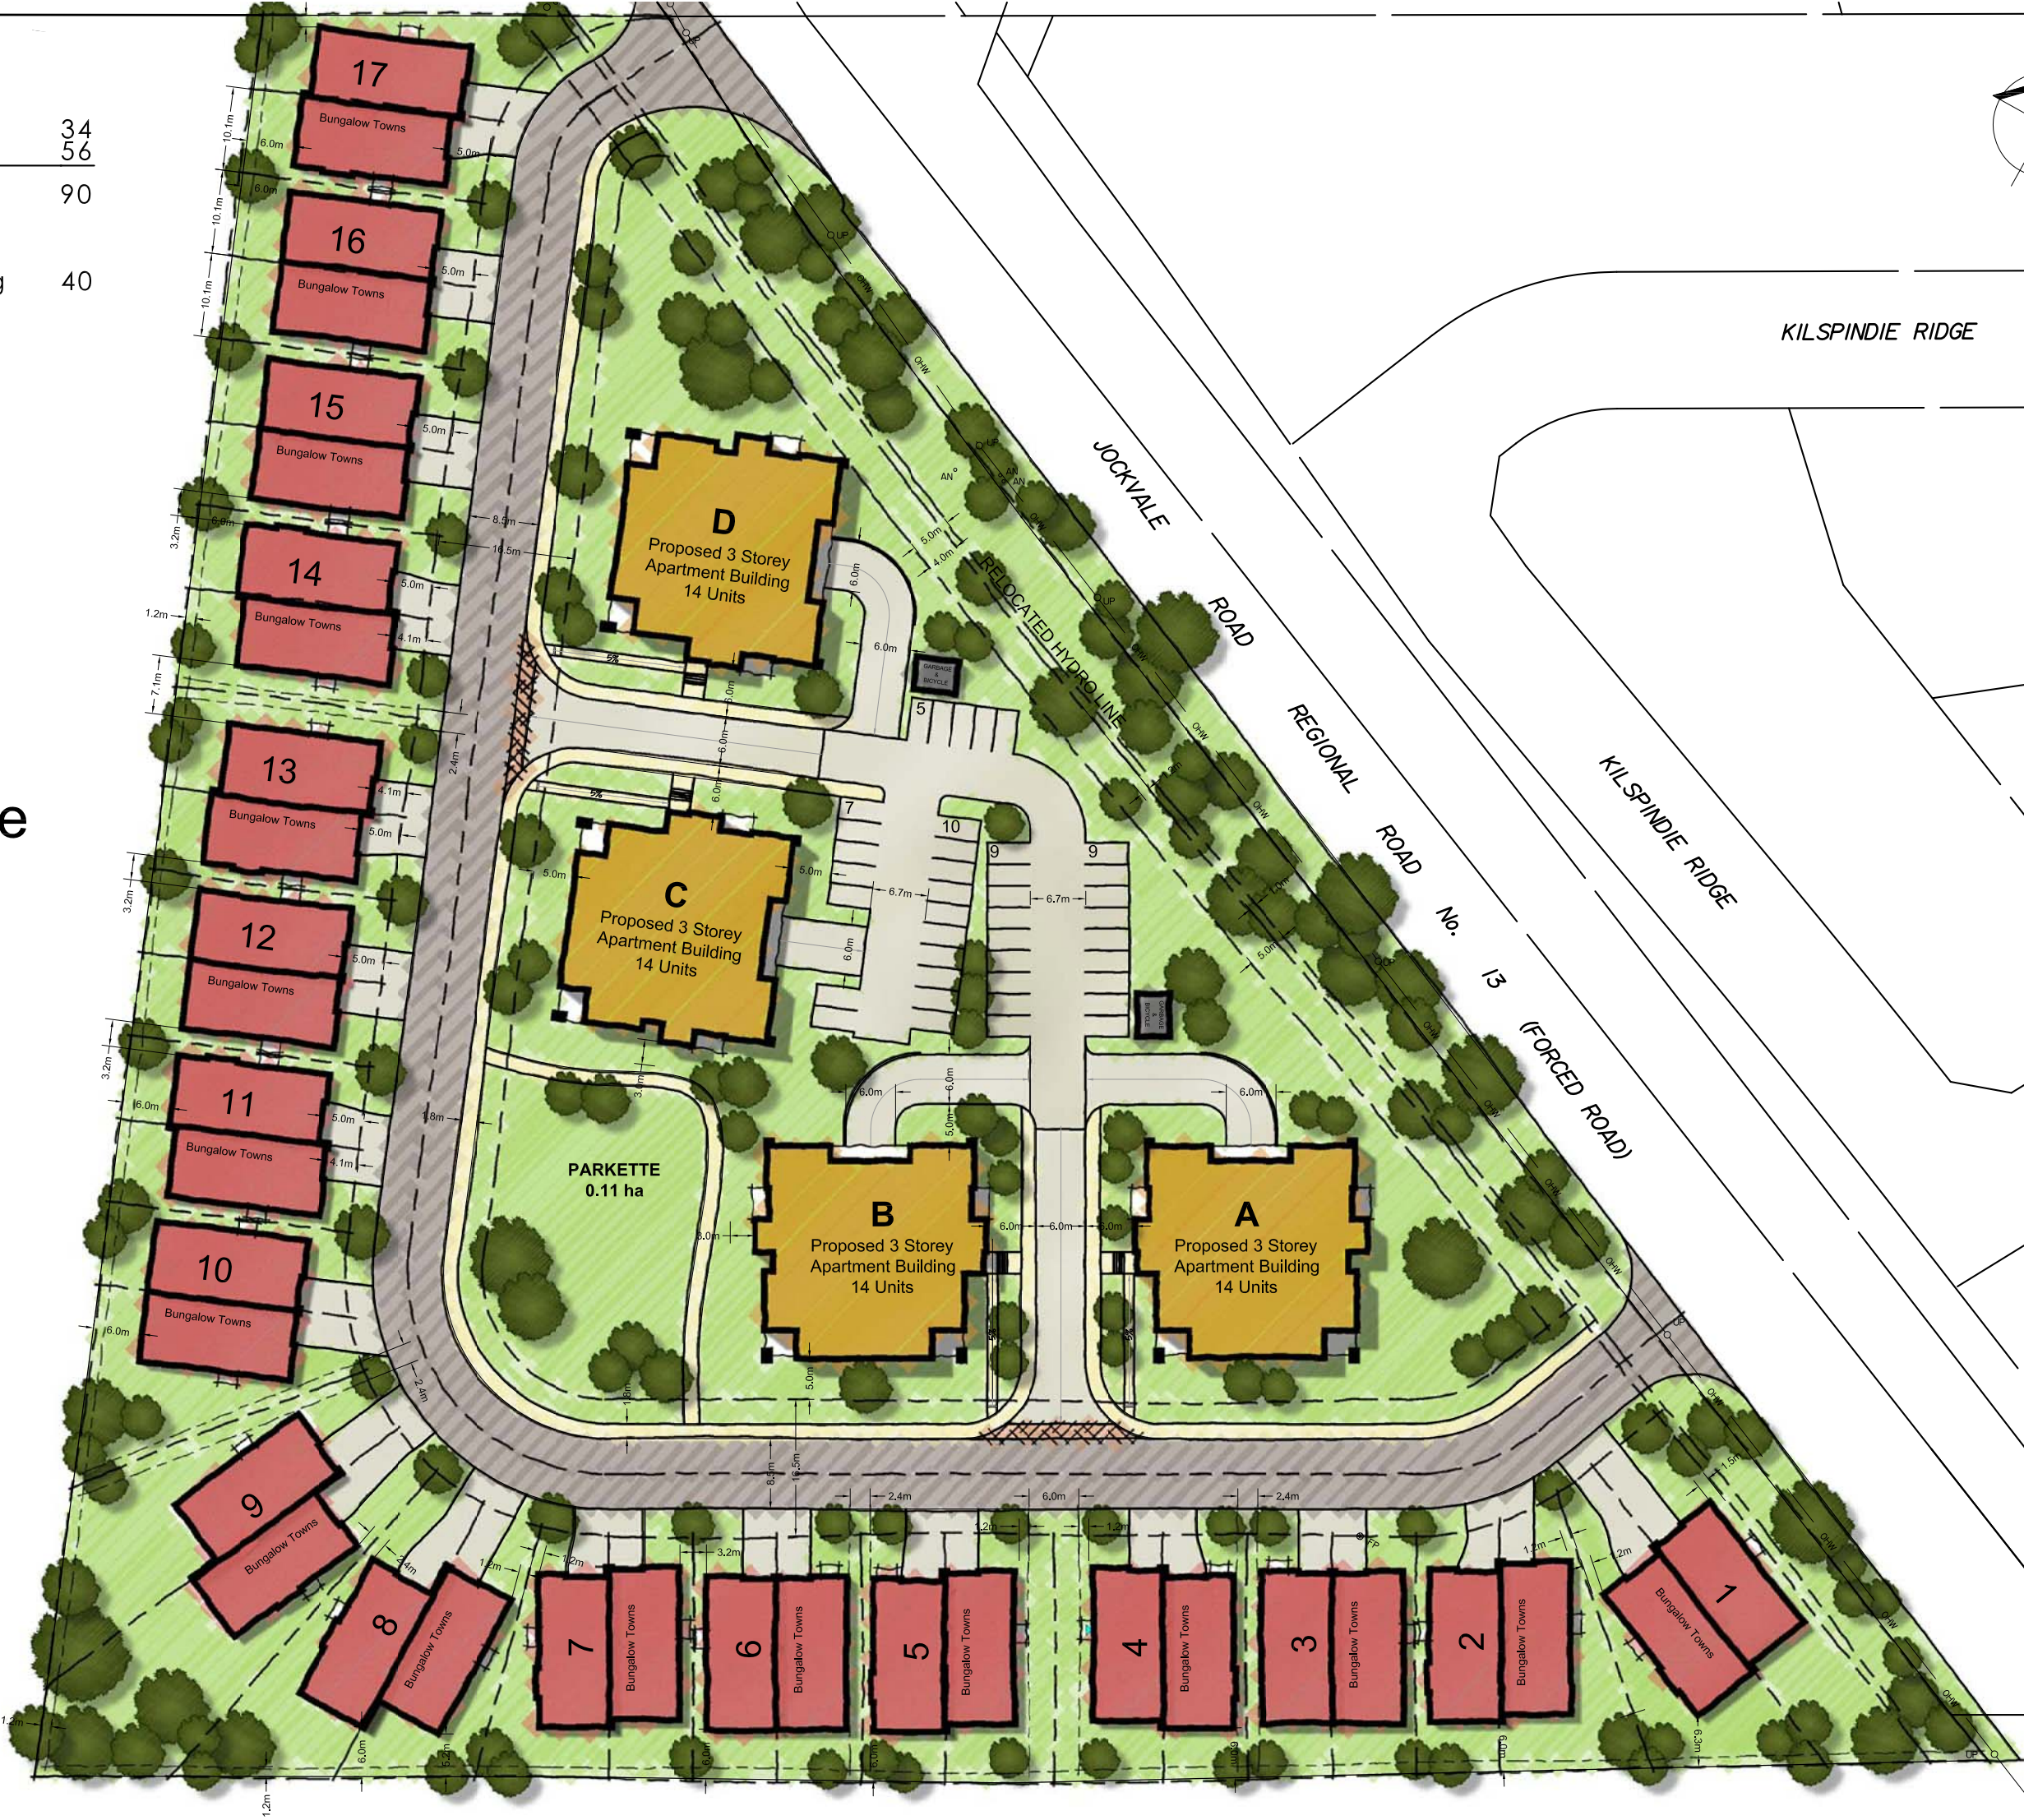
concept site plan

The current development concept would involve development of the majority of the Site to accommodate four (4) three storey condominium buildings with a total of approximately 56 condo flats and underground parking. The development would also include approximately 34 semi-detached bungalow Town Houses, 40 surface parking spaces, and a park block. To facilitate development, the existing house on the Site will be demolished. Stormwater servicing will be provided by an interim stormwater management pond in the golf course property to the south of the Site.

As shown in the Concept Plan, the development would result in the removal of the majority of the vegetation within the development area. Treed areas in the adjacent golf course property are not owned by Uniform Developments and will not be impacted by the proposed undertaking. Treed areas within the adjacent golf course property south, west and east of the Site, will act as a visual barrier between the golf course and the development. For mitigation measures to protect retained trees during tree removal, refer to Section 4.0 of the TCR (Appendix A).

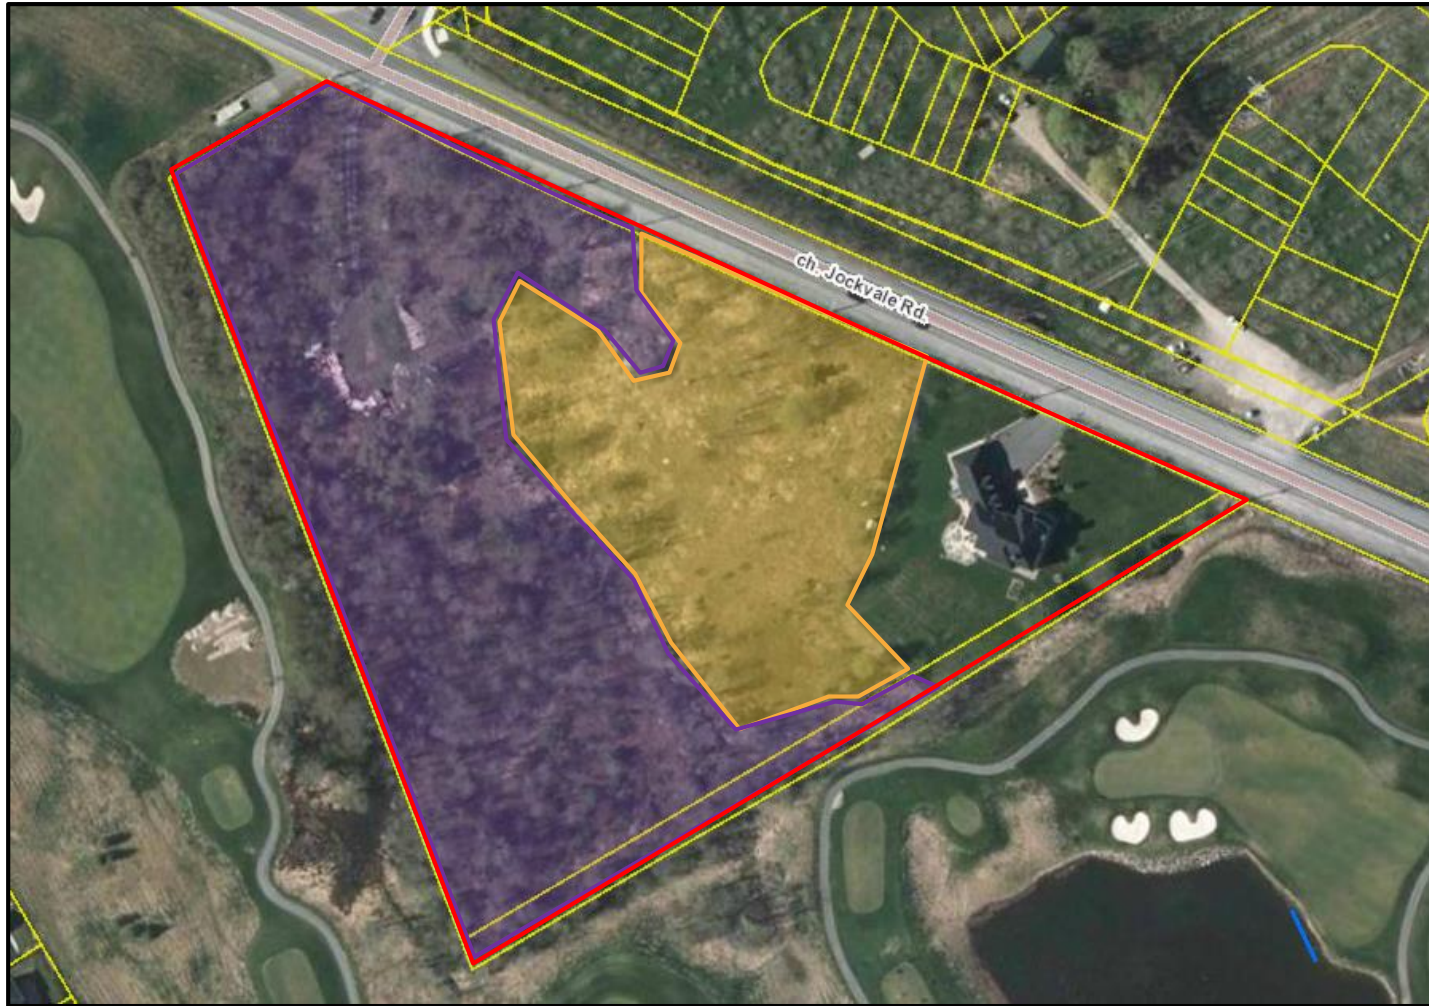
# FIGURE 1: VEGETATION MAPPING

Figure 1 shows vegetative community mapping. Open areas within the Site include the Cultural Meadow, the yard around the existing house, and a clearing in the northern part of the Cultural Woodlot where there is a small tin shed and woodpiles. These open areas account for approximately 50% of the Site. The Cultural Meadow is occupied by sparse woody vegetation. Low growing shrubs include Common Buckthorn, Wild Red Raspberry, and Domestic Apple. Isolated White Ash, Manitoba Maple, Staghorn Sumac, American Elm, and Trembling Aspen up to 20 cm dbh are also present. Groundcover is dominated by forb species including Canada Goldenrod and New England Aster. Common Ragweed, Common Burdock, Yellow Rocket, Lamb's Quarter's Pigweed, Chickory, Bull Thistle, Queen Anne's Lace, Ox-eye Daisy, Common Plantain, Bladder Campion, Dandelion, Red and White Clover, and Common Mullein are also present. The Cultural Meadow is a highly disturbed environment with a high proportion of weedy invasive species.

The remaining approximately 50% of the Site is occupied by a highly disturbed Cultural Woodlot. Within the Cultural Woodlot American Elm and White Ash are co-dominant, each accounting for approximately 40% of stems. Manitoba Maple and Domestic Apple are well represented, each accounting for approximately 10% of stems. There are a few older stems of these species up to 45 cm diameter at breast height (dbh) in size, primarily in the vicinity of the small patch of older trees in the northern part of the Site (as shown in the 1976 historic air photo) (Refer to Appendix A). Throughout the Site greater than 90% of stems are under 25 cm dbh in size. A large proportion of stems in the eastern part of the Cultural Woodlot are very recent regrowth, under 10 cm dbh in size.

As shown in Figure 1 (Refer to the attached EIS), currently approximately 50% of the Site consists of predominantly open areas with sparse tree cover. Most of the Site has been historically cleared for farming within the last 40 years. Historic air photos show that in 1976 there was a small isolated stand of trees in the northern part of the Site, and that the remainder of the Site and surrounding areas was cleared for agricultural usage (Photograph 1). By 1991, the Site was no longer used intensively for agriculture, and limited regeneration was occurring primarily in the northern and western portions of the Site (Photograph 2). These historic air photos indicate that the majority of tree cover within the Site is younger than approximately 25 to 35 years of age.

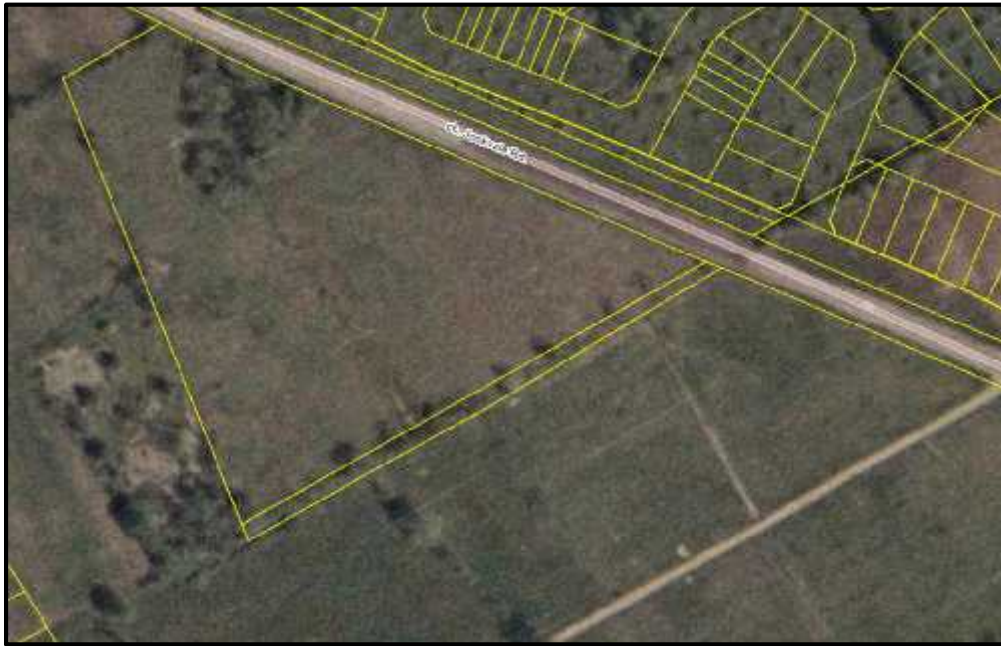
**Photograph 1:** Historic Air Photo from 1976. Property boundary shown in yellow. Note majority of Site and surrounding areas were cleared and utilized for agricultural purposes in 1976. Small patch of trees shown in northern part of Site (Photos from City of Ottawa 2016).

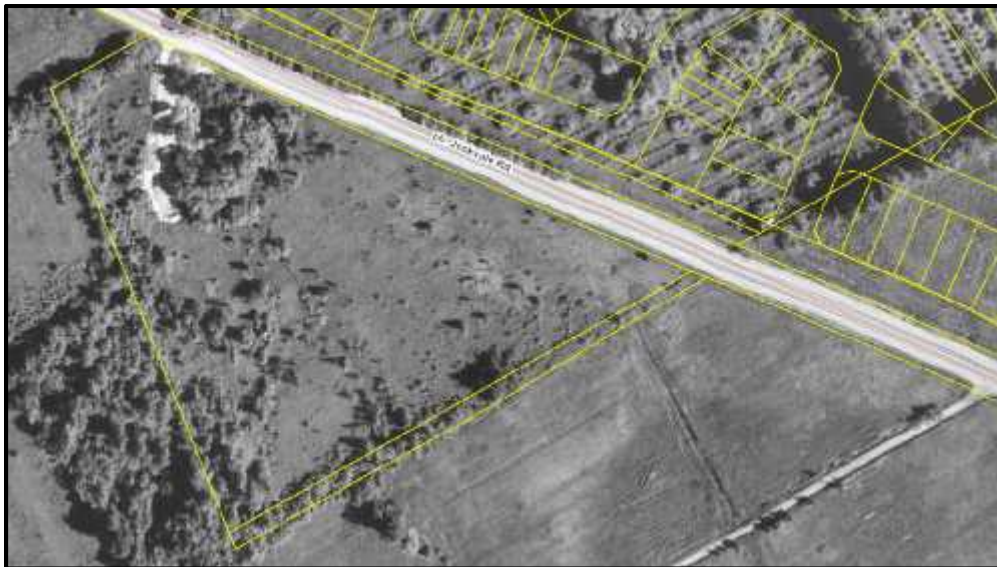
**Photograph 2:** Historic Air Photo from 1991. Property boundary shown in yellow. Note area that is currently shown as Cultural Woodland was predominantly cleared in 1991 with limited regeneration at that time (Photos from City of Ottawa 2016).

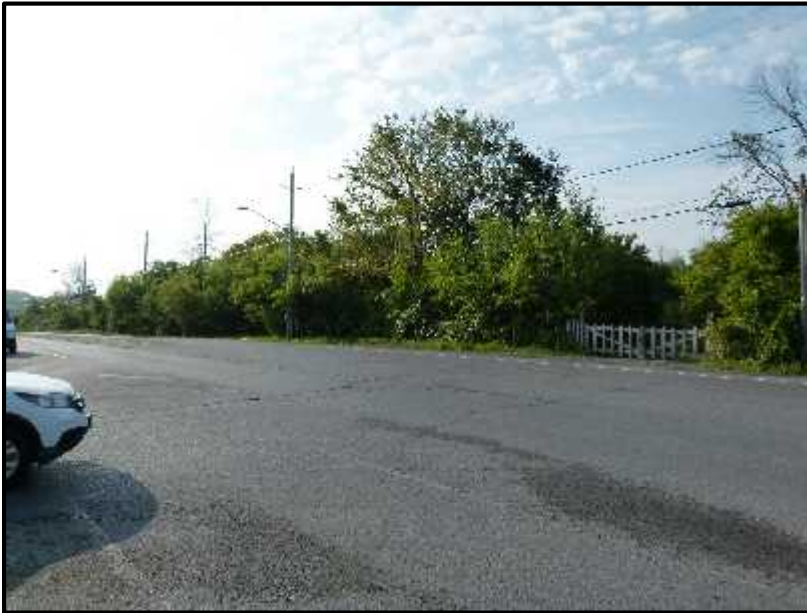
**Photograph 3:** Looking southeast at northern edge of Site. Jockvale Road in foreground, Site in background (September 3<sup>rd</sup>, 2015).

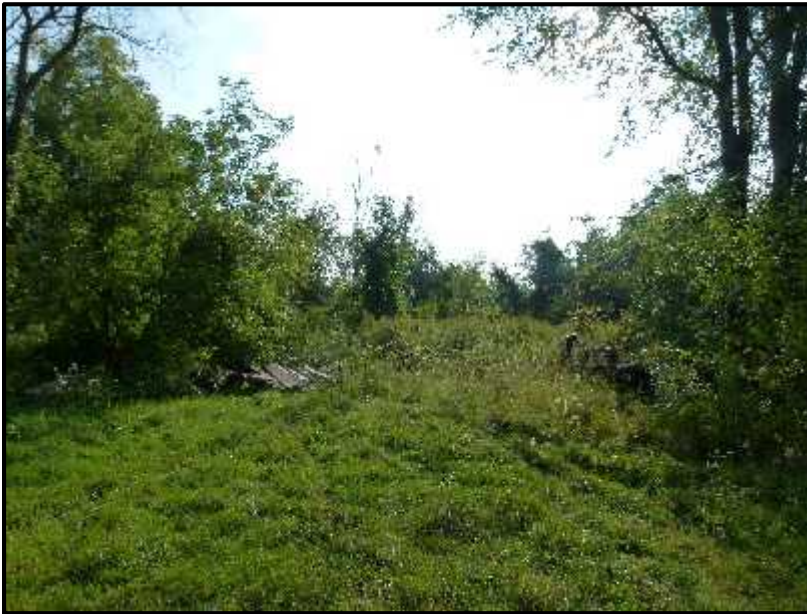
**Photograph 4:** Cleared area in northern part of Site – looking east at Cultural Meadow (September 3<sup>rd</sup>, 2015).

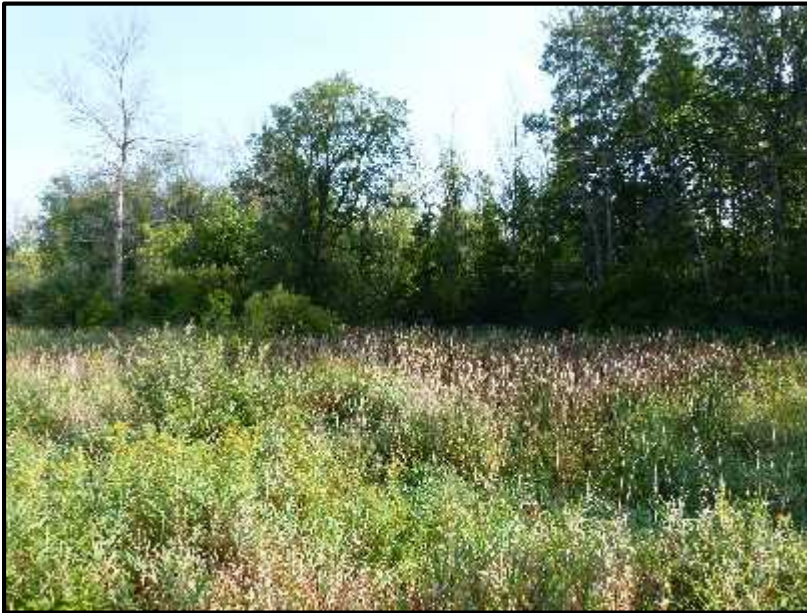
**Photograph 5:** Southwest corner of Site, looking north at Cultural Meadow with Cultural Woodlot in background (September 3<sup>rd</sup>, 2015).

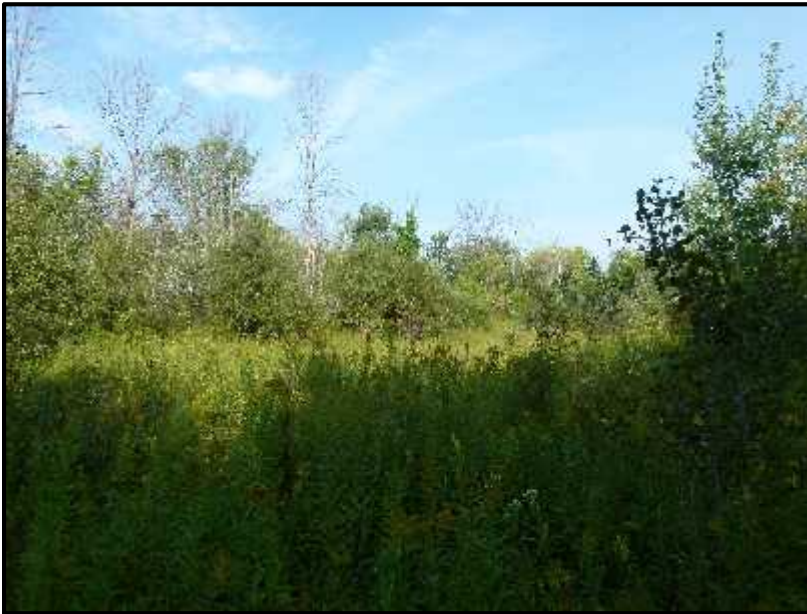
**Photograph 6:** Cultural Meadow in southeastern portion of the Site, looking west (September 3<sup>rd</sup>, 2015).

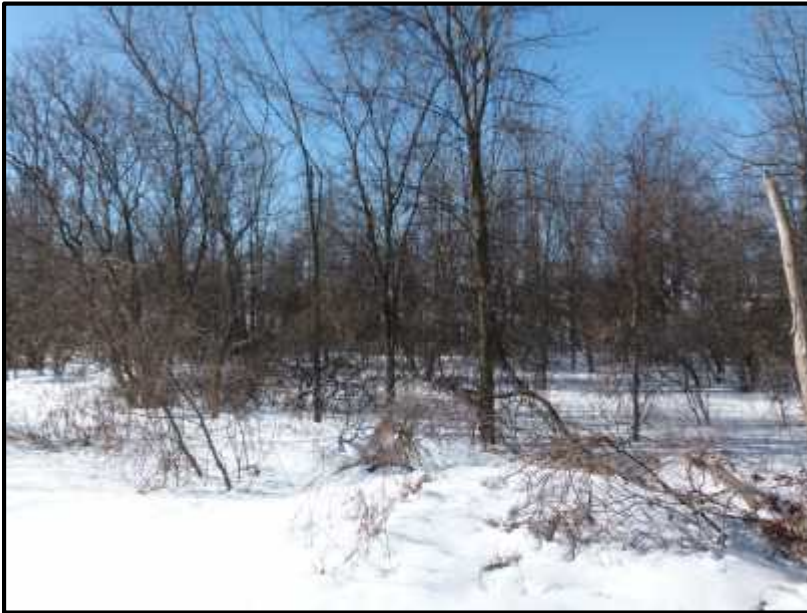
**Photograph 7:** Cultural Woodlot in winter, note low density of large stems (February 22<sup>nd</sup>, 2016).

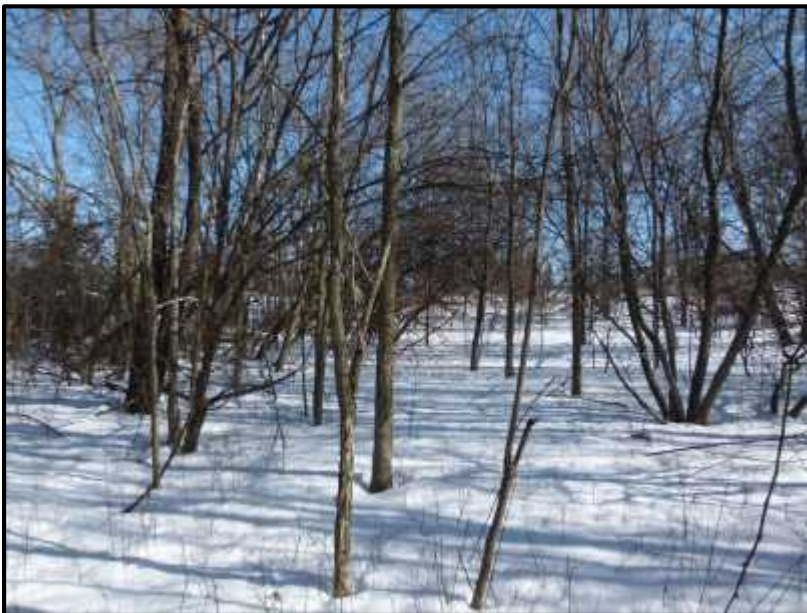
**Photograph 8:** Cultural Woodlot in winter, note low density of large stems (February 22<sup>nd</sup>, 2016).

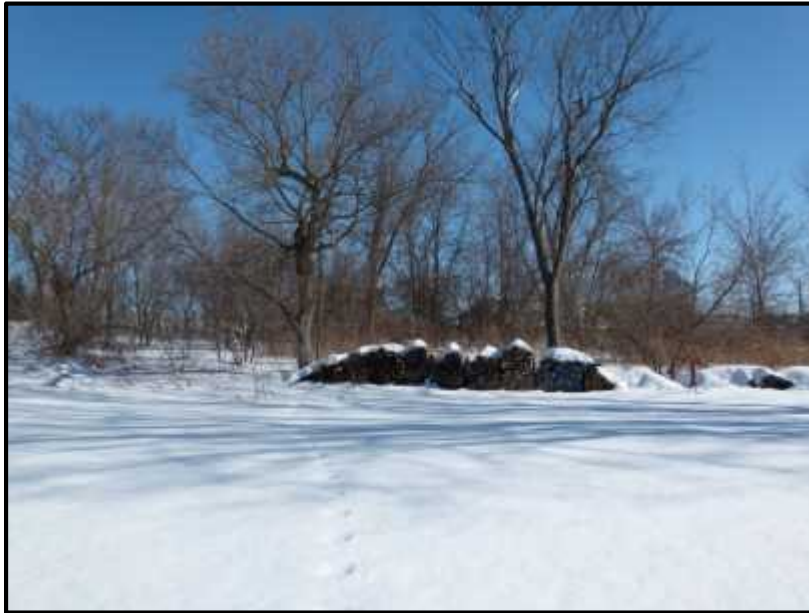
**Photograph 9:** Clearing in northern part of Site with woodpiles. Note isolated larger trees in small patch in northern part of Site (February 22<sup>nd</sup>, 2016).

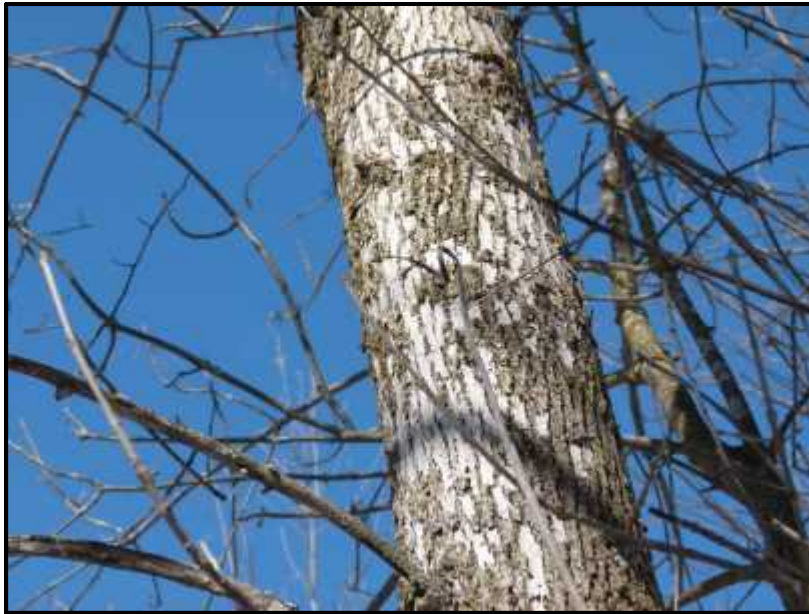
The Cultural Woodlot is highly fragmented with many small openings. These openings have been created by a mix of disturbance factors including wind throw and dieback of large American Elms (likely due to Dutch Elm Disease), as well as dieback of large White Ash (due to Emerald Ash Borer). Most of the large American Elm and White Ash are in very poor condition and are either dead or visibly declining. Damage to the majority of large trees within the Site has left the woodlot highly degraded. Extensive evidence of infestation by Emerald Ash Borer was noted, as shown in Photographs 10 and 11 (below).

**Photograph 10:** White Ash with extensive damage from Emerald Ash Borer (February 22<sup>nd</sup>, 2016).

In order to mitigate the loss of woody vegetation from Site clearing, trees and shrubs will be replanted selectively between lots, at the back and front of lots, and in community amenity areas. The Concept Plan shows potential tree and shrub planting locations. The planting locations and specific planting requirements will be confirmed by a detailed Landscaping Plan. Plantings should emphasize the use of native trees and shrubs, which may include those identified in Appendix B. Planting of Ash trees should be avoided due to the high likelihood that any planted Ash trees will become infested with Emerald Ash Borer.

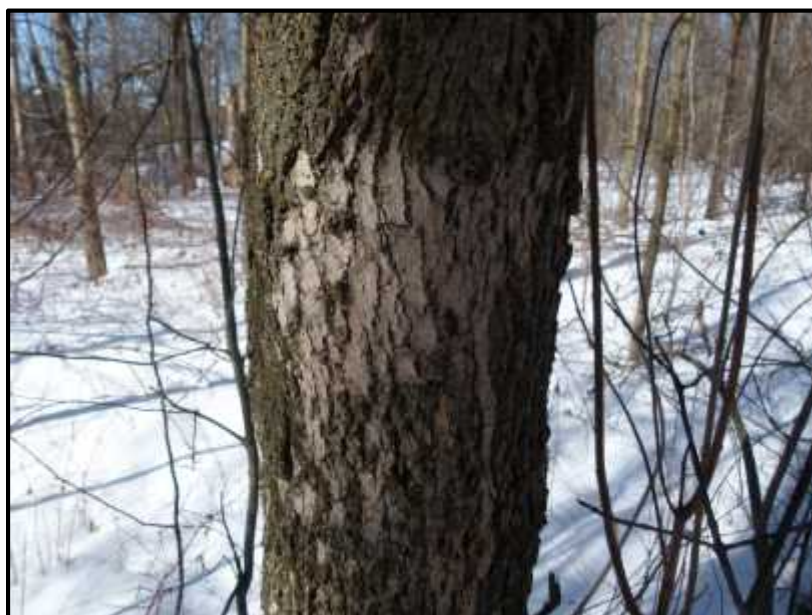
**Photograph 11:** White Ash with extensive damage from Emerald Ash Borer (February 22<sup>nd</sup>, 2016).
