**Phase I - Environmental Site Assessment**

Residential Property  
3740 Jockvale Road  
Ottawa, Ontario

December 10, 2015

Report: PE3664-1

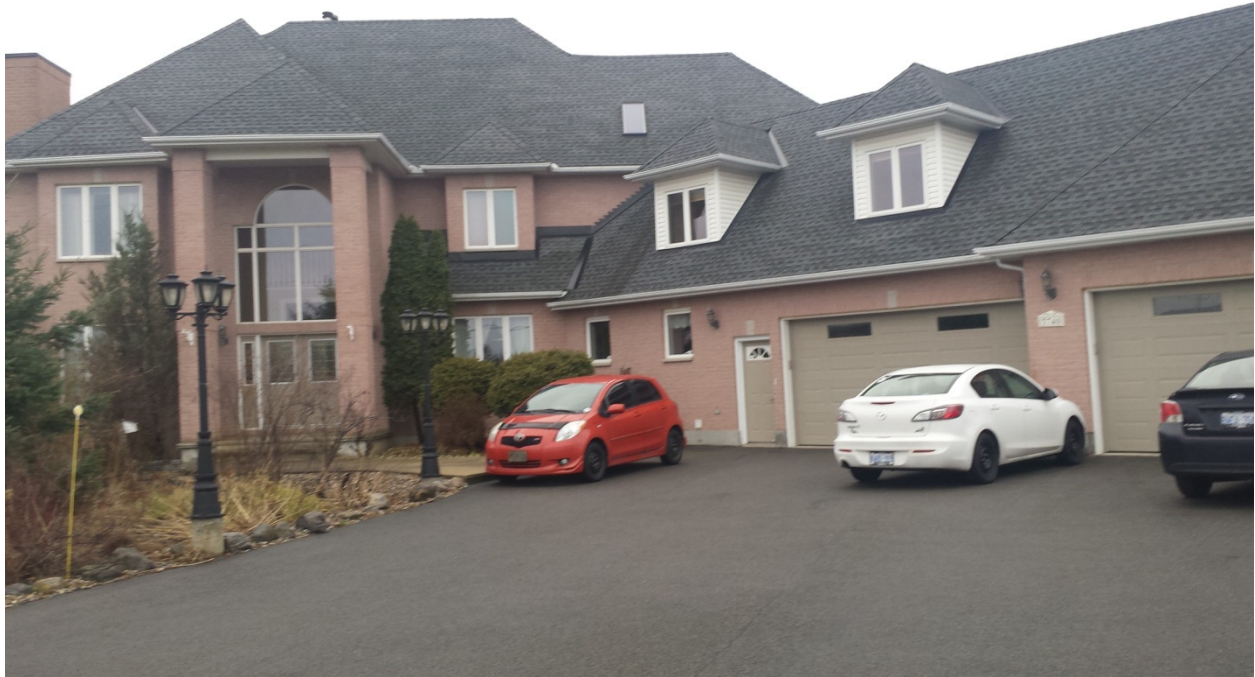
The dwelling was constructed in 1995, and no environmental concerns were identified with respect to building materials. The building is currently heated and cooled with a propane fired furnace and air conditioner. The furnace and propane tank were installed in 2013; prior to this time, the building was heated with fuel oil. The location of the former fuel oil tank was observed in the basement of the subject building. No signs of stains or leaks were observed in the concrete, and the concrete was in good condition. Several floor drains were present in the basement floor, which lead to a French drain system. No water was observed in the drains at the time of the site visit, and no sump pump is present.

Photograph 1: North facing side of the residential dwelling at 3740 Jockvale Road.

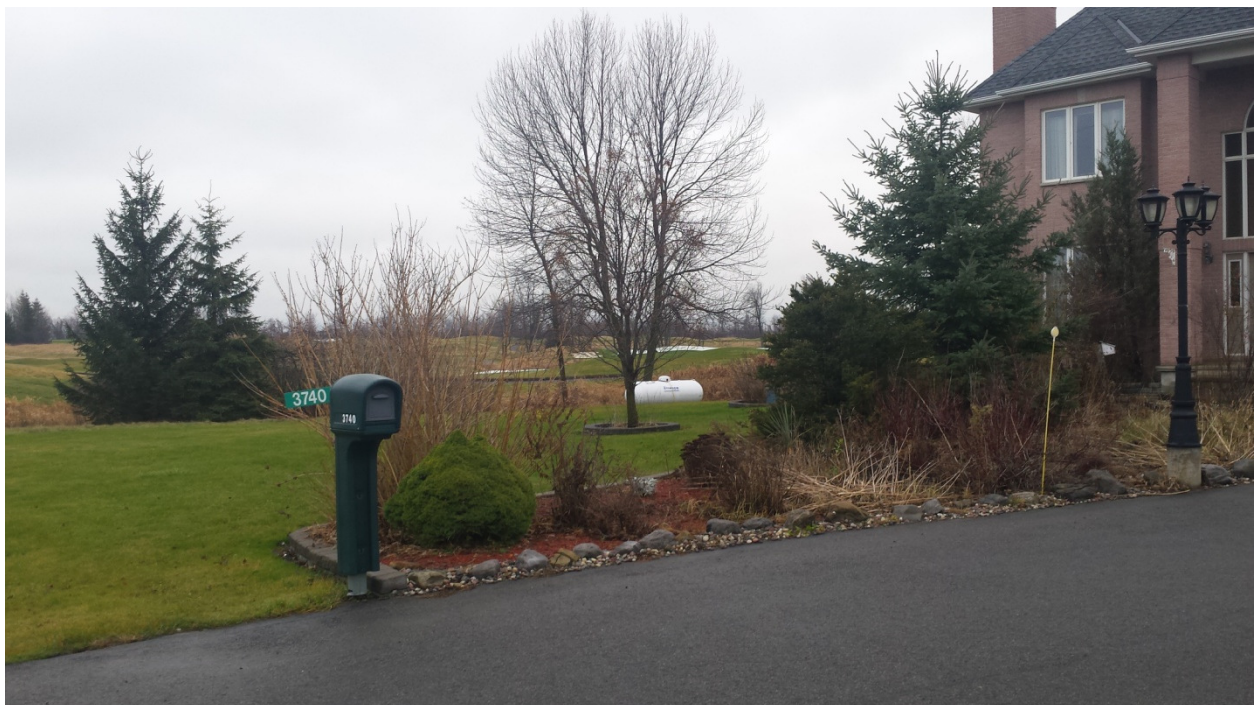
Mr. Rocco Iamello, the son of the current owner, was not aware of any environmental concerns with respect to the subject site. According to Mr. Iamello, the fuel oil furnace was replaced with a propane furnace and tank approximately two (2) years ago.

Photograph 4: Propane tank at the southeast edge of the property, looking south.

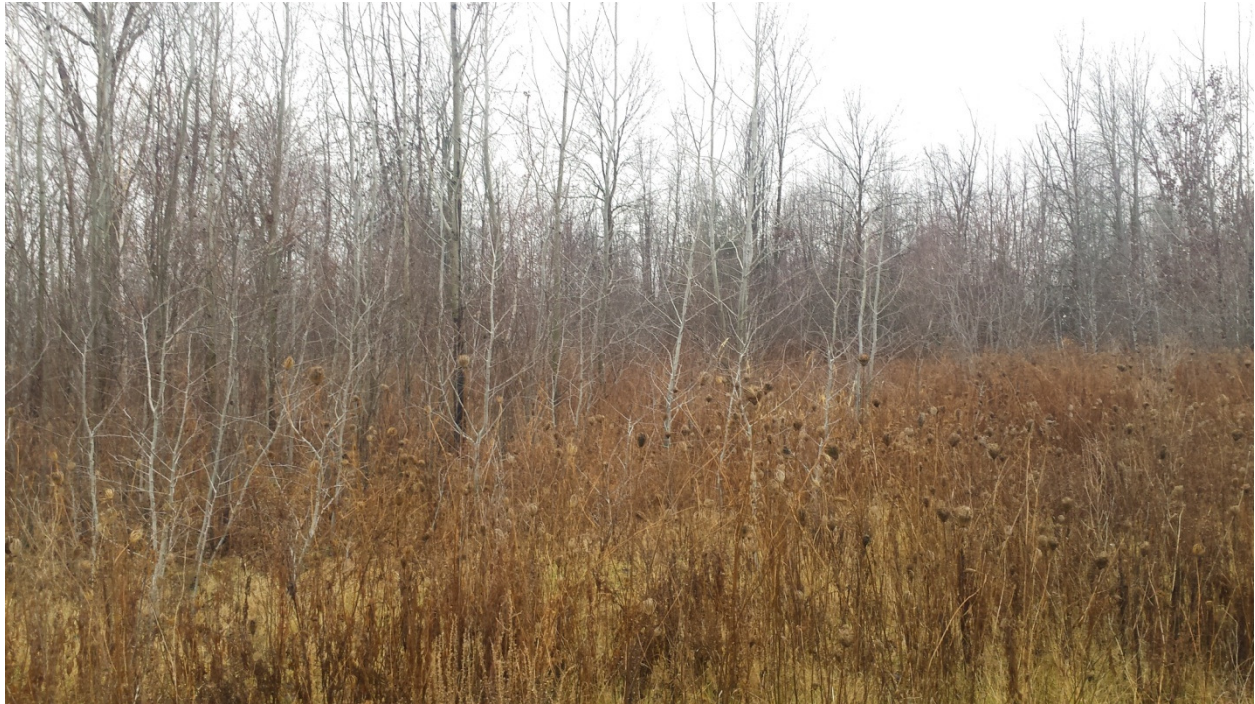
Photograph 5: Brush and trees occupy the remainder of the site (view looking west).

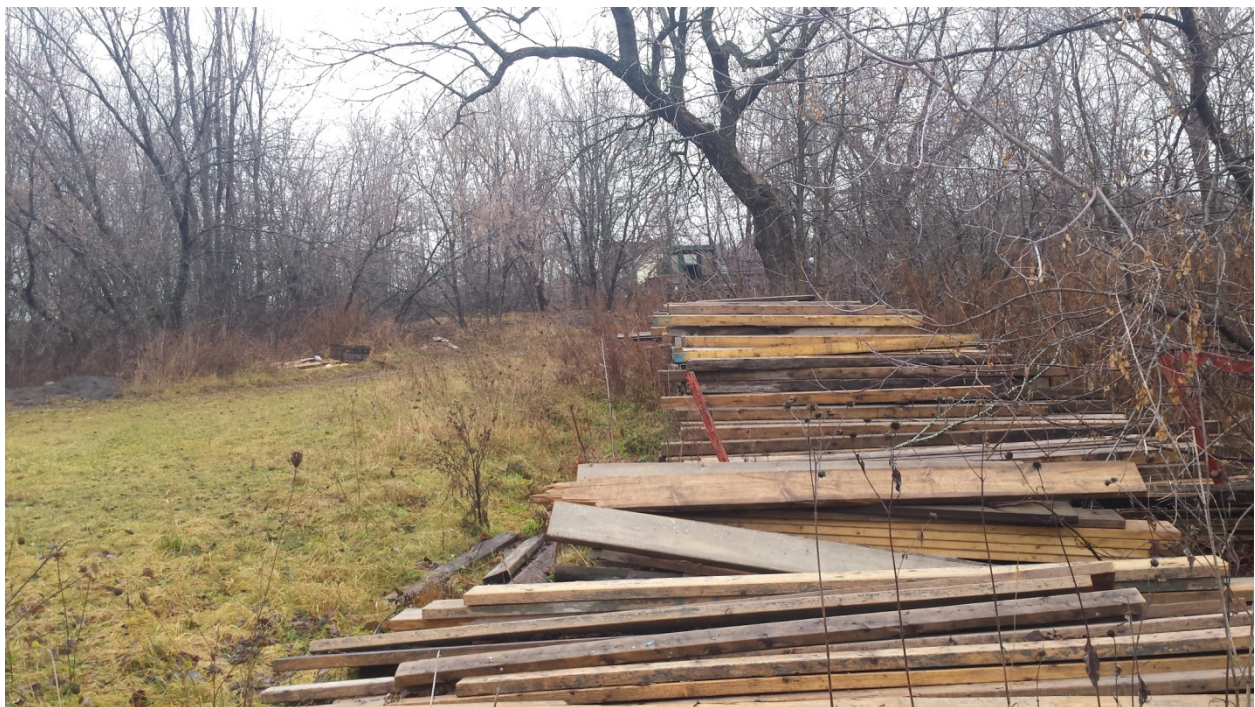
Photograph 6: Open workspace area at the west end of the property, looking south. This area contains materials used for concrete forming.

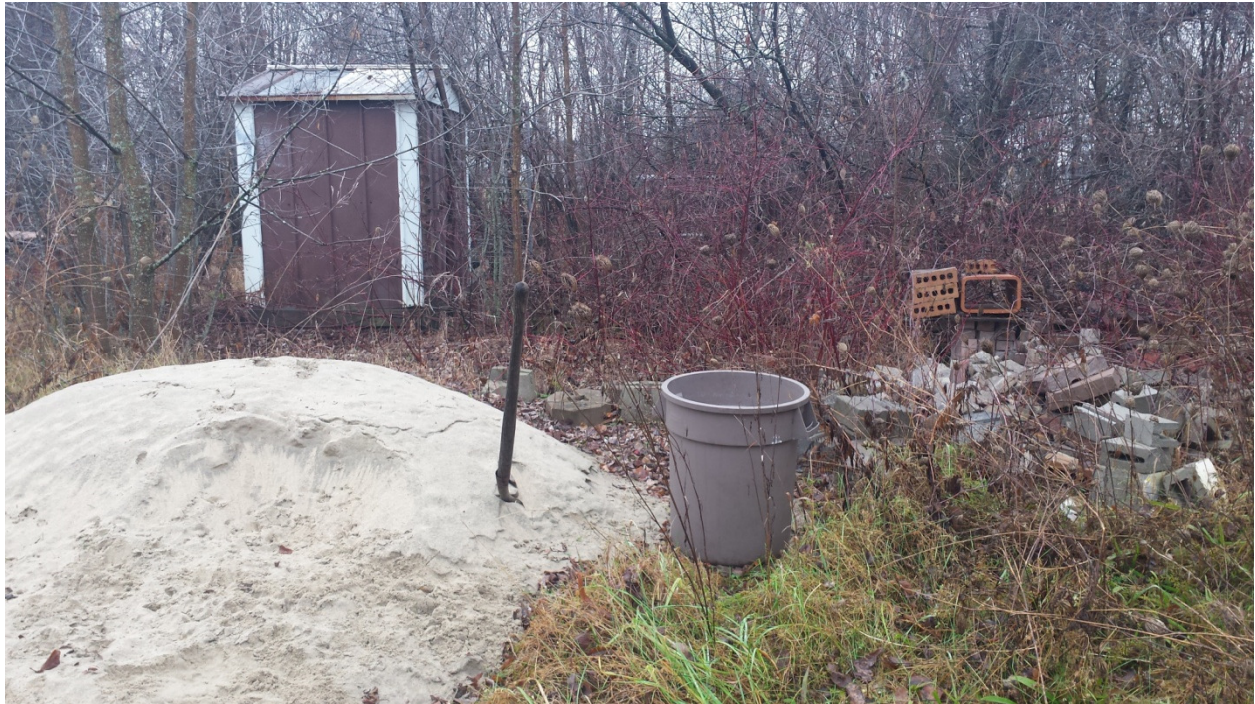
Photograph 7: Storage shed, sand, and concrete blocks at western work area of the property.

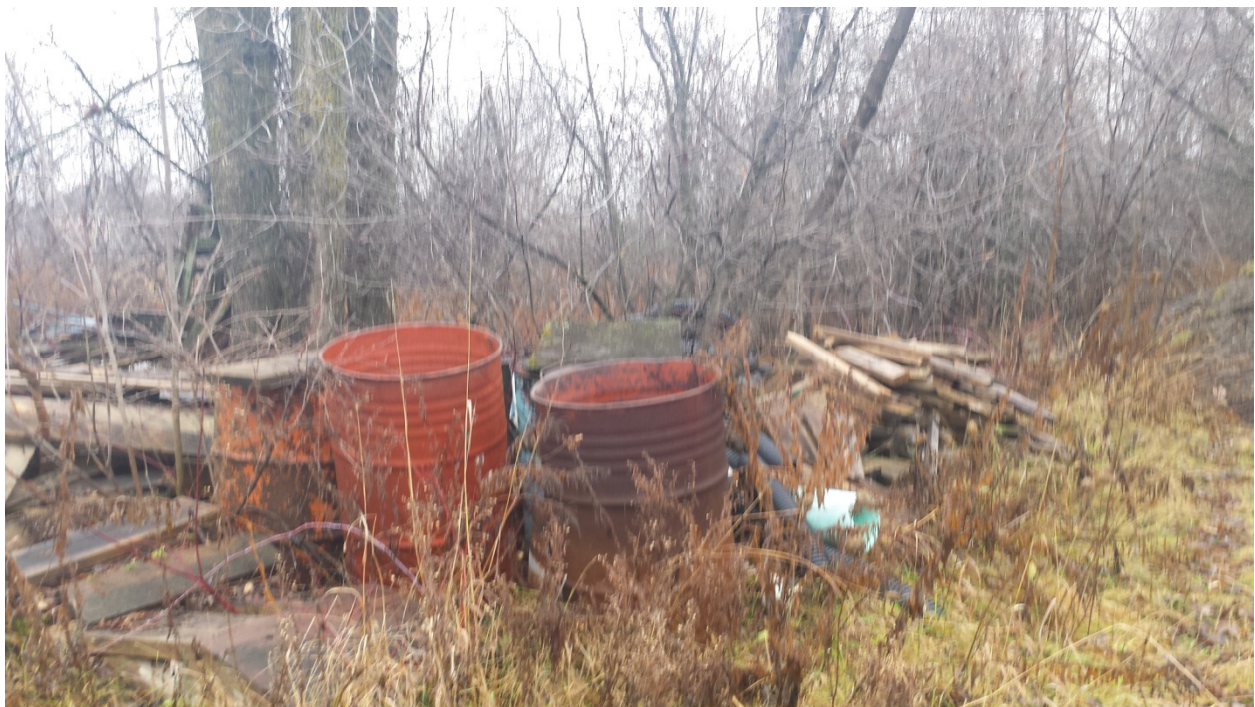
Photograph 8: Empty barrels and work materials at the western work area of the property.
