Phase One Environmental Site Assessment

3809 Borrisokane Road, Ottawa, ON

Caivan Brazeau Development Corporation

December 2018

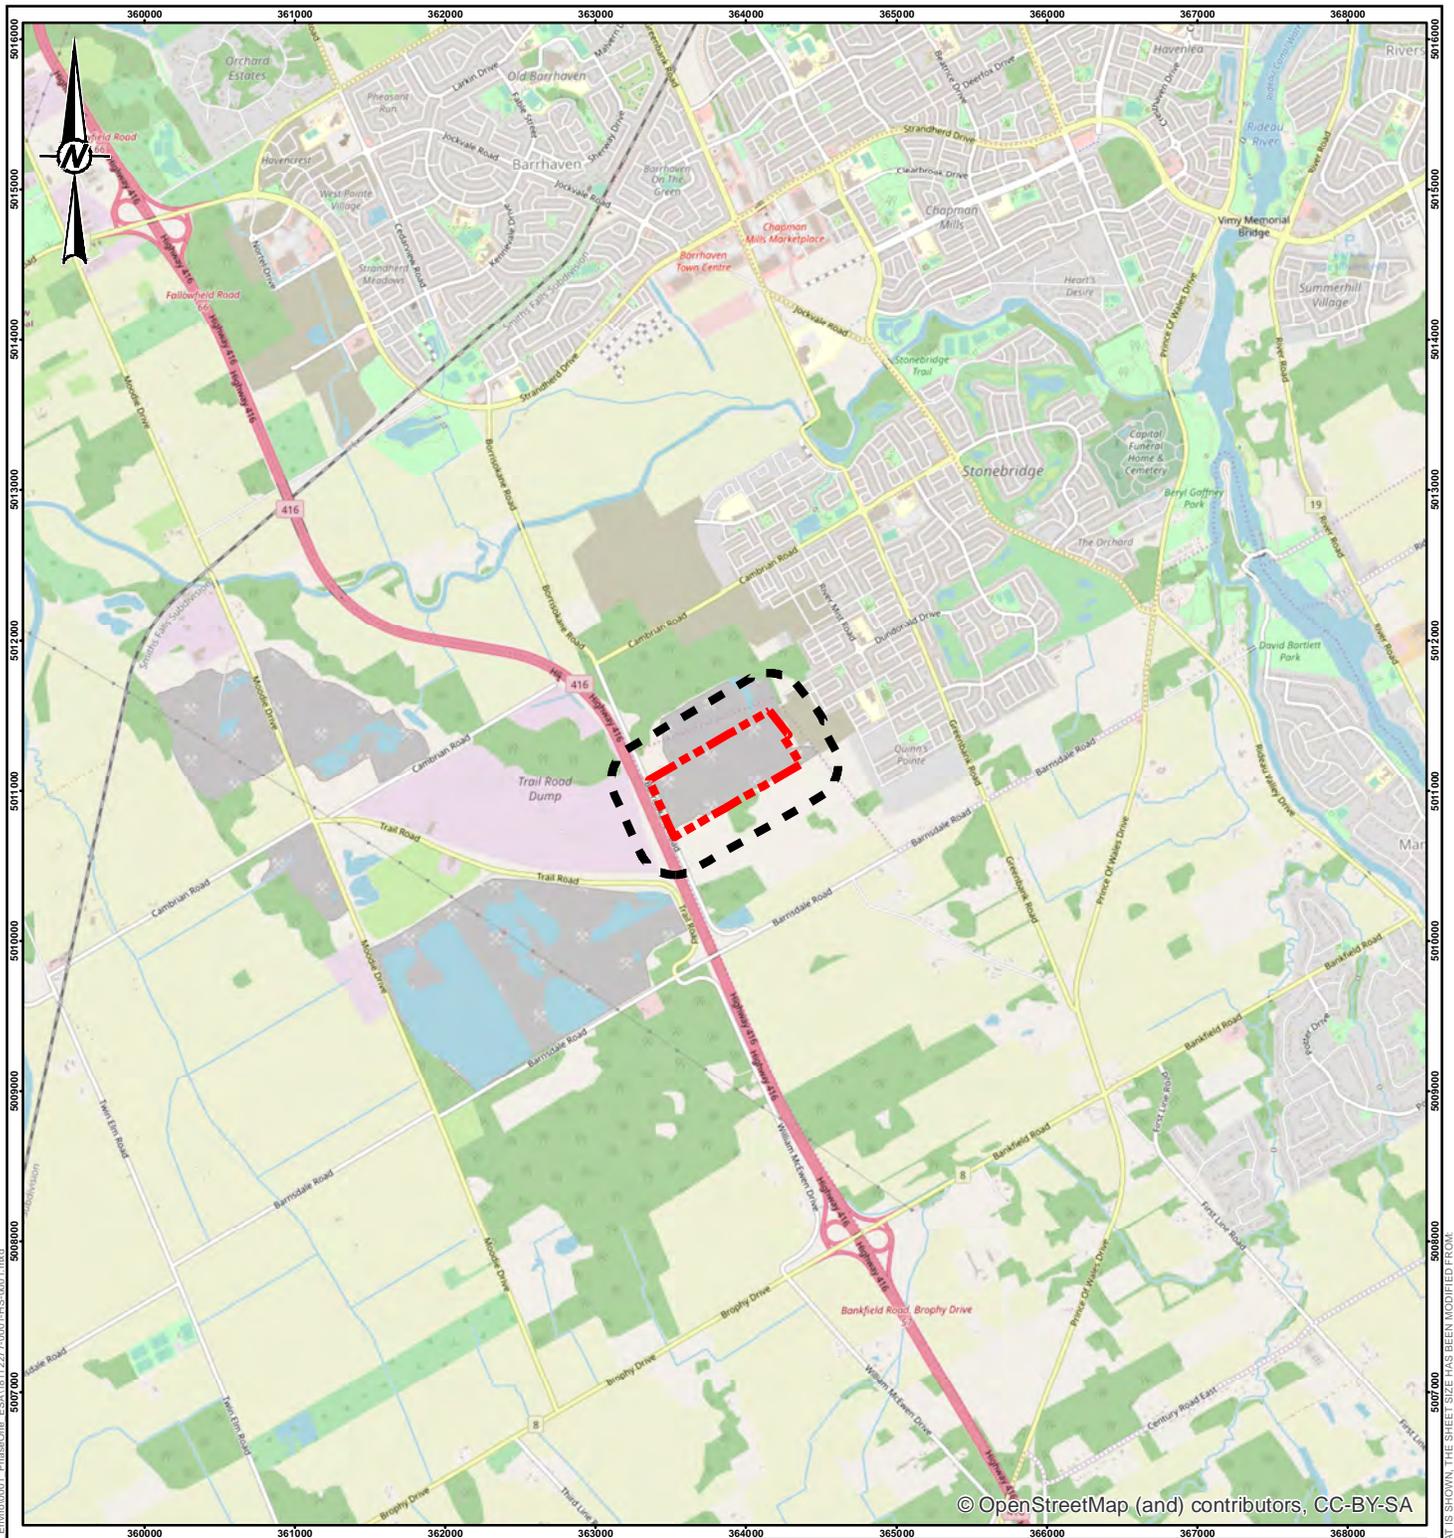
Golder Associates Ltd. (Golder) was retained by Caivan Brazeau Development Corporation (Caivan) to conduct a Phase One Environmental Site Assessment (Phase One ESA) for the property located at 3809 Borrisokane Road in Ottawa, hereafter referred to as the “Site” or “Phase One Property”. The Site covers an area of 37.8 hectares (93.4 acres) and is located north of Barnsdale Road and east of Veterans Memorial Highway (“ON 416”) in Ottawa, Ontario, as shown in Figure 1.

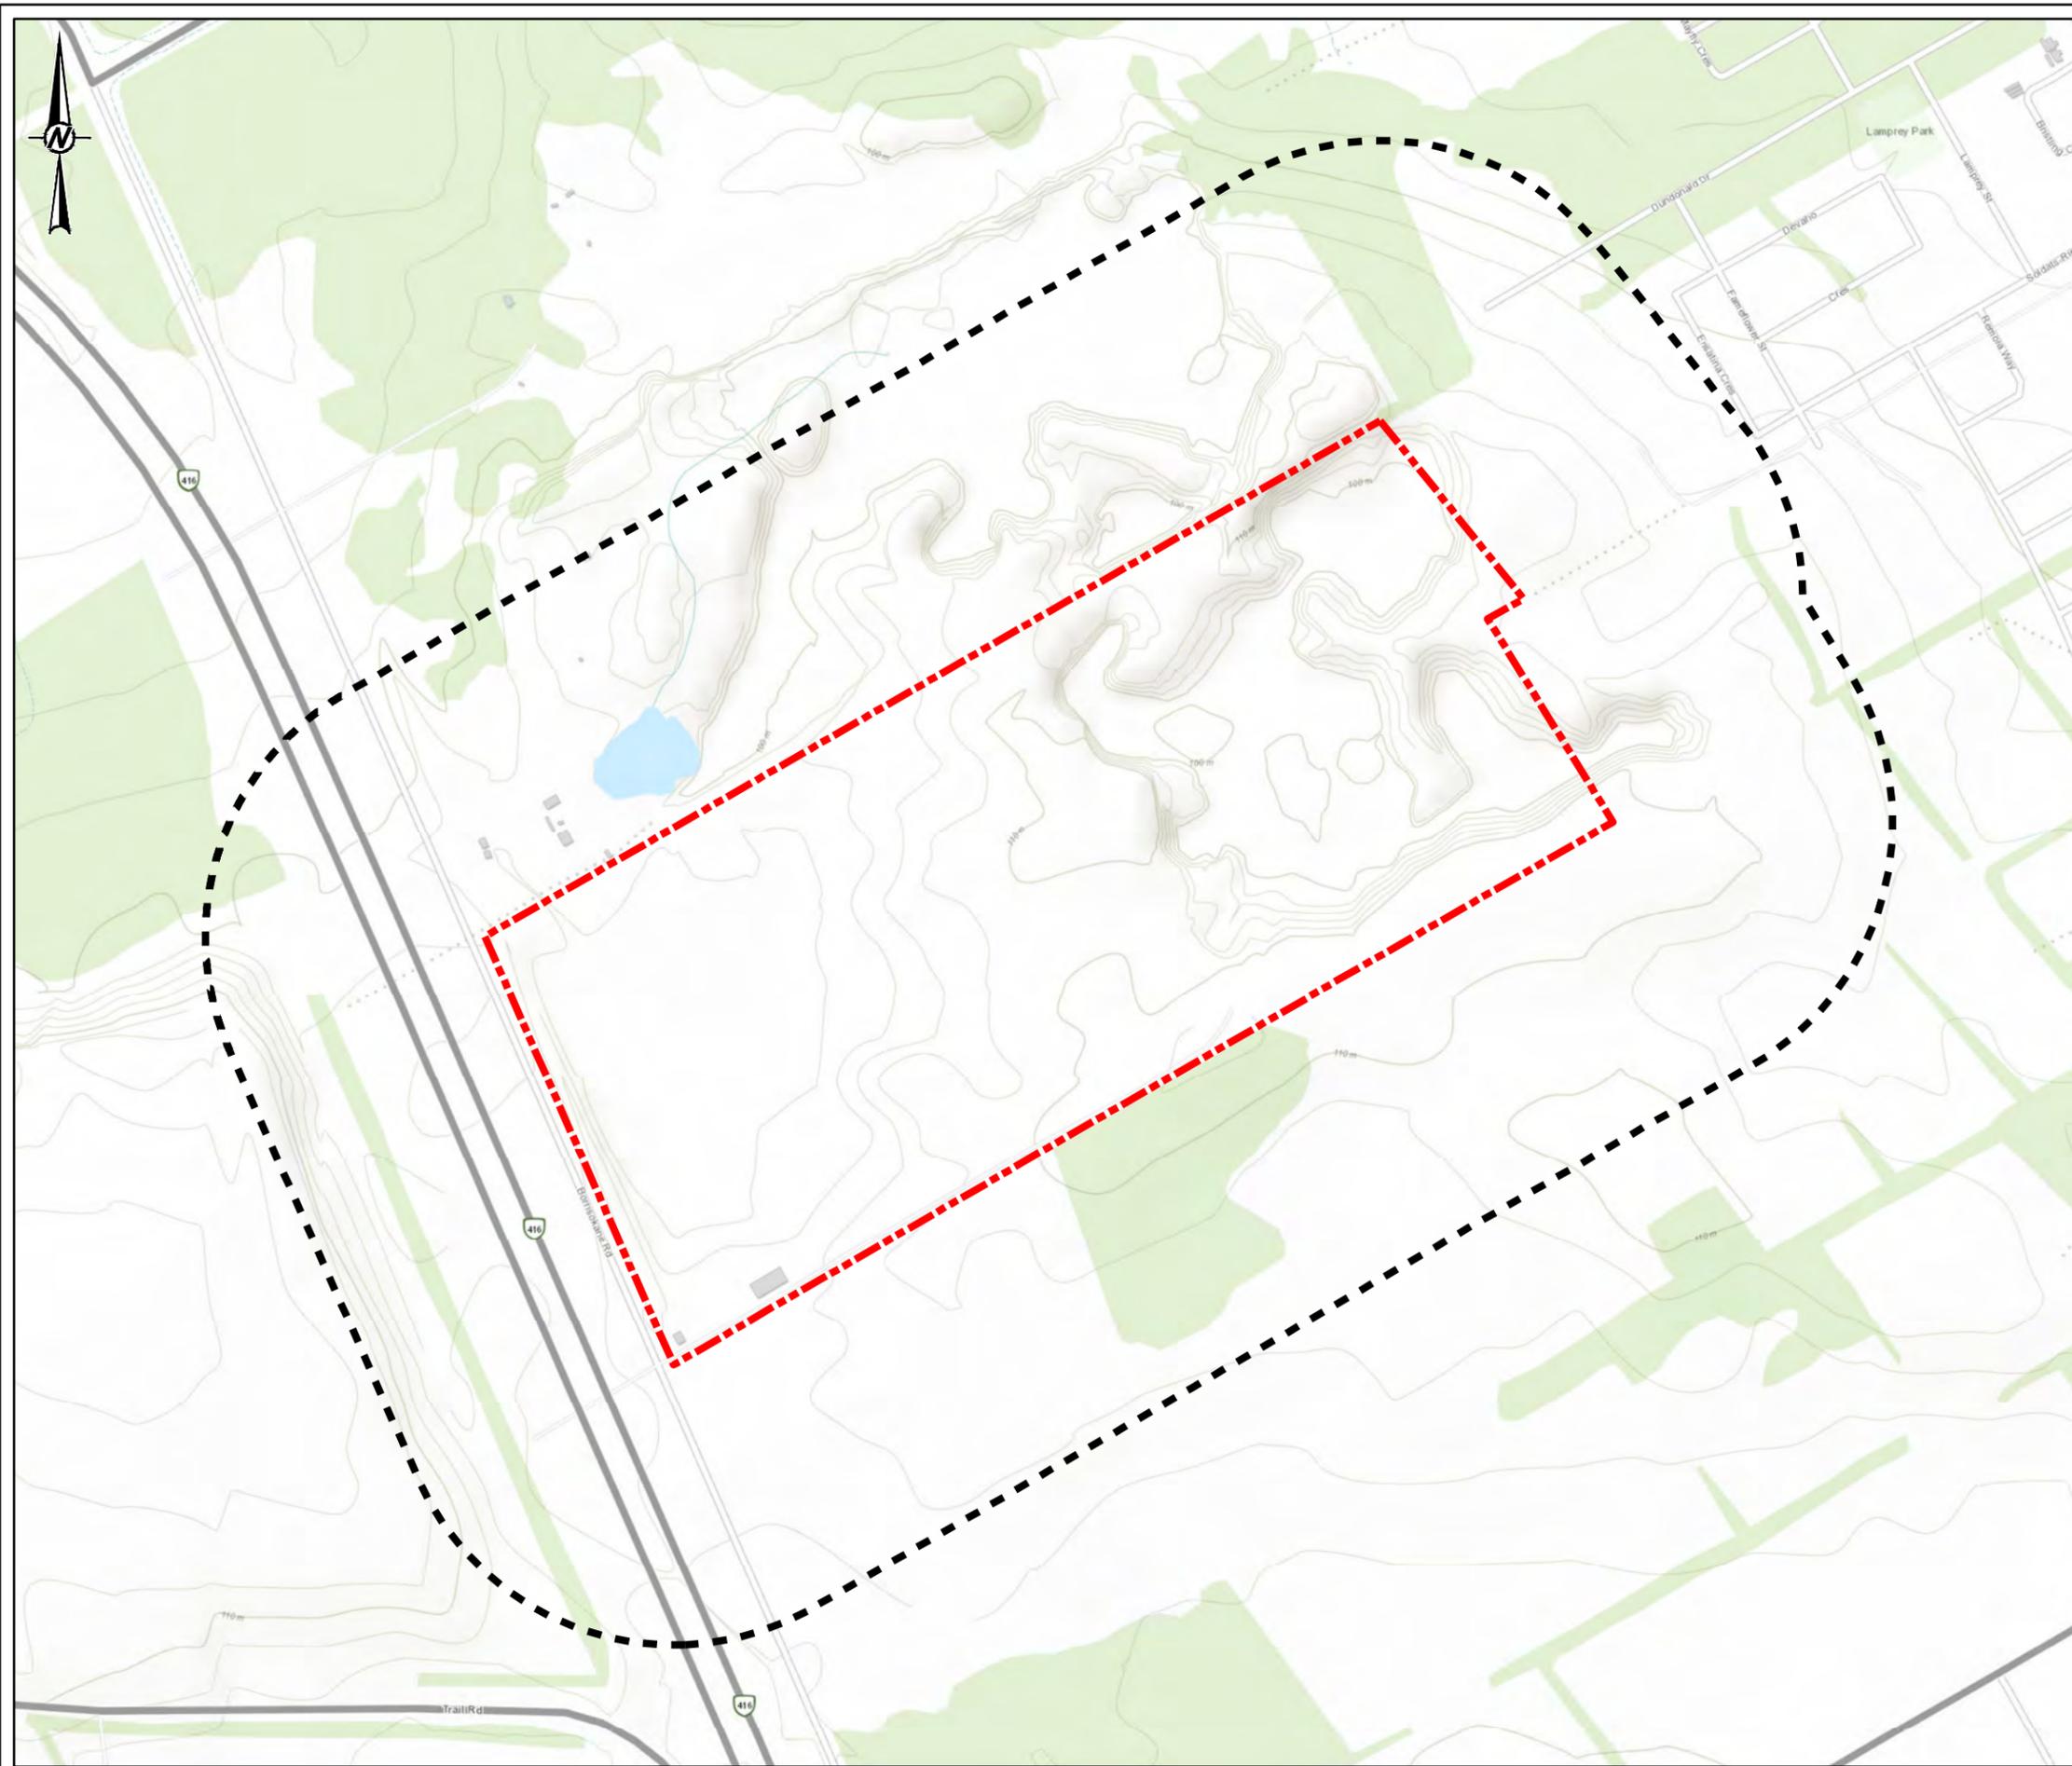
The following records were reviewed to identify topographic, geologic and hydrogeological conditions at the Site. A topographic map (Ontario Base Map) showing the Site area and the location of any water bodies is provided in Figure 3. Additional information on Site features, as observed at the time of the Site visit, is provided in Section 6.

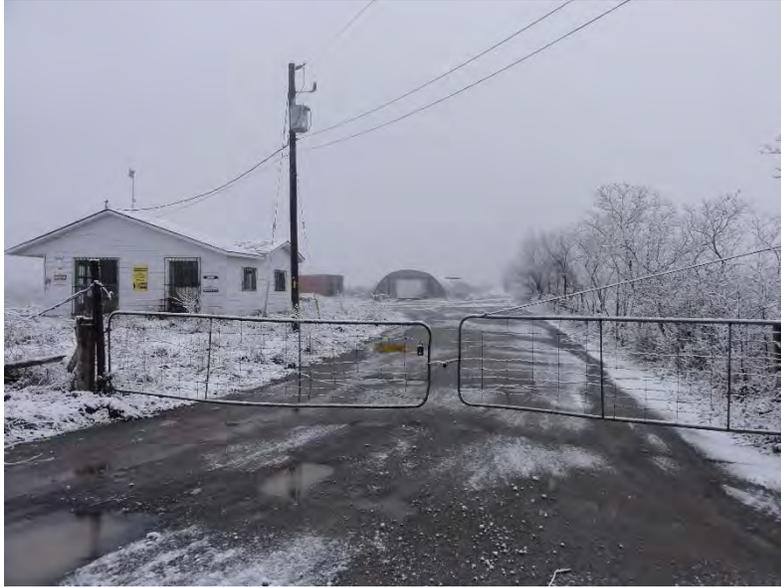
Photo 5 – Asphalt paved driveway access to the Site, off Borrisokane Road.

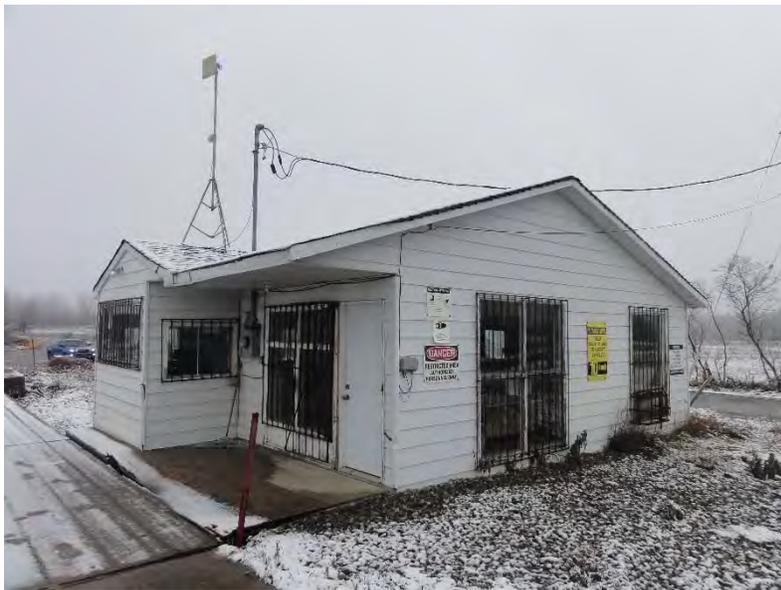
Photo 6 – View of scale office building located on the southwest corner of the Site, looking southeast.

The scale office building located on the southwest portion of the Site was serviced by an off-Site pole mounted transformer. The office used to be heated by a portable electric heater and cooled by a window mounted air-conditioning unit. A large storage shed observed east of the scale office building was rented out by previous owners to landscaping companies for equipment storage. No ASTs or USTs were reportedly associated with these building structures current and historically. No evidence of any stains, spills or stressed vegetation in the vicinity of these building structures were observed at the time of the Site visit, based on limited visibility due to snow cover. A large metal tank was observed on the western portion of the Site which was reportedly used for water storage used by the landscaping companies renting part of the Site.

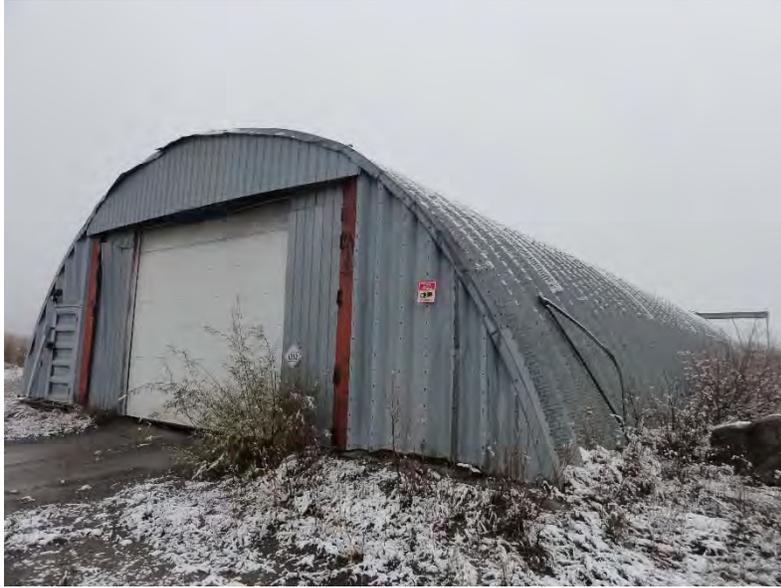
Photo 7 – A storage shed located on the southwest corner of the Site (formerly used for tool storage).

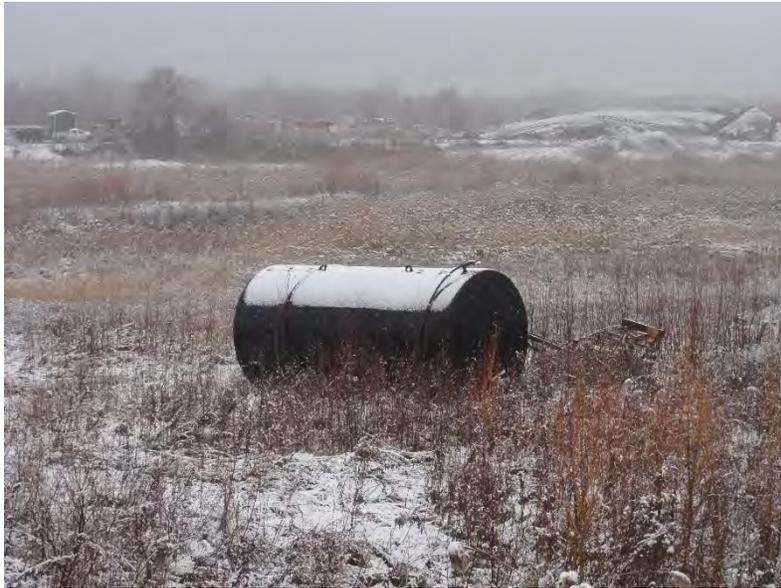
Photo 9 – View of water storage tank (according to the Site Representative) located north of the storage shed.

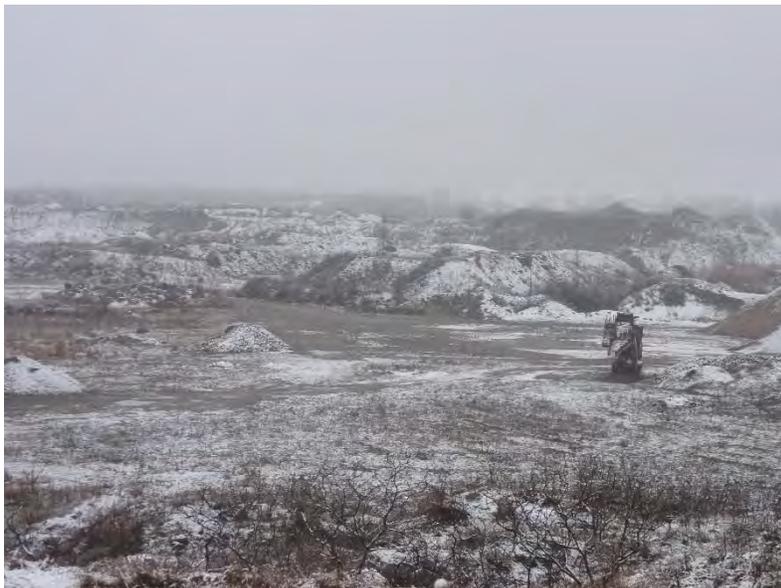
Photo 10 – View of the excavation with typical stockpiles on the eastern portion of the Site.

The access driveway on the southwest corner of the Site extended along the south perimeter to a steep decline ramp to the excavation floor which consisted of various stockpile materials including sand, and boulders that were reportedly generated from extraction and screening activities at the Site. Two small stockpiles of red clay bricks and concrete debris was observed on the excavation floor; however, the Site Representative indicated that these materials were imported but not used to backfill any parts of the Site. Other stockpiles with overgrown vegetation observed at the Site reportedly consisted of topsoil sourced from the Site and were to be used for backfilling purposes at the Site.

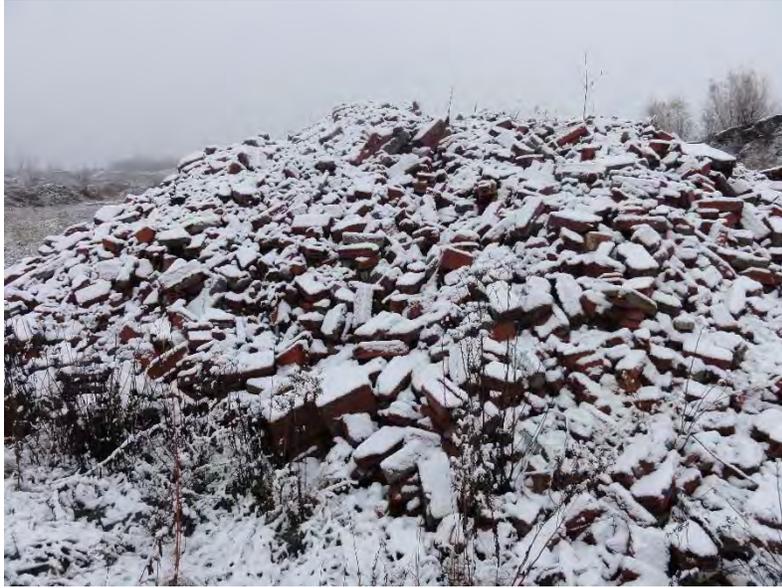
Photo 11 – Imported clay/red brick stockpiles located on the excavation floor of the Site.

- Stockpiles of fill materials were observed throughout the Site at the time of the Site visit; however, were generated as part of the extraction and screening activities on-Site and did not include any imported materials. Two stockpiles (one each of red clay bricks and concrete debris) were observed on the excavation floor although were not used for backfilling purposes according to the Site Representative. These are considered waste materials that needs to be managed and not fill materials of unknown quality and origin on the Site. As such, presence of these imported materials (red clay bricks and concrete debris) are not considered an on-Site PCA

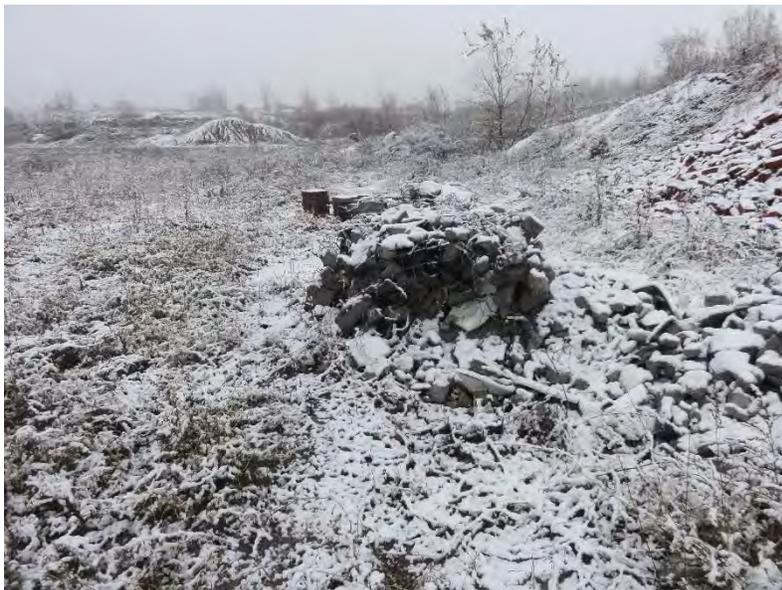
Photo 12 – Imported concrete materials stockpiled located on the excavation floor of the Site.

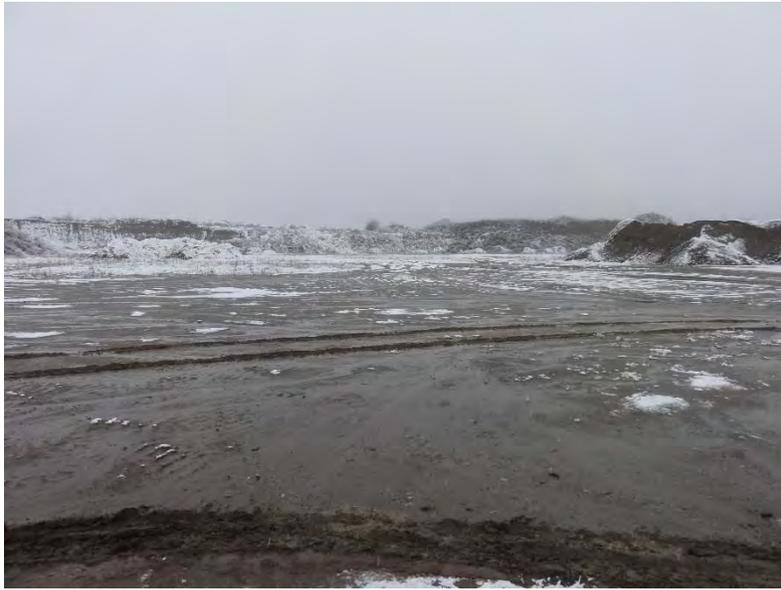
Photo 13 – General view of typical excavation floor of the Site.

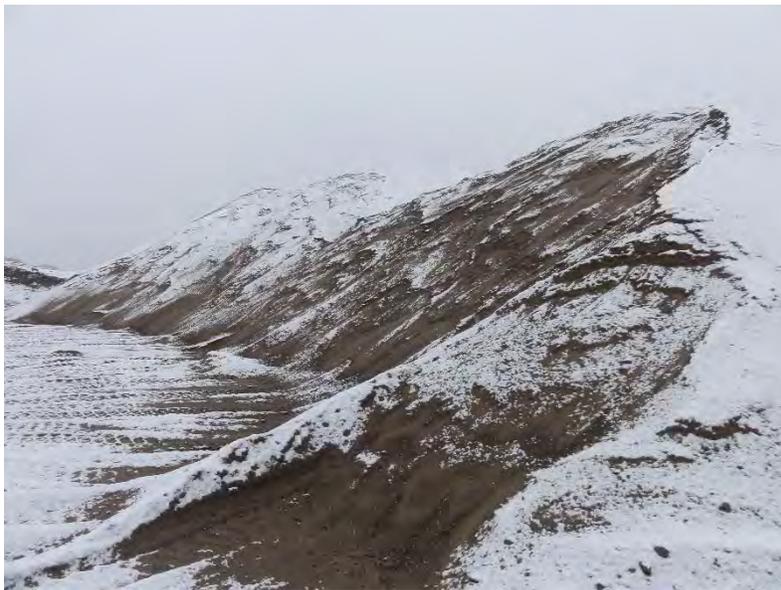
Photo 14 – Excavated materials stockpiled (following screening) as clean sand on the eastern portion of the Site.

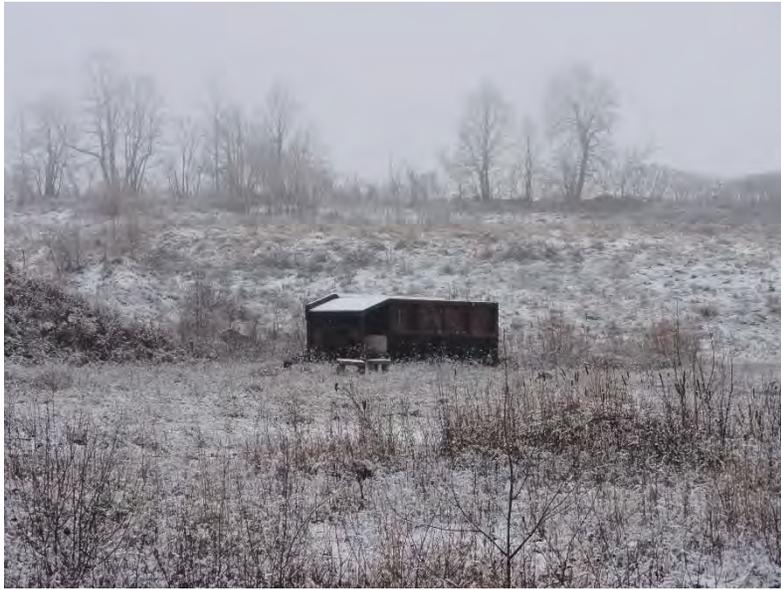
Photo 15 – Inactive incinerator located on the eastern portion of the Site.

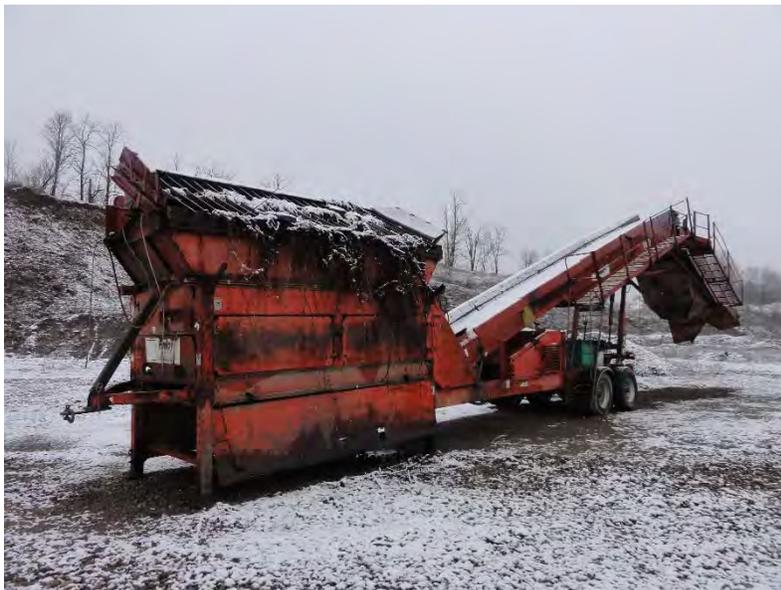
Photo 16 – Sand filter machine (currently inactive) located on the east portion of the Site (no evidence of any stains or spills observed).

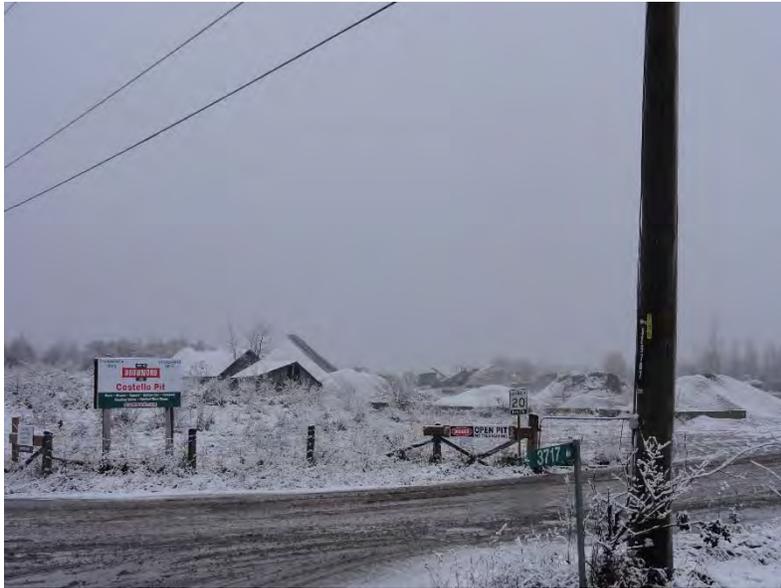
Photo 17 – View of active quarry (sand, gravel and other materials) facility at 3717 Borrisokane Road, immediate north of the Site.

During the Site visit, an active sand pit was observed immediate north of the Site which has been operational since at least 1967 as per review of aerial photographs. The other surrounding lands included residential developments consisting of single-family homes and town house buildings to the adjacent east; undeveloped lands reportedly proposed for residential land use to the immediate south; and, roadways (Borrisokane Road) and highway (ON 416) followed by a waste management facility at Trail Road.
