Phase I Environmental Site Assessment

Stonebridge – Phase 16
Part of 2701 Longfields Drive
Ottawa, Ontario

Report: PE4327-2

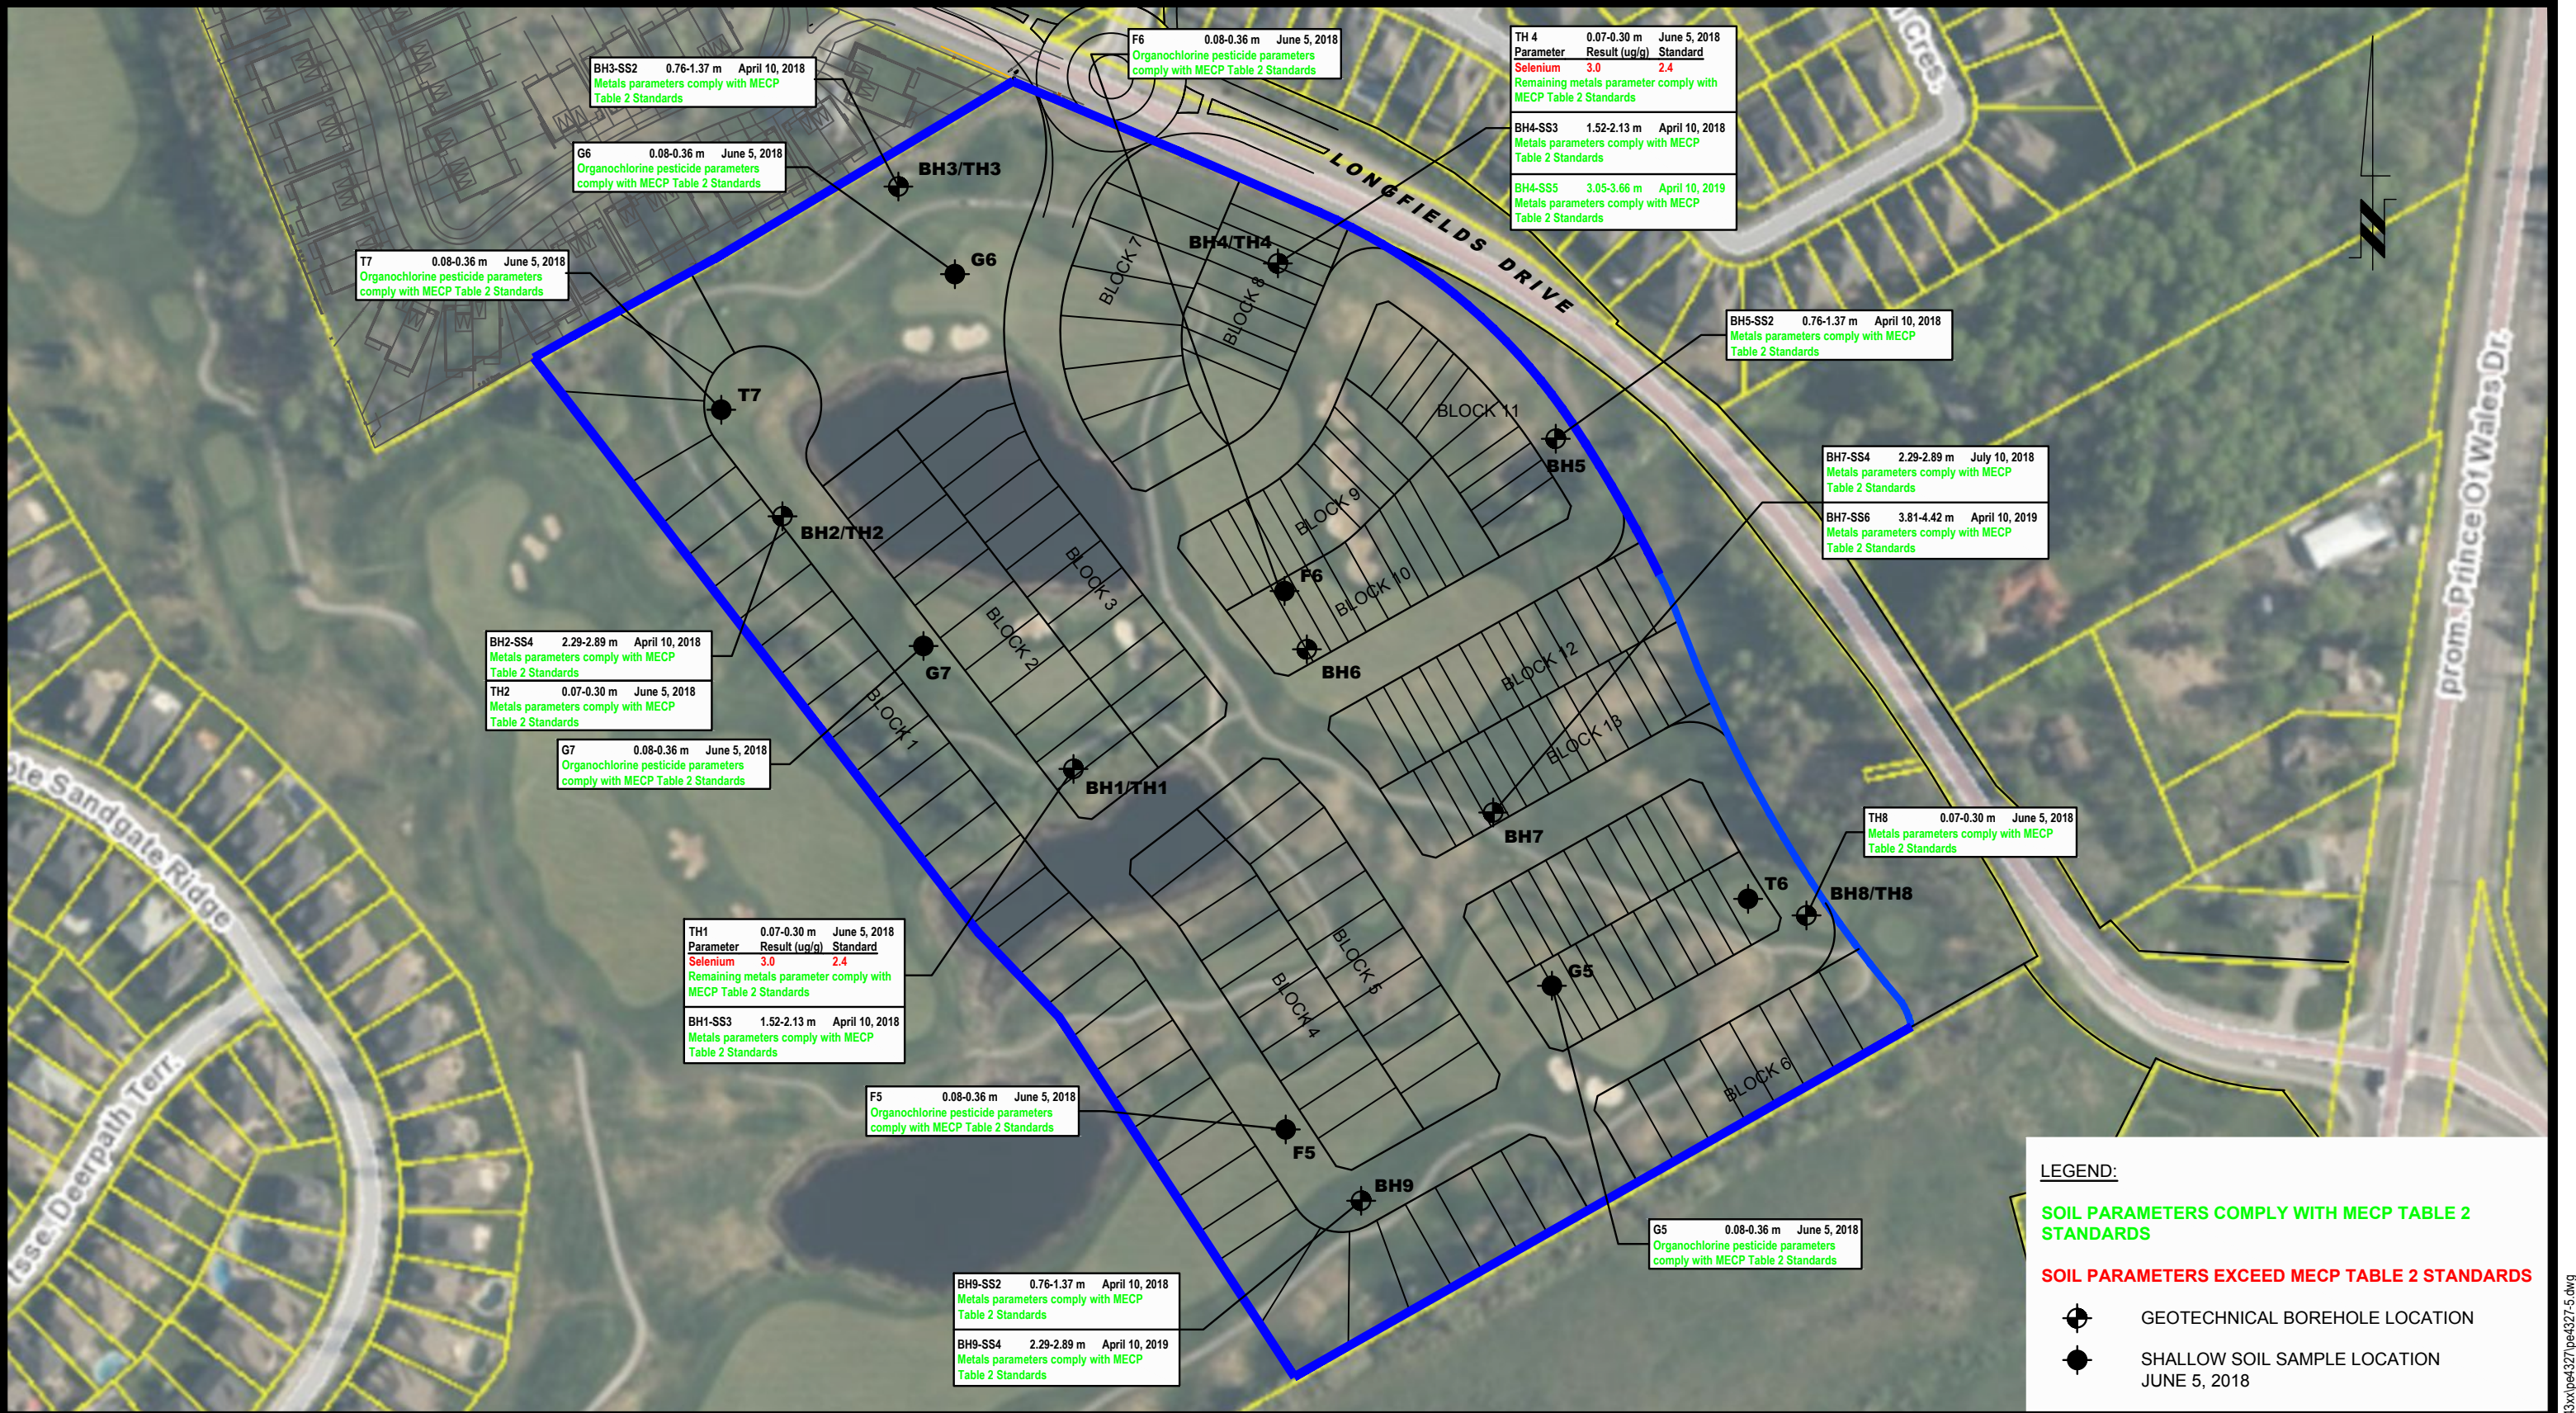
DRAWING PE4327-5 - TEST HOLE LOCATION PLAN

The proposed residential lot layout is depicted on the geotechnical Test Hole Location Plan, included in Appendix 1.

SOIL PARAMETERS COMPLY WITH MECP TABLE 2 STANDARDS
