Amberwood Village Recreation Association
54 Springbrook Drive
Stittsville (Ottawa), ON, K2S 1B9

RE: 54 Springbrook Drive
Combined Environmental Impact Statement & Tree Conservation Report – Addendum #1

FIGURE 1: SITE OVERVIEW

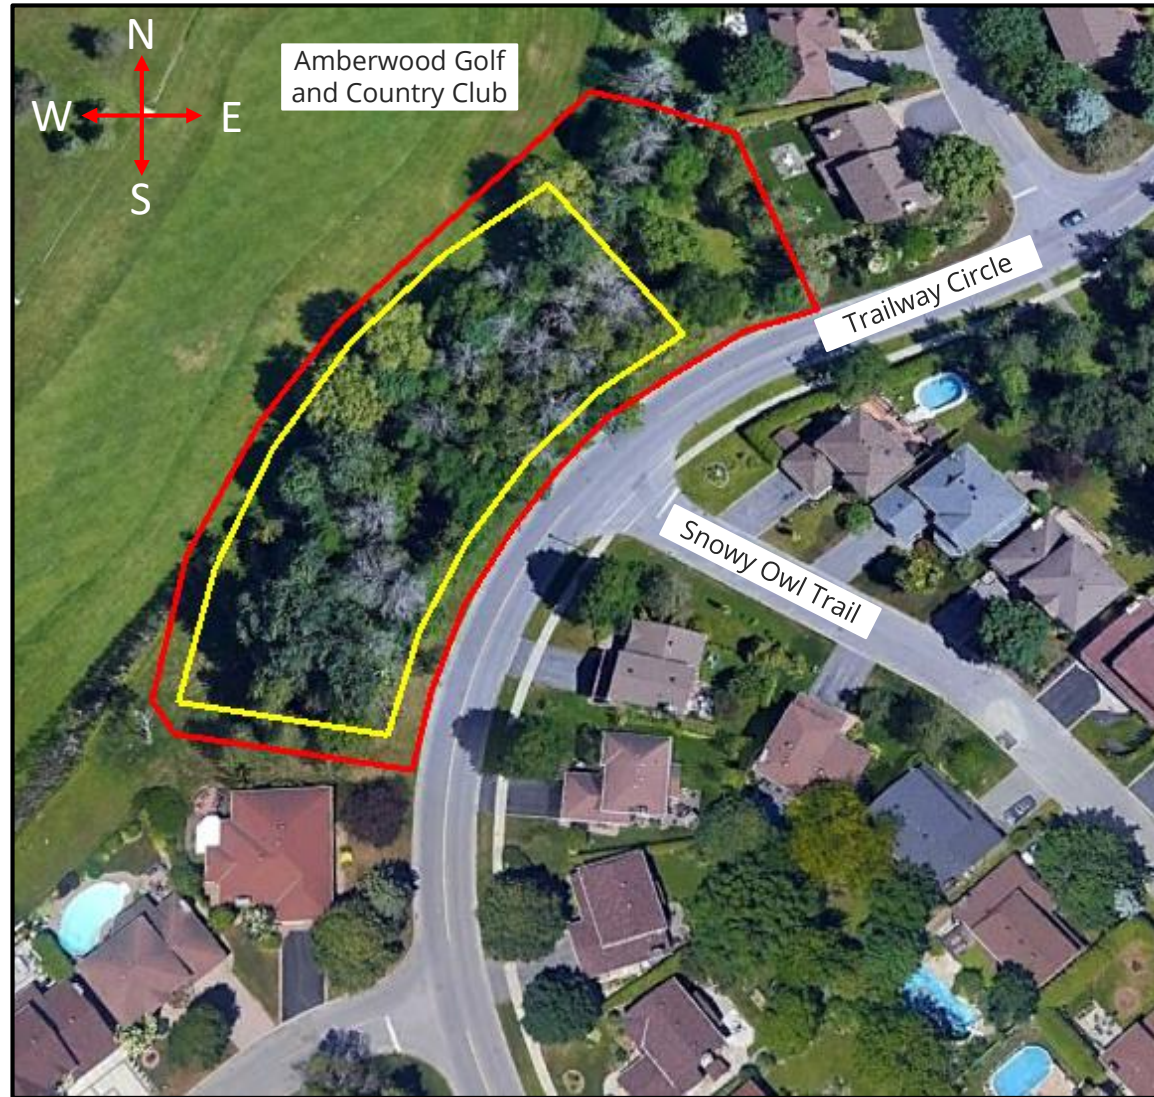
— - Tree Survey Area — - Approximate Development Limits

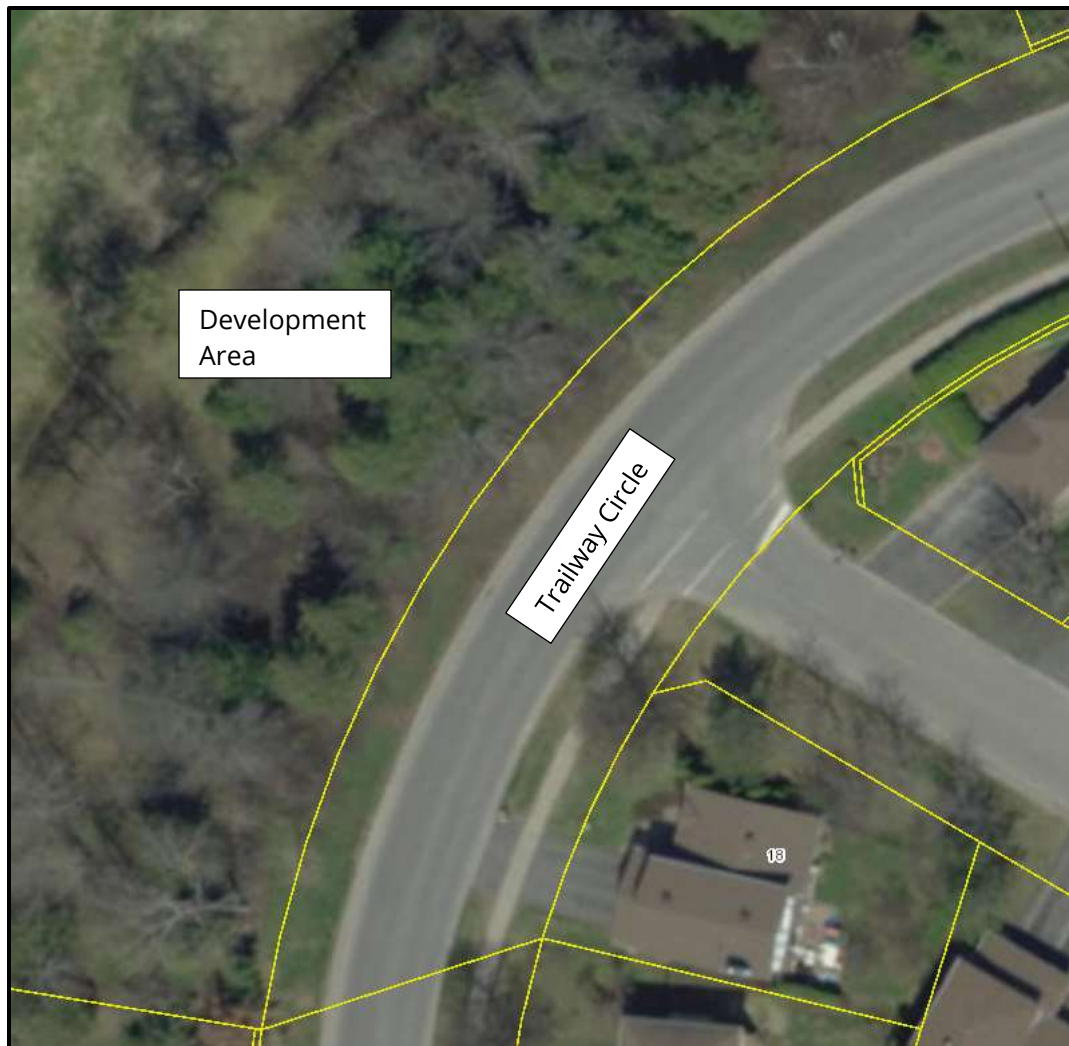
Photograph 1: Air photo showing the Right of Way (ROW) of Trailway Circle adjacent to the eastern boundary of the Site. Note that although portions of the canopy of some trees overhang the ROW, there are no tree stems found growing within the ROW adjacent to the eastern boundary of the Site (Air Photo taken from City of Ottawa (2020)).

- **East Boundary:** Trailway Circle forms the eastern boundary of the Site. An aerial photograph is included below, which shows the limits of the Right of Way (ROW) of Trailway Circle (Photograph 1). A ground level photograph of the ROW of Trailway Circle is also included below (Photograph 2). Photograph 1 and 2 demonstrate that the trees growing along the eastern boundary of the Site occur entirely within the Site. Although portions of the canopy of some trees overhang the ROW of Trailway Circle, there are no tree stems found growing within the ROW adjacent to the Site boundary. As such, there are no trees found growing within City of Ottawa property (e.g. the ROW of Trailway Circle) adjacent to the eastern Site boundary. The front yards of the future residential homes will face Trailway Circle. Tree retention is not feasible within the front yards of the future residential homes, as the retention of existing trees would block construction access and would interfere with grading and excavation requirements. As such, tree retention along the eastern boundary of the Site is not anticipated to be feasible.

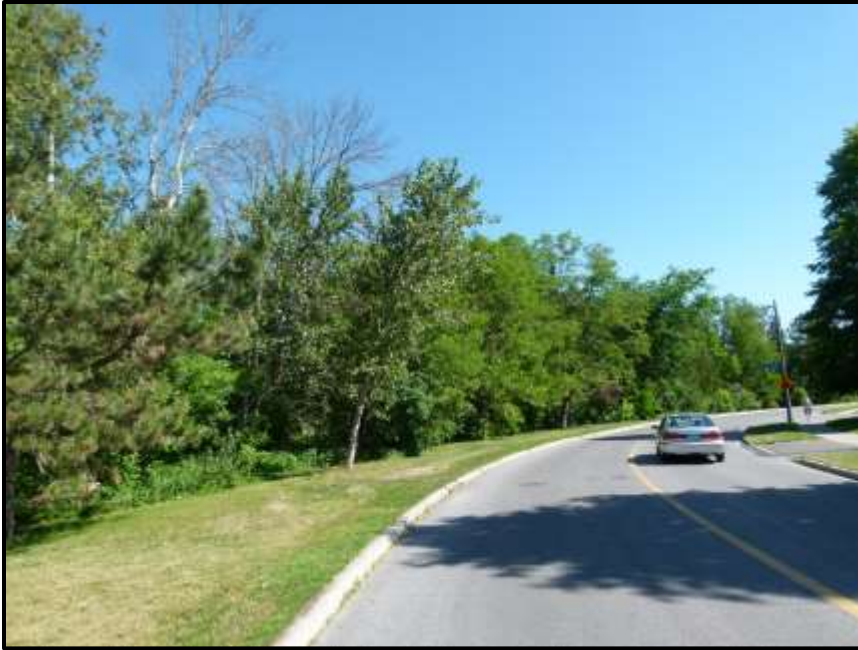
Photograph 2: Looking north at the Right of Way (ROW) of Trailway Circle. Note that although portions of the canopy of some trees overhang the ROW, there are no tree stems found growing within the ROW adjacent to the eastern boundary of the Site (June 19th, 2020).

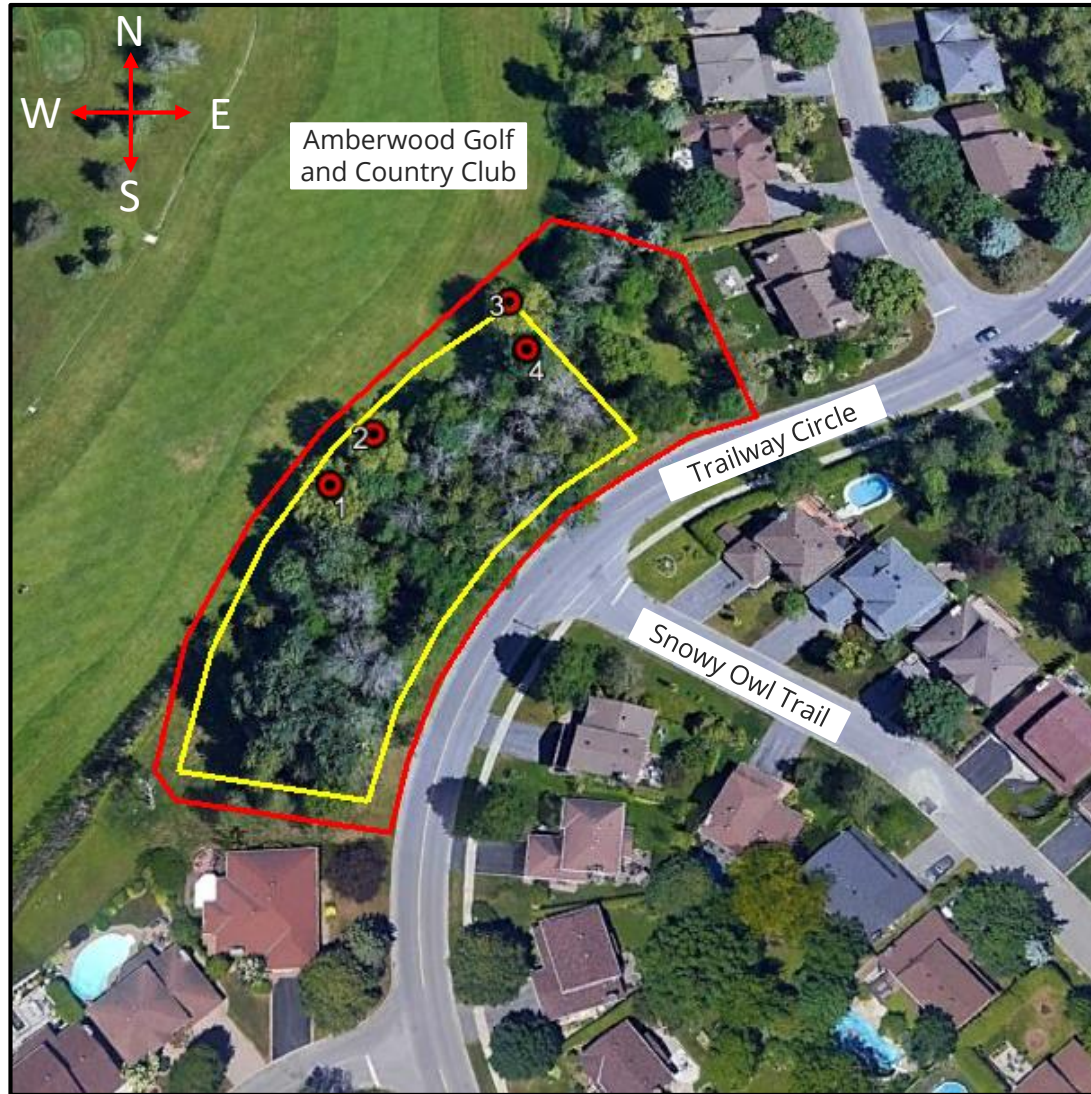
FIGURE 2: DISTINCTIVE TREE LOCATIONS

- Trees ≥ 50 cm dbh

Please Note:
This is not a
legal land
survey. All
dimensions
and locations
are shown as
approximate.
dbh =
Diameter at
Breast Height.

As described in Section 3.3.1 of the Combined Environmental Impact Statement (EIS) and Tree Conservation Report (TCR), four (4) trees were found within the Site that are each ≥ 50 cm diameter at breast height (dbh) in size (MES 2020). The City of Ottawa definition of Distinctive Trees includes any trees that are ≥ 50 cm dbh in size. Section 3.3.1 and Section 4.1 of the Combined EIS and TCR argued that the four (4) trees which exceed 50 cm dbh in size should not be considered Distinctive Trees, due to the fact that each tree is either a planted landscaping feature, a non-native species, and/or a fast growing species that reaches 50 cm dbh in size at a comparatively young age. It should be noted that the rationale provided in Section 3.3.1 and Section 4.1 of the Combined EIS and TCR is not consistent with the City of Ottawa's definition of Distinctive Trees, which identifies Distinctive Trees based solely on their size. As such, the fact that the four (4) trees which exceed 50 cm dbh in size are each either planted landscaping features, non-native species, and/or fast growing species, does not impact their ability to qualify as Distinctive Trees under the City of Ottawa's definition. Therefore, the four (4) trees which exceed 50 cm dbh in size should be understood to qualify as Distinctive Trees. The locations of the four (4) Distinctive Trees are shown below in Figure 2. The potential retention of trees within the Site is discussed above in the previous section.

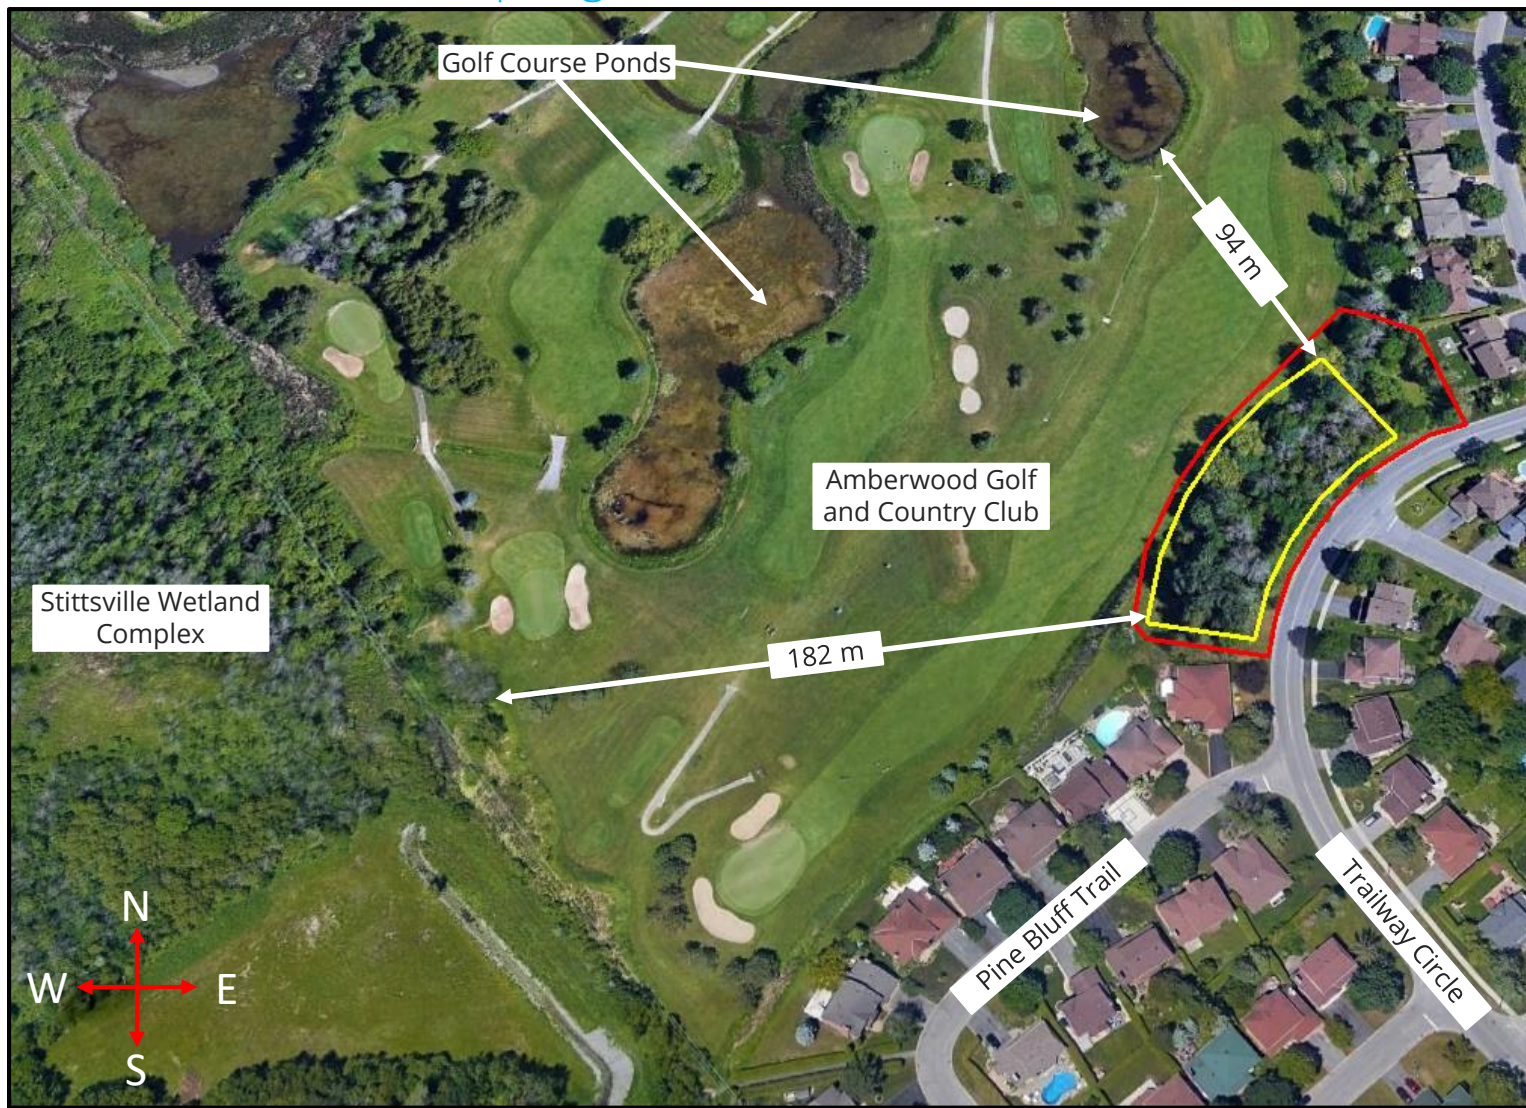
FIGURE 3: ADJACENT FEATURES

— - Tree Survey Area — - Approximate Development Limits

As shown in Figure 3 (below), several ponds are found northwest of the Site within the Amberwood Golf and Country Club. In Section 3.4 of the Combined Environmental Impact Statement (EIS) and Tree Conservation Report (TCR), as well as elsewhere throughout the report, the ponds were referred to as 'Stormwater Management Ponds'. It should be noted that it is not known whether the ponds were designed to provide stormwater management functions and/or whether the ponds are subject to an existing Environmental Compliance Approval (ECA). Due to the fact that it is unknown whether or not the ponds provide Stormwater Management functions, the ponds have been relabeled in Figure 3 as 'Golf Course Ponds' (see below). Throughout the Combined EIS and TCR, all instances where the ponds within the adjacent Amberwood Golf and Country Club were referred to as 'Stormwater Management Ponds' should be understood to be corrected to read as 'Golf Course Ponds'. The description of the Golf Course Ponds included in Section 3.4 of the Combined EIS and TCR is otherwise unchanged.
