Phase I Environmental Site Assessment

Vacant Land
244 Rideau Place
Ottawa, Ontario

TC United Group

Report: PE3788-1

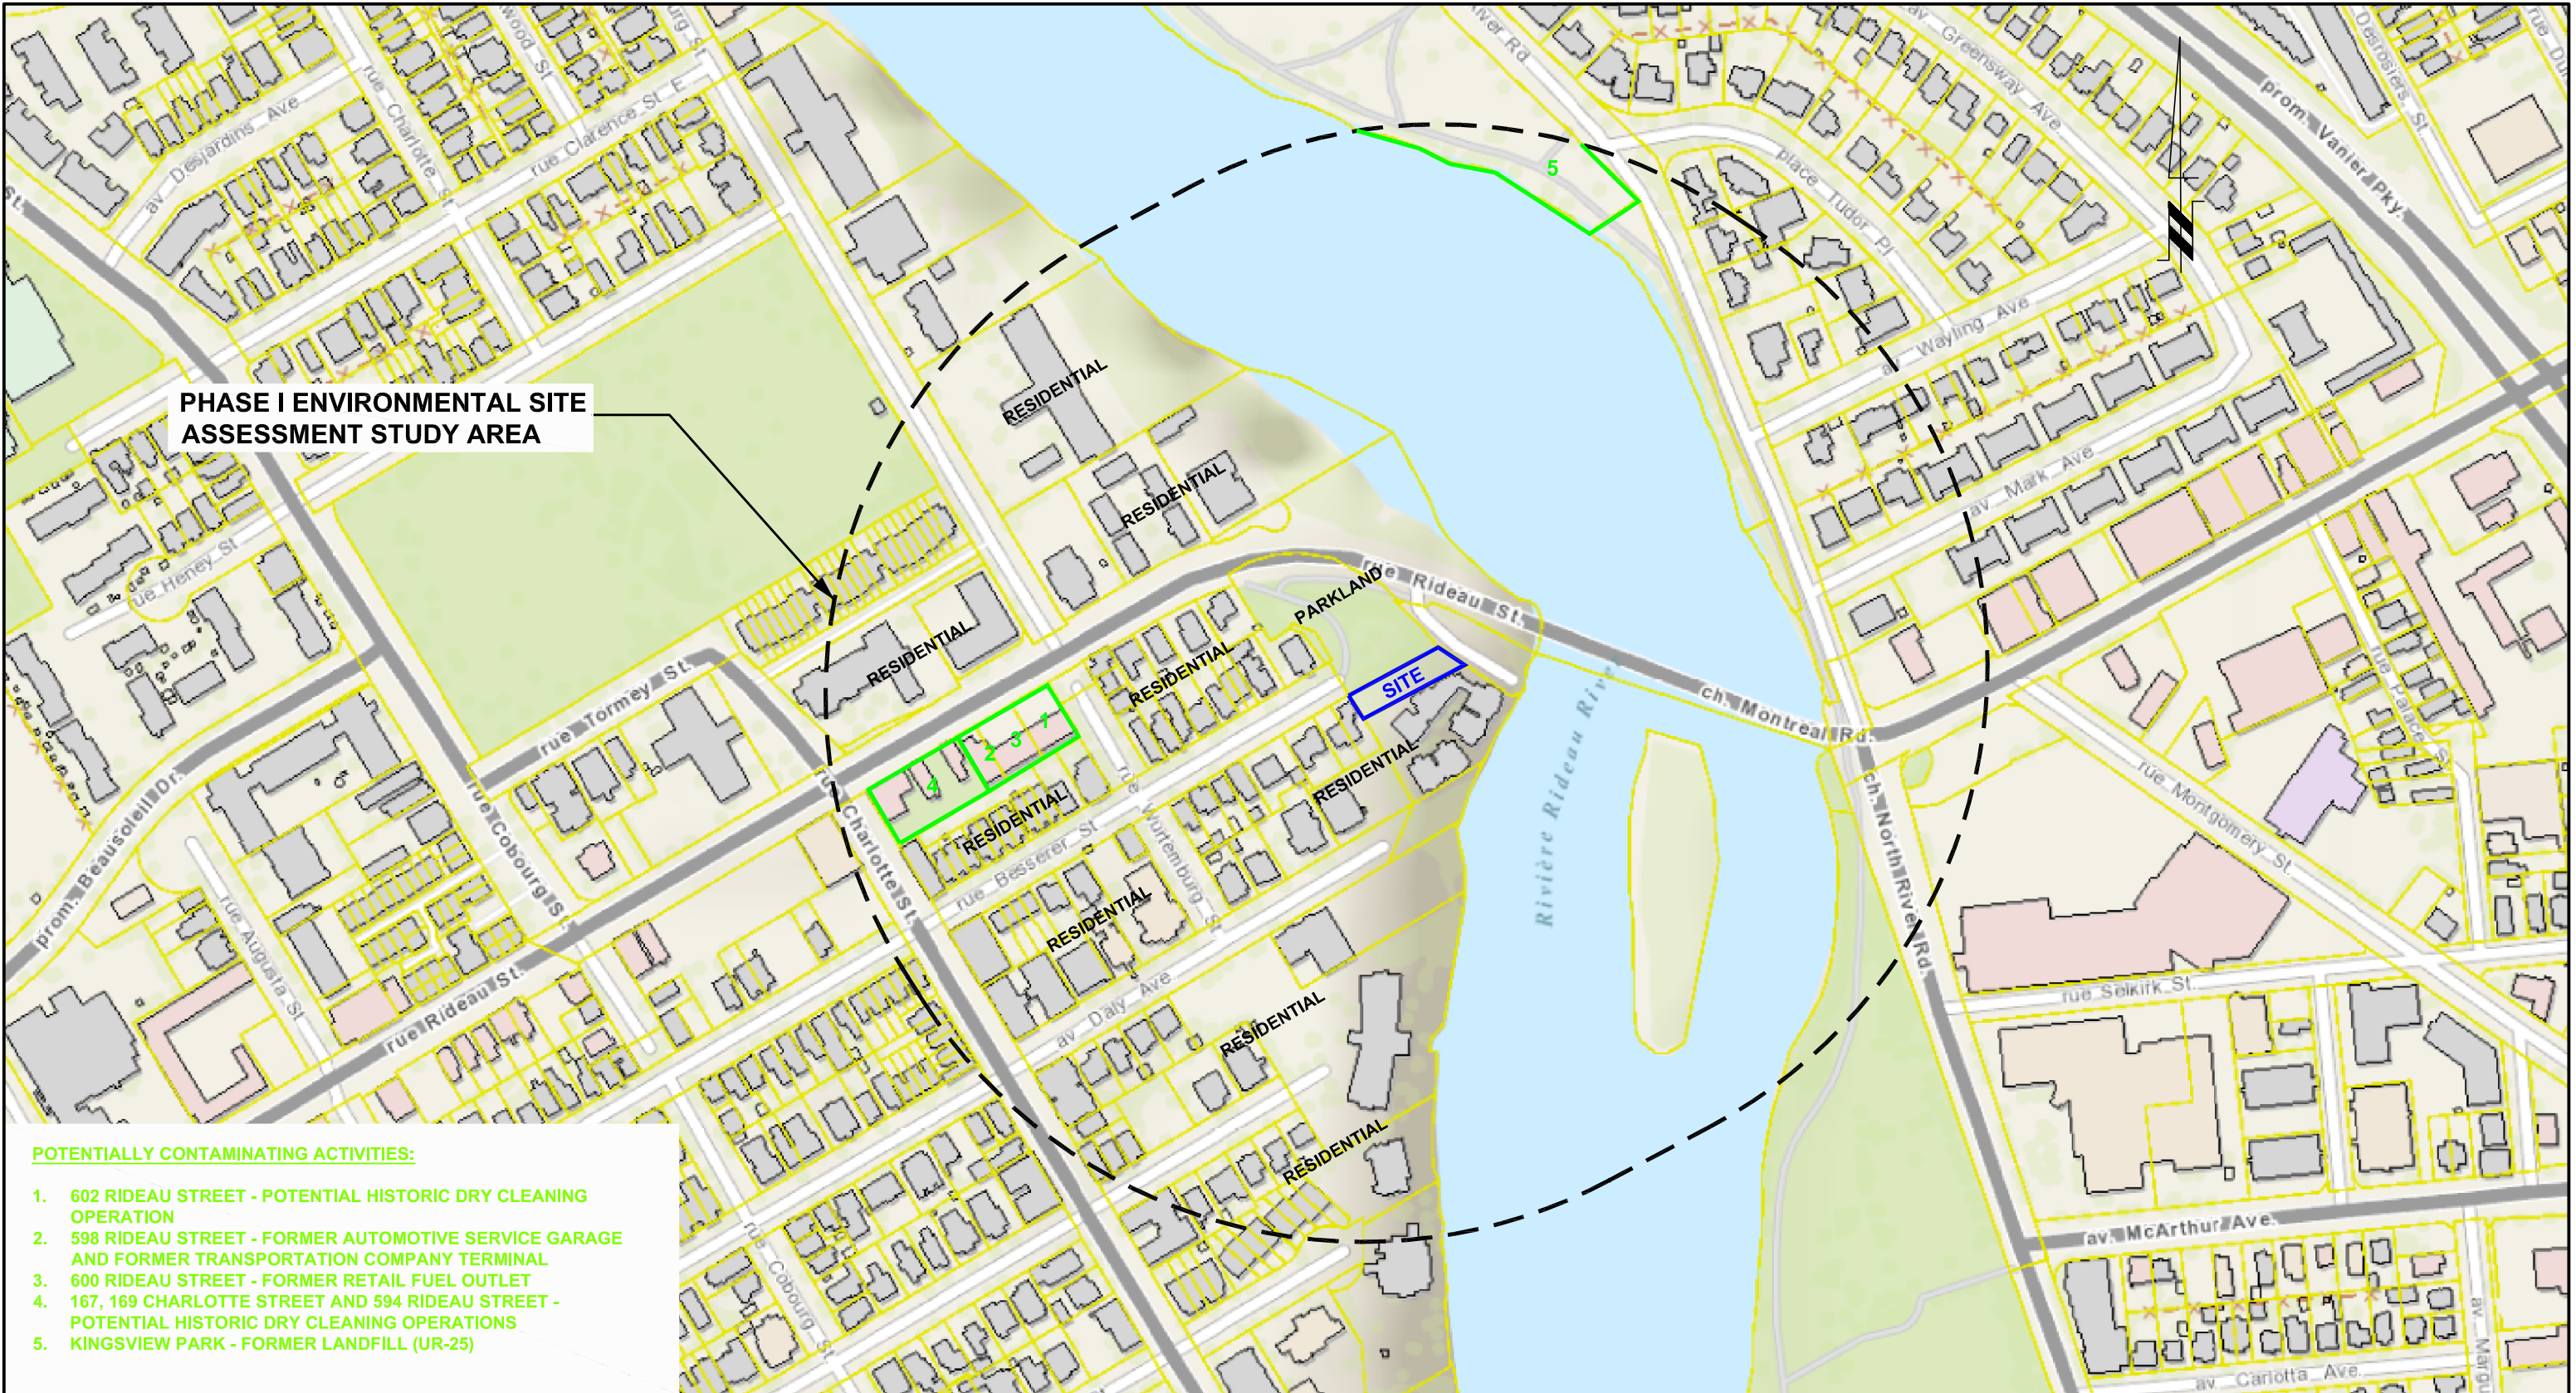
DRAWING PE3788-2 – SURROUNDING LAND USE PLAN

The current use of the neighbouring properties is not considered to pose an environmental concern to the subject site. Current land use in the Phase I study area is illustrated on Drawing: PE3788-2 – Surrounding Land Use Plan in the Figures section of this report, following the text.

No PCAs were identified on the subject site. Off-site PCAs identified in the Phase I study area are not considered to represent APECs on the subject site due to separation distance or downgradient location. Land use within the Phase I study area is shown on Drawing PE3788-2 - Surrounding Land Use Plan.

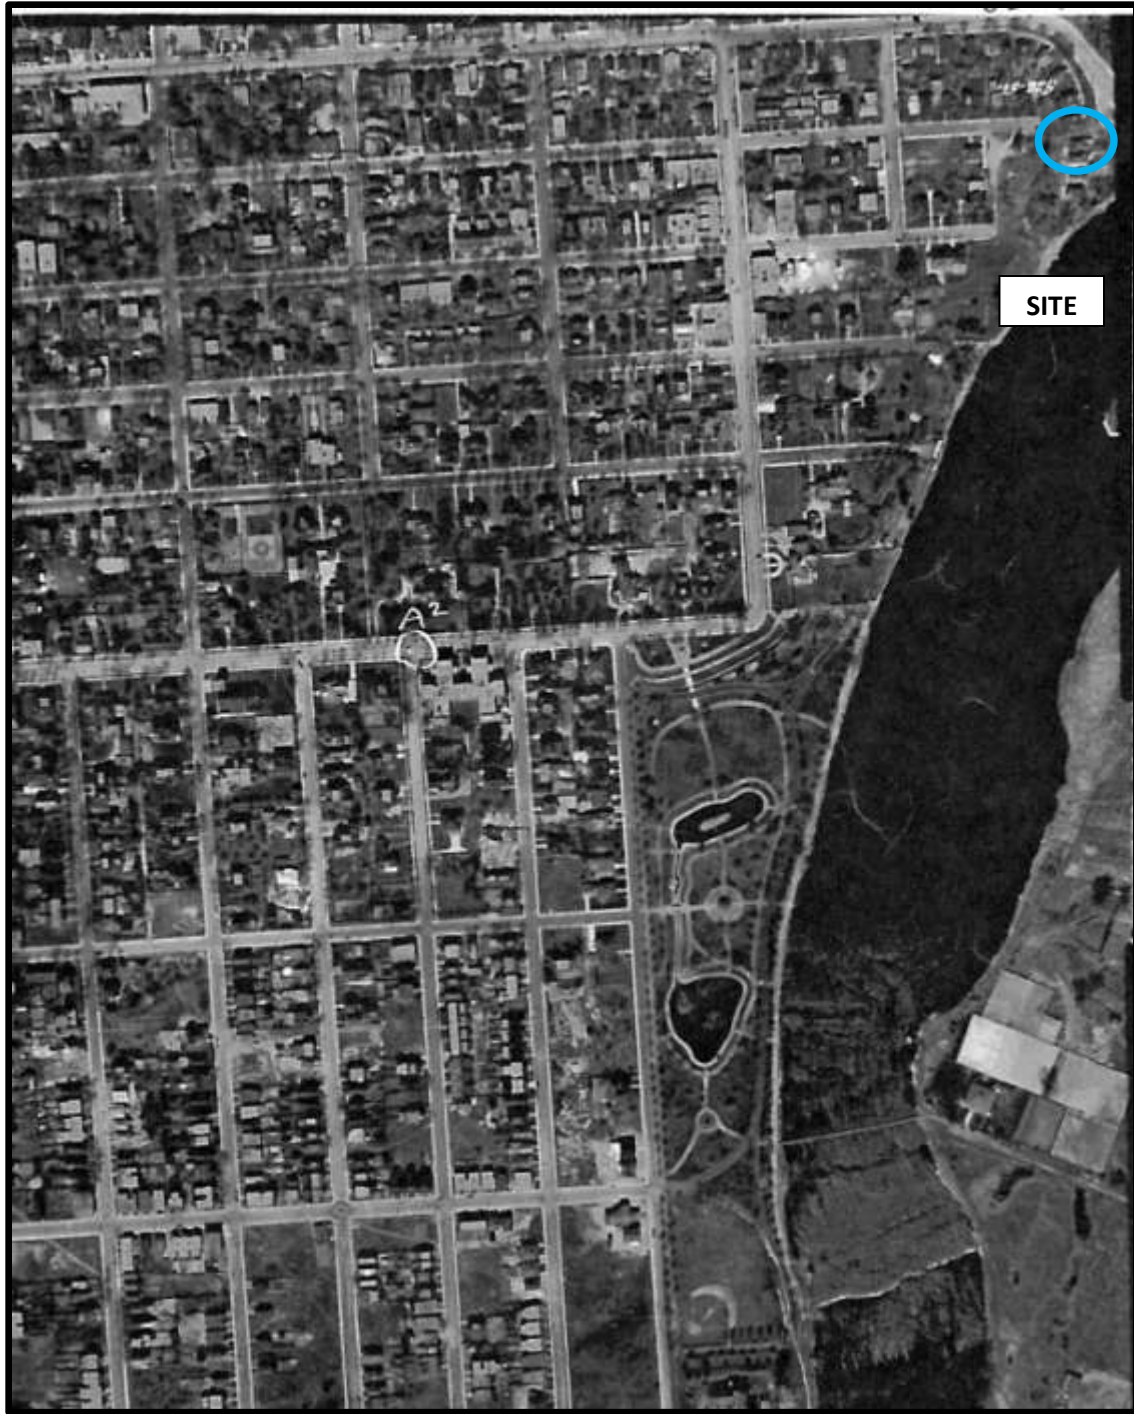
AERIAL PHOTOGRAPH
1928

| 1928 | The subject property is occupied by a residential dwelling. Adjacent properties to the north, south and west are occupied by residential dwellings. The Rideau River is located to the east. |

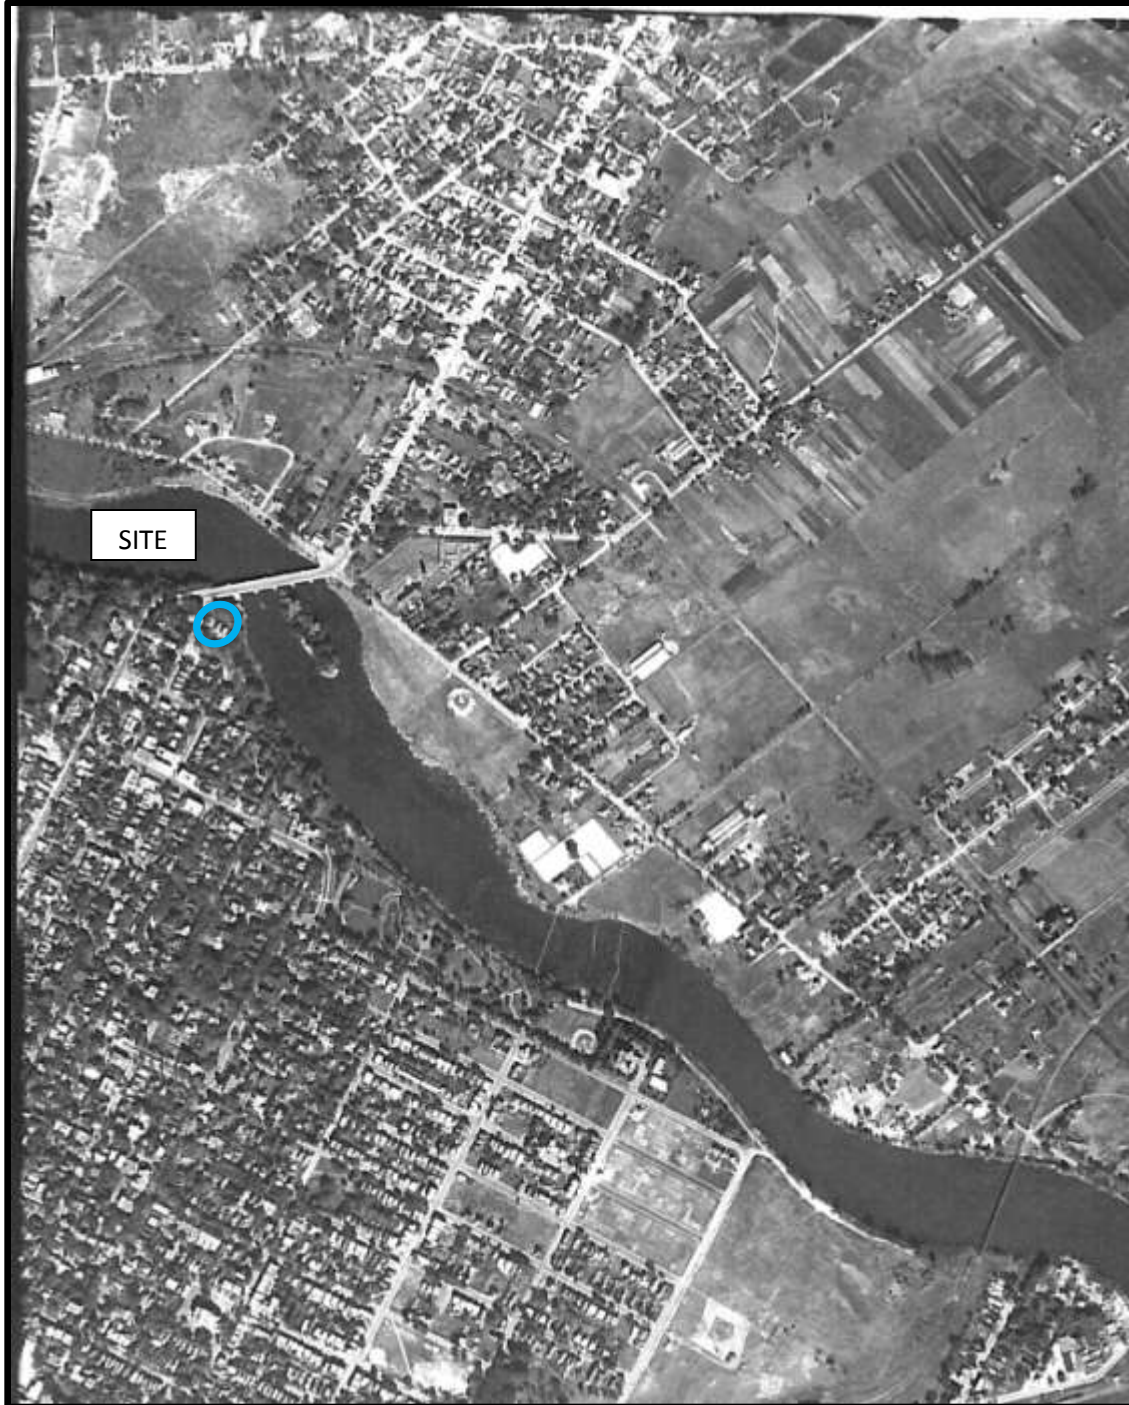
AERIAL PHOTOGRAPH
1938

| 1938 | No significant changes have been made to the subject site or neighbouring properties. |

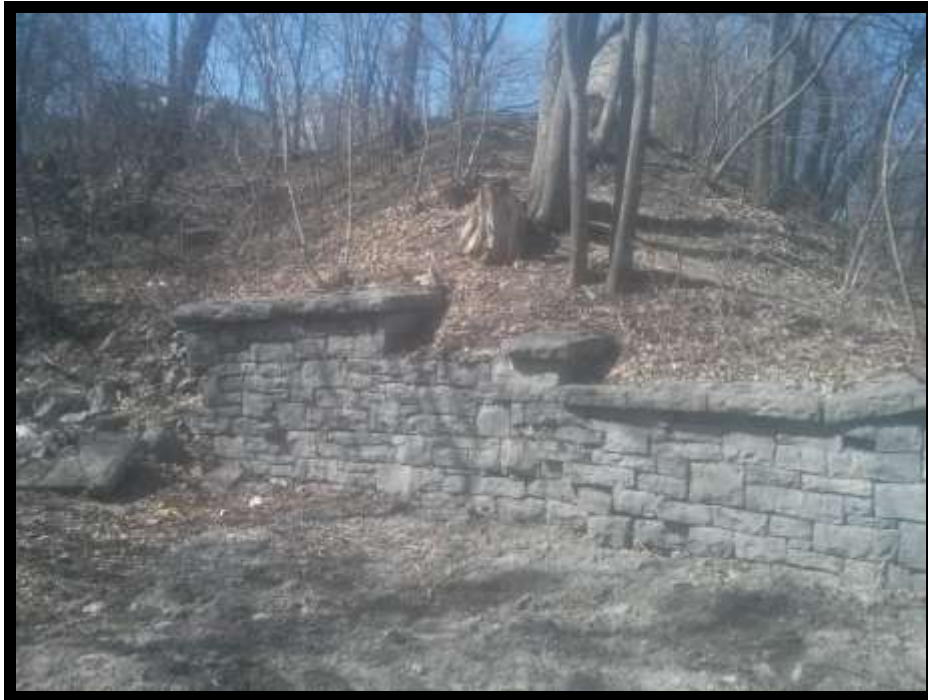
Photograph 1: View of TP 1 location and retaining wall along northern property line, facing northwest.

A geotechnical investigation conducted on the subject site by Paterson in March 2016 included a test pit (TP 1). The test pit was terminated 2.5 meters below grade and identified topsoil with rootlets and gravel overlying stiff to very stiff silty clay material. No groundwater was encountered in the test pit. No visual or olfactory evidence of contamination was observed during the geotechnical investigation.

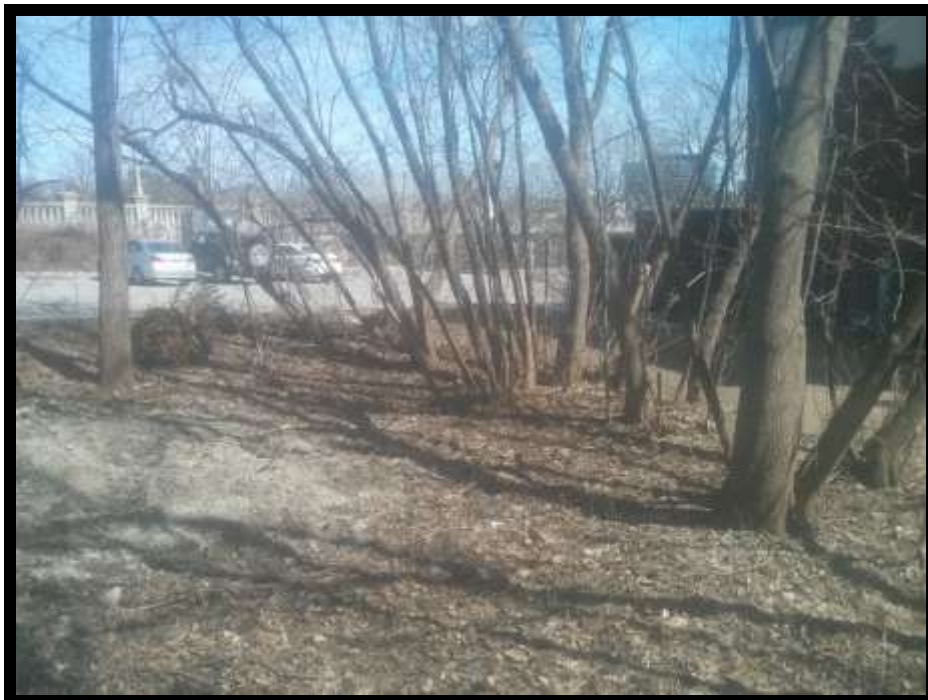
Photograph 2: View of subject site and adjacent residential condominium, facing southeast towards Rideau Place.
