Phase I-II Environmental Site Assessment

10 King Street
Richmond (Ottawa), Ontario

Talos Custom Homes Limited

Report: PE1623-1

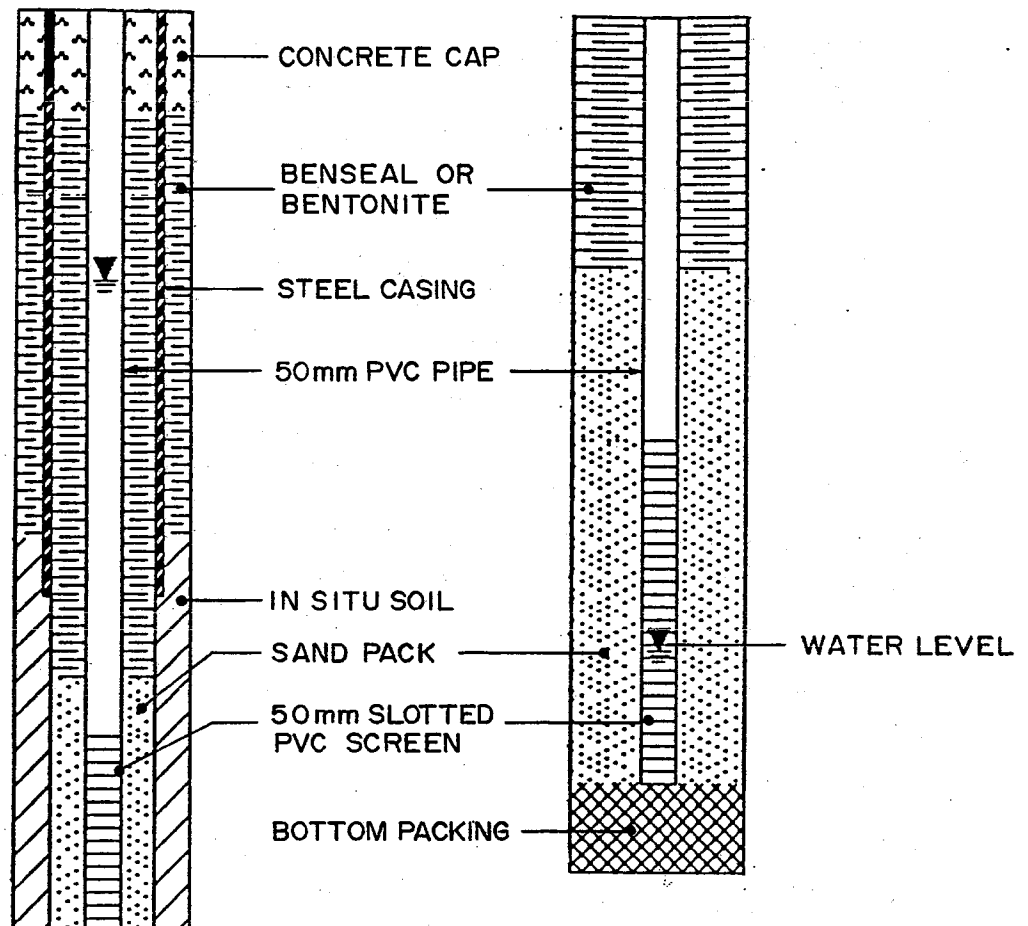
MONITORING WELL AND PIEZOMETER CONSTRUCTION

Monitoring Well Construction

Piezometer Construction

- ☐ Slotted 50 mm diameter PVC screen at base of borehole.
- ☐ 50 mm diameter PVC riser pipe from the top of the screen to the ground surface.
- ☐ No.3 silica sand backfill within annular space around screen.
- ☐ 300 mm thick bentonite hole plug directly above PVC slotted screen.
- ☐ Clean backfill from top of bentonite plug to the ground surface.

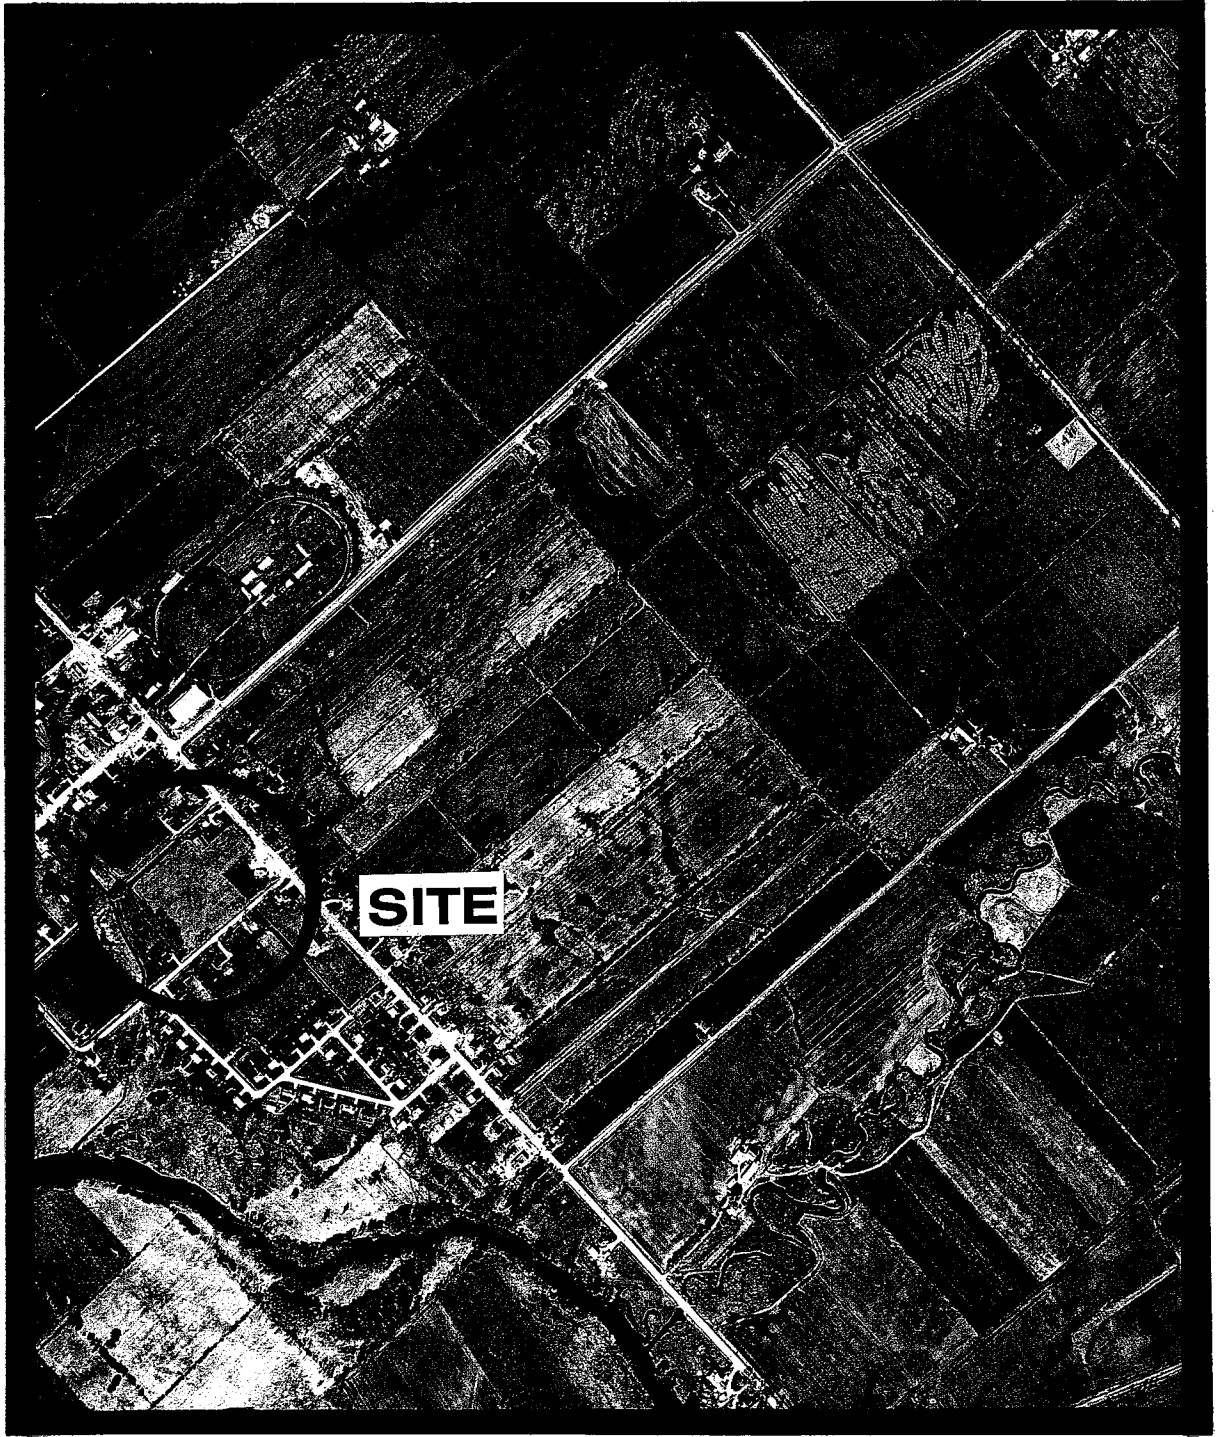
AERIAL PHOTOGRAPH
1963

| 1963 | The site remains vacant/agricultural land. A drainage ditch has been constructed on the property south of the site, leading to the Jock River further to the south. Two (2) properties have been or are being developed north of the subject site, on the south side of Perth Street. Residential development has continued in the area, specifically east of King Street. |

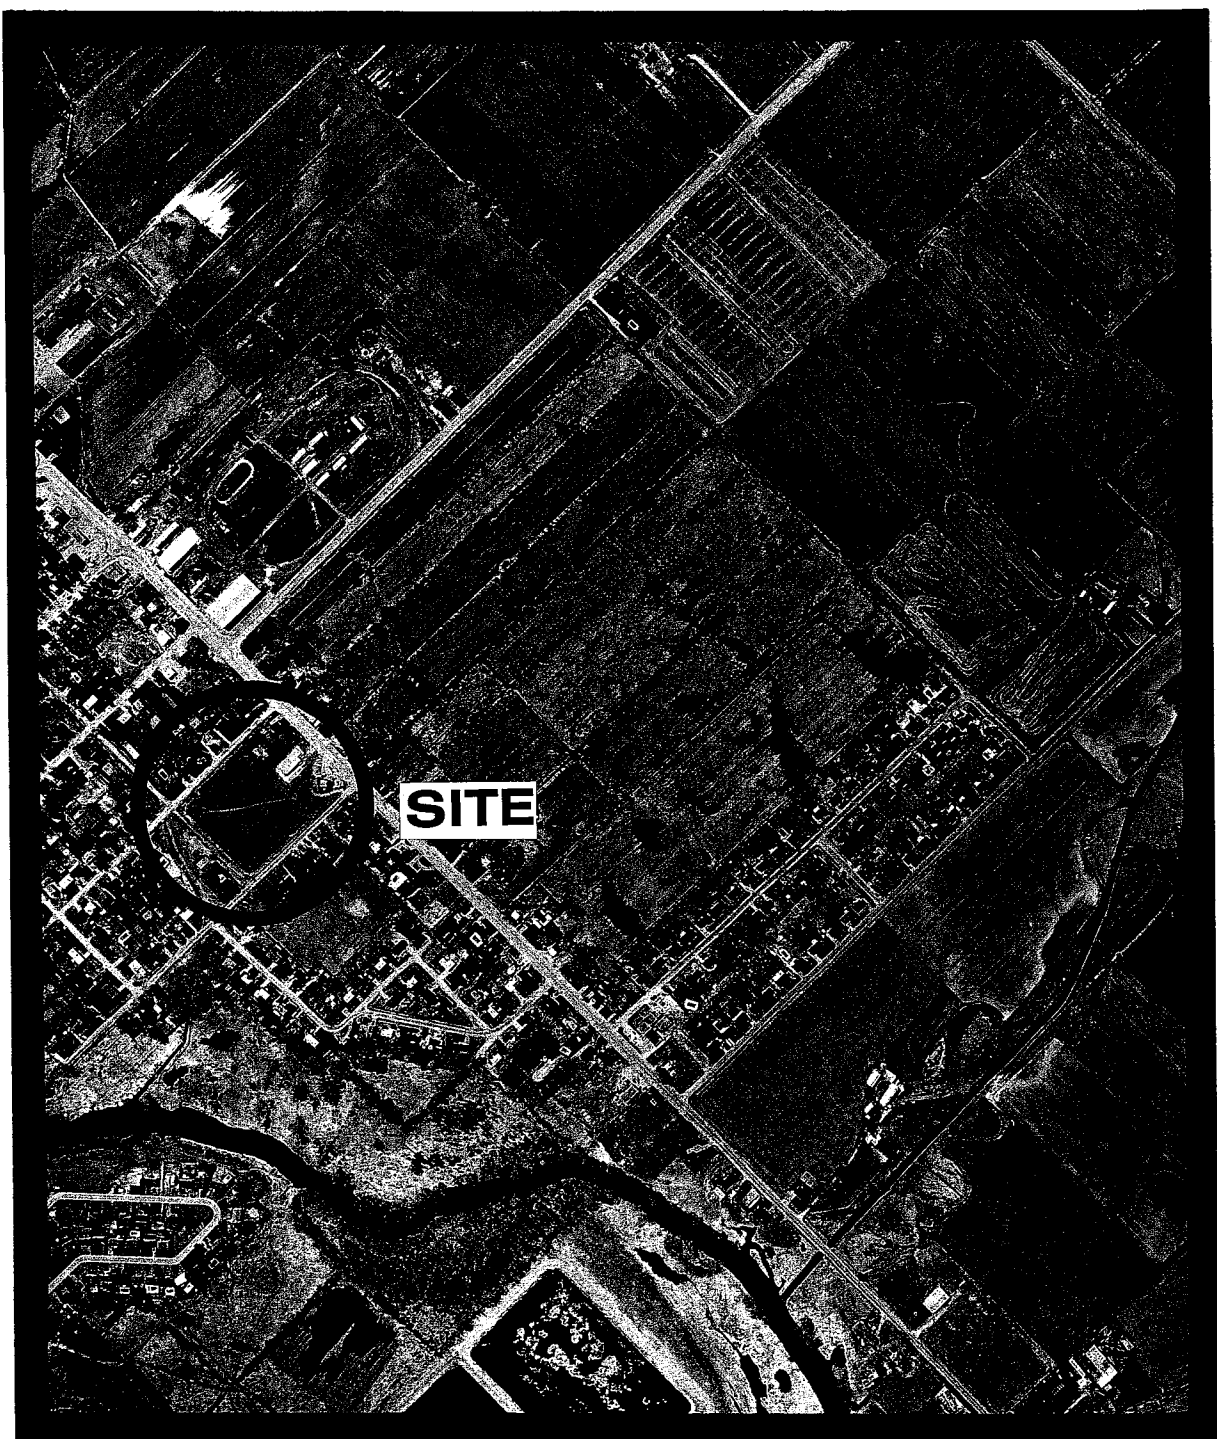
AERIAL PHOTOGRAPH
1980

| 1980 | The property north of the subject site, in the southwest corner of the Perth Street and King Street intersection, is occupied by a retail fuel outlet. Another structure has been developed north of the site, west of the gas station. The subject property and the remainder of the adjacent lands remain primarily unchanged. |

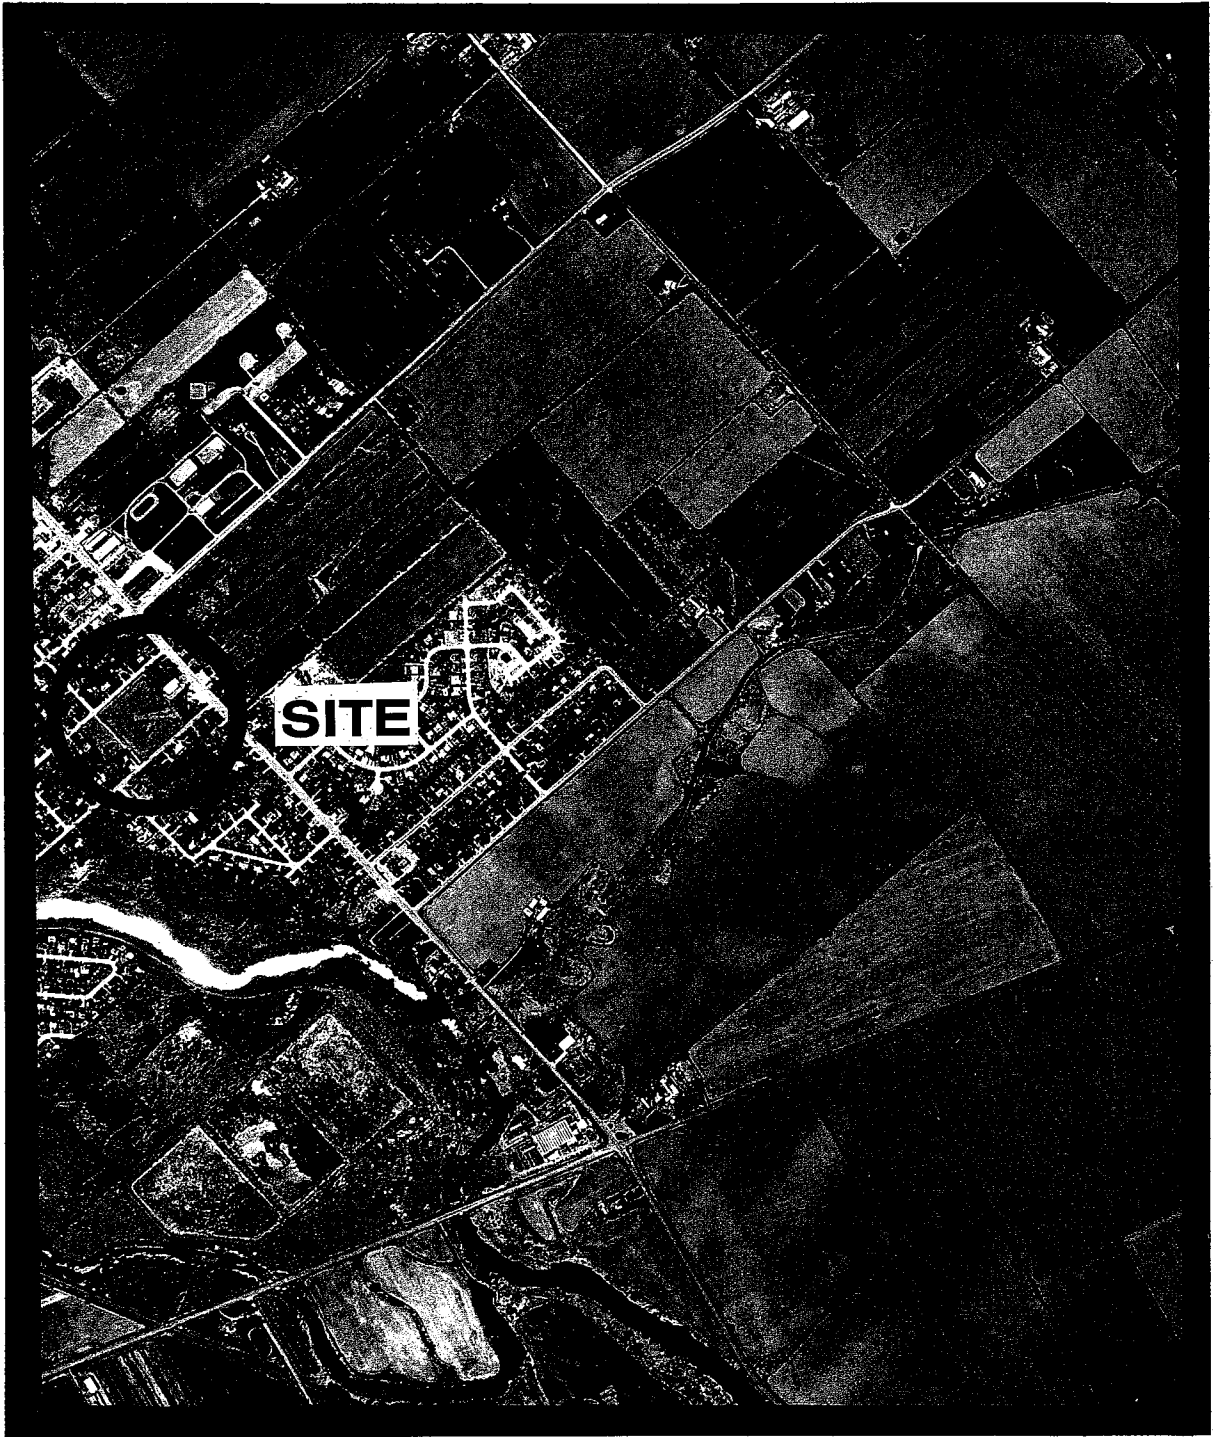
AERIAL PHOTOGRAPH
2001

| 2001 | The subject site and neighbouring properties are relatively unchanged from the previous photo. |
