**PERFORMANCE ASSESSMENT OF A
PERFORATED PIPE STORMWATER
EXFILTRATION SYSTEM**

TORONTO, ONTARIO

**STORMWATER ASSESSMENT MONITORING
AND PERFORMANCE (SWAMP) PROGRAM**

December, 2004

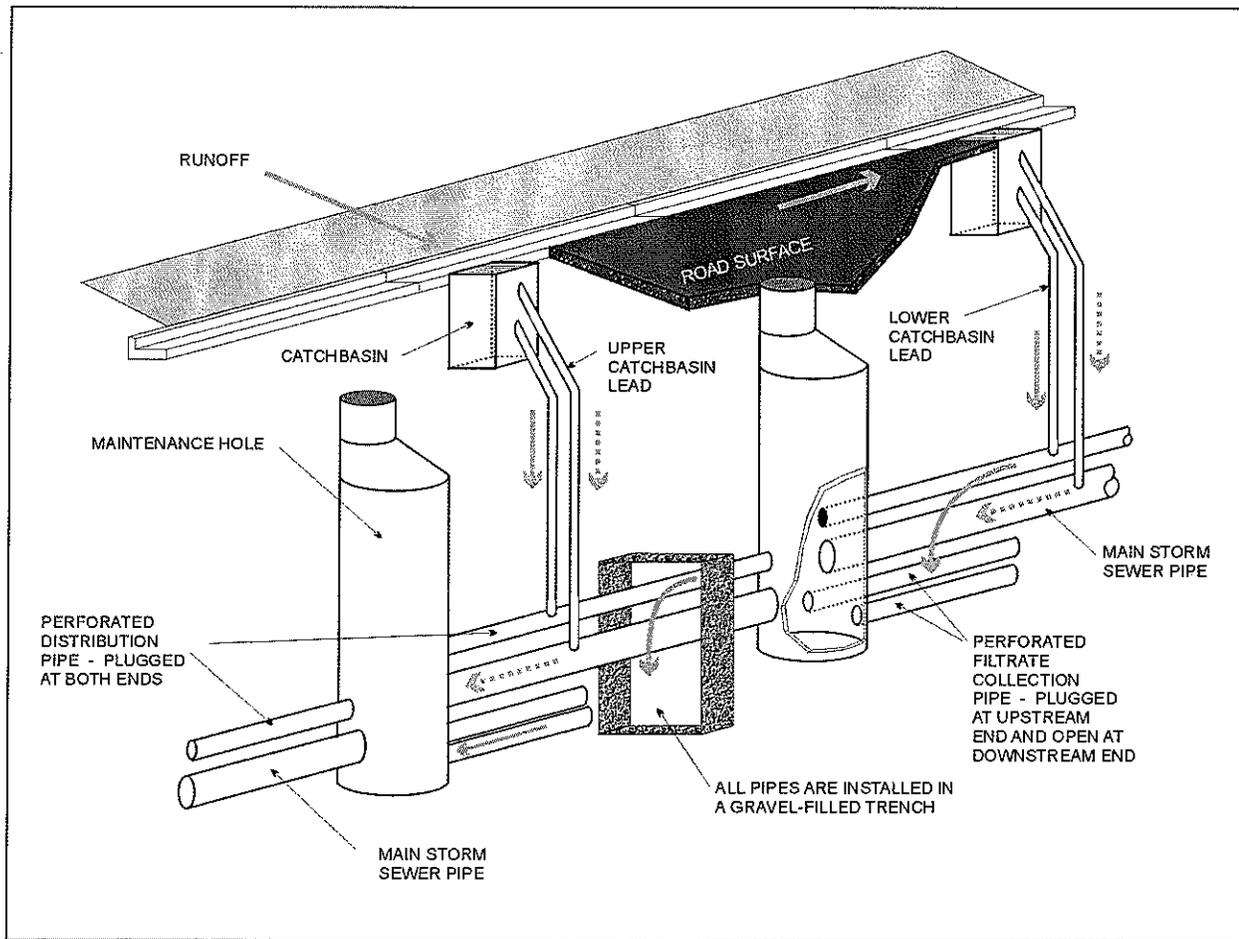
Figure 2: Etobicoke filtration system schematic

In the *filtration* system, a perforated pipe is located *above* the main sewer pipe (Figure 2). Runoff from the catchbasins is directed to this perforated pipe, from where it is distributed into the gravel bed. The runoff is filtered down through the gravel and some of it may exfiltrate to the local soil. Most of the filtered water is collected by two perforated pipe underdrains located below the main sewer pipe and discharged to the downstream maintenance hole from where it is conveyed by the next leg of the main sewer pipe. The principal effects of the filtration system are to dampen variations in flow rate and to filter pollutants out of the runoff. If the rate of runoff exceeds the throughput capacity of the filtration system, water in the catchbasins rises to a level at which a second catchbasin outlet pipe conveys the excess flow directly to the main sewer pipe, bypassing the gravel filter bed.

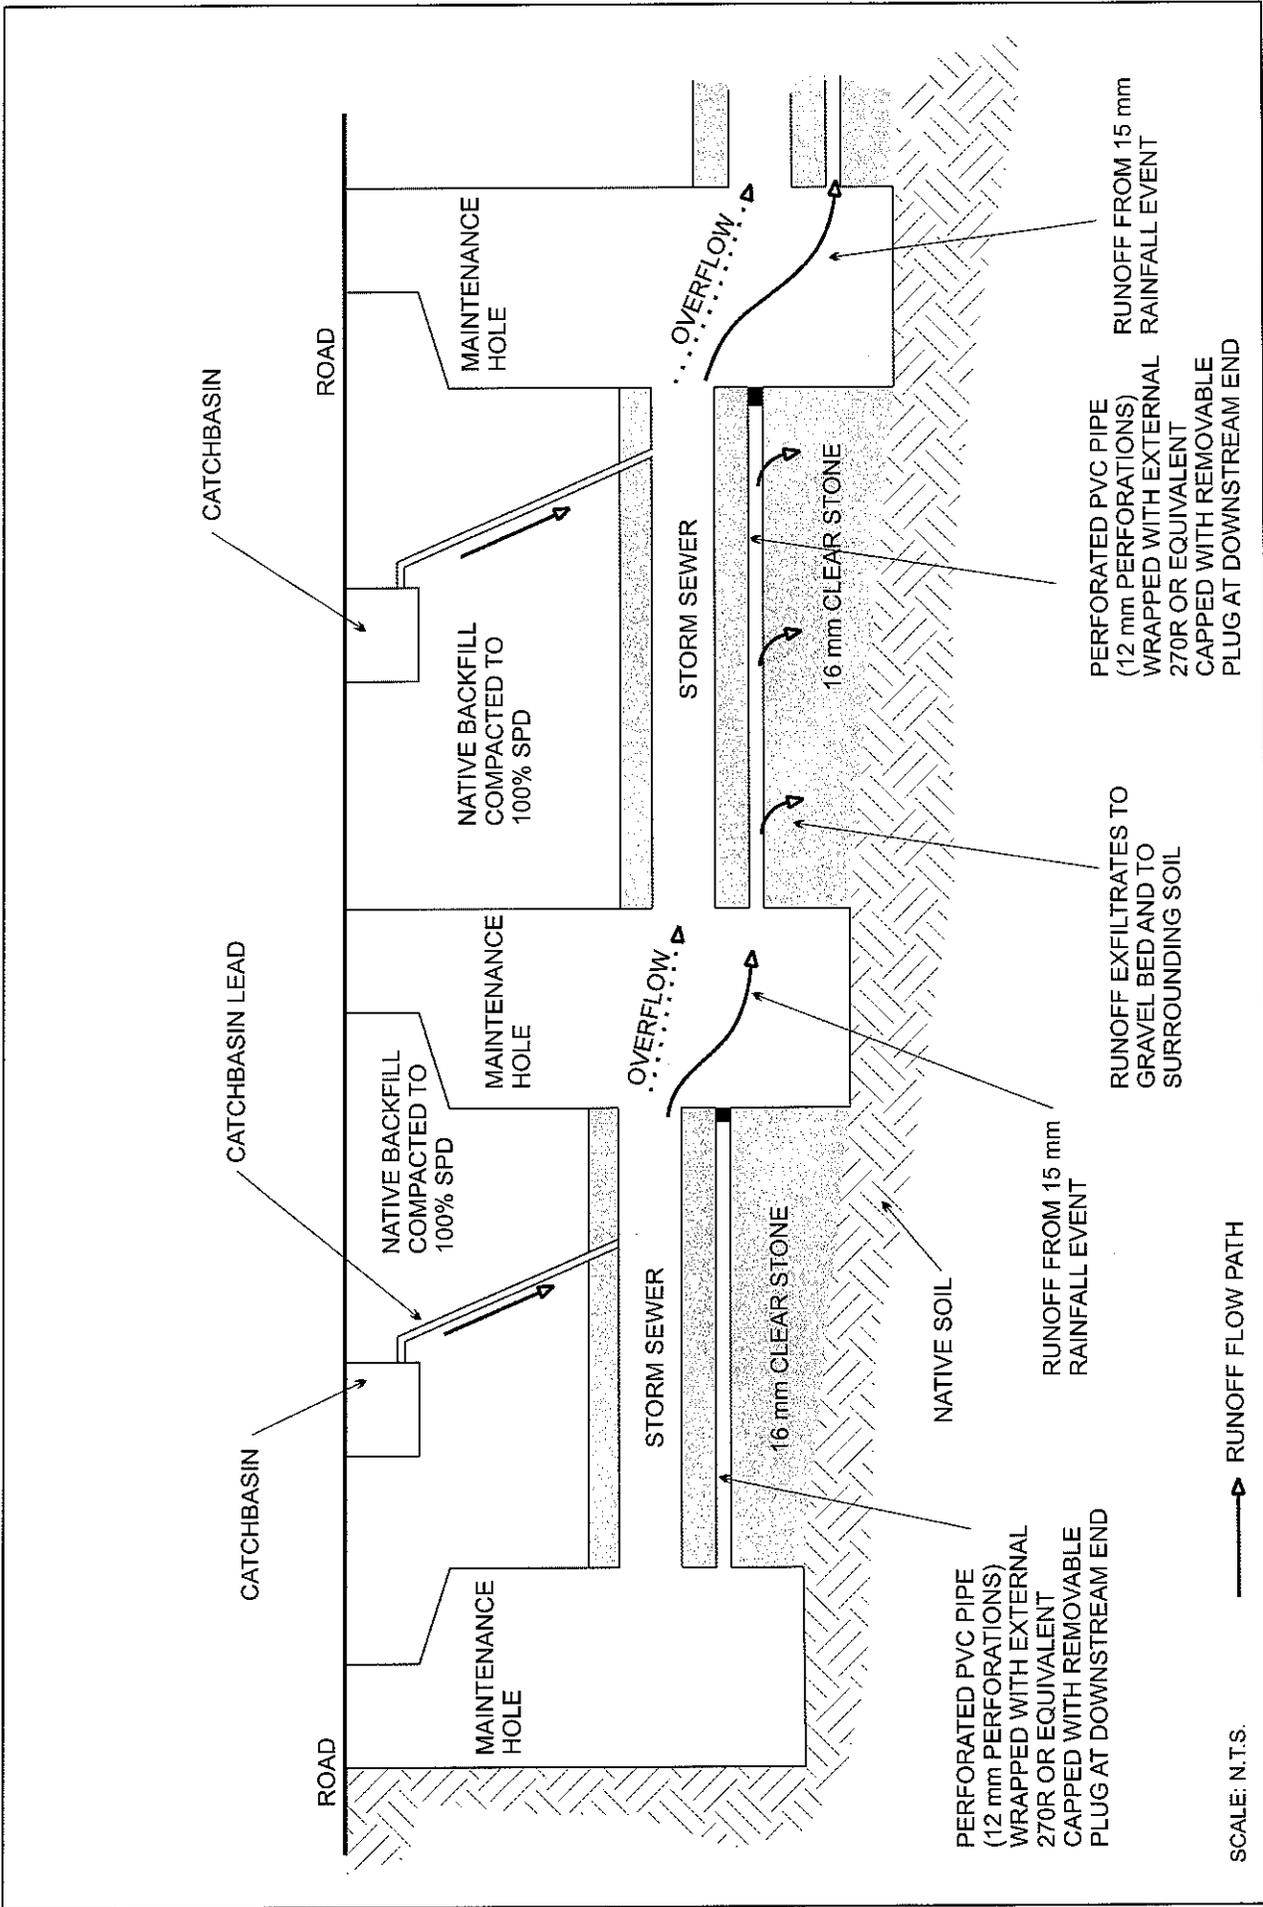
Figure 2.2: Exfiltration system - typical profile

The exfiltration system is designed to provide sufficient storage to capture the runoff from a 15-mm, 1-hour design storm, and is best suited for areas with permeable soils. During large runoff events, excess runoff bypasses the perforated pipe system as overflow and is conveyed through the conventional storm sewer to the downstream maintenance hole.

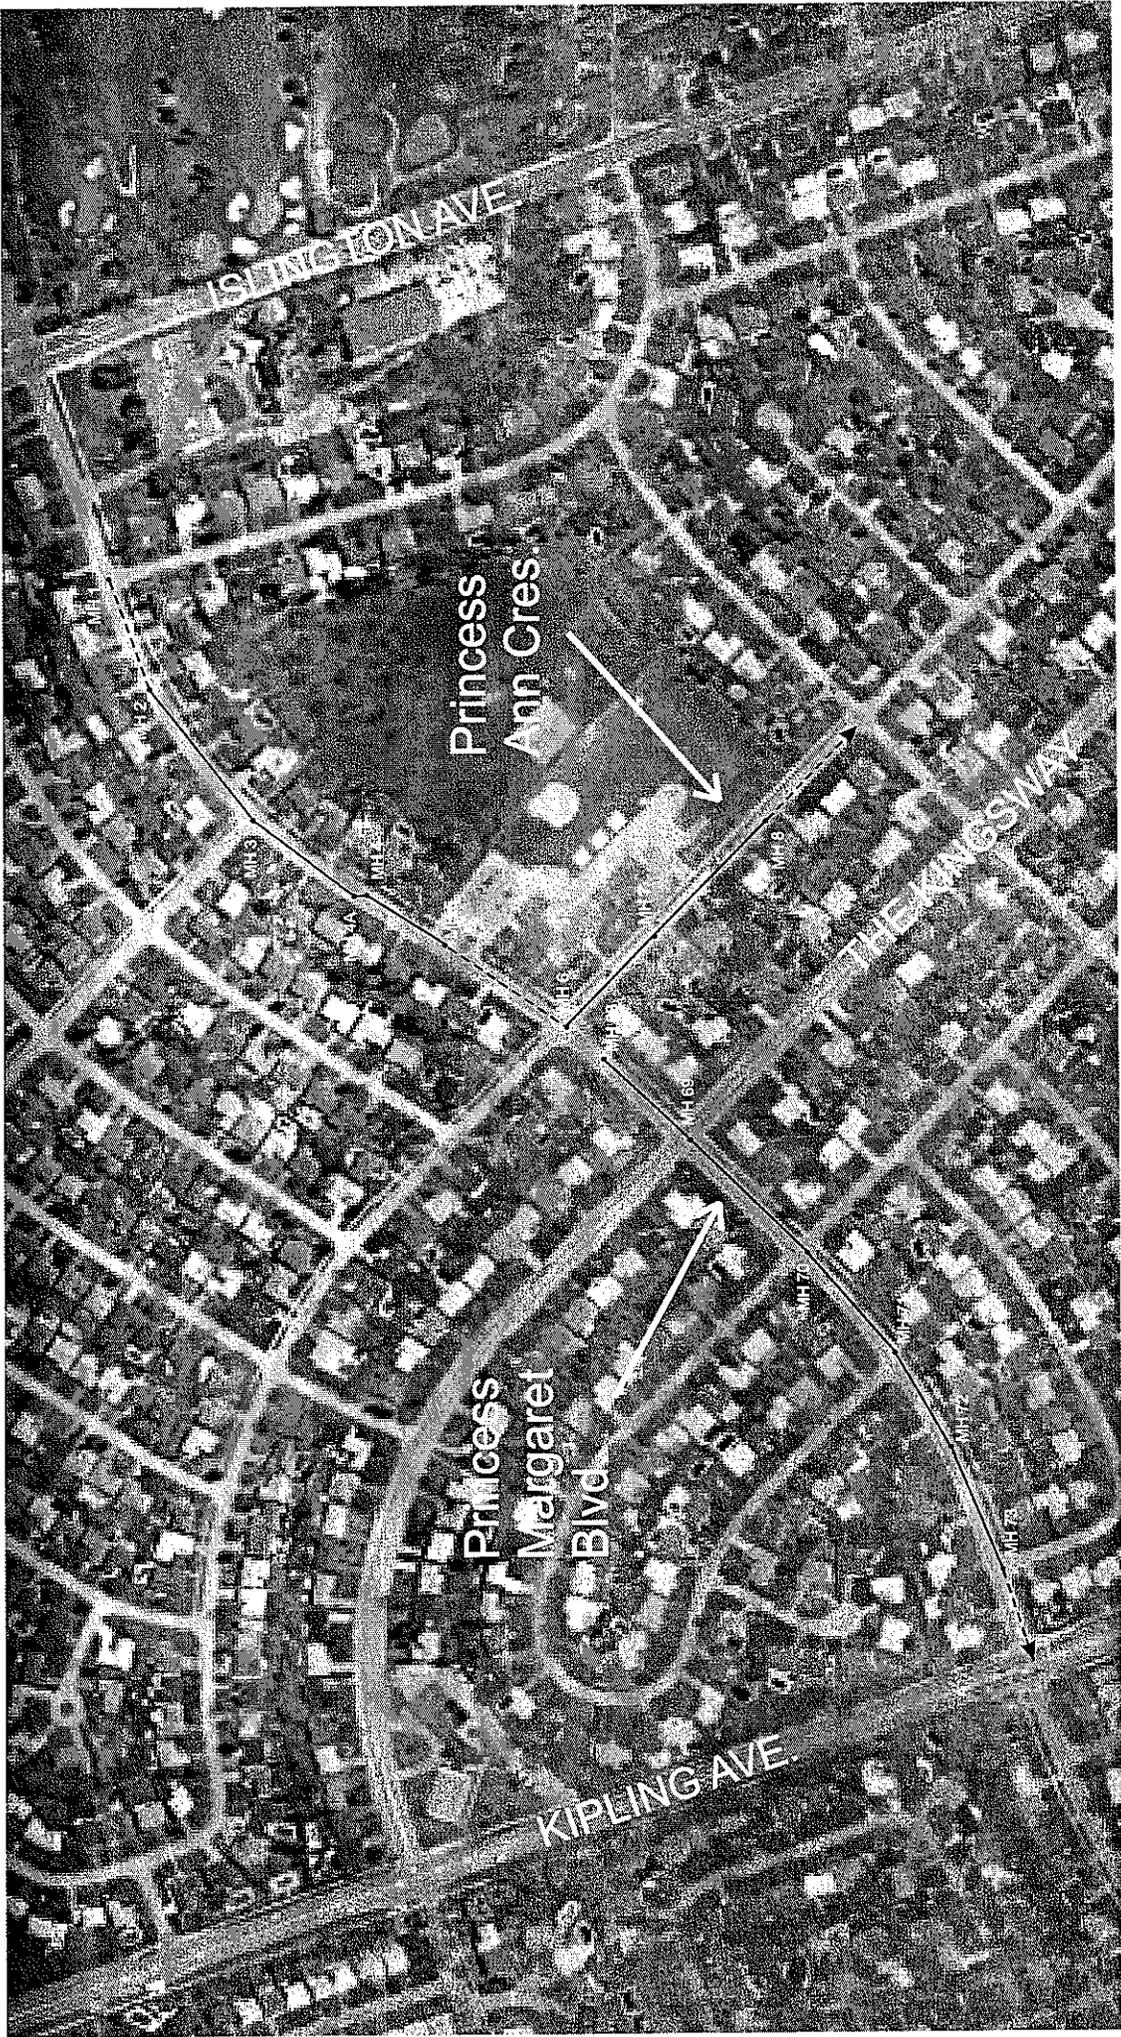
Figure 3.2: Princess Margaret Boulevard exfiltration facility

— Exfiltration sewer system
- - - Conventional storm sewer

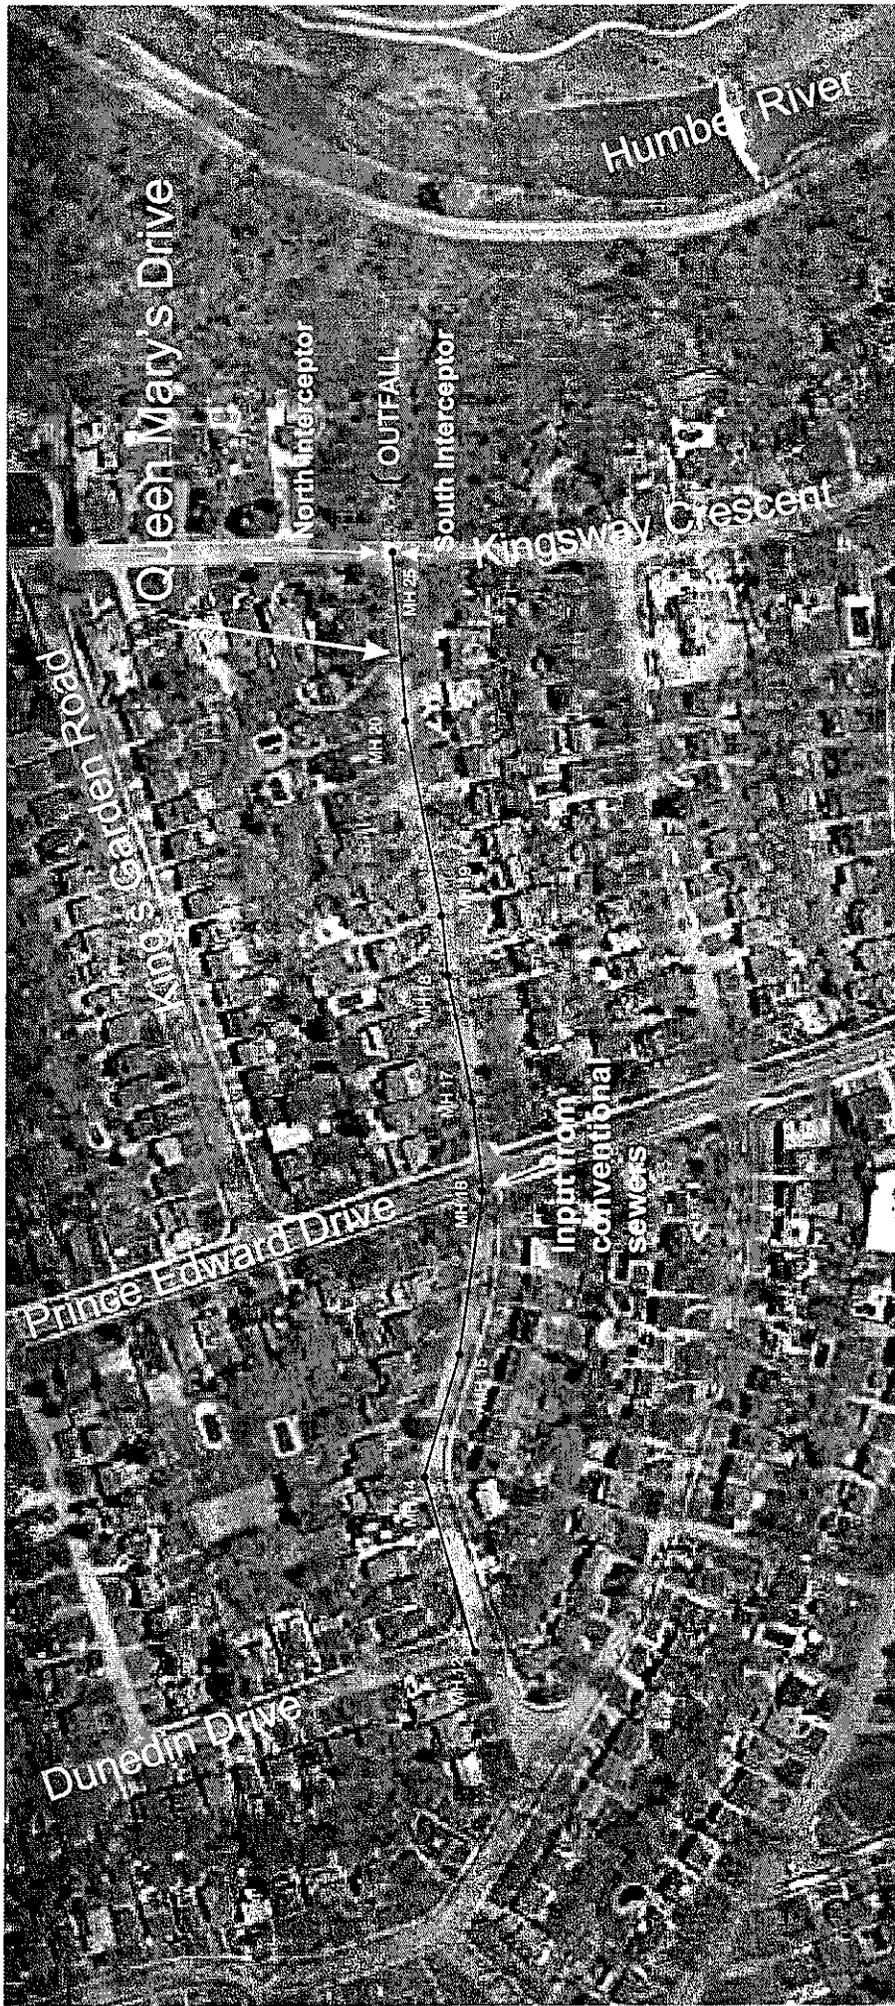
Figure 3.3: Queen Mary's Drive exfiltration facility

Municipal as-built drawings of the Queen Mary's Drive site reveal a complex construction process that included the abandonment of an existing storm sewer and several changes to the proposed new storm sewer. The new exfiltration sewer system starts at maintenance hole 12 (MH 12) near Dunedin Drive at the west end of Queen Mary's Drive. The sewer flows eastward for 0.44 km, including eight more maintenance holes and 32 catchbasins. A short conventional sewer discharges any excess flow through an outfall to the Humber River.

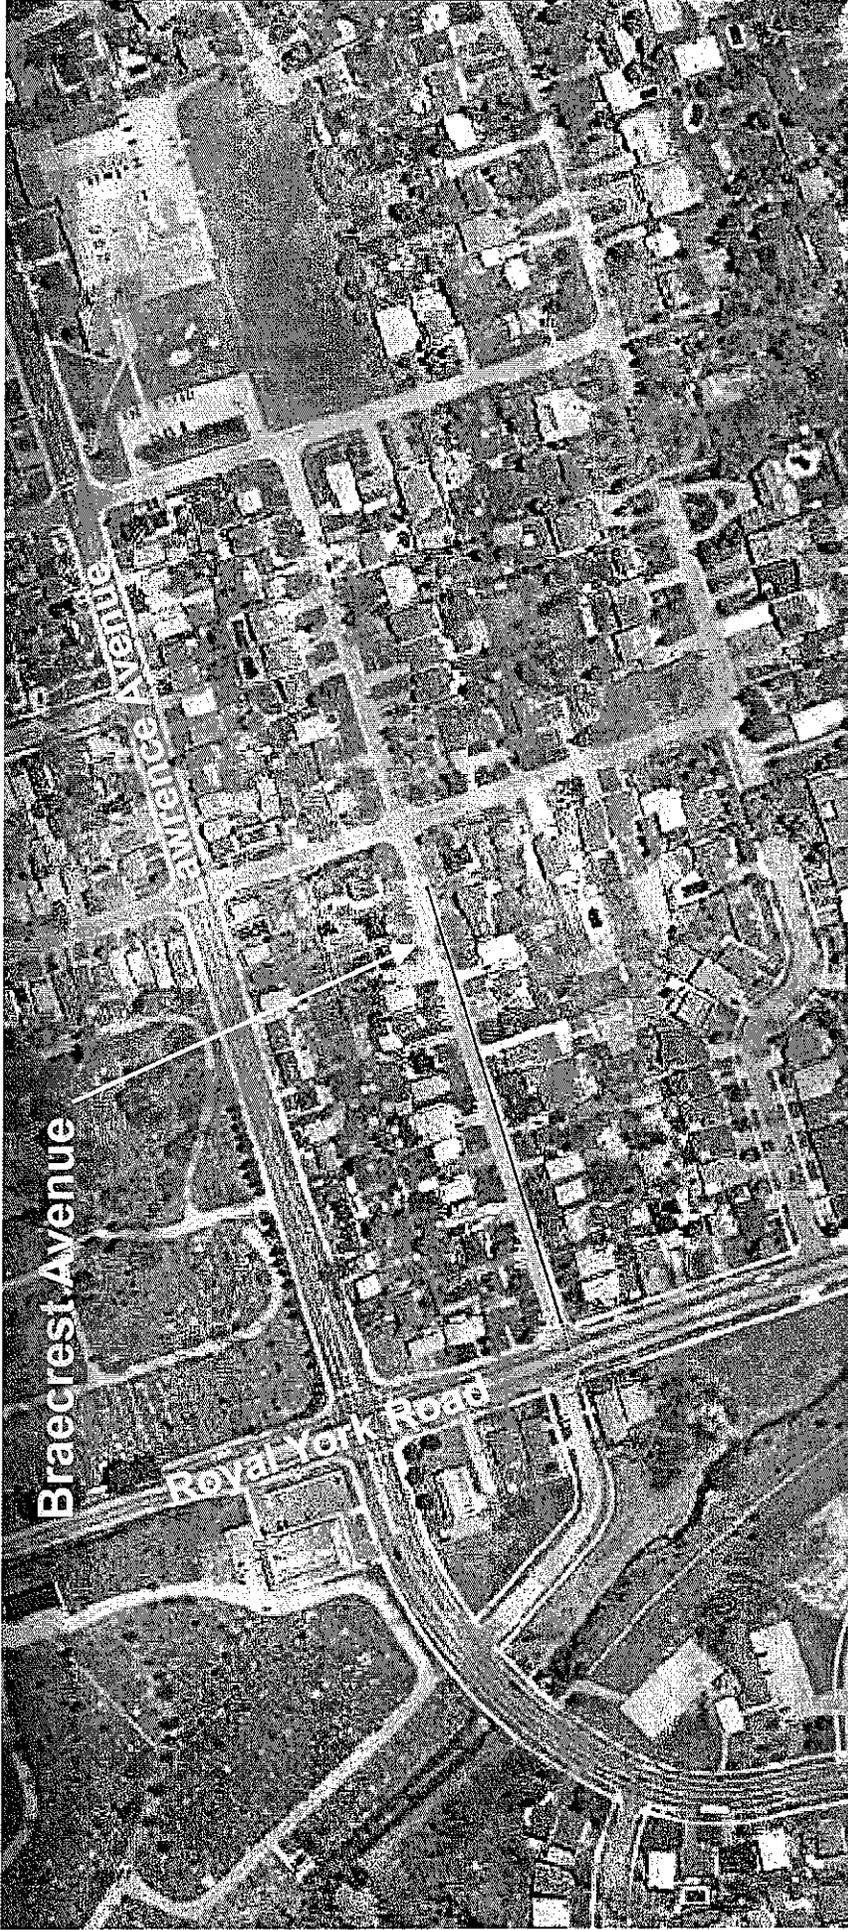
Figure 3.4: Braecrest Avenue filtration facility

The Braecrest Avenue study site (Figure 3.4) consists of a 2.4 ha drainage area with low-density residential housing. A 0.2 km filtration system was installed in 1993, draining west toward Royal York Road. The highest point of this study site is located approximately at the intersection of Braecrest Avenue and Roxaline Street. A conventional storm sewer was constructed at the same time, serving the eastern part of Braecrest Avenue and draining eastward to Westona Street. The roadway originally had a ditch-type cross-section and was reconstructed to curb-and-gutter during the installation of the filtration system. A geotechnical investigation indicated that the soil types are brown silty clay and dark gray sand loam containing organic matter. Additional soil records available from the City of Etobicoke showed that on Braecrest Avenue, the dominant soils are clay loam. Local well records indicated the upper soils (up to 7 m deep) in the area are brown clay, suggesting the dominance of relatively impervious soils. Consequently, the filtration system was considered to be appropriate at this site.

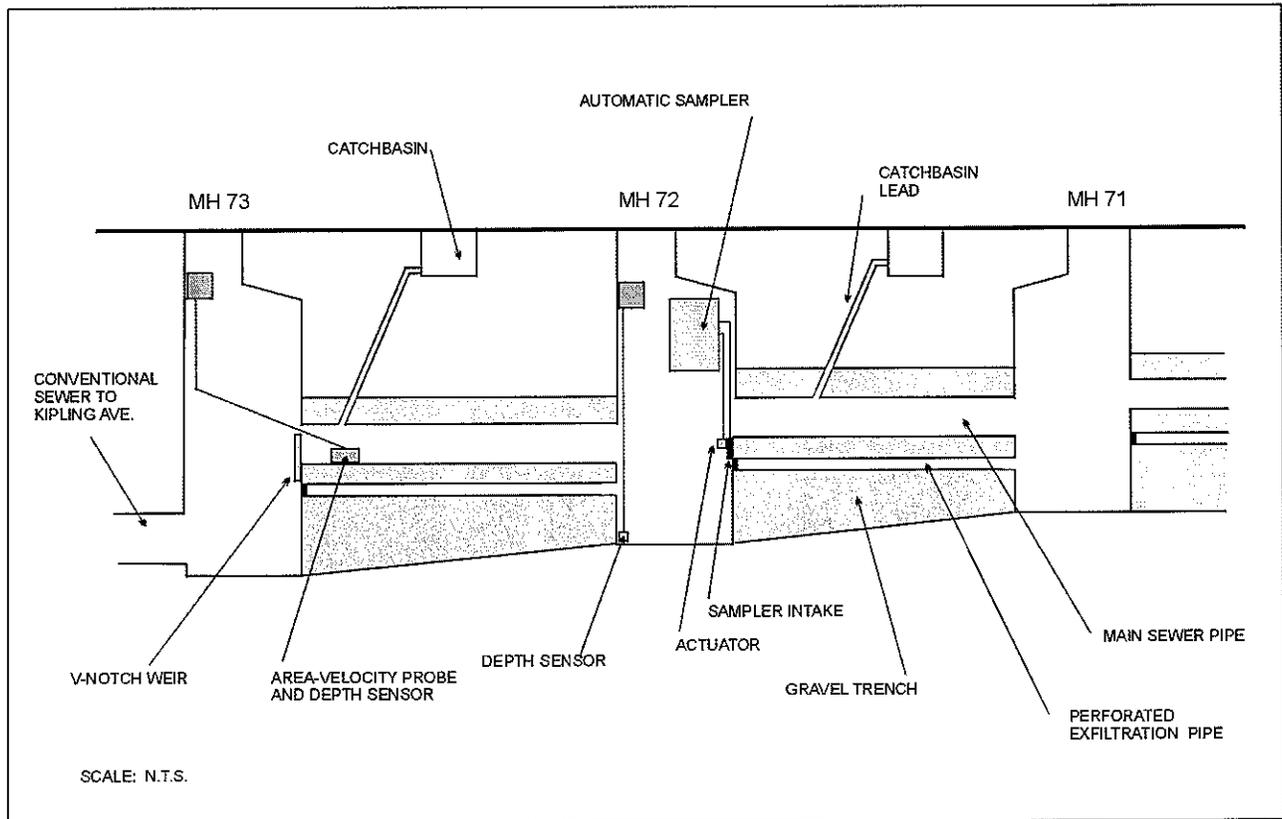
Figure 5.1: Princess Margaret Boulevard monitoring setup

The 22.5° v-notch weir was installed in the storm sewer upstream of MH 73 in order to enhance the accuracy of flow measurements. This improvement was required because the depths of flow found in the main storm sewer were insufficient to produce a reliable reading from an area-velocity flow meter. The v-notch weir created an upstream pool of water, permitting adequate submergence of the flow sensor such that the depth readings could be used in conjunction with a conventional weir equation to calculate the flow. The flow meter sensor was mounted on a steel ring, which was fixed at a location approximately 2 m upstream of the weir. At a sewer slope of 1.65%, the water level retained behind the weir was measured at a constant 170 mm from the invert of the storm sewer.

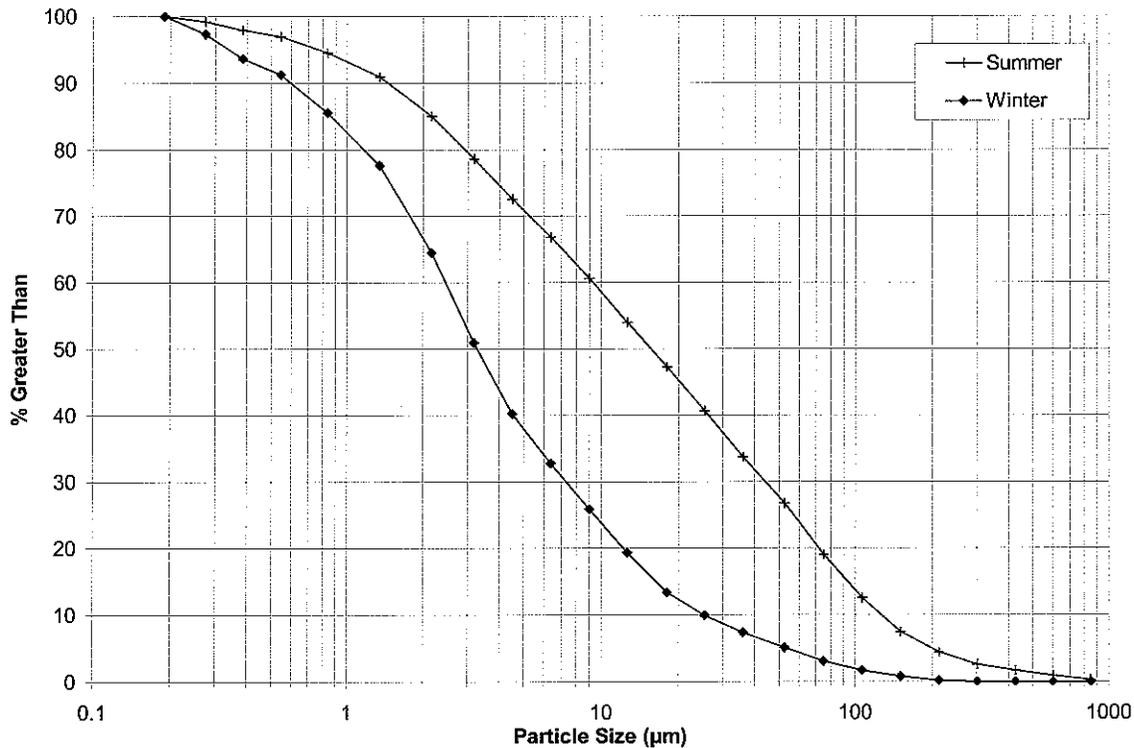
Figure 5.2: Princess Margaret Boulevard average particle size distributions

Figure 5.2 shows the average particle size distributions for the suspended particles found in the main pipe samples. As would be expected, the particulates were more coarse in summer than in winter, with the summer/fall average size being between 10 and 20 μm and the winter/spring average size being between 3 and 4 μm .

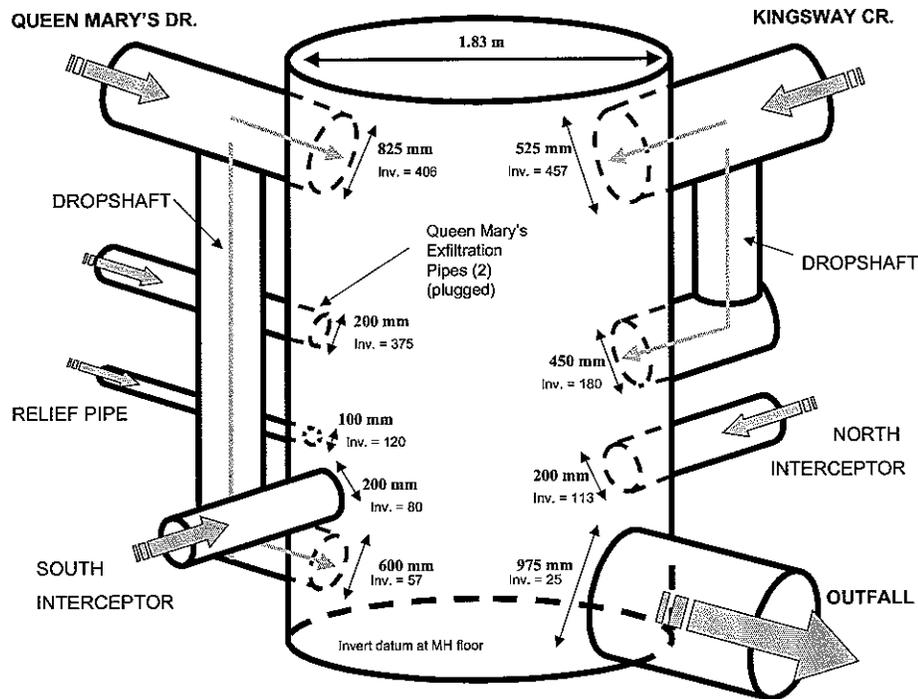
Figure 5.3: Schematic diagram of maintenance hole 25

An automatic sampler and a liquid level actuator were installed to collect samples from the bottom of MH 25. In addition, grab samples were collected from the main storm sewer of the exfiltration system and the 100 mm diameter relief drain. Water quality sampling began in mid-November of 1996. Table G.1 in Appendix G provides the chronology of the monitoring program.

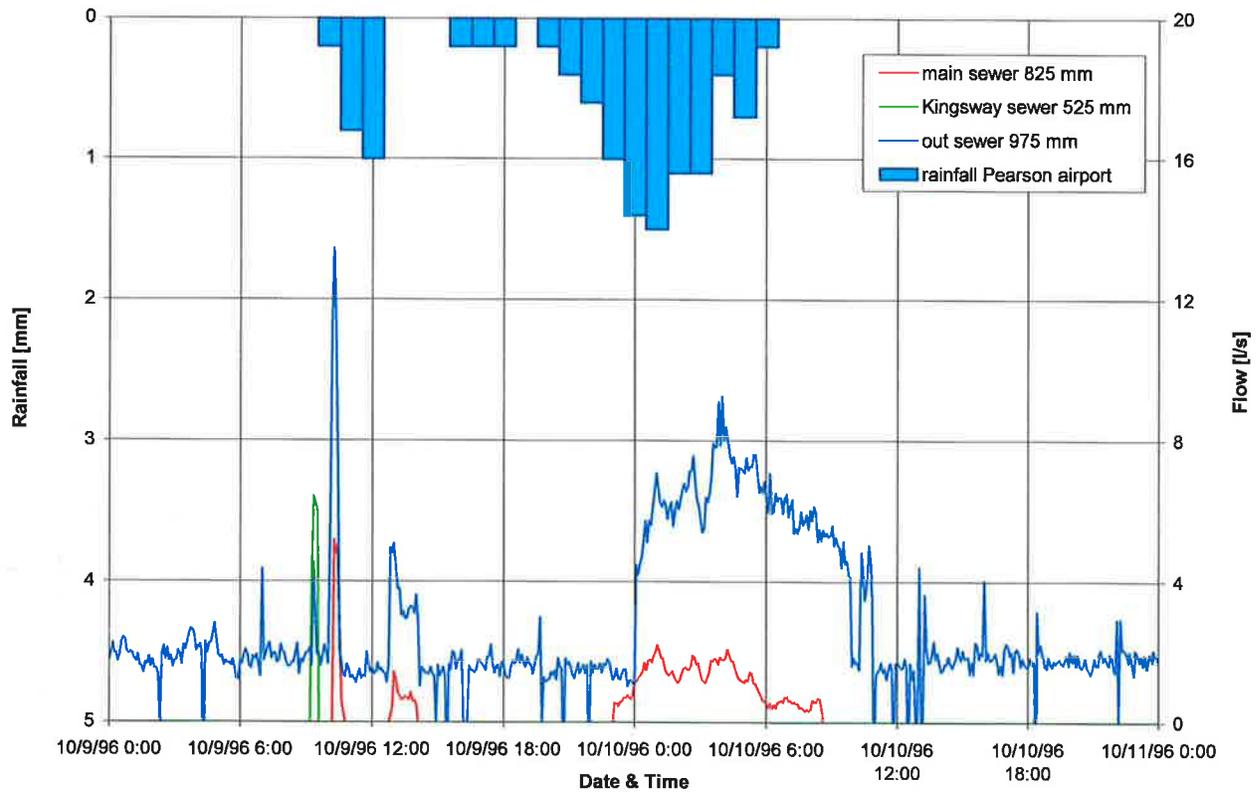
Figure 5.4: Queen Mary's Drive event of October 9-10, 1996

to respond to the rainfall pattern. As previously stated, the sensors were not capable of measuring low flows and the hydrographs consequently start and end abruptly. In addition, the sensor in the Kingsway Crescent sewer appears to have stopped reporting after the initial few observations. The measured inflow was only 33% of the measured outflow during this period. Because additional, unmeasured flows would have come from the north and south interceptor sewers, a volumetric balance could not have been obtained from the data set.

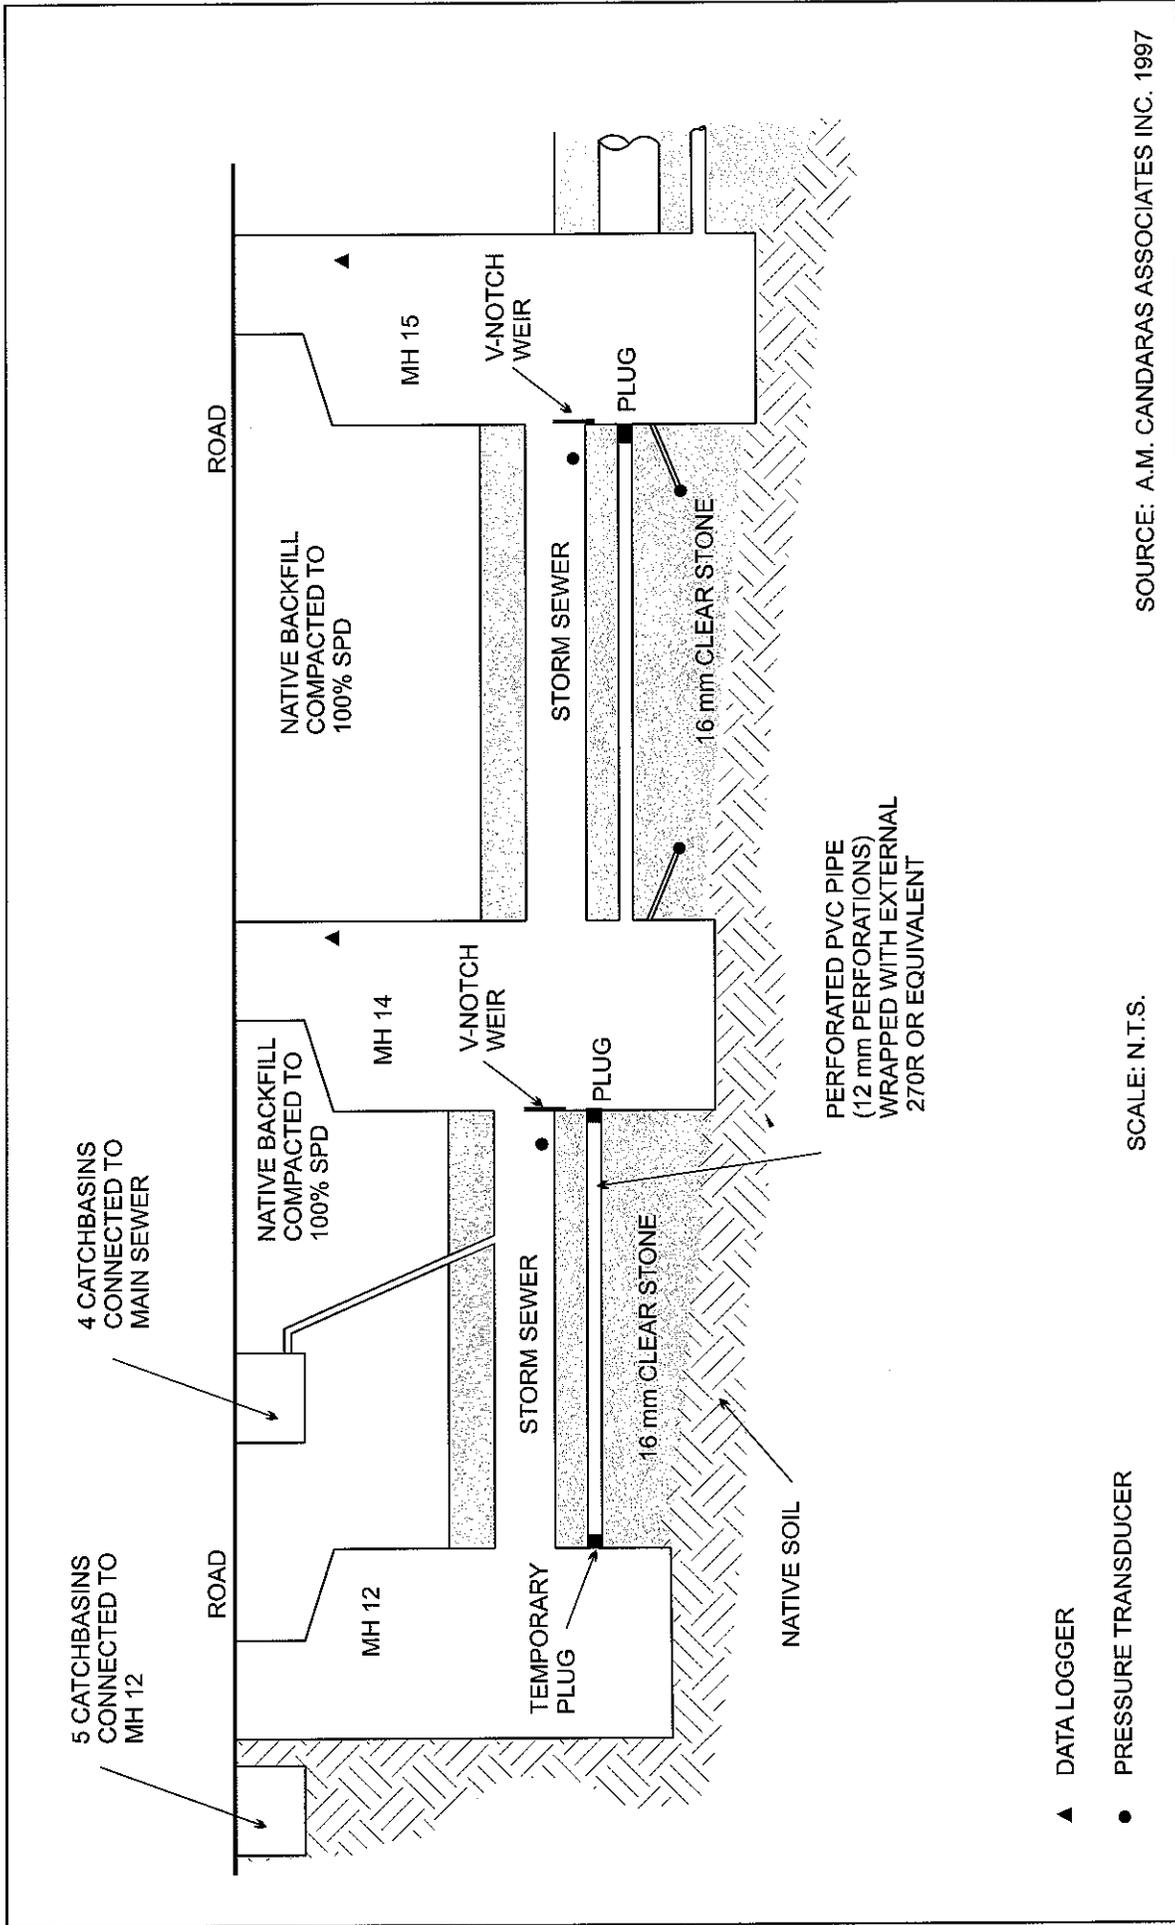
Figure D.1: Queen Mary's Drive monitoring configuration 1994-1995

Hydraulic monitoring was conducted at the upstream end of the system (Figure D.1). The inlets to the perforated pipes in maintenance hole 12 (MH 12) were plugged for this study so that any influent from the catch basins connected directly to MH 12 or to the storm sewer pipe between MH 12 and MH 14 would appear as influent flow to MH 14. A pressure transducer and weir were installed in MH 14 to measure the runoff entering the system. Flow entering MH 14 had an opportunity to exfiltrate through the perforated pipes and gravel trench between MH 14 and MH 15. Any overflow could be measured as influent to MH 15 by a pressure transducer and weir. There are no catchbasin leads entering the storm sewer between MH 14 and MH 15. Pressure transducers were also installed in monitoring wells in the gravel bed at MH 14 and MH 15.

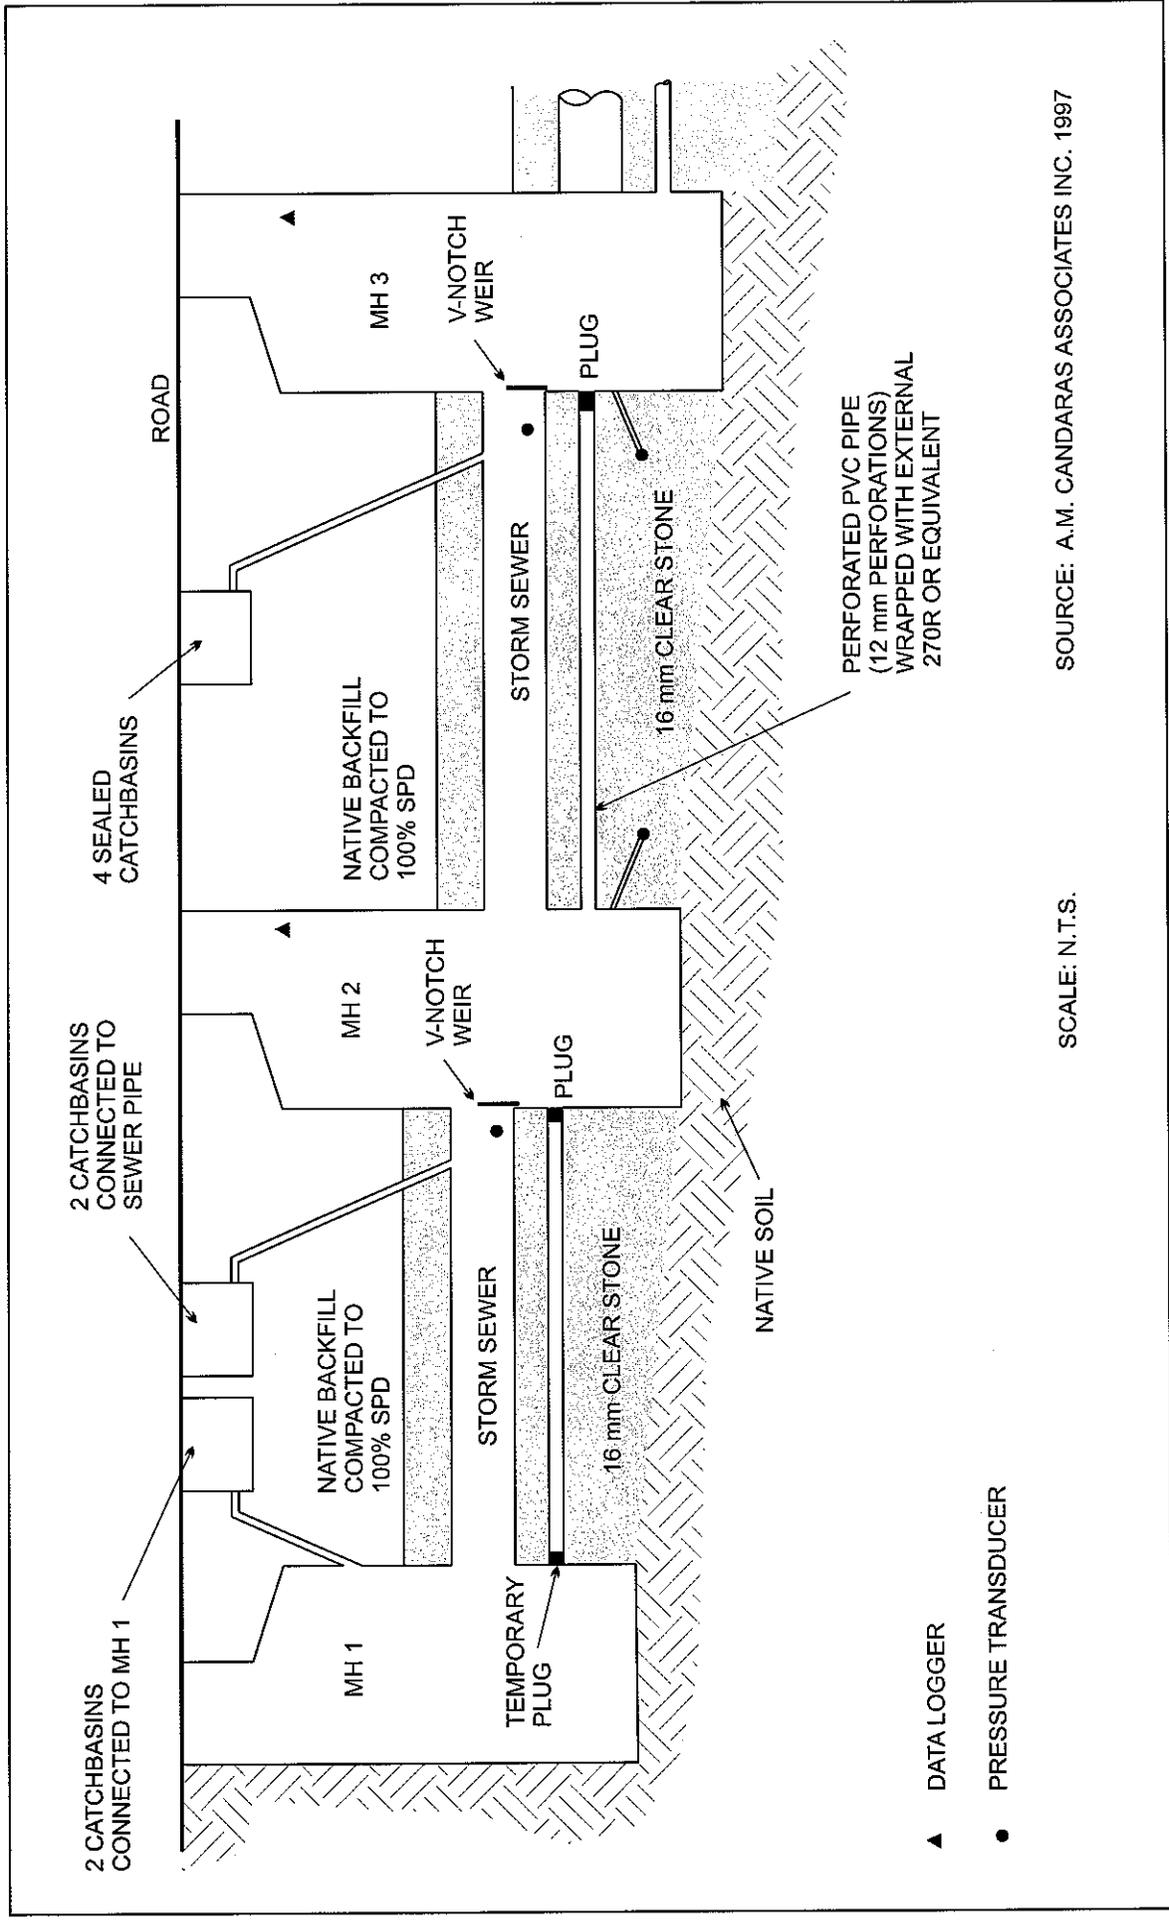
Figure D.3: Princess Margaret Boulevard monitoring configuration 1994-1995

The fourth event (October 5-6, 1995) had a total rainfall of 63 mm and a duration of 18 hours. The peak inflow was 10 L/s and the peak outflow was 3.3 L/s. The maximum water depth in the gravel bed at MH 3 was 0.5 m, and that at MH 2 was 0.38 m.

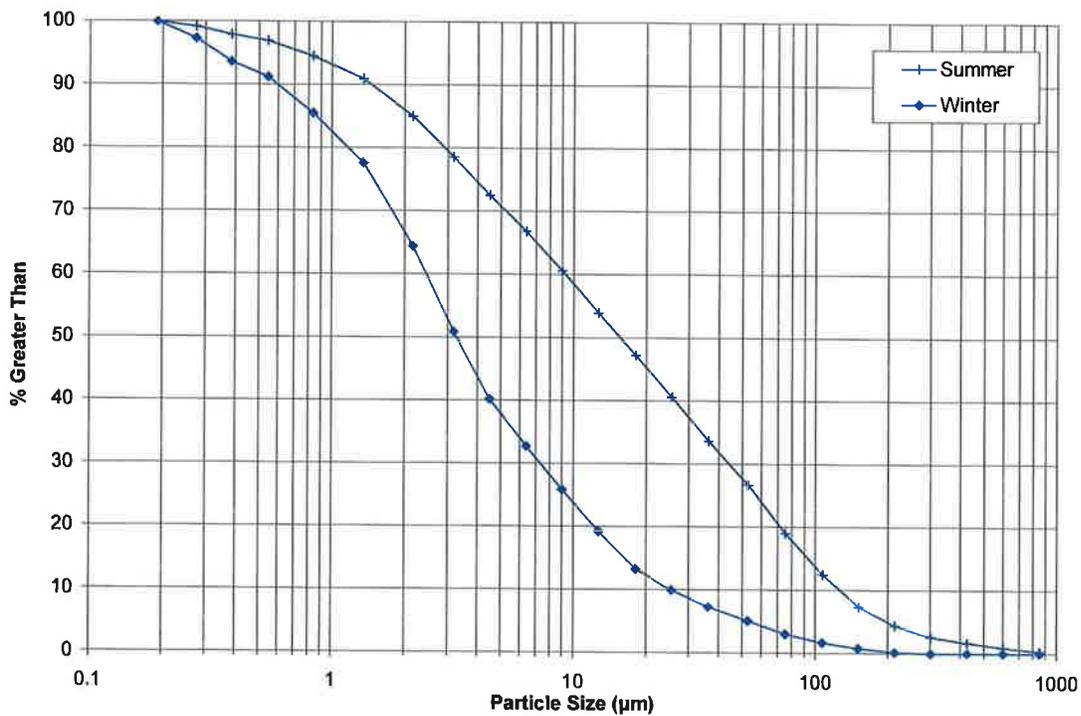
Figure F.25: Average particle size distributions -- Princess Margaret exfiltration facility

Figure F.25 compares the average summer/fall and winter/spring particle size distributions. The winter/spring suspensions had a smaller average size than those of the summer/fall monitoring period. This difference is often attributed to reduced flow rates associated with snowmelt. However, as discussed with respect to Figure F.23, sampling technique may explain much of the difference. Winter monitoring was based on grab samples and summer monitoring was based largely on composite samples. The use of various monitoring techniques at this site during the summer/fall period has shown that sampling method can influence the results.

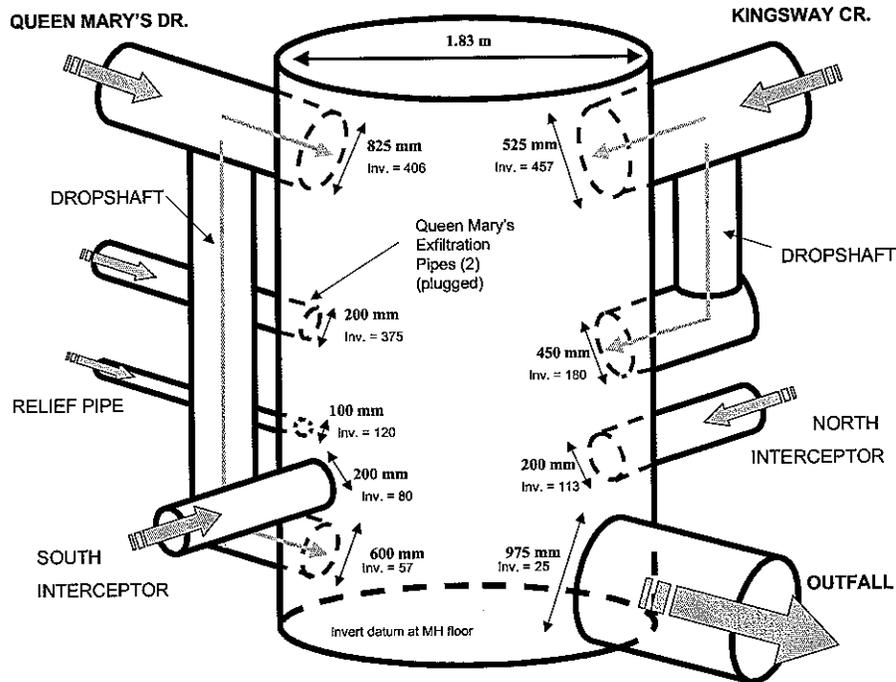
Figure G.5: Schematic diagram of maintenance hole 25

A portion of Kingsway Crescent north of Queen Mary's Drive, including part of Kings Garden Road, drain into maintenance hole 25 (3.8 ha). Catchbasins on Kingsway Crescent south of Queen Mary's Drive also drain to maintenance hole 25; the tributary area is apparently included in the 3.8 ha. This area does not impact the exfiltration system directly but does contribute to the total outflow.

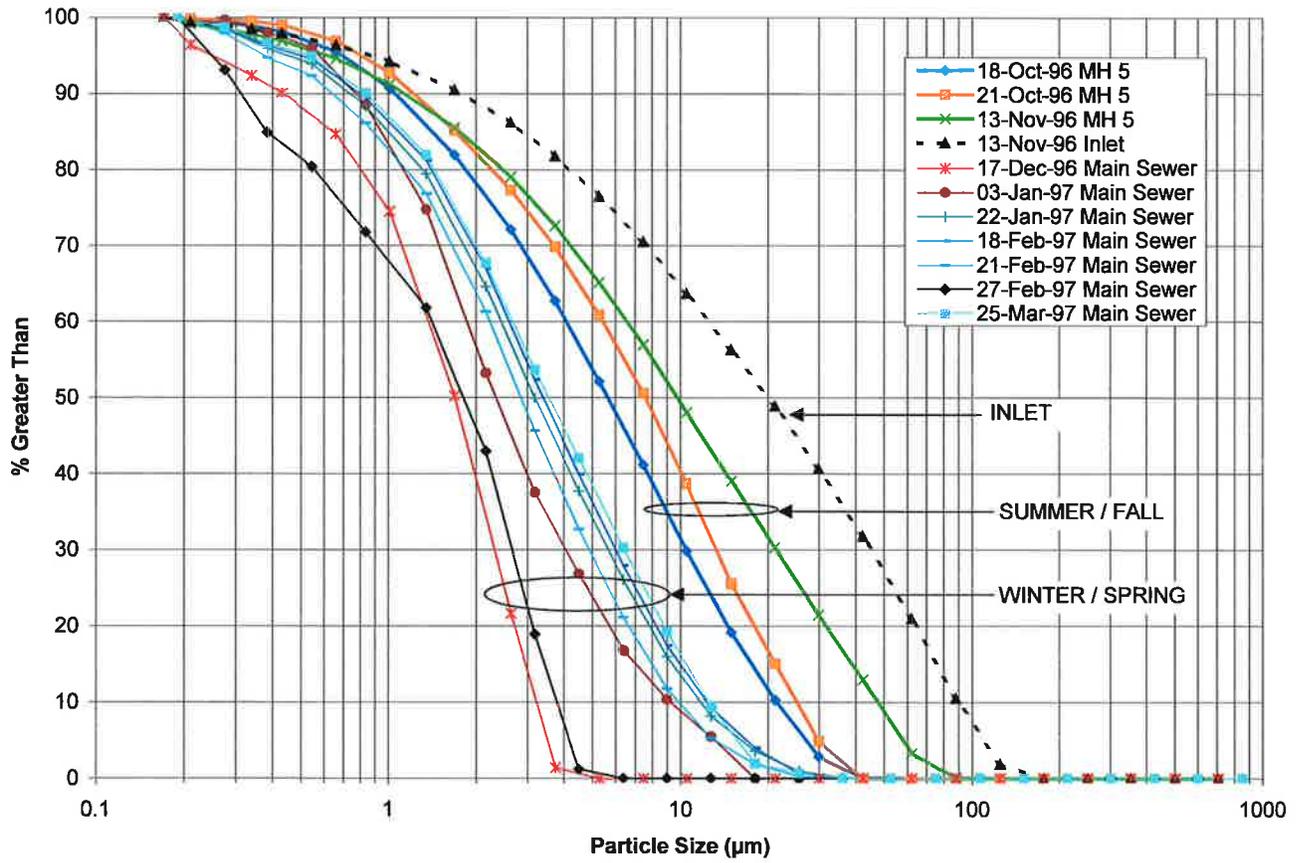
Figure H.5: Particle size distributions -- Braecrest Avenue filtration facility

Particle size data are available for all samples (Figure H.5). The three outlet samples from the summer/fall period have similar particle size distributions with an average size from approximately 5 to 10 μm . The inlet distribution measured on November 13th had an average size of approximately 20 μm . The particle sizes in the winter sample were noticeably finer, with an average size between approximately 1.5 and 3.5 μm . This difference between the summer and winter conditions is consistent with the decrease in the average outlet TSS concentration and the increase in the average outlet turbidity between summer and winter.
