**Phase One Environmental
Site Assessment
365 Forest Street, 1420 Richmond
Road & 2589 Bond Street
Ottawa, Ontario**

OTT-00252625-A0

May 7, 2021

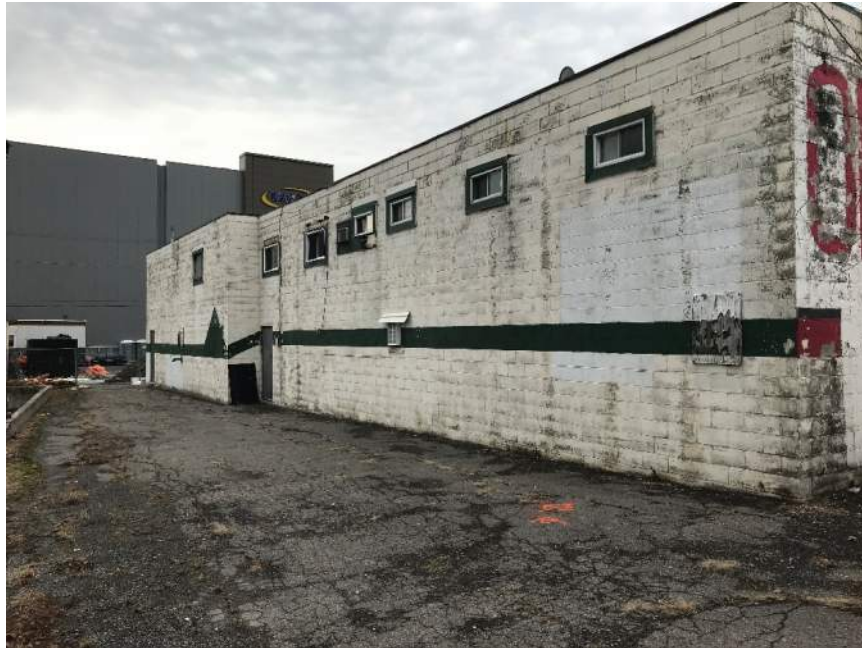
Photograph No. 9

The 365 Forest Street lot is improved with a single story, slab-on-grade multi-tenant building. The northern portion is a single bay automotive garage bay, with the southern portion formerly tenanted a restaurant. A mezzanine residential apartment was found at the southern side of the building but was not accessed due to structural concerns due to water damage. The building is built of painted masonry block with stucco on the western façade and the building has a flat roof.

View of east edge of 365 Forest Street building

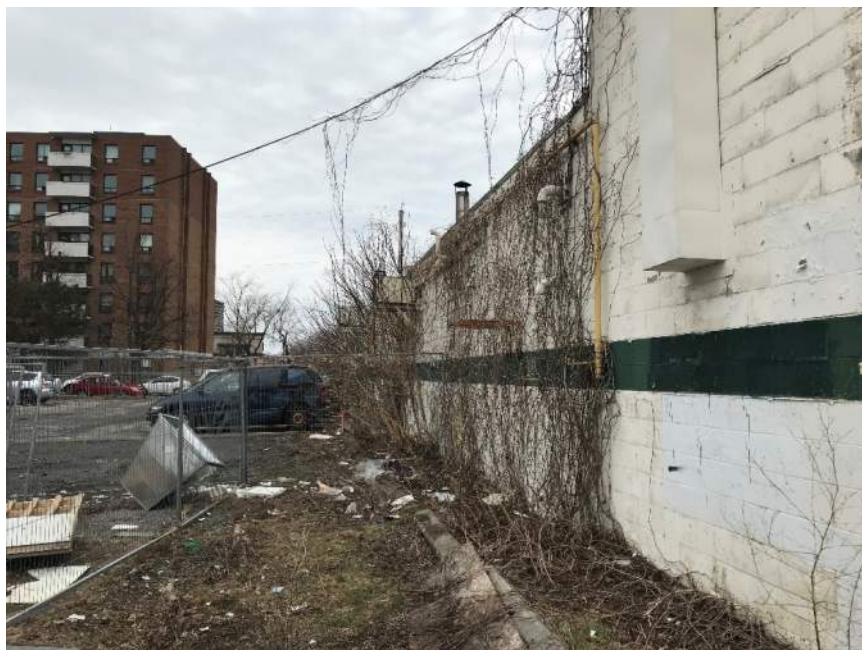
Photograph No. 10

View of south side of 365 Forest Street building

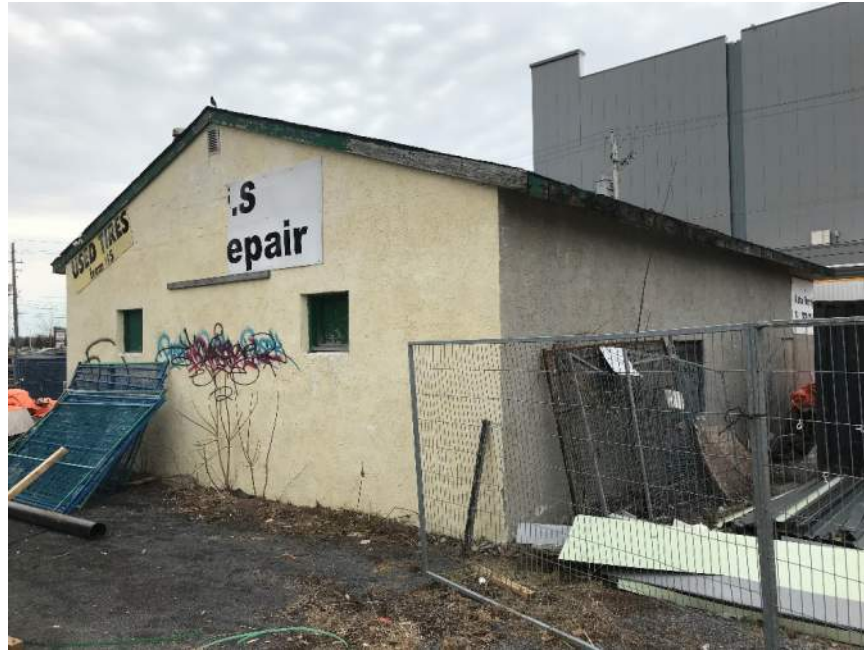
Photograph No. 11

The 2589 Bond Street property is improved with a single-story, peaked roofed, single bay garage building formerly used for automotive repairs. It is constructed of stucco covered block. At the time of the investigation, this lot and building were not accessible.

View of 2589 Bond Street building looking northwest

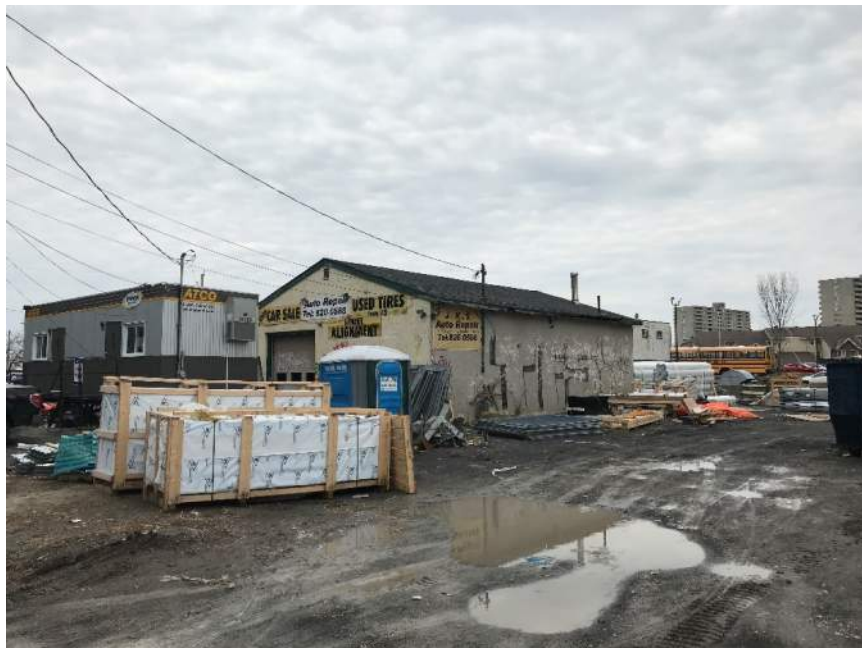
Photograph No. 14

View of 2589 Bond Street building looking northwest note temporary construction storage

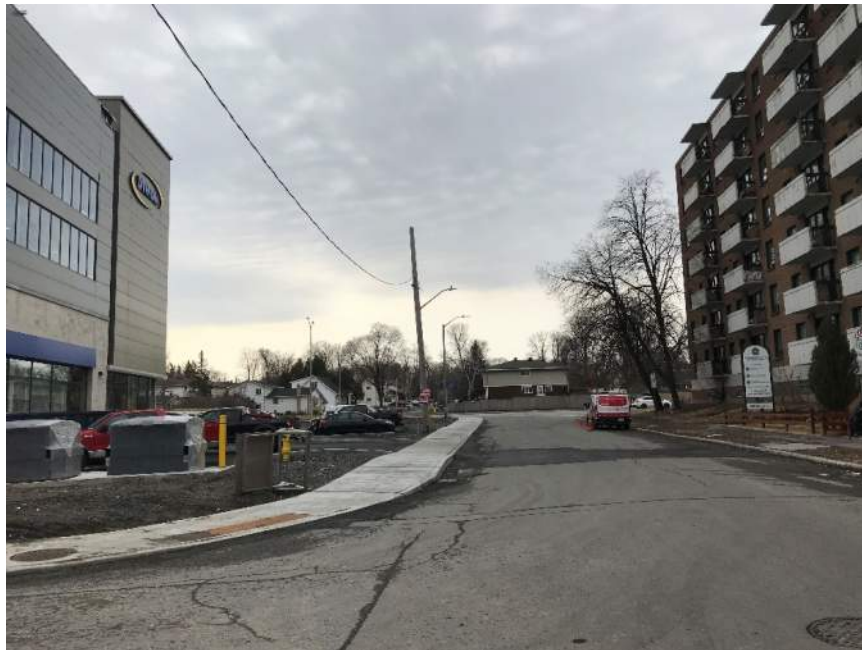
Photograph No. 15

View of Forest Street looking south at former gas station site, now large storage building

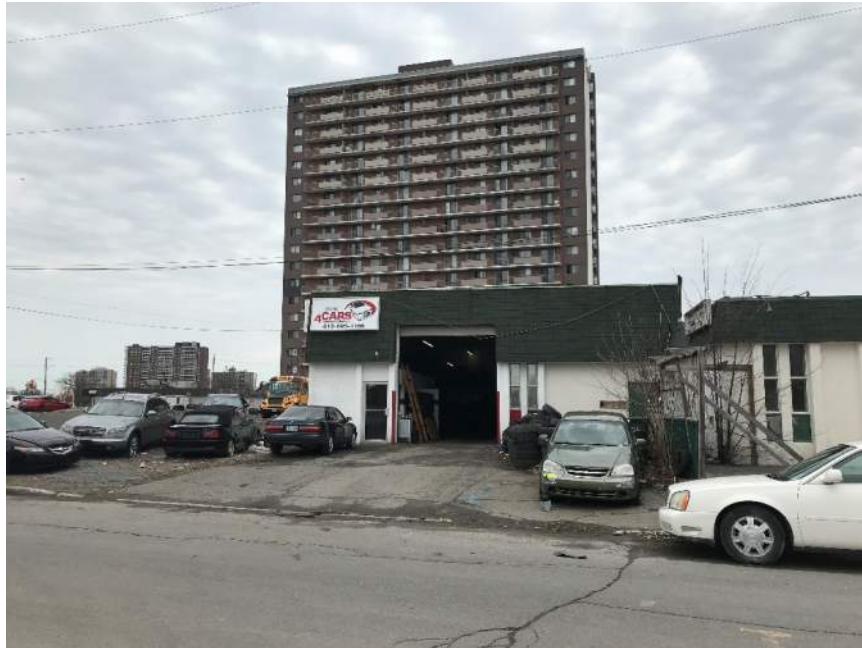
Photograph No. 17
View of 365 Forest Street service garage

At the time of the investigation, the garage bay at 365 Forest Street was in use by an automotive tire sales/repair shop. The remaining tenant spaces were vacant.

No sumps or pits were observed on the Phase One property. Trench drains were observed in the garage bay at 365 Forest Street. No oil/water separator was observed for these drains, but it may have been obscured due to poor housekeeping/tire storage.

No areas of stressed vegetation or stained soil was observed. Areas of stained pavement was observed in the vicinity of the garage bay at 363 Forest Street. This is considered an APEC.

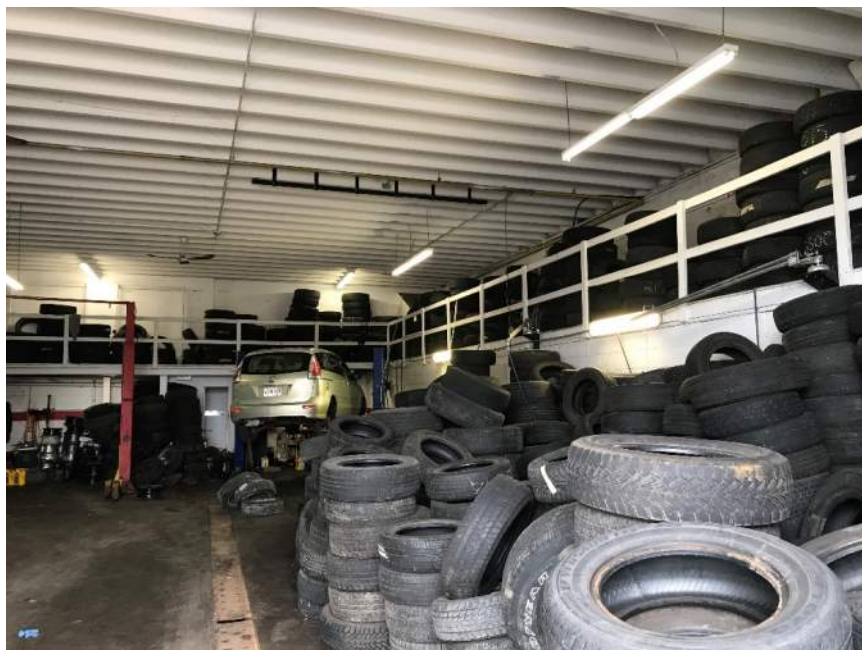
Photograph No. 18
View of interior of 365 Forest Street service garage

Heating systems observed at the Phase One property consisted of natural-gas fired convection blower in the garage bay of 365 Forest Street. None others were observed. No cooling systems were observed.
