**Phase One Environmental Site Assessment Update**  
**1055 Klondike Road**  
**Ottawa, Ontario**

**Phase One Environmental Site Assessment Update**  
**1055 Klondike Road**  
Ottawa, Ontario

June 10, 2021  
Project: 64153.85

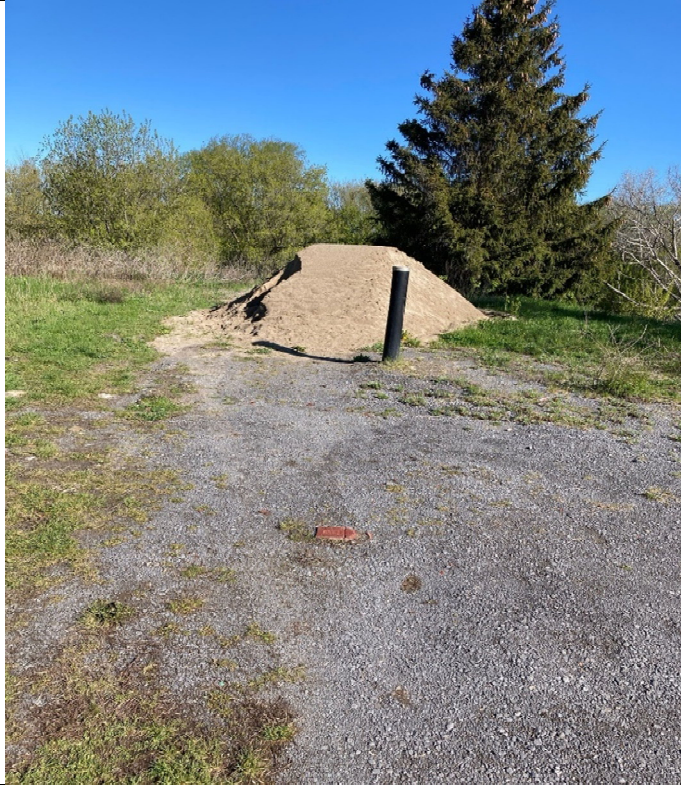
Photograph I1: Unknown fill within the subject site. The unknown fill was observed at the end of the gravel path in the centre of the subject site. The origin of the fill was determined during the interview with site representative Brian Saumure.

- Mr. Saumure identified the fill of unknown origin at the end of the gravel path observed during the site reconnaissance to be fill which was brought in by Latimer Excavating from a sand pit on Vances Side Road in Dunrobin as part of the demolition. This fill was used to fill in the hole which was the crawl space of the former residential building; and;

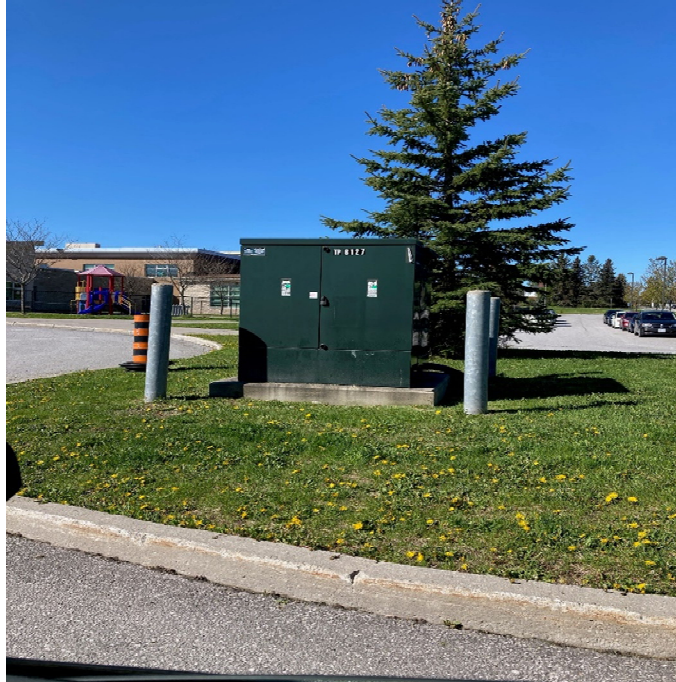
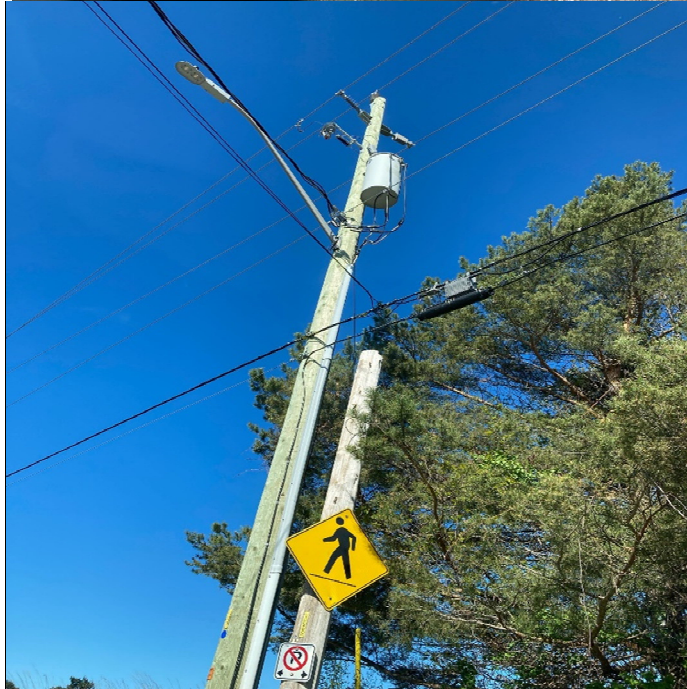
Photograph I3: Pole and pad mounted transformers identified throughout the study area.

Pole mounted and pad mounted transformers were identified in the study area the time of site reconnaissance. The transformers appeared to be in good condition with no evidence of leaking or staining.
