Geotechnical Investigation

Warehouse and Offices
Intersection of Rideau Street
and Somme Street
Ottawa, Ontario

Consolidated Fastrate (Ottawa)
Holdings Inc.

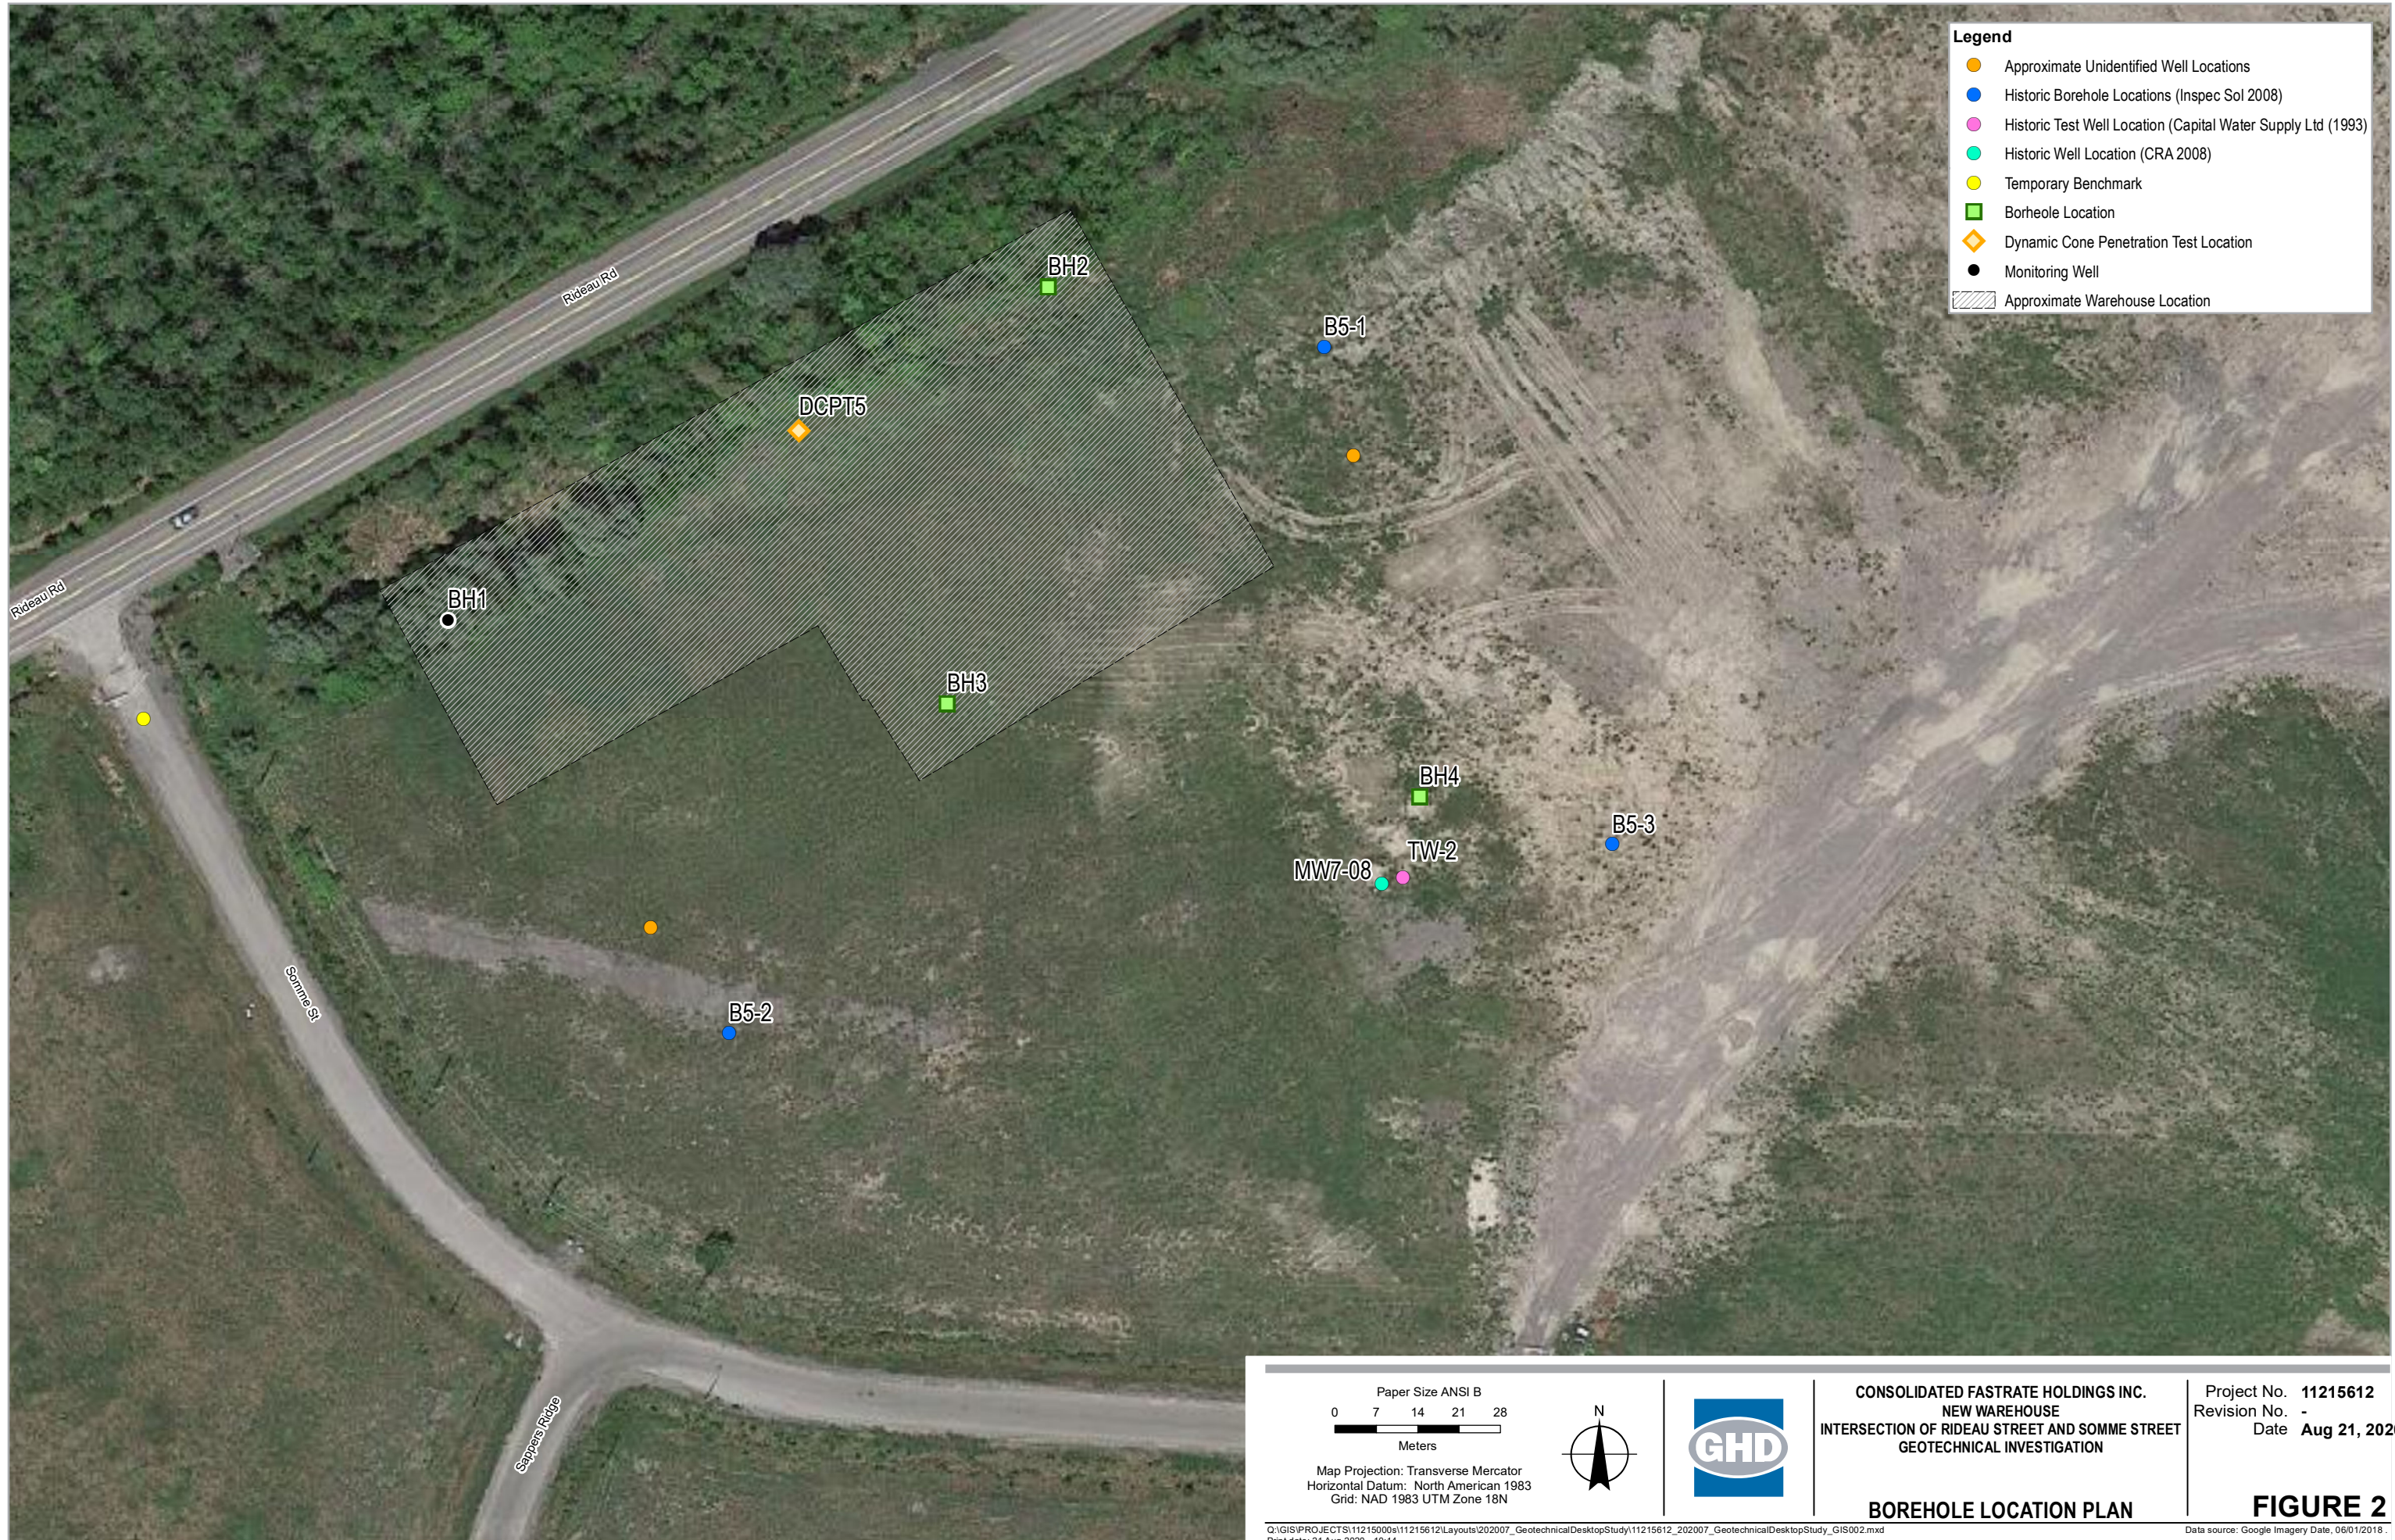
Figure 1	Site Location Map
Figure 2	Borehole Location Plan

General descriptions of the subsurface conditions are summarized in the following sections, with a graphical representation of each borehole on the Borehole Logs. Notes on Boreholes are provided in Appendix A, at the end of this Report.

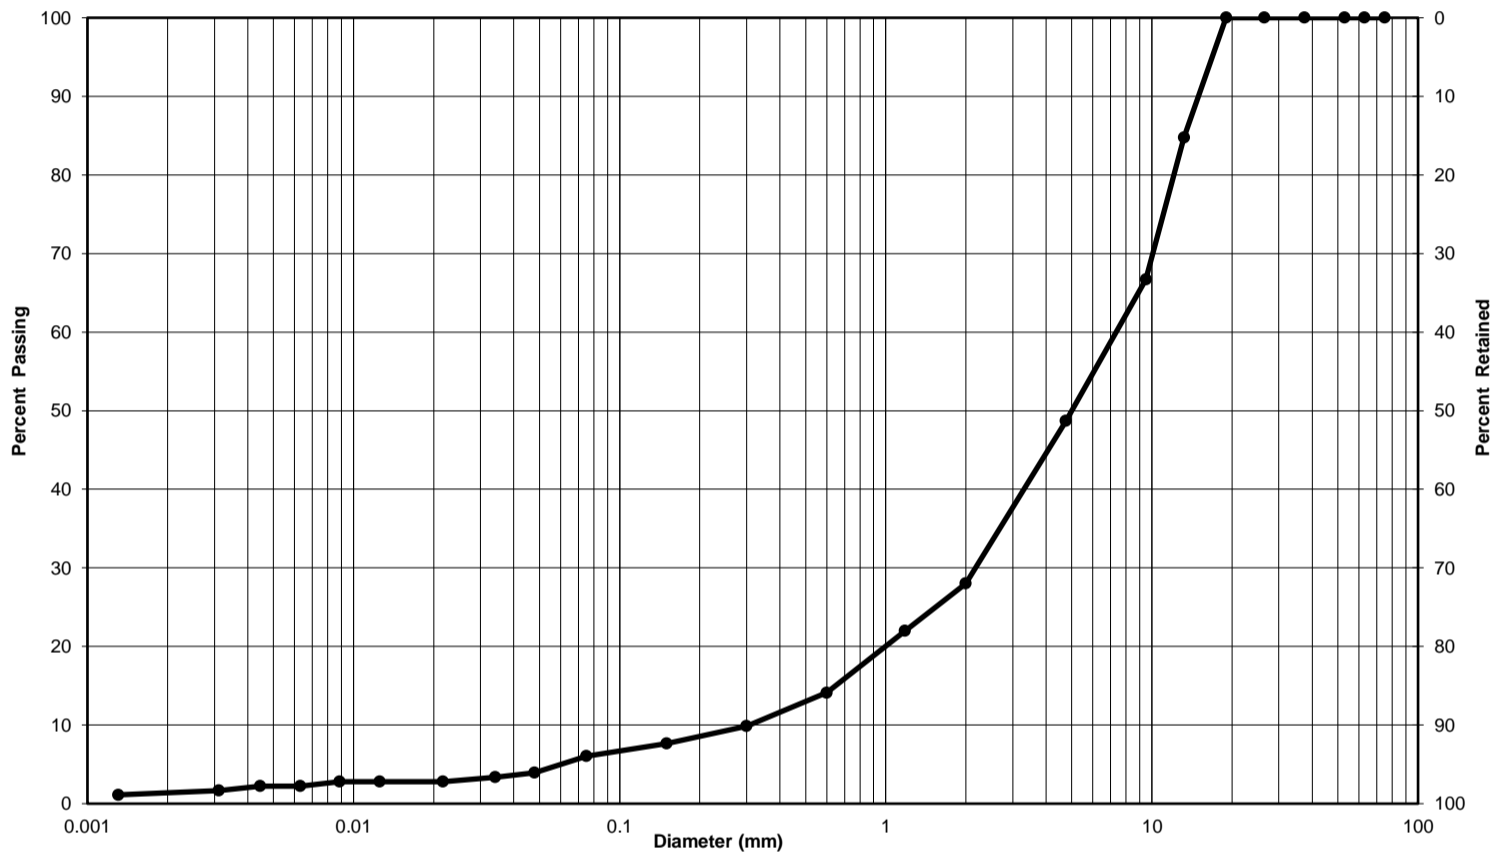
Particle-Size Analysis of Soils
MTO LS-702 (Geotechnical)

Client:	Consolidated Fastrate (Ottawa) Holdings Ltd.	Lab No.:	G-20-13
Project, Site:	New Warehouse, Somme Street, Ottawa, ON	Project No.:	11215612
Borehole No.:	1	Sample No.:	3
Depth:	1.5 - 2.1m	Enclosure:	-

Soil Description	Gravel (%)	Sand (%)	Clay & Silt (%)
Gravel and Sand, trace Silt, trace Clay	51	43	6
			1 %

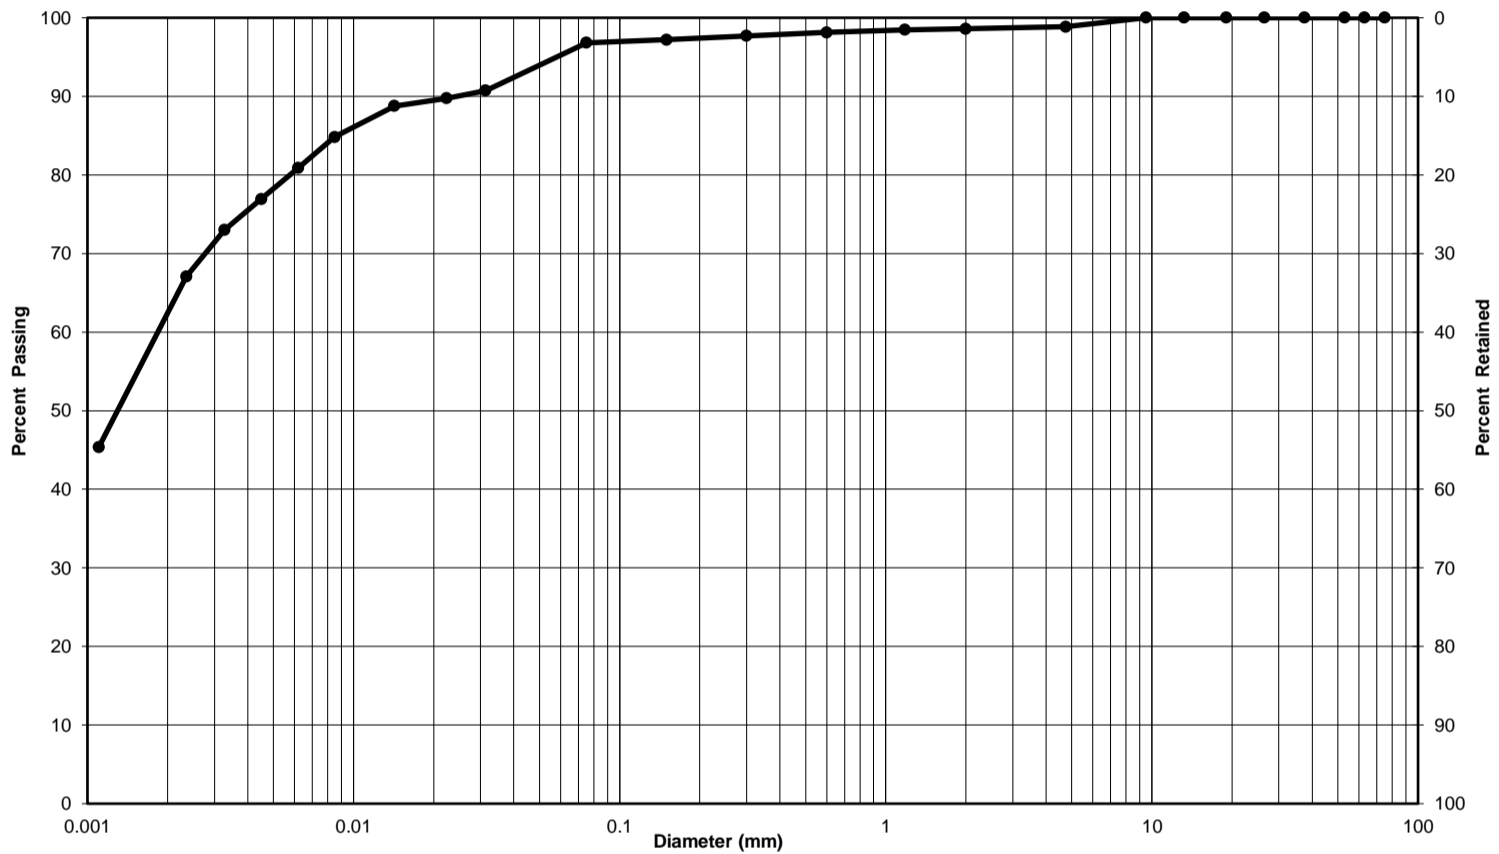
**Particle-Size Analysis of Soils
MTO LS-702 (Geotechnical)**

Client: Consolidated Fastrate (Ottawa) Holdings Ltd. **Lab No.:** G-20-13
Project, Site: New Warehouse, Somme Street, Ottawa, ON **Project No.:** 11215612
Borehole No.: 2 **Sample No.:** 4
Depth: 2.3 - 3.0m **Enclosure:** -

Soil Description	Gravel (%)	Sand (%)	Clay & Silt (%)
Clay and Silt, trace Sand, trace Gravel	1	2	97
Clay-size particles (<0.002 mm):	61 %

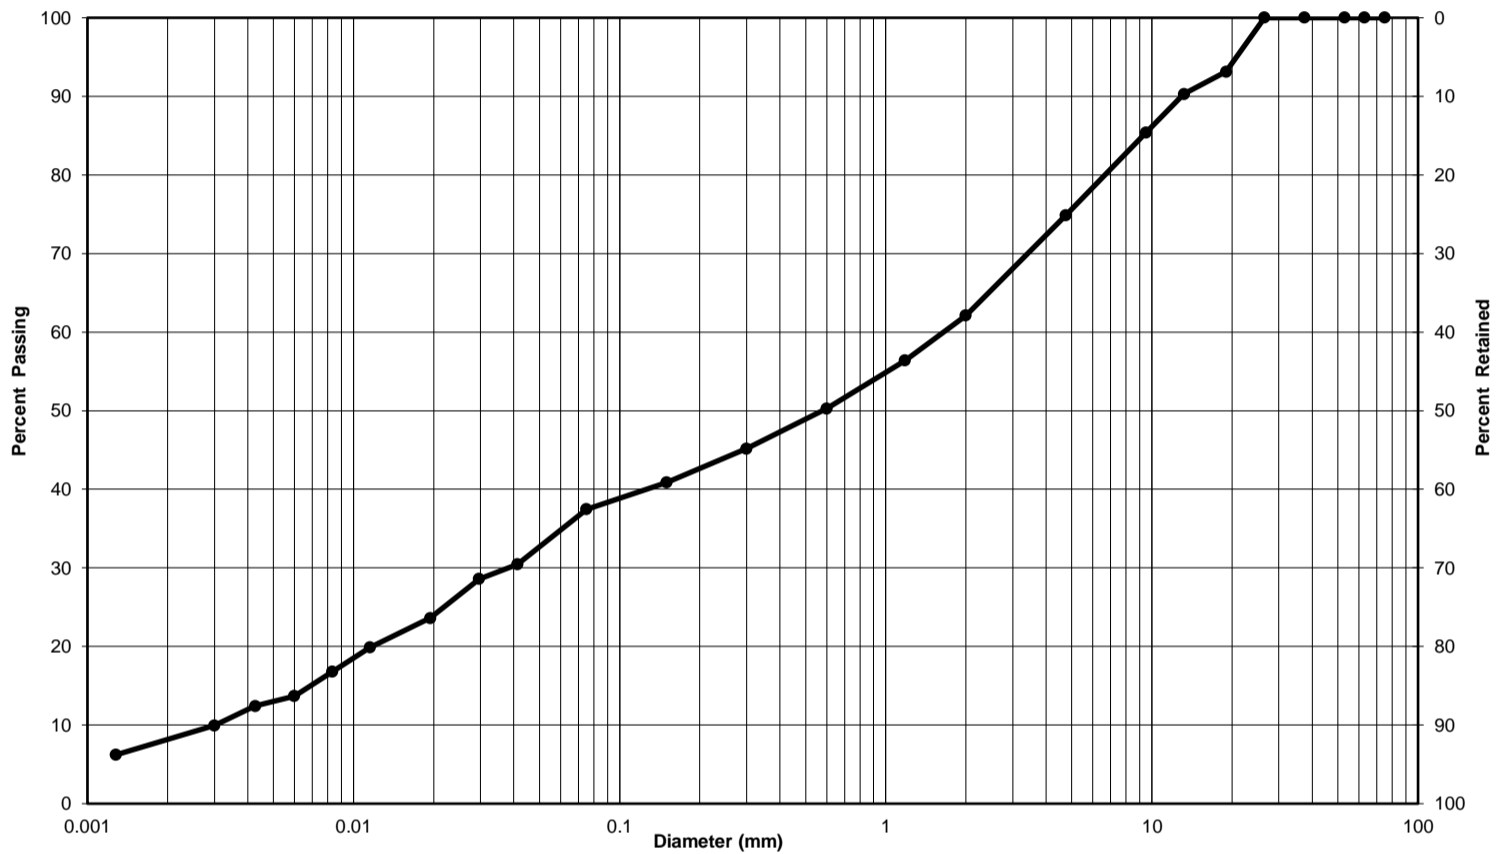
**Particle-Size Analysis of Soils
MTO LS-702 (Geotechnical)**

Client:	<u>Consolidated Fastrate (Ottawa) Holdings Ltd.</u>	Lab No.:	<u>G-20-13</u>
Project, Site:	<u>New Warehouse, Somme Street, Ottawa, ON</u>	Project No.:	<u>11215612</u>
Borehole No.:	<u>2</u>	Sample No.:	<u>7</u>
Depth:	<u>4.5 - 6.1m</u>	Enclosure:	<u>-</u>

Soil Description	Gravel (%)	Sand (%)	Clay & Silt (%)
Gravelly, Silty, Sand, trace Clay	25	38	37
Clay-size particles (<0.002 mm):	8 %

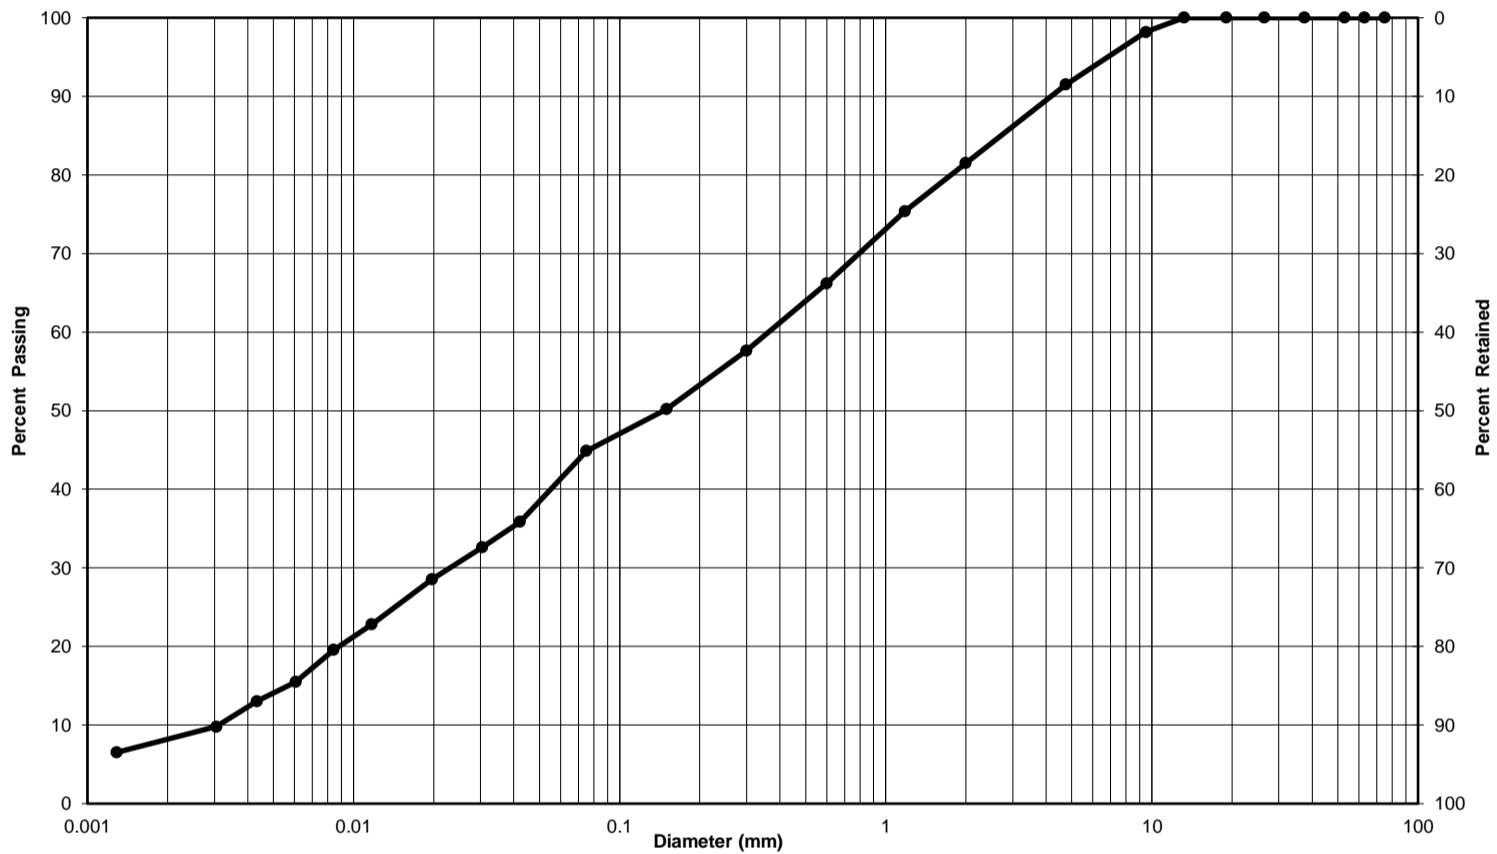
Particle-Size Analysis of Soils
MTO LS-702 (Geotechnical)

Client:	<u>Consolidated Fastrate (Ottawa) Holdings Ltd.</u>	Lab No.:	<u>G-20-13</u>
Project, Site:	<u>New Warehouse, Somme Street, Ottawa, ON</u>	Project No.:	<u>11215612</u>
Borehole No.:	<u>3</u>	Sample No.:	<u>10</u>
Depth:	<u>6.9 - 7.5m</u>	Enclosure:	<u>-</u>

Soil Description	Gravel (%)	Sand (%)	Clay & Silt (%)
Sand and Silt, trace Gravel, trace Clay	8	47	45
Clay-size particles (<0.002 mm):			8 %

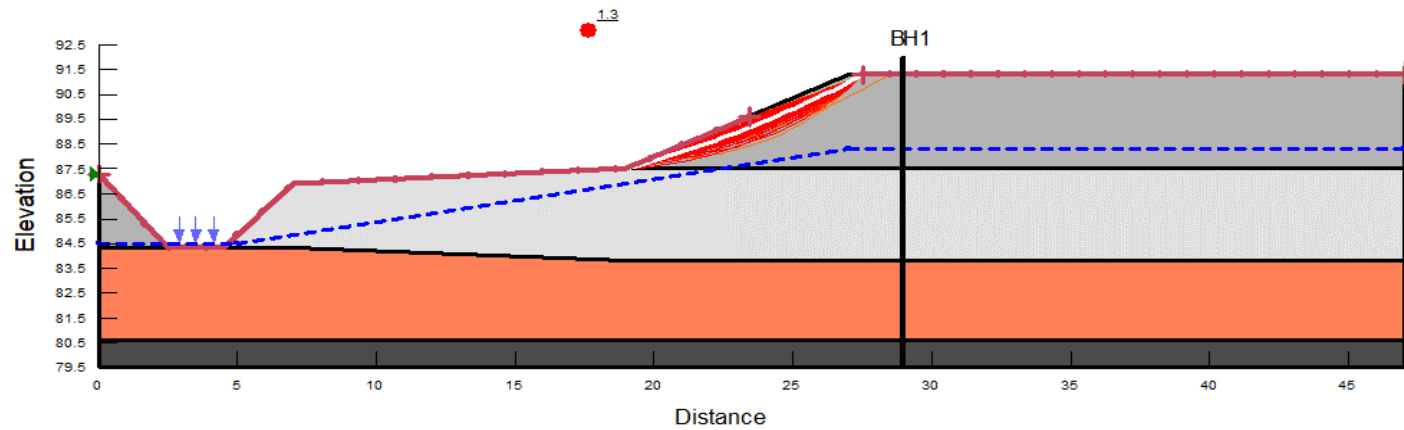
SLOPE STABILITY ANALYSIS - BH1
 DRAINED CONDITION
 STATIC ANALYSIS

Color	Name	Unit Weight (kN/m³)	Cohesion' (kPa)	Phi' (°)
■	Bedrock			
■	Existing Fill - Clayey silty sand	19	3	30
■	Existing Fill - Sand	19	0	30
■	Native Silty Sand/Sandy Silty	20	0	30

The slope stability analysis was carried out using the SLOPE/W 2019 software package produced by GEO-SLOPE International Ltd. Each trial was modeled using the Morgenstern-Price method, and the optimized critical slip-surface was selected. In general, this approach calculates a factor of safety that represents the ratio of forces resisting a failure (i.e., shear strength, friction, etc.) to those favouring failure (weight, external loading, etc.). Theoretically, a factor of safety of 1.0 would represent a stable slope. However, the City of Ottawa recommends a minimum factor of safety of 1.5 under static condition and 1.1 under pseudo-static conditions.

Borehole Location	Condition (Drained)	Factor of Safety
BH1	Static	1.3
	Pseudo Static	0.9
BH2	Static	1.6
	Pseudo Static	1.1

Based on the preliminary slope stability analysis, depending on the composition and compactness state of the fill material, the factor of safety for the slope may be equal or slightly below (i.e., 1.3 under static condition and 0.9 under pseudo-static condition) the recommend values of 1.5 for static condition and 1.1 for pseudo-static condition. If the existing slopes are to remain on the Site, some slope remediation or adjustment may be required depending on the proposed structure location and distance from the slope. GHD must be provided a topographic survey plan for the existing slope and the proposed finish grade at the detailed design stage to determine the design setback allowance for the building and revise or confirm analysis. It is noted that the condition of the slope must be monitored during site preparation and building construction.

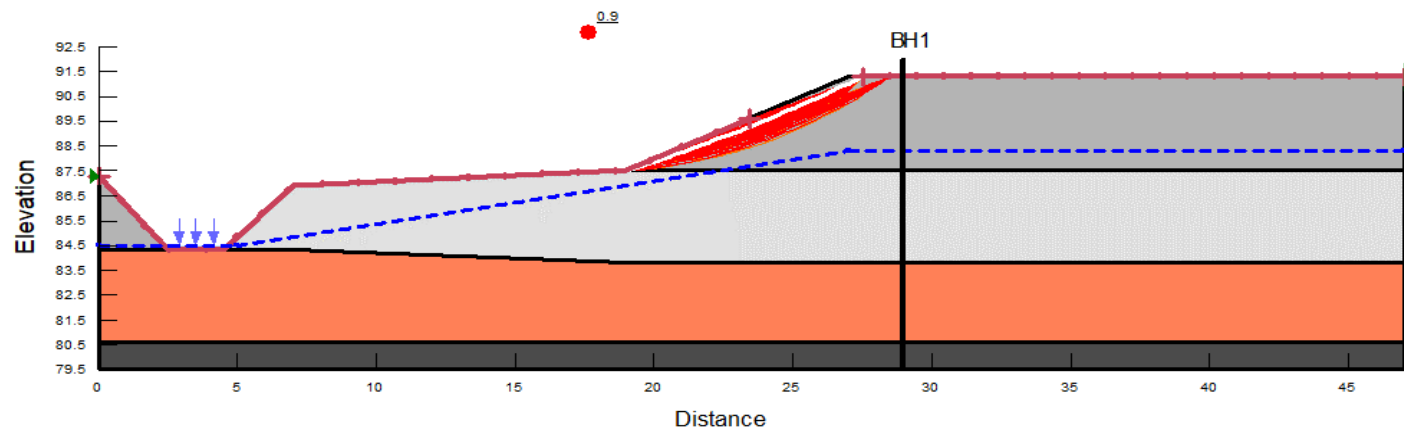
SLOPE STABILITY ANALYSIS - BH1
 DRAINED CONDITION
 PSEUDO-STATIC ANALYSIS

Color	Name	Unit Weight (kN/m ³)	Cohesion' (kPa)	Phi' (°)
■	Bedrock			
■	Existing Fill - Clayey silty sand	19	3	30
■	Existing Fill - Sand	19	0	30
■	Native Silty Sand/Sandy Silty	20	0	30

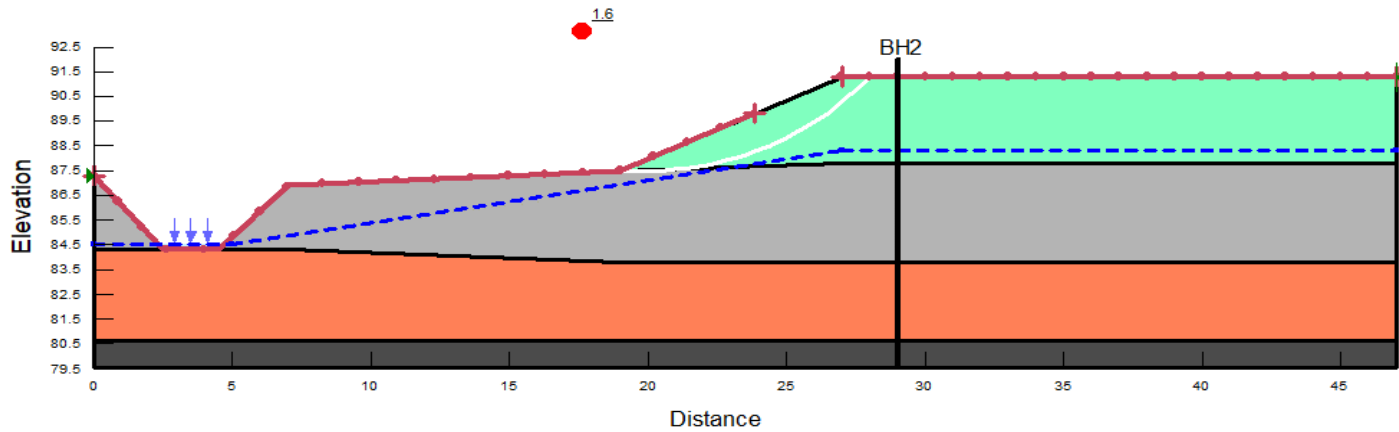
SLOPE STABILITY ANALYSIS - BH2
DRAINED CONDITION
STATIC ANALYSIS

Color	Name	Unit Weight (kN/m ³)	Cohesion' (kPa)	Phi' (°)
■	Bedrock			
■	Existing Clay Fill	17	3	25
■	Existing Granular Fill	19	0	30
■	Native Silty Sand/Sandy Silty	20	0	30

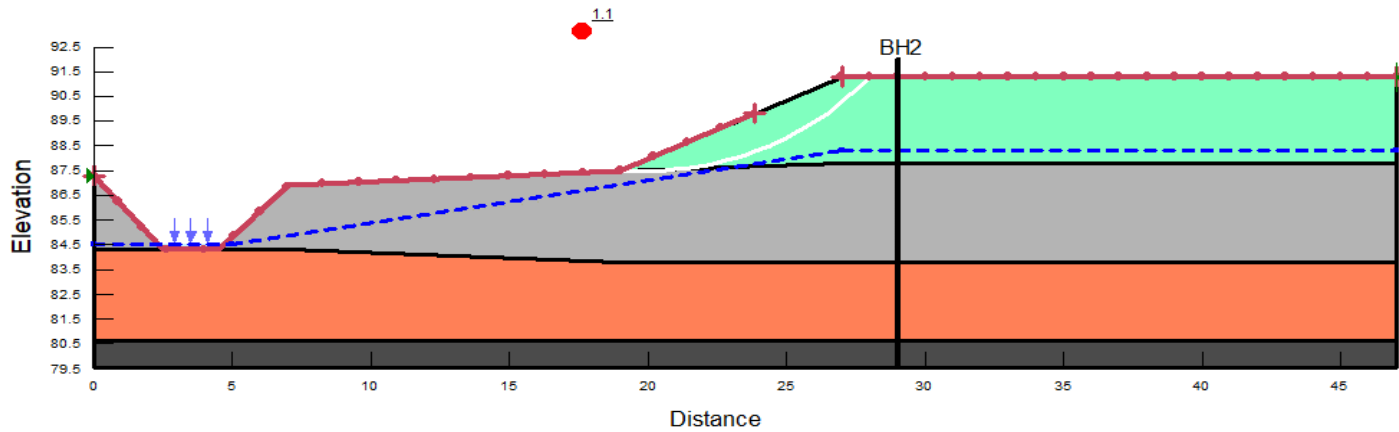
SLOPE STABILITY ANALYSIS - BH2
 DRAINED CONDITION
 PSEUDO-STATIC ANALYSIS

Color	Name	Unit Weight (kN/m ³)	Cohesion' (kPa)	Phi' (°)
█	Bedrock			
█	Existing Clay Fill	17	3	25
█	Existing Granular Fill	19	0	30
█	Native Silty Sand/Sandy Silty	20	0	30
